# Inspection of Automatic Sprinkler System

Draeger/FSI	Complete
Client/Site Name	
Draeger/FSI	
Billing Address	
Fire Sprinkler Installations	
Attention:	
Hein Fietze Jullian Niehaus	
Document No	UNC.9918
Prepared by	Keith van Onselen
Conducted on	14.12.2022 13:27 SAST
Site Location	Draeger ERF 60952 East London Industrial Development Zone (ELIDZ) East London

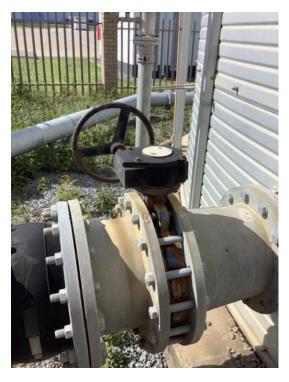
Photo 5

5.6 Suction Isolating	y Valves Secured in the	<b>Open Position</b>
-----------------------	-------------------------	----------------------

No

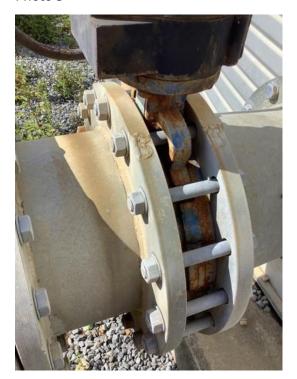
Photo 7

5.9 Drain valves secured in the Closed Position.	No
5.10 Flanges / Equipment Short Bolted	Yes

We recommend that the bolts for these flanges be removed and replaced with the correctly sized bolts so as to ensure that at least two full thread pitches past the chamfer protrude beyond the nut

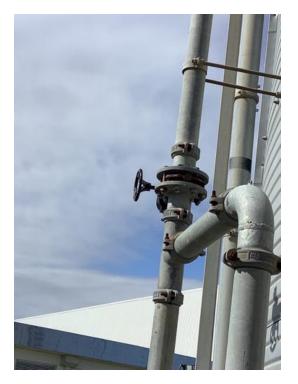
Photo 6

5.7 Tank Suction Piping Correctly Supported	No
5.8 Infill Isolating Valves Secured in the Open Position.	No

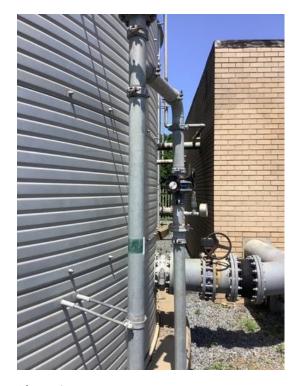
Photo 9

- The minimum tank infill diameter must be 100mm, it is recommended that the infill be rectified by your installer.

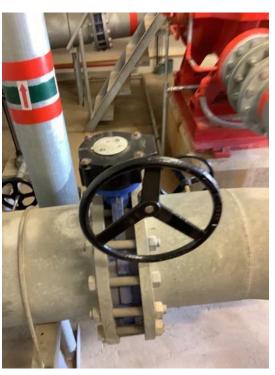
Photo 12

# 6.1.9 Diesel Engine Stop Lever Labeled Yes 6.1.10 Isolating Valves Correctly Labeled No

It is recommended all isolating valves be labeled "Normally Open" or "Normally Closed".

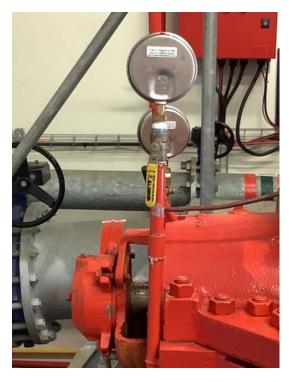
Photo 13

6.2.3 Mechanical Ventilation Installed	Yes
6.2.4 Hour Meters Installed	Yes
6.2.5 Correct Pressure Gauges Installed	Yes
6.2.6 Correct Suction Pressure Gauge Installed.	Yes
6.2.7 Correct Gauge Cocks Installed	No

All pressure gauges fitted to a sprinkler system shall be fitted with an isolating gauge cock with bleed to be able to confirm gauge operation back to zero and enable each pressure gauge to be readily removed without interruption of the installation water supplies.

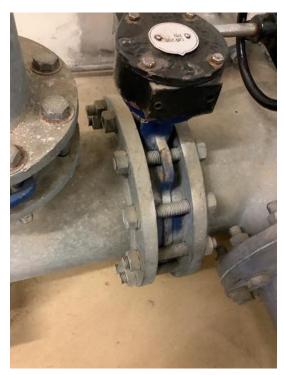
Photo 16

#### 6.2.9 Flanges / Equipment Short Bolted

We recommend that the bolts for these flanges be removed and replaced with the correctly sized

bolts so as to ensure that at least two full thread pitches past the c	hamfer protrude beyond the
nut.	name produce beyond the

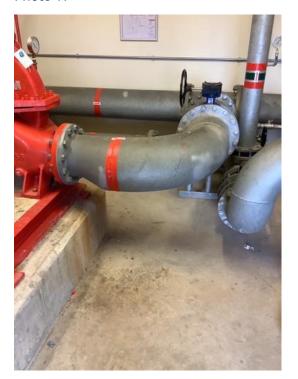
Photo 19

6.8.7 Base Grouted In	Yes
6.8.8 Base Painted	Yes
6.8.9 Delivery Piping Correctly Supported	Yes
6.8.10 Suction Piping Correctly Supported	No

It is recommended that additional support be provided on the pump suction line as close to the pump casing as possible. This is to ensure that there is no strain on the pump casing. If strain is present, it results in axial loading which in turn places excessive wear on the pump resulting in eventual or premature failure. It has been found that some pump and suction alignments have placed excessive strain on the volute of the pump resulting in poor performance.

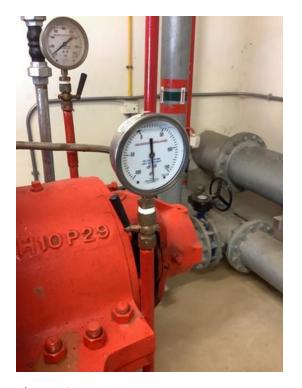
Photo 18

Gauge is faulty. This must be addressed by your installer

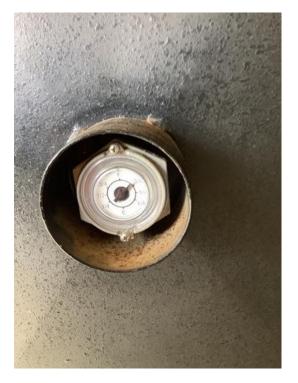
Photo 23

6.5.2 Diesel Tank Level

This tank must be kept full at all times and sufficient fuel for an additional six hours running time, (on full load) must be kept within on site.

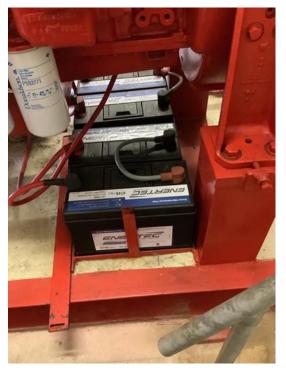
Photo 27

6.5.17 Eccentric Reducer Piped Correctly	Yes
6.5.18 Correct Fuel Lines	Yes
6.5.19 Oil Level	O.K.
6.5.20 Batteries Installed on Stillage	Yes
6.5.21 Batteries Locked	No

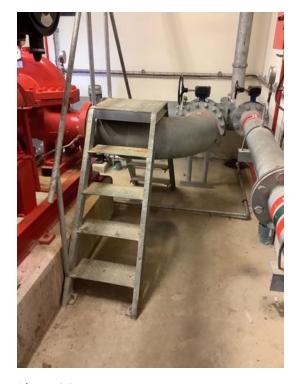
Photo 26

#### **6.5.16 Suction Piping Correctly Supported**

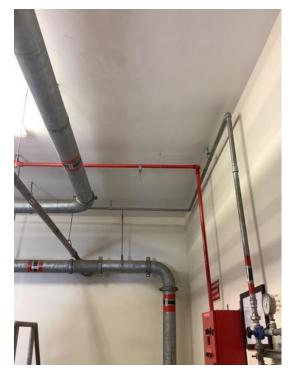
Photo 37

A hanger supporting the remote test line has come adrift

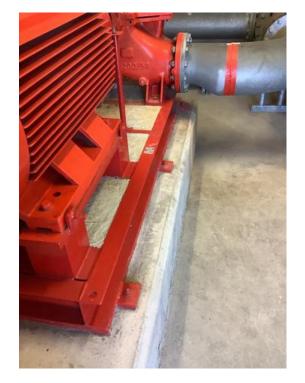
Photo 39

Foundation bolts have been passed through lugs that have been welded to the base plate for the pump set base frame. The bolts should pass through the purpose made holes in the pump set base frame. The stability of the pump set checked by your installer

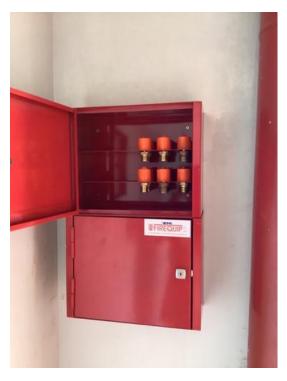
Photo 49

7.5 Sprinkler Valve Instruction Chart	Yes
7.6 Is a sprinkler spares box present	Yes
7.6.1 Was the spares box contents accessible	Yes
7.6.2 Are the spares quantities correct	No

The correct quantity of spare sprinklers and compatible sprinkler spanner of the types used must be kept within the spares box at all times.
