Inspection of Automatic Sprinkler System

Bushveld Energy

UNC.9855

Bushveld Energy
ELIDZ (East London Industrial
Development Zone)
ERF 60936

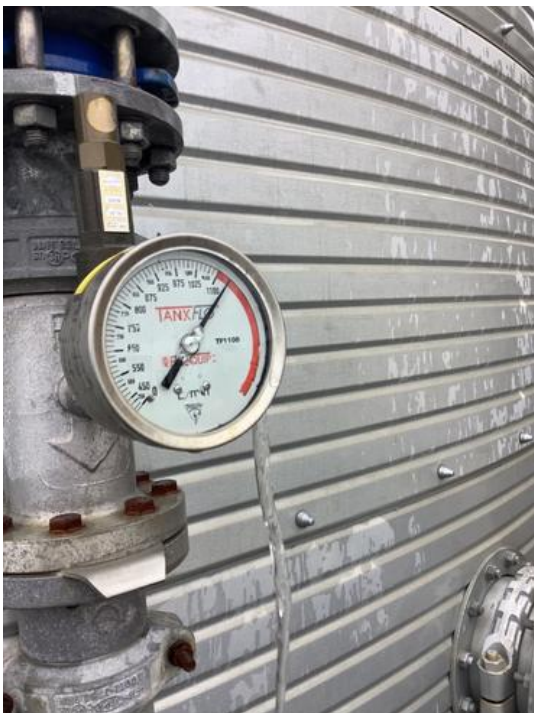
Photo 3

Both infills to the tanks were found in the closed position and the diesel driven pump failed to meet its duty requirements

5.2 Tank Infill

Recorded

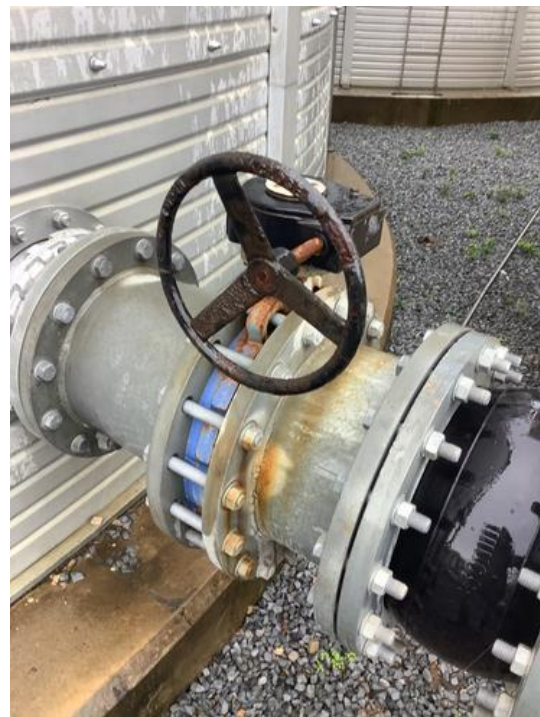
Photo 6

5.6 Suction Isolating Valves Secured in the Open Position

No

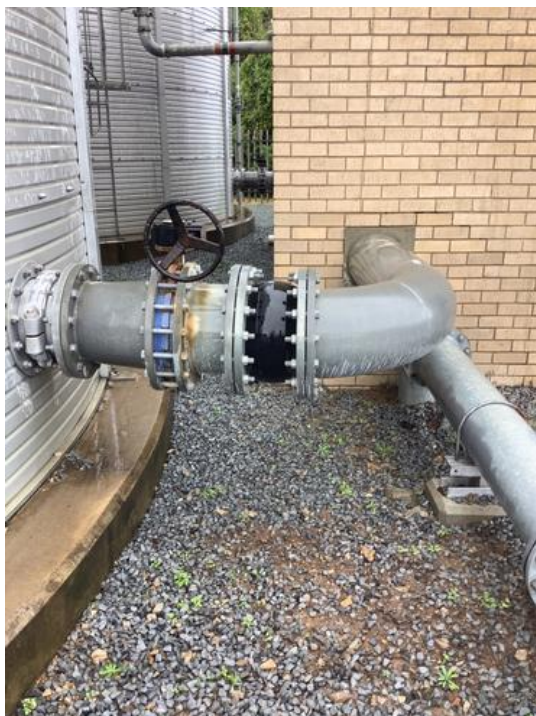
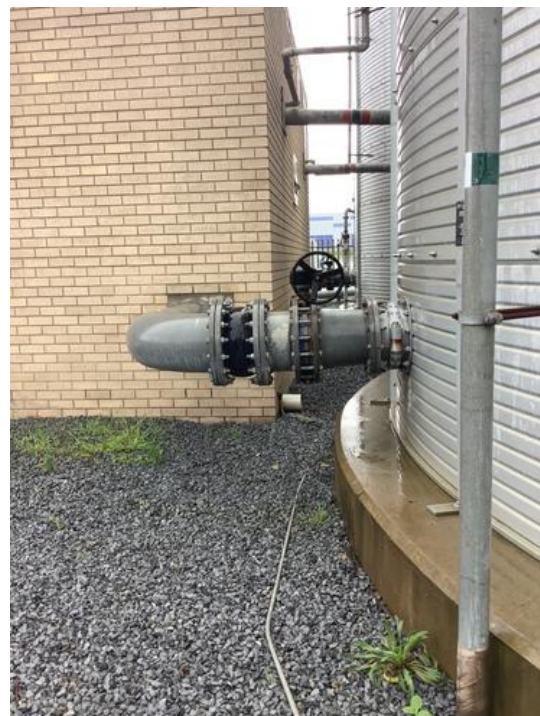
5.7 Tank Suction Piping Correctly Supported

No

It is recommended that additional support be provided on the tank suction line.

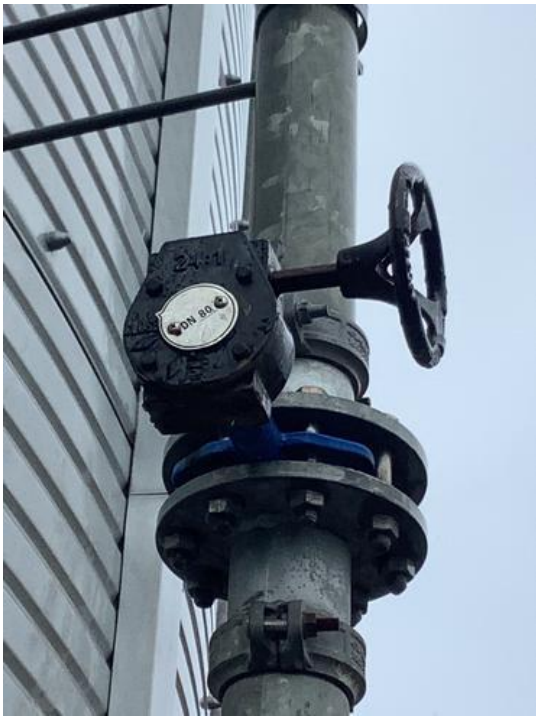
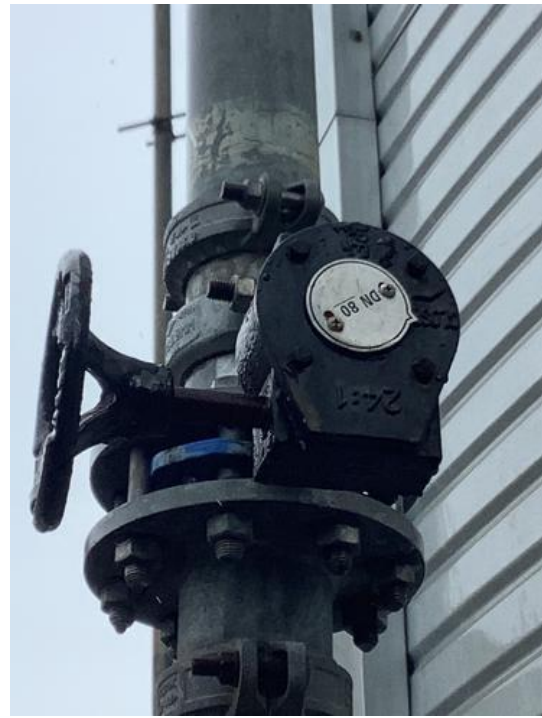
Refer to Water Supplies - Section 5.
Tanks are not full and both infill valves were found in the closed position

5.8 Infill Isolating Valves Secured in the Open Position.

No

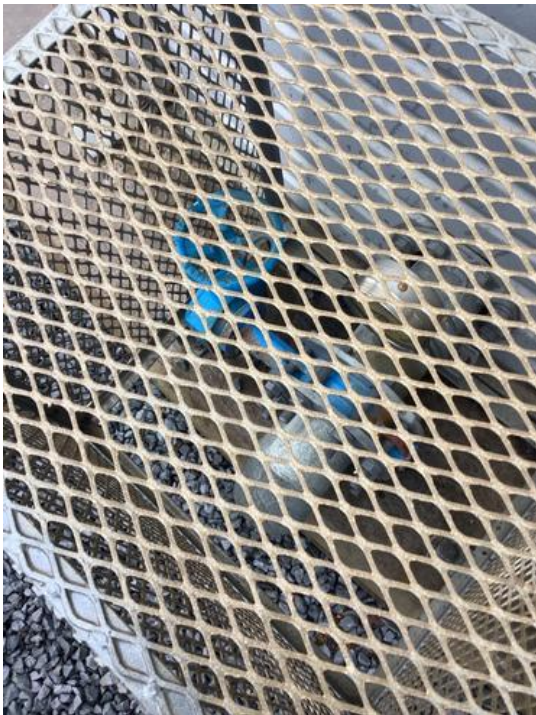
Photo 11

5.9 Drain valves secured in the Closed Position.

No

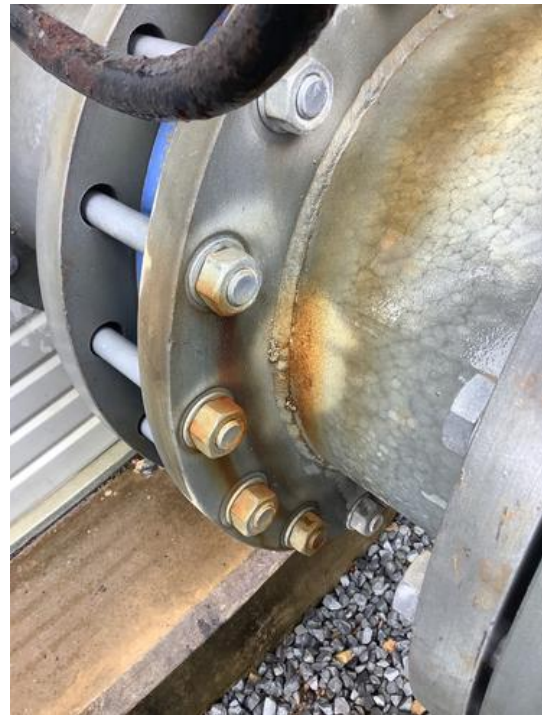
Photo 12

5.10 Flanges / Equipment Short Bolted

Yes

We recommend that the bolts for these flanges be removed and replaced with the correctly sized bolts so as to ensure that at least two full thread pitches past the chamfer protrude beyond the nut.

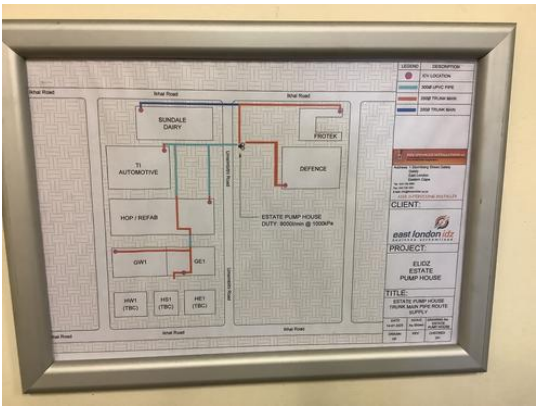
Photo 14

6.1.8 Block Plan Installed - Correct Details

No

It is recommended that a block plan be provided with the following indicated thereon:

The flows and pressures for the remote and favorable areas of operation recorded on the block plans must reflect the maximum pressure (Pmax) and the maximum flow (Qmax) respectively.

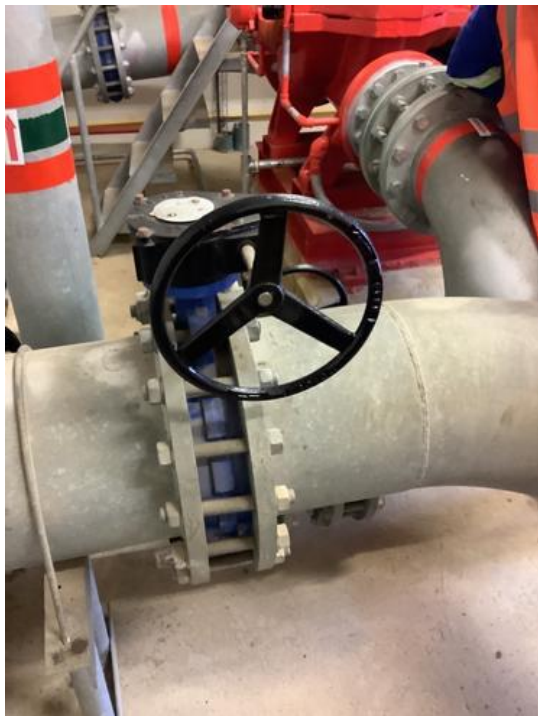
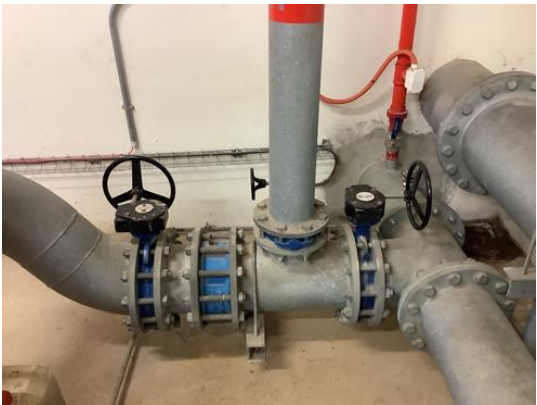
6.1.10 Isolating Valves Correctly Labeled

No

It is recommended all isolating valves be labeled "Normally Open" or "Normally Closed".

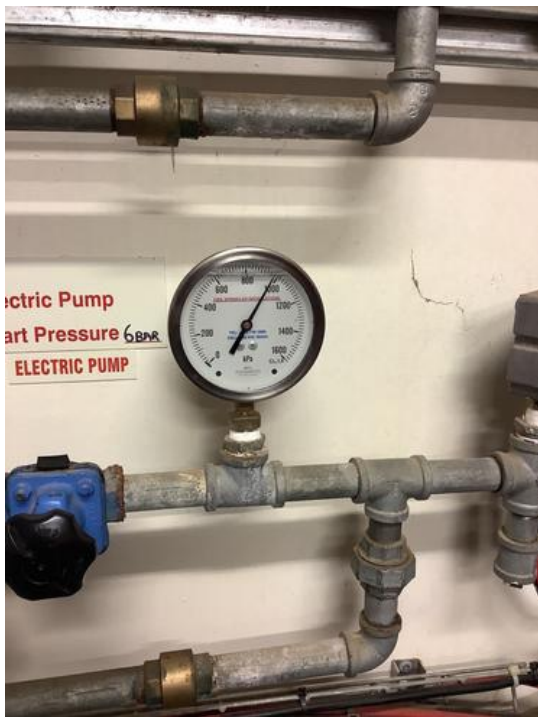
Photo 17

6.2.7 Correct Gauge Cocks Installed

No

All pressure gauges fitted to a sprinkler system shall be fitted with an isolating gauge cock with bleed to be able to confirm gauge operation back to zero and enable each pressure gauge to be readily removed without interruption of the installation water supplies.

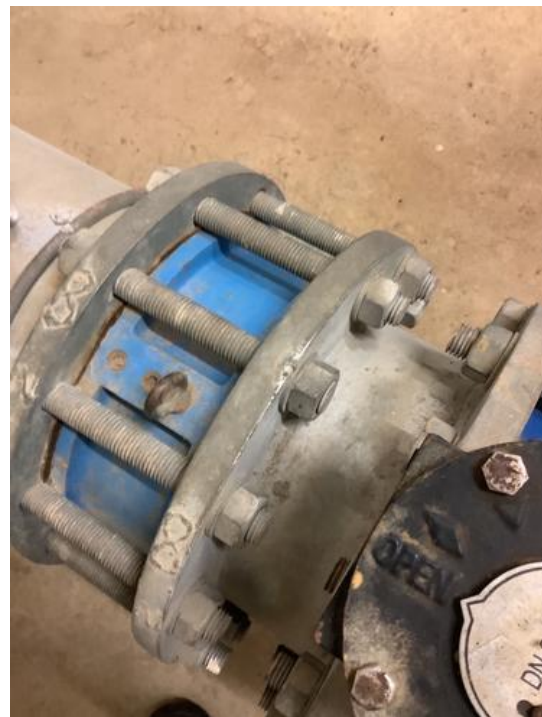
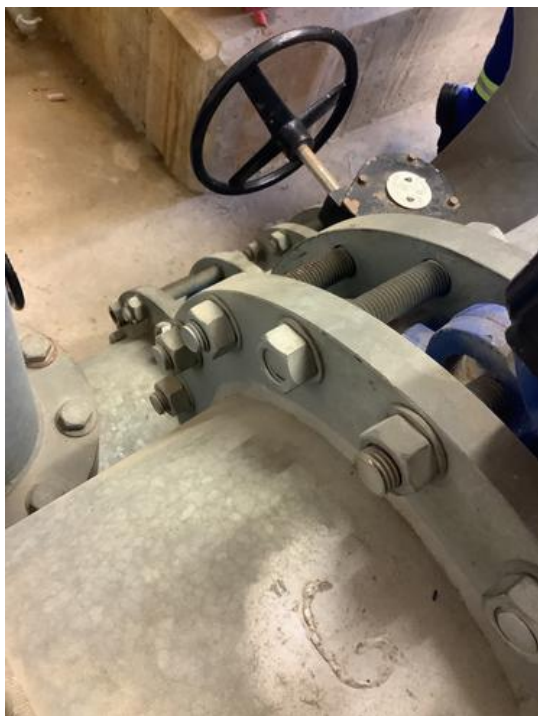
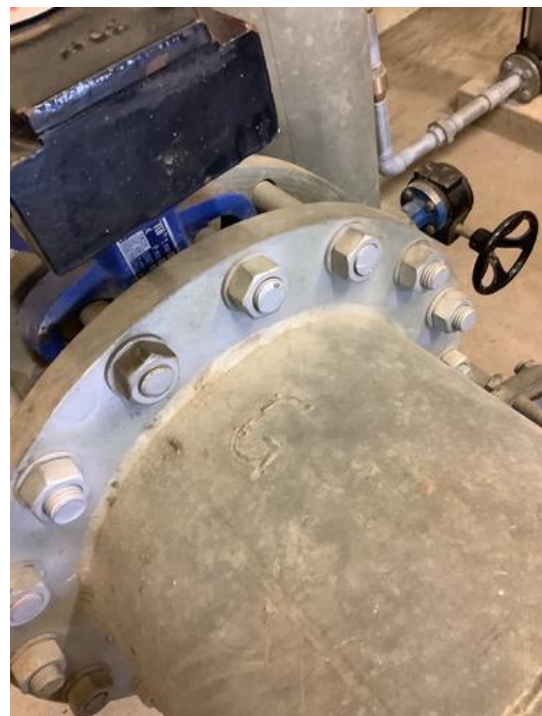
6.2.9 Flanges / Equipment Short Bolted

Yes

We recommend that the bolts for these flanges be removed and replaced with the correctly sized bolts so as to ensure that at least two full thread pitches past the chamfer protrude beyond the nut.

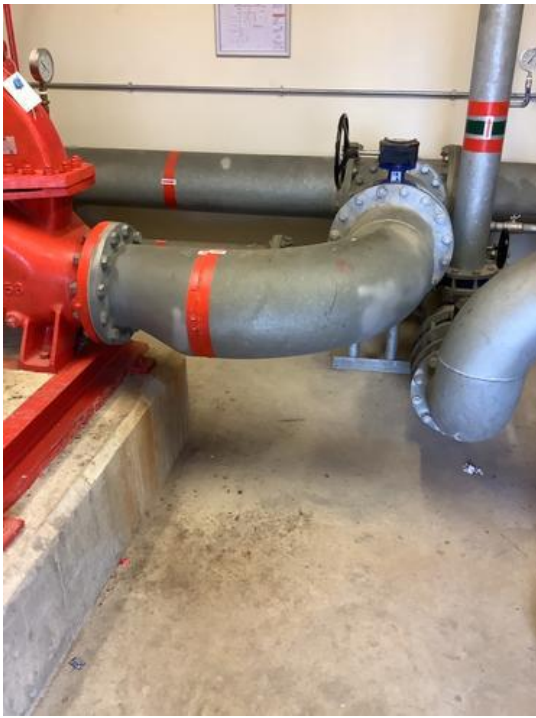
Photo 25

6.8.10 Suction Piping Correctly Supported

No

It is recommended that additional support be provided on the pump suction line as close to the pump casing as possible. This is to ensure that there is no strain on the pump casing. If strain is present, it results in axial loading which in turn places excessive wear on the pump resulting in eventual or premature failure. It has been found that some pump and suction alignments have placed excessive strain on the volute of the pump resulting in poor performance.

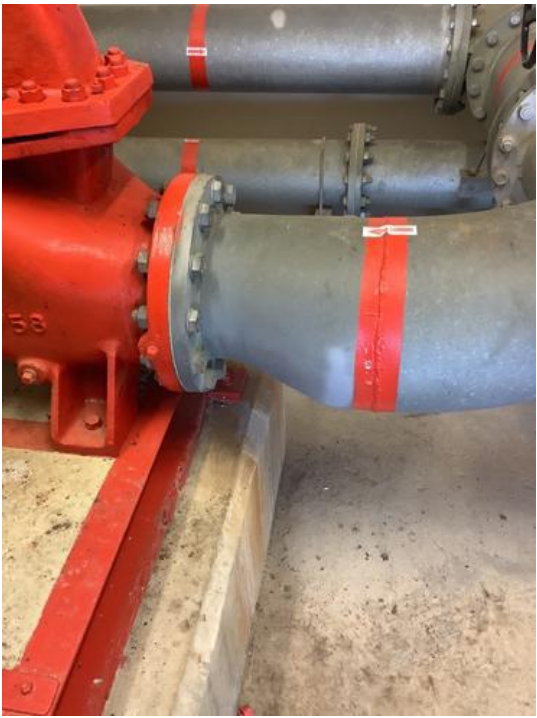
Photo 26

6.8.11 Eccentric Reducer Piped Correctly

No

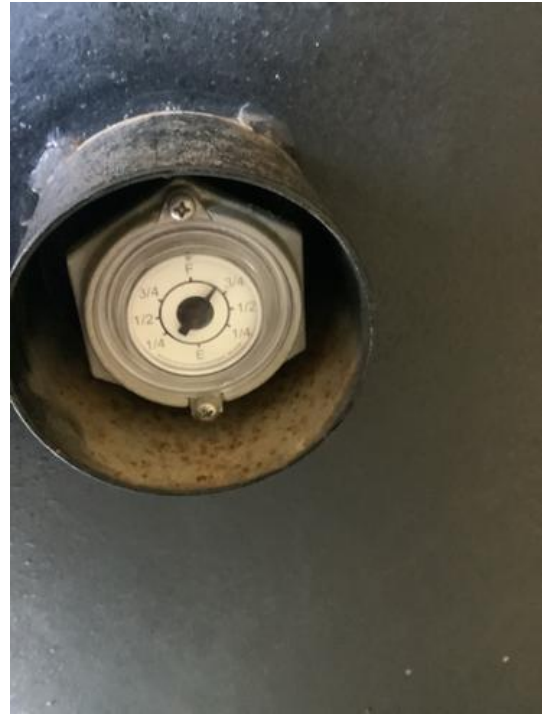
Photo 30

6.5.2 Diesel Tank Level

3/4

This tank must be kept full at all times and sufficient fuel for an additional six hours running time, (on full load) must be kept within on site.

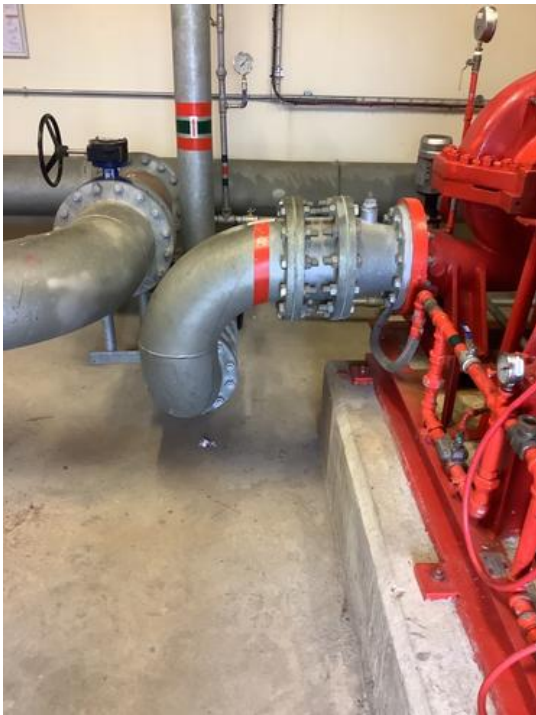
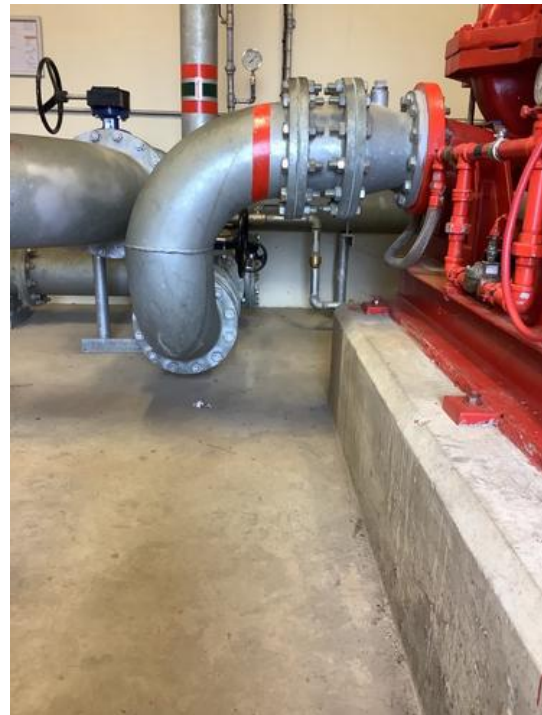
6.5.15 Delivery Piping Correctly Supported

No

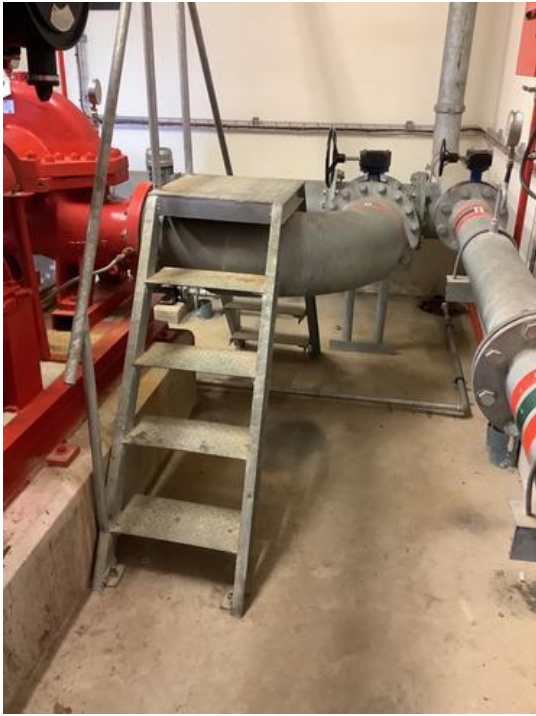
Photo 33

6.5.16 Suction Piping Correctly Supported

No

It is recommended that additional support be provided on the pump suction line as close to the pump casing as possible. This is to ensure that there is no strain on the pump casing. If strain is present, it results in axial loading which in turn places excessive wear on the pump resulting in eventual or premature failure. It has been found that some pump and suction alignments have placed excessive strain on the volute of the pump resulting in poor performance.

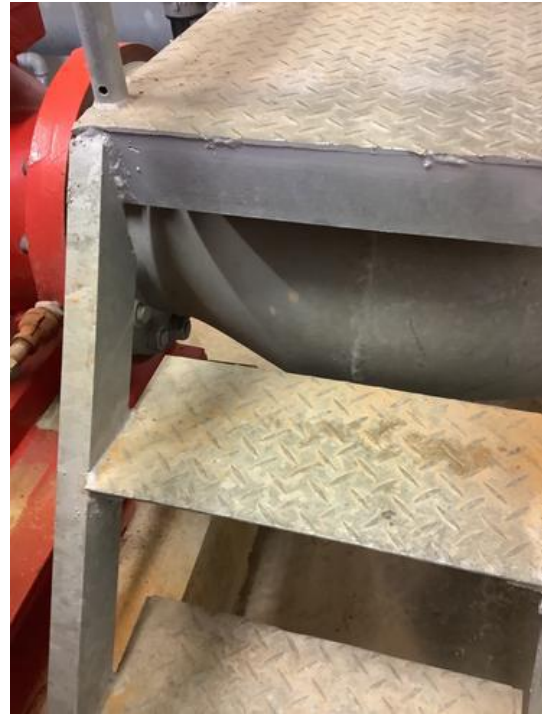
Photo 34

**6.5.17 Eccentric Reducer Piped Correctly**

No

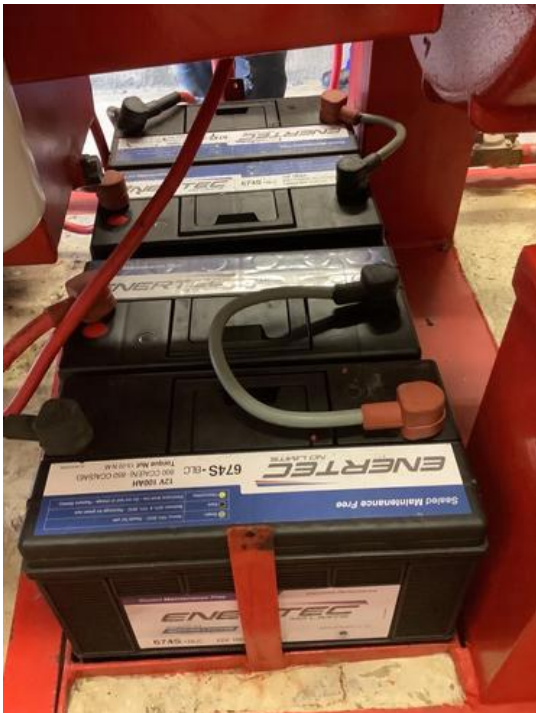
Photo 35

6.5.21 Batteries Locked

No

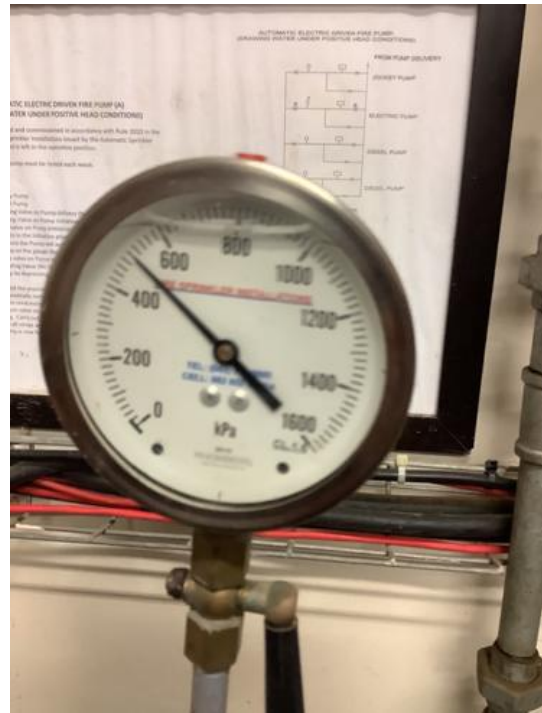
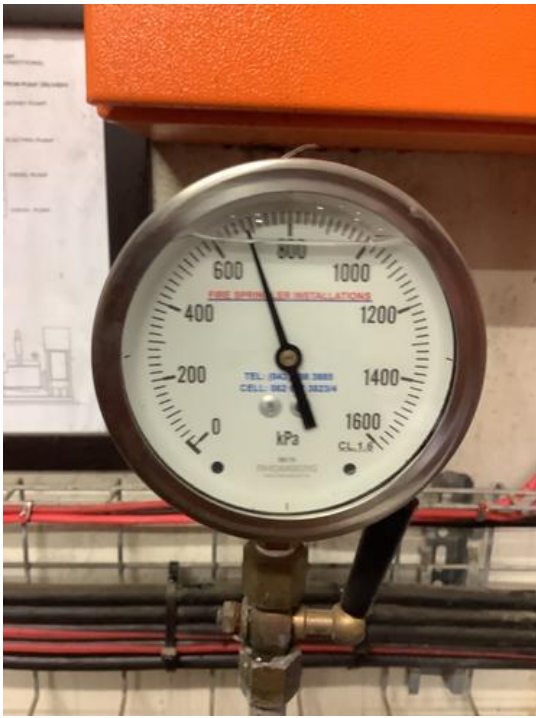
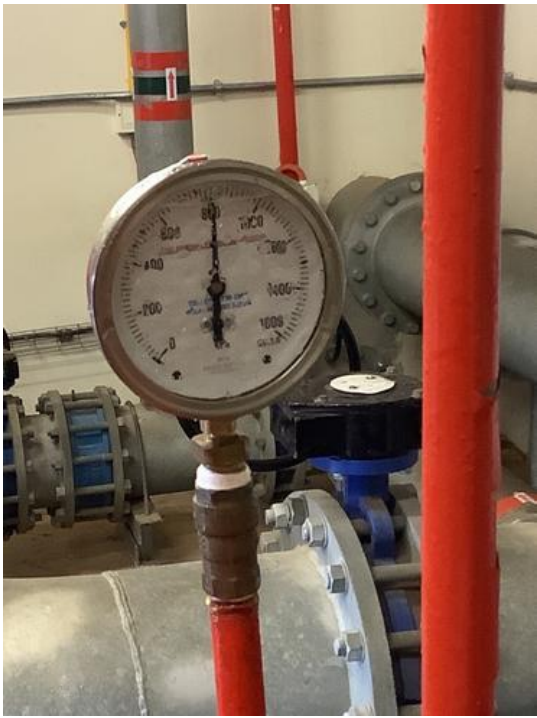
6.6.9 Flow Test Recorded

9000 l/min @ 800 kPa

6.6.10 Pump Flow Test

Failed

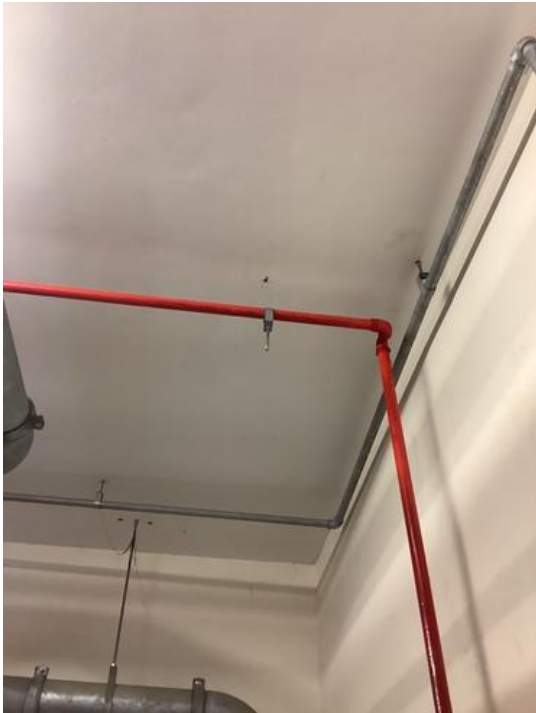
Photo 39

A hanger supporting the remote test line has come adrift

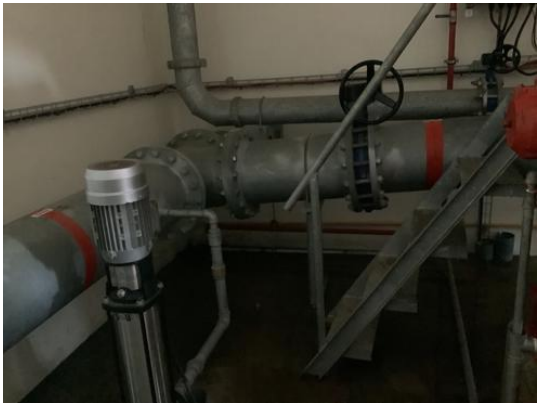
Photo 40

The suction line inclines slightly towards the pump.
