# Inspection of Automatic Sprinkler System

Fire Suppression Solutions - Automould - ELIDZ -  
East London

UNC.8484

Automould (New warehouse  
extension)

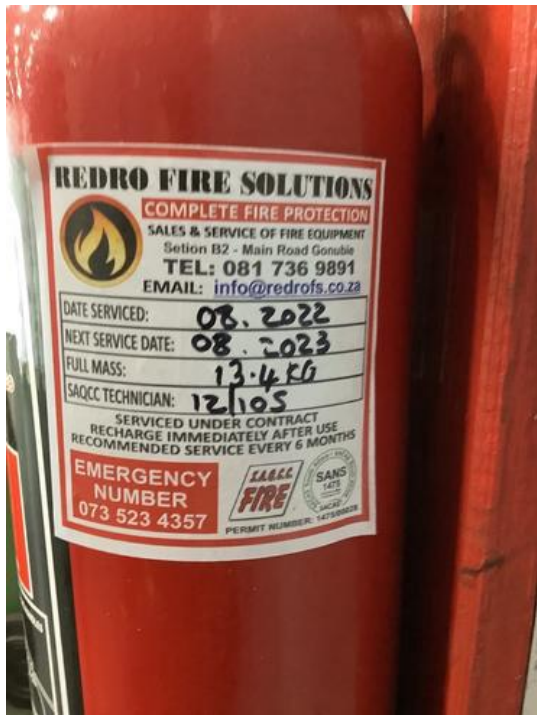
Photo 1

Clear access to the hand fire appliances must be maintained at all times.

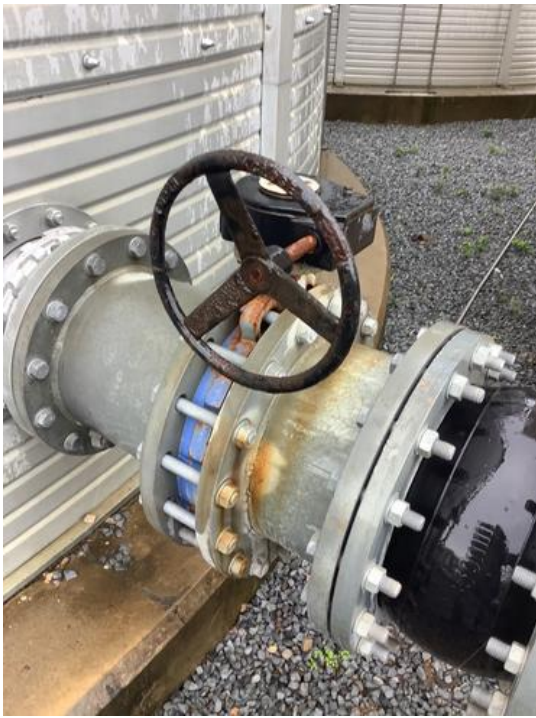
Photo 5

**5.6 Suction Isolating Valves Secured in the Open Position**

No

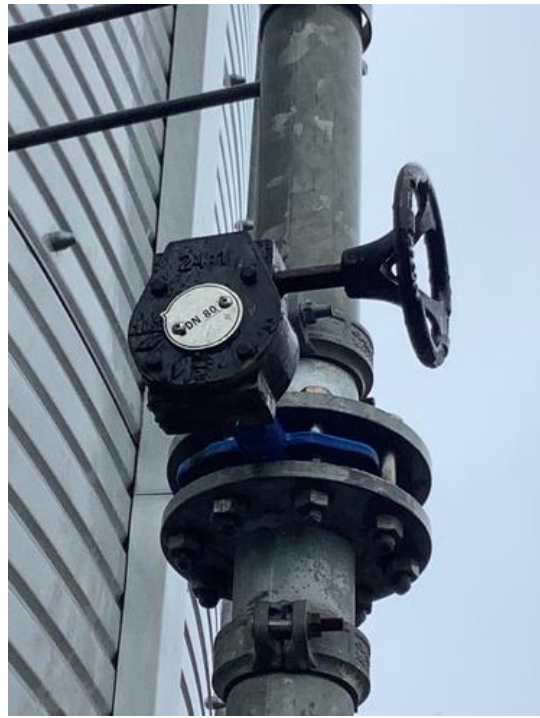
Photo 6

**5.8 Infill Isolating Valves Secured in the Open Position.**

No

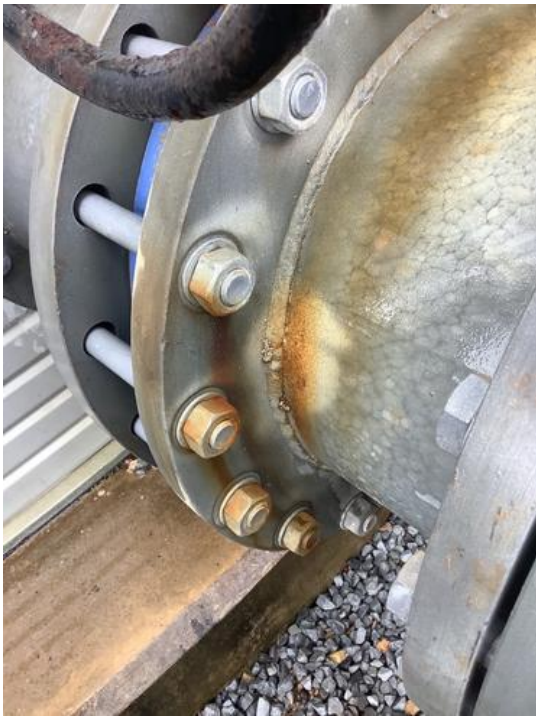
Photo 9

**5.10 Flanges / Equipment Short Bolted**

Yes

We recommend that the bolts for these flanges be removed and replaced with the correctly sized bolts so as to ensure that at least two full thread pitches past the chamfer protrude beyond the nut.

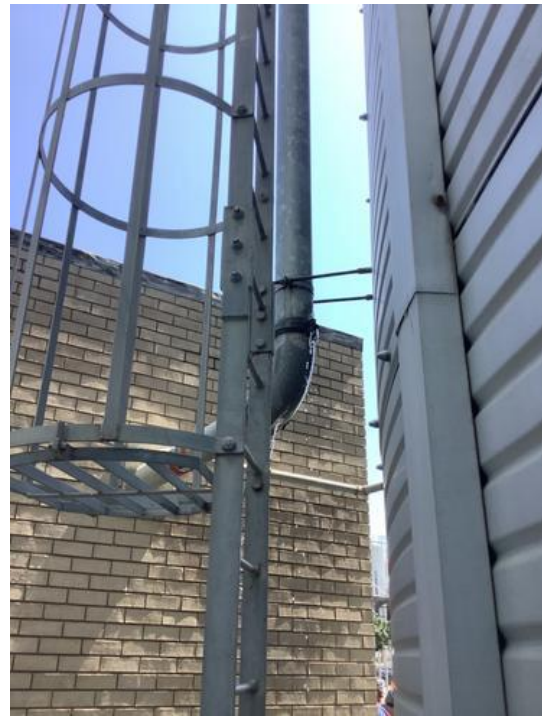
Photo 10

There is a leak in the test line return pipe

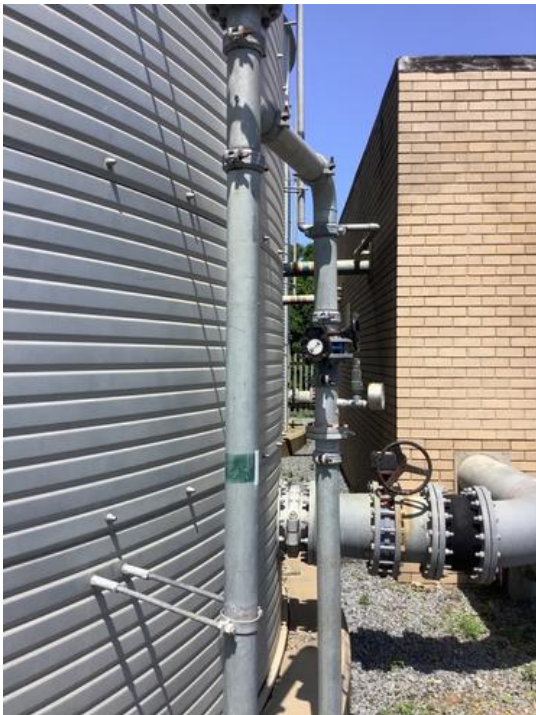
Photo 11

- The minimum tank infill diameter must be 100mm, it is recommended that the infill be rectified by your installer.

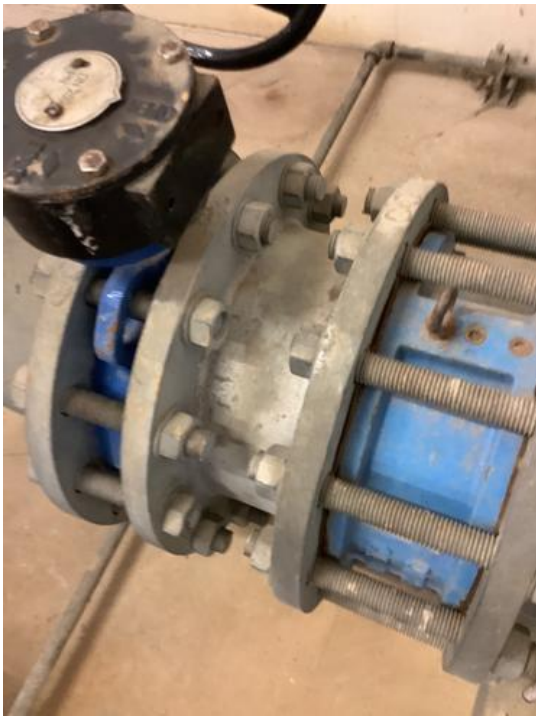
Photo 17

**6.2.9 Flanges / Equipment Short Bolted**

Yes

We recommend that the bolts for these flanges be removed and replaced with the correctly sized bolts so as to ensure that at least two full thread pitches past the chamfer protrude beyond the nut.

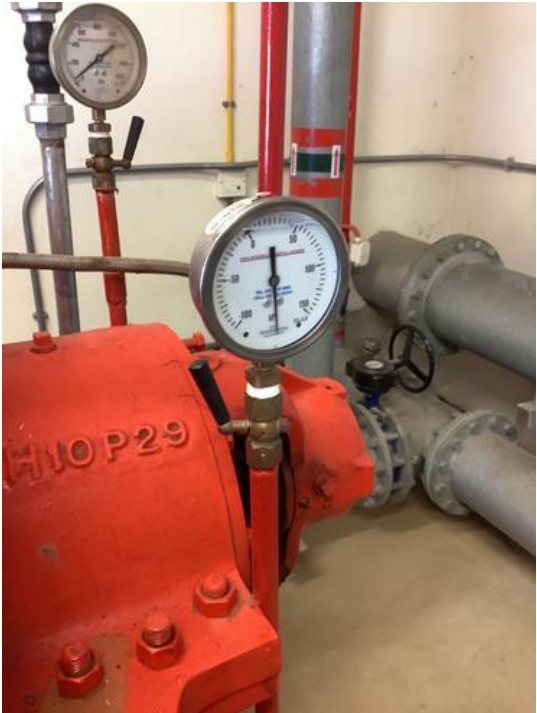
Photo 20

Gauge is faulty. This must be addressed by your installer

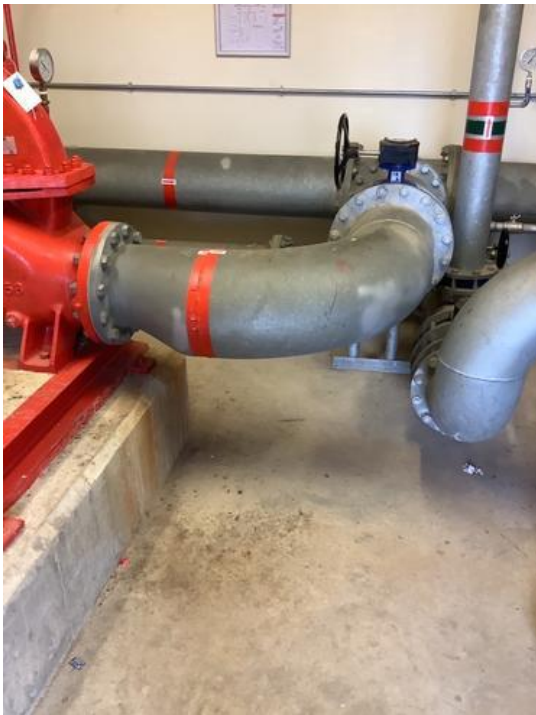
Photo 21

### 6.8.10 Suction Piping Correctly Supported

No

It is recommended that additional support be provided on the pump suction line as close to the pump casing as possible. This is to ensure that there is no strain on the pump casing. If strain is present, it results in axial loading which in turn places excessive wear on the pump resulting in eventual or premature failure. It has been found that some pump and suction alignments have placed excessive strain on the volute of the pump resulting in poor performance.

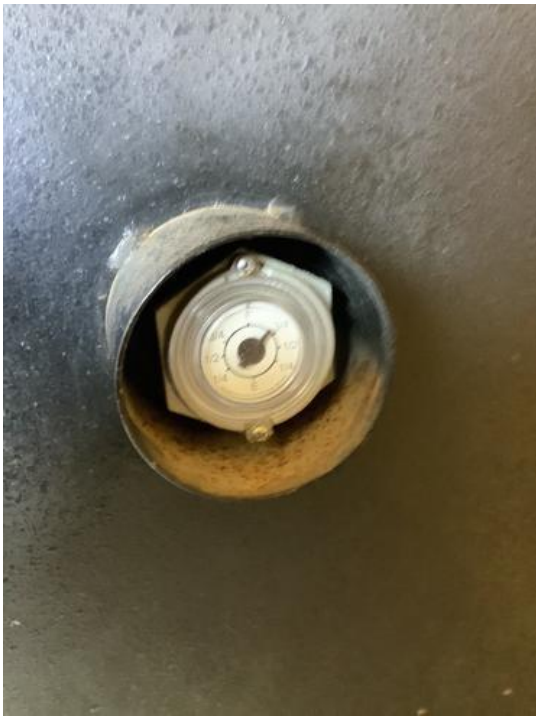
Photo 25

##### 6.5.2 Diesel Tank Level

3/4

This tank must be kept full at all times and sufficient fuel for an additional six hours running time, (on full load) must be kept within on site.

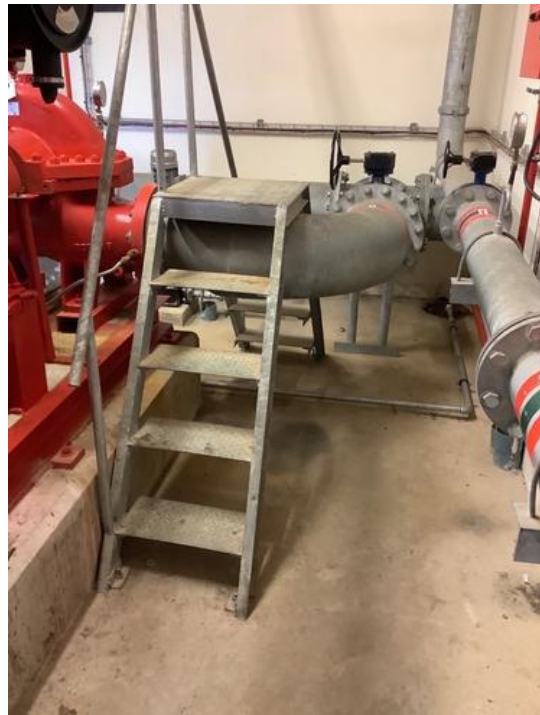
Photo 28

**6.5.16 Suction Piping Correctly Supported**

No

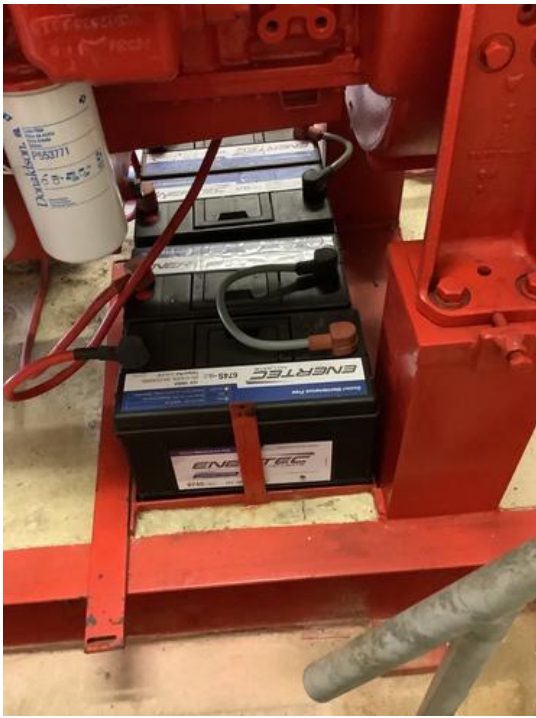
Photo 29

**6.5.21 Batteries Locked**

No

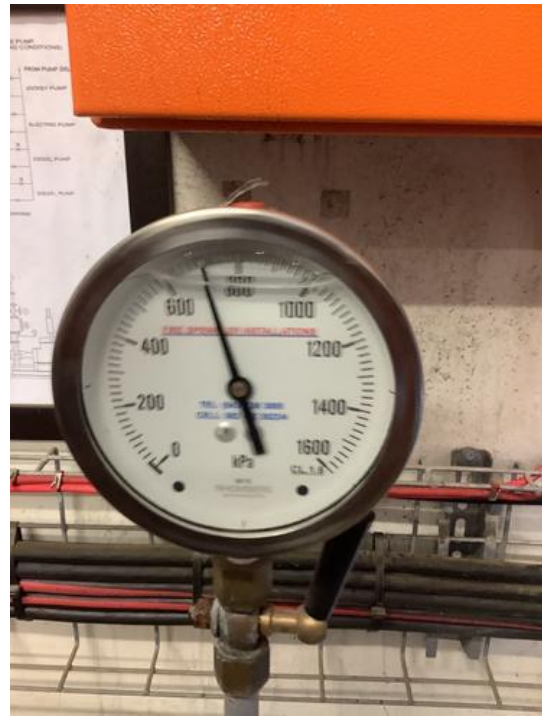
Photo 30

### 6.6.9 Flow Test Recorded

9000 l/min @ 800 kPa

Failed
