# Inspection of Automatic Sprinkler System

Automould - ELIDZ - East London

UNC.8484

09.05.2024 08:00 SAST

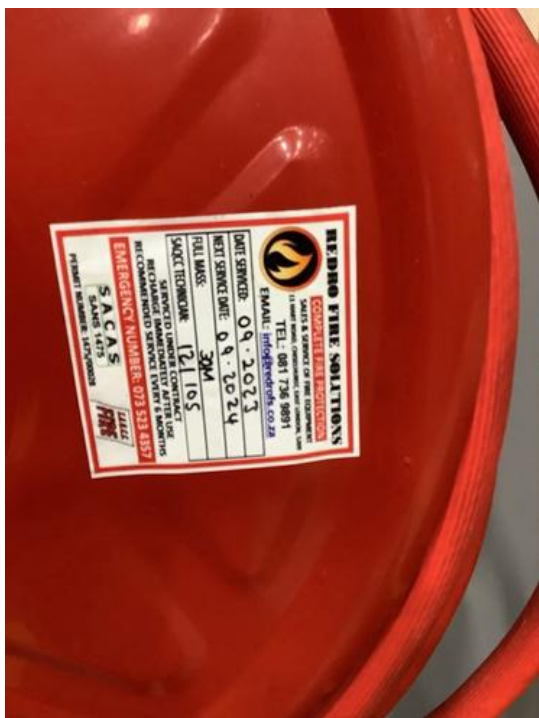
Photo 1

Clear access to the hand fire appliances must be maintained at all times.

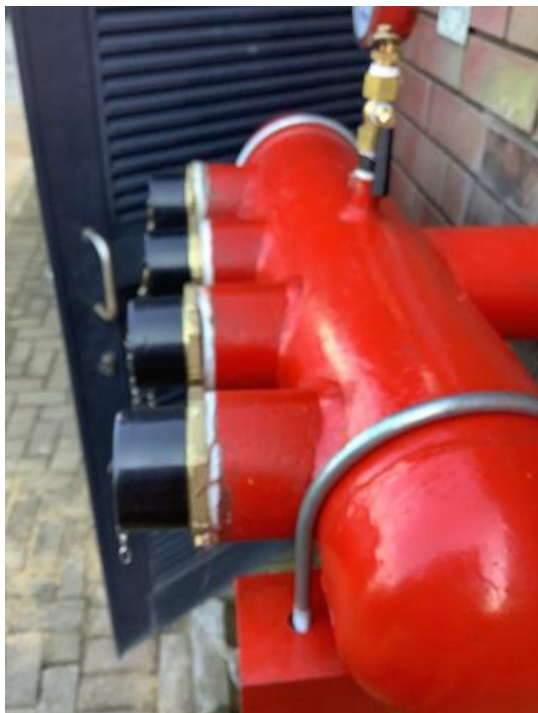
Photo 7

It appears that the booster connection piping to the main distribution riser is too long, which may restrict the opening of the booster plunger into the main distribution riser, this will prevent effective boosting of the sprinkler system and must be revised.

Installations must be fitted with fire brigade booster connections which will enable the fire brigade to pump water into the installation using their own equipment.

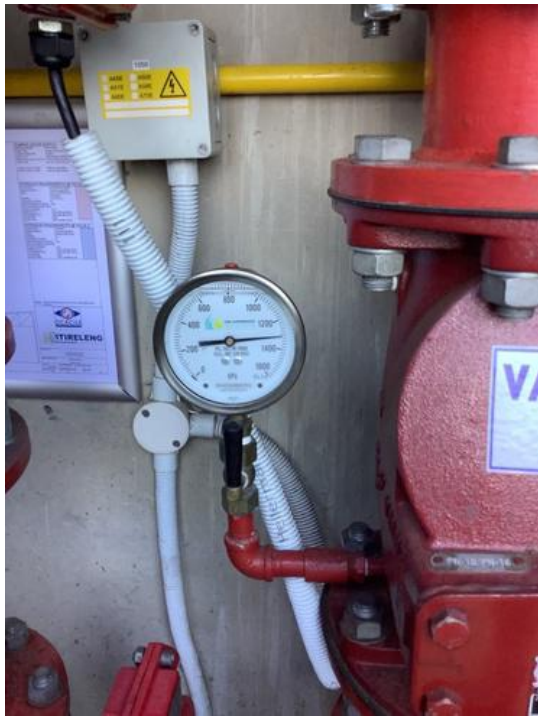
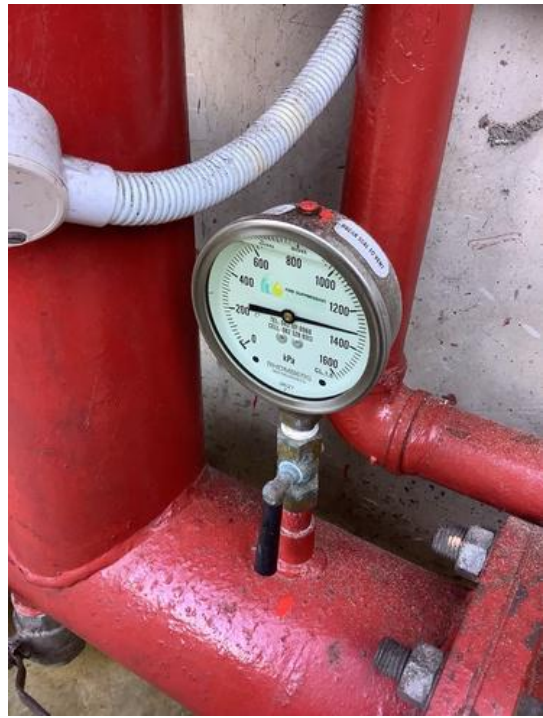
The system pressure has exceeded the maximum allowable pressure of 1200 kPa, this must be investigated and rectified by your installer.

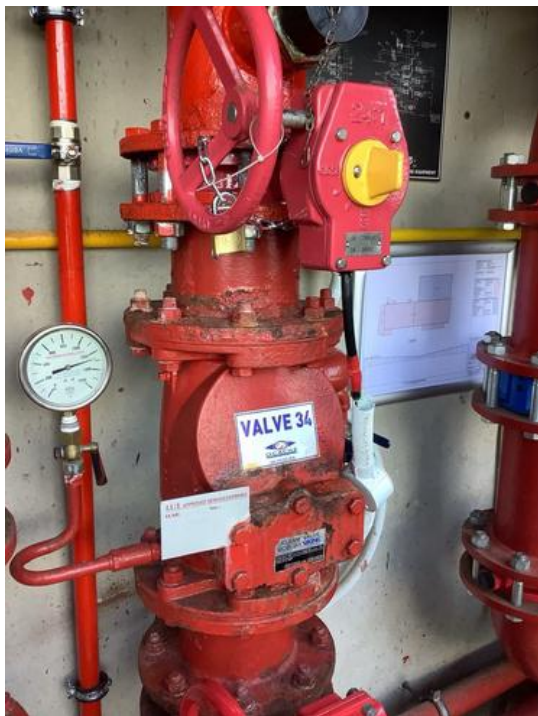
Photo 11

Corrosion is evident on the sprinkler pipe work and must be addressed by your installer.

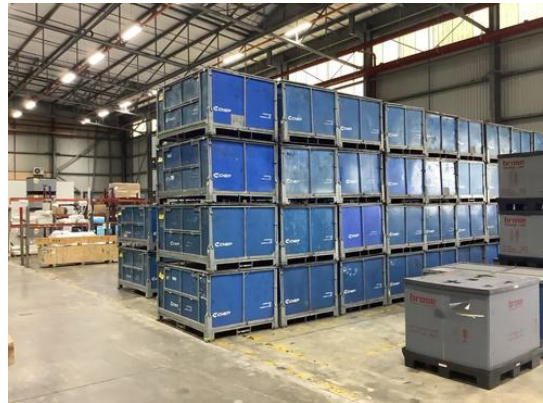
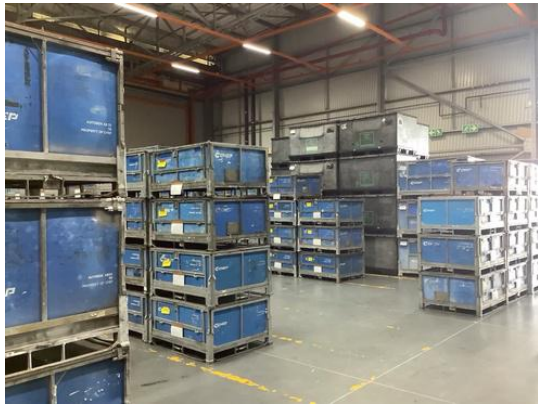
### Free Standing Block Storage and aisle widths are not being maintained. ☒

No block of storage shall exceed 150 m<sup>2</sup> of floor area and shall be surrounded by aisle widths of not less than 2,4 m.

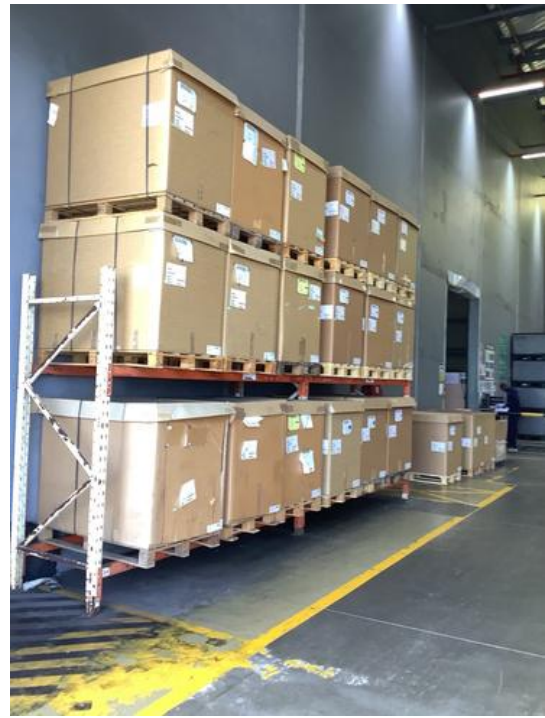
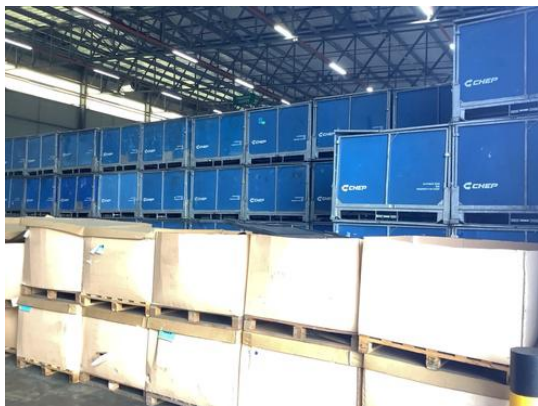
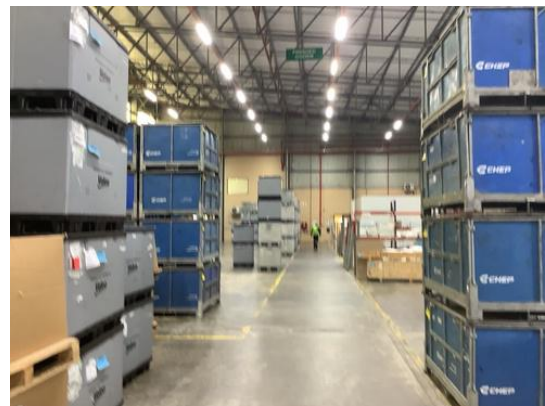
Yes

The storage heights must be maintained in accordance with the maximum allowable stack heights as detailed in this report. Should this not be possible, intermediate level protection is deemed to be mandatory.

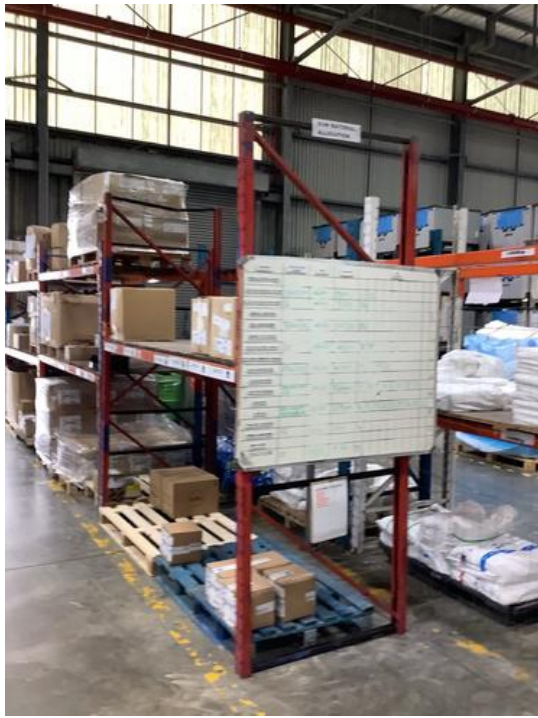
Photo 17

### Shelves exceed 1,0 metre in width. ☒

The shelves must be reduced to a maximum width of 1,0 metre or intermediate sprinkler protection will be mandatory at each shelf tier level.

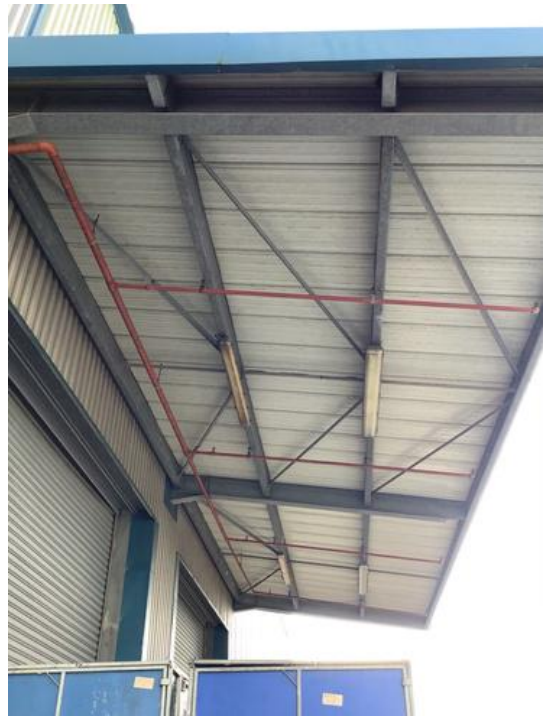
Photo 18

Corrosion is evident on the sprinkler pipe work and must be addressed by your installer.

Hangers are rusted

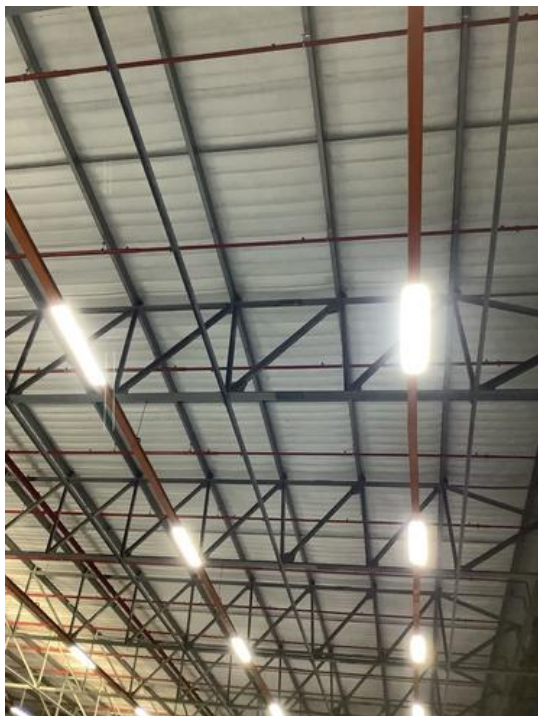
Photo 19

**Additional range pipe hangers must be installed to support**

the range pipe lengths extending between the first sprinkler and the main distribution pipe.

Production side of main between second and third sprinklers

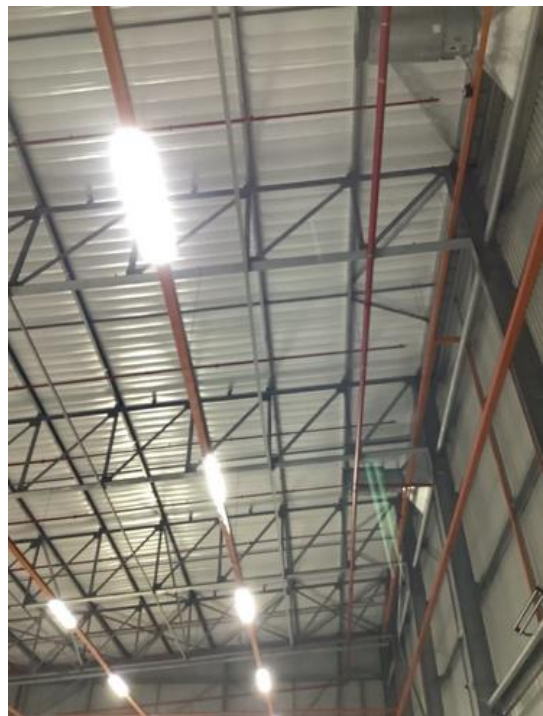
Photo 20

Distribution pattern of sprinklers affected.

Second Sprinkler from east wall

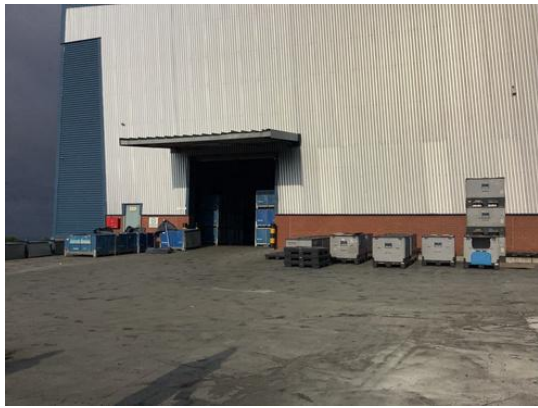
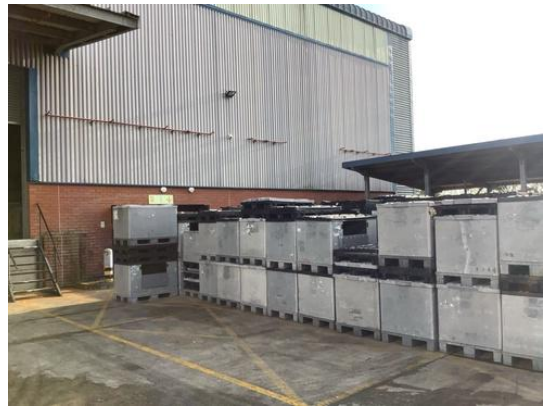
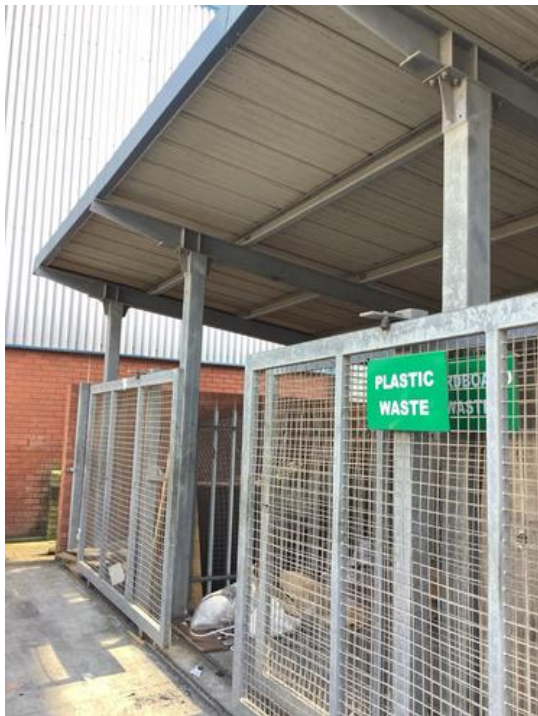
Storage too close to building.

Between loading canopies

Drencher heads required which are purpose made sprinklers designed to spray water over a surface to provide protection against fire exposure. It is not acceptable to use standard sprinkler heads with the fusible elements removed for the purpose of providing wall or face wetting. The drencher system must extend along the walls of the protected building to a distance of 15.0

metres beyond each end of the stored goods. The feed for the drenchers must be taken from the underside of the valves and not from the downstream side of the installation. The stop valve controlling the drencher installation shall be located near to the sprinkler control valves, but must be at least 10,0 metres from the goods stored or from the area where they are expected to operate.

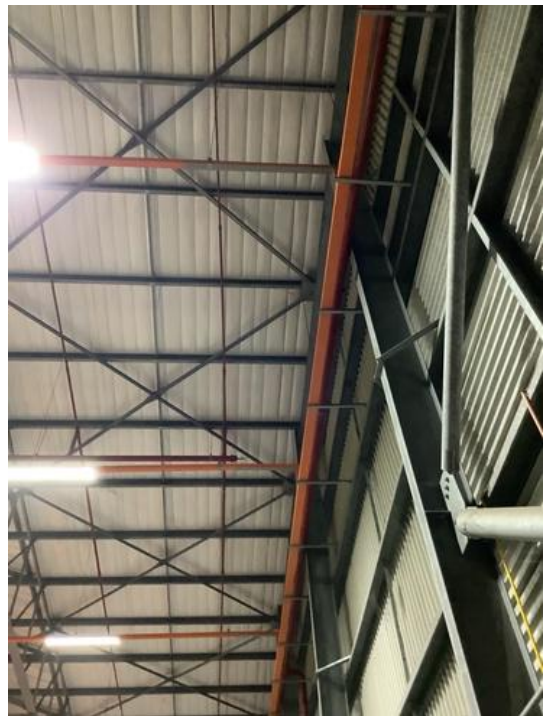
Photo 24

**Sprinklers are out of effective working distance.**

Last range

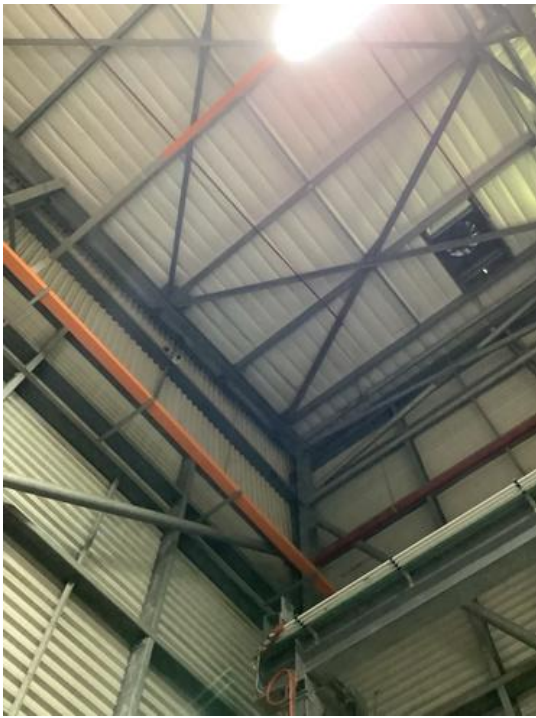
Photo 25

**Hangers have come adrift and must be re-fixed to their original positions.**

Back right. Last range

**The sprinkler pipe work must be correctly supported.**

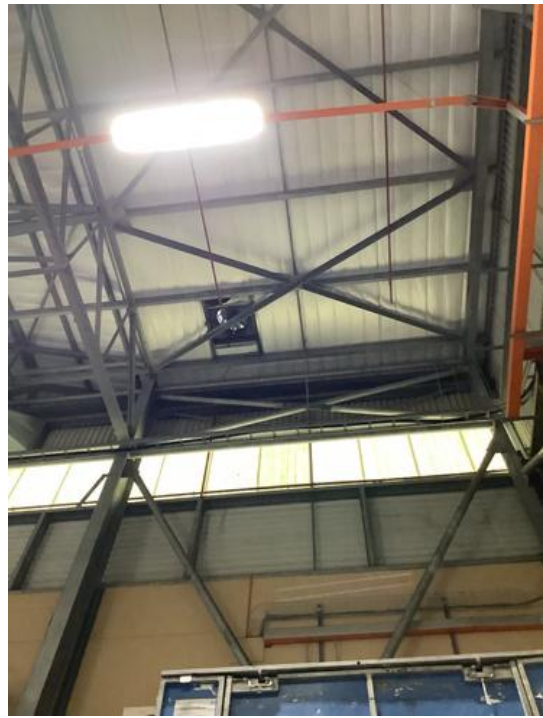
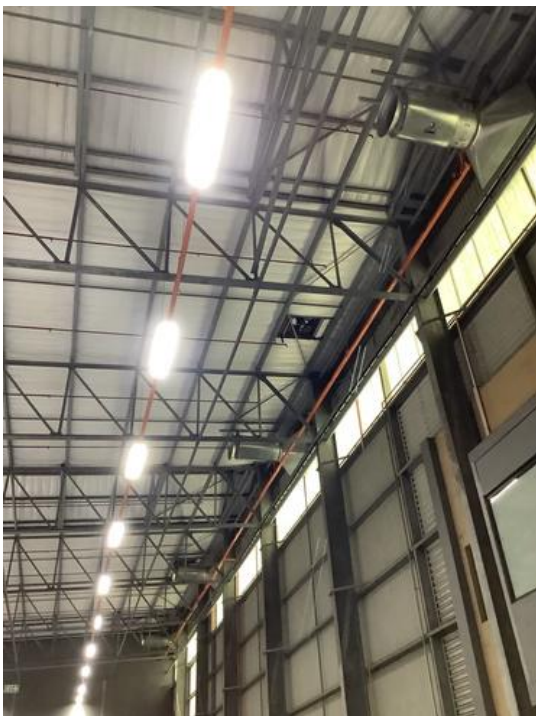
**Sprinklers installed beneath open cell surfaces / translucent sheeting.**

Under extraction vents

All sprinklers located beneath open celled floors or stairwells and translucent sheeting must have approved water shields fitted above the sprinklers.
