Inspection of Automatic Sprinkler System

BE5 DSV East London Industrial
Development Zone

UNC.8480

09.05.2024 08:00 SAST

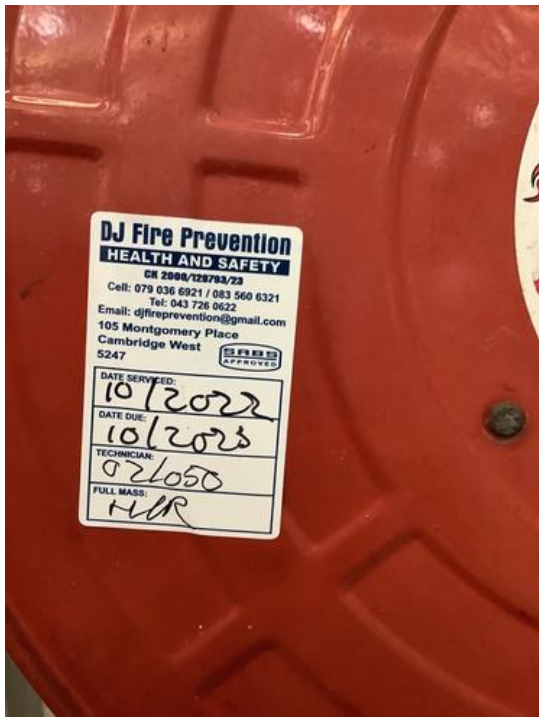
Photo 1

Clear access to the hand fire appliances must be maintained at all times.

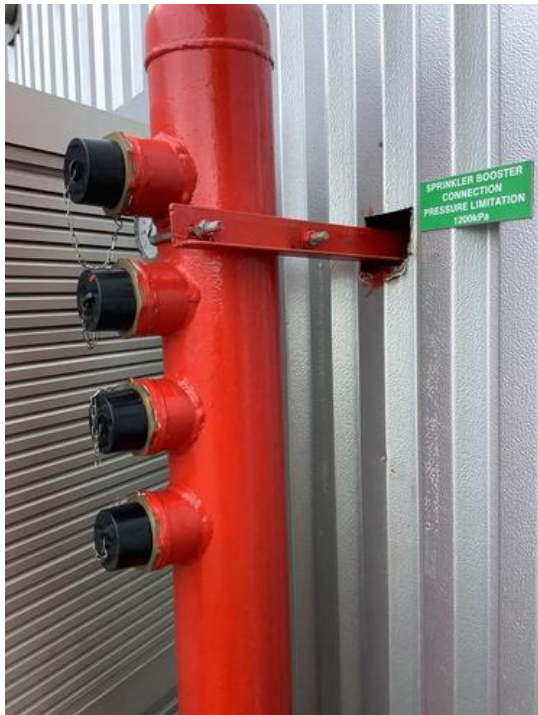
Photo 9

No

It appears that the booster connection piping to the main distribution riser is too long, which may restrict the opening of the booster plunger into the main distribution riser, this will prevent effective boosting of the sprinkler system and must be revised.

Installations must be fitted with fire brigade booster connections which will enable the fire brigade to pump water into the installation using their own equipment.

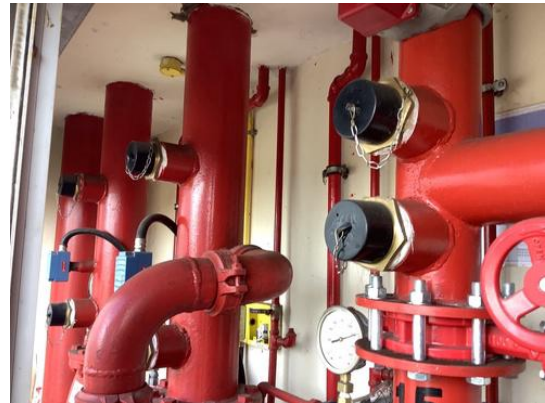
Photo 10

No

The riser main must be properly supported in accordance with the rules.

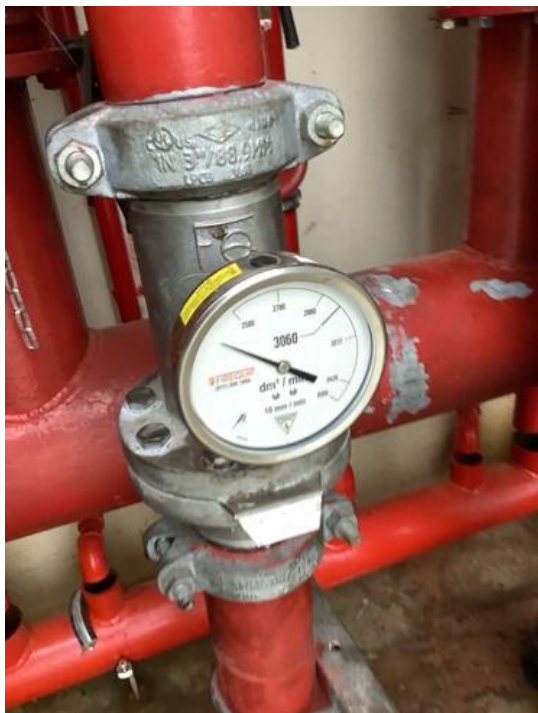
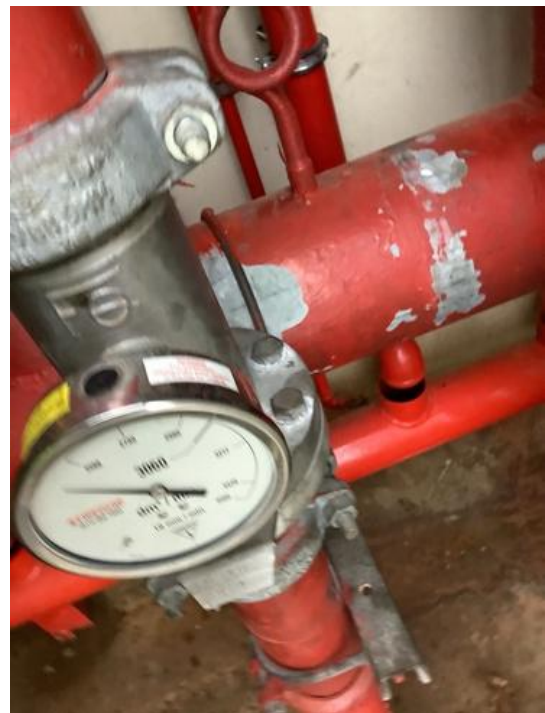
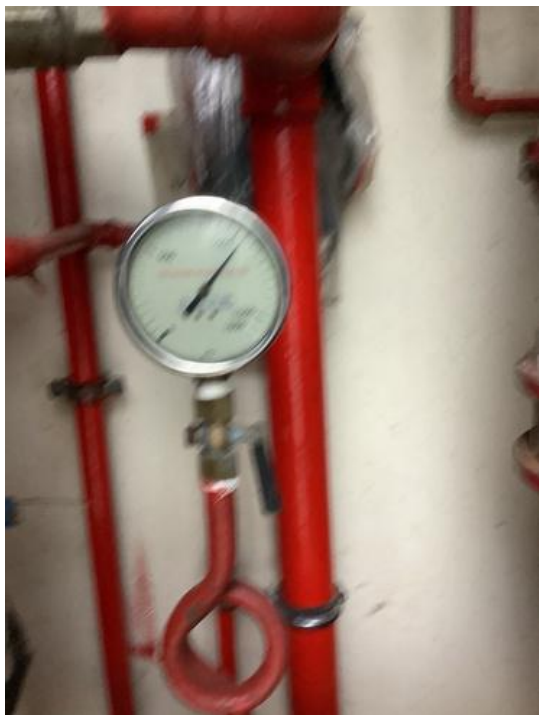
The flow test arrangement must be installed as per the manufacturers specifications

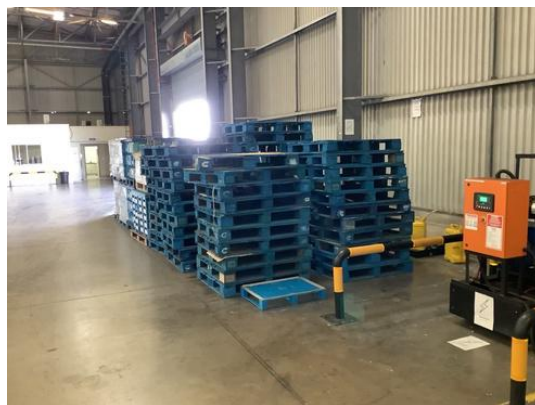
Photo 14

- Warehouse
The idle pallets stored within the warehouse must be removed, the roof installation is not designed to achieve the required densities, in the event of a fire the system will be overwhelmed and rendered useless.

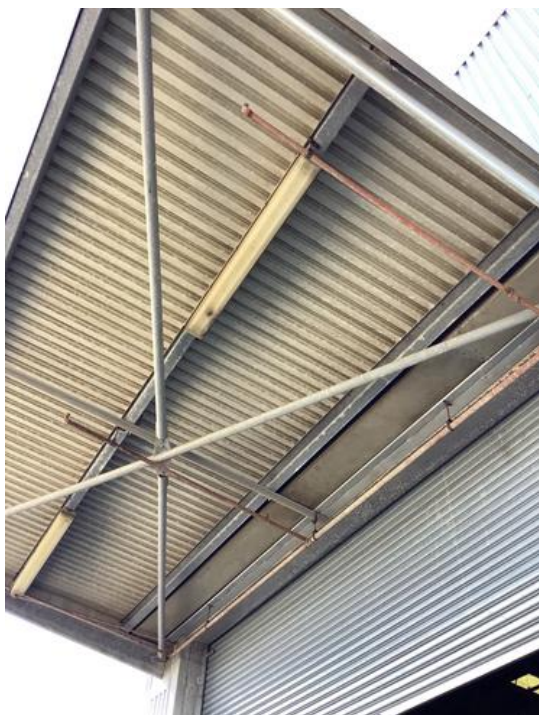
Photo 16

Corrosion is evident on the sprinkler pipe work and must be addressed by your installer.

External canopies

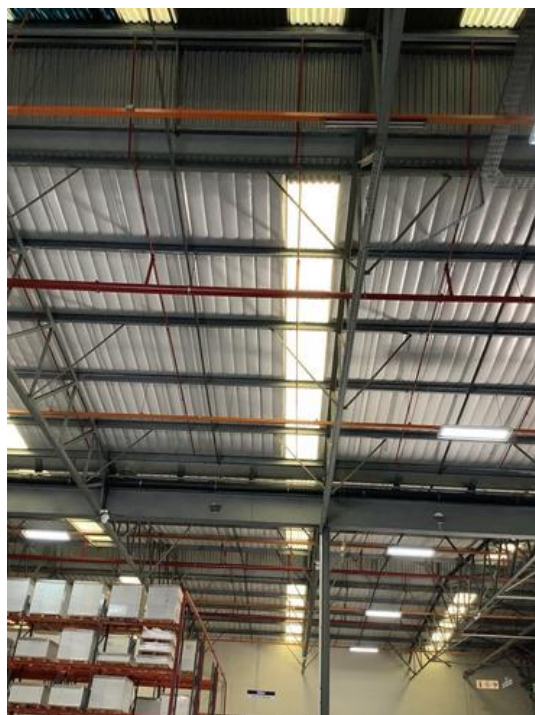
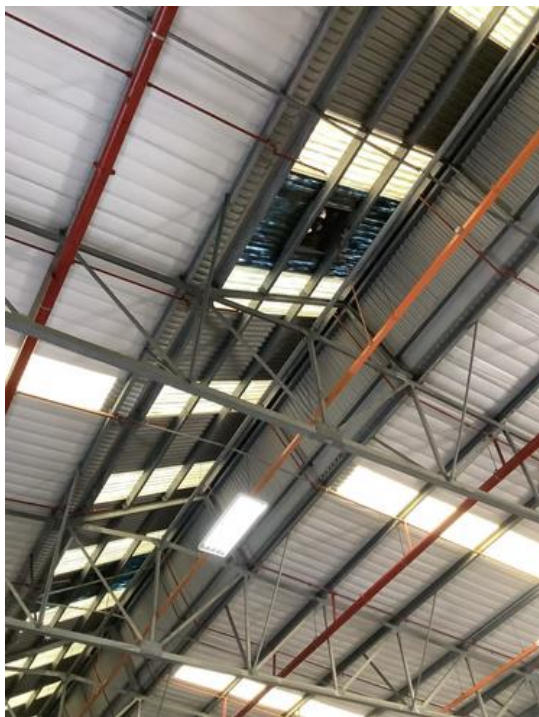
Sprinklers installed beneath open cell surfaces / translucent

sheeting.

At roof where applicable

All sprinklers located beneath open celled floors or stairwells and translucent sheeting must have approved water shields fitted above the sprinklers.

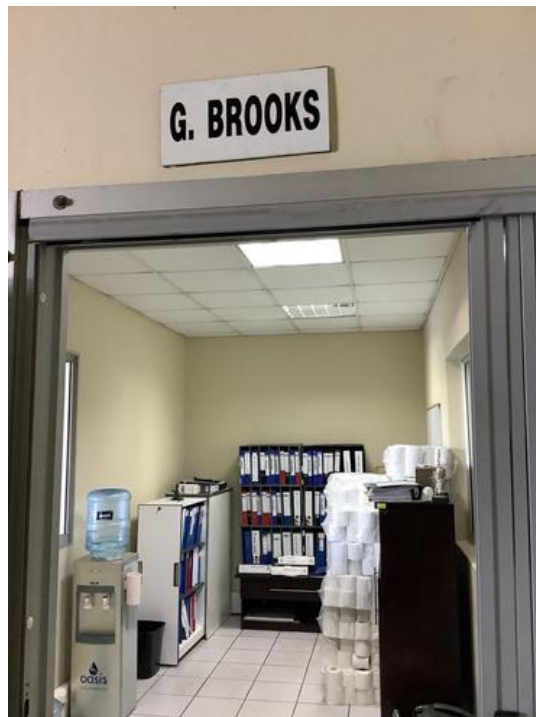
Photo 18

Portion of premises sprinkler protected with communicating sections that are not.

Partial protection can lead to a fire originating in the protected area radiating heat into the unprotected portion of the premises and starting secondary fires. The heat from these fires radiates or spreads back into the protected area causing excessive sprinkler operation.

Conversely, a fire originating in the unprotected portion will radiate heat or spread into the protected portion rapidly causing unnecessary sprinkler operation and overwhelming the sprinkler system installed.

G Brooks office

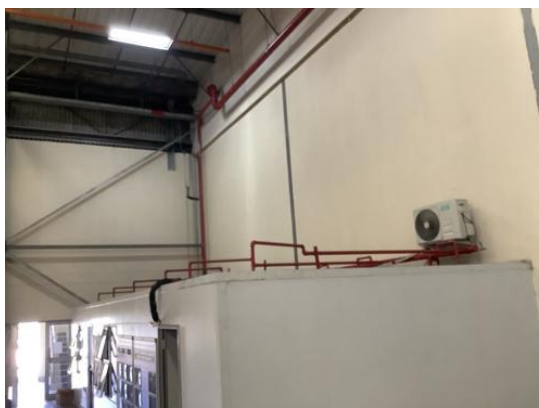
Photo 19

The sprinkler pipe work must be correctly supported.

Back offices

Pipe work must be supported independently from the composite panel, and the dry dropper must not be attached to the fabric of the cold room with mastic or insulating material that permanently bonds the dropper to the refrigerated structure.
In the event of collapse of the cold room, the cold room material must drop away from the sprinkler system.
