Inspection of Automatic Sprinkler System

CE1 Linde & Wiemann East London
Industrial Development Zone

UNC.8479

19.06.2024 07:11 SAST

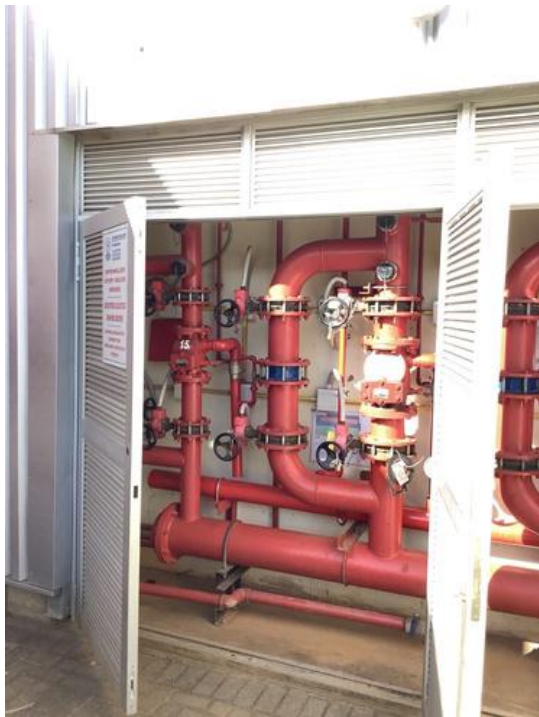
Photo 1

South west corner of building

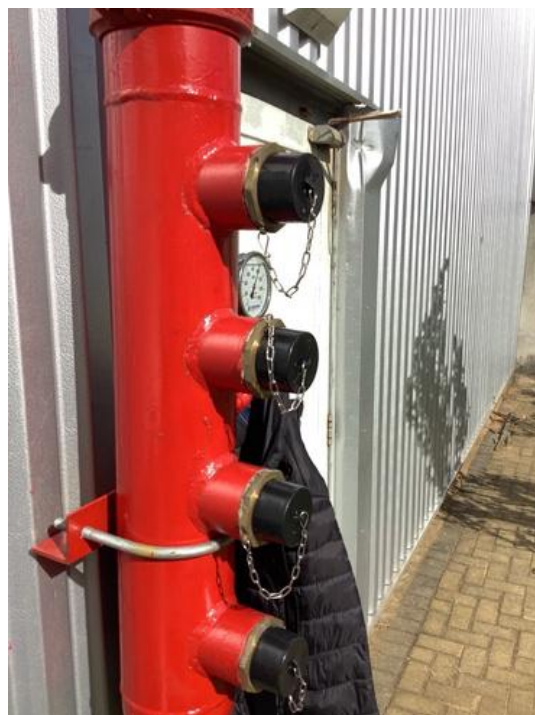
Photo 6

It appears that the booster connection piping to the main distribution riser is too long, which may restrict the opening of the booster plunger into the main distribution riser, this will prevent effective boosting of the sprinkler system and must be revised.

Installations must be fitted with fire brigade booster connections which will enable the fire brigade to pump water into the installation using their own equipment.

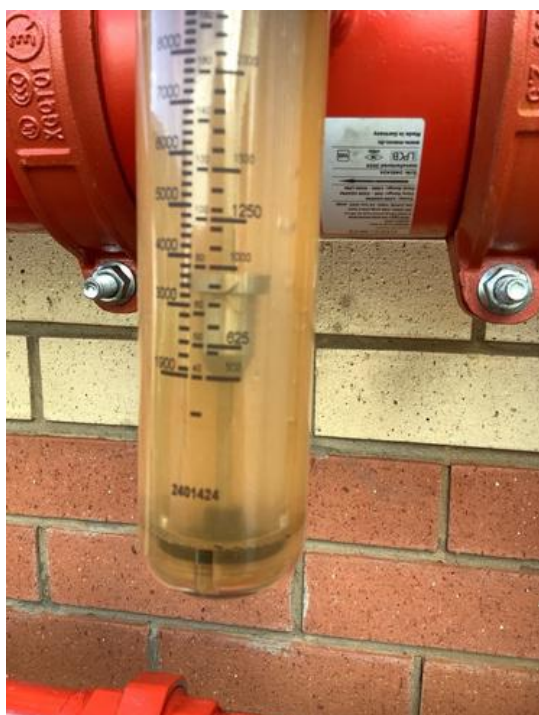
Photo 7

3500 l/min @ 1200 kPa

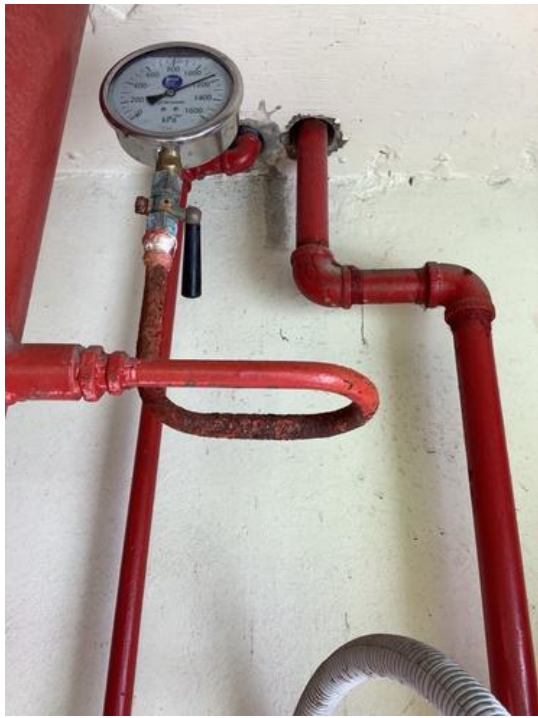
Photo 9

Valve 45 gauge and pipe work must be replaced

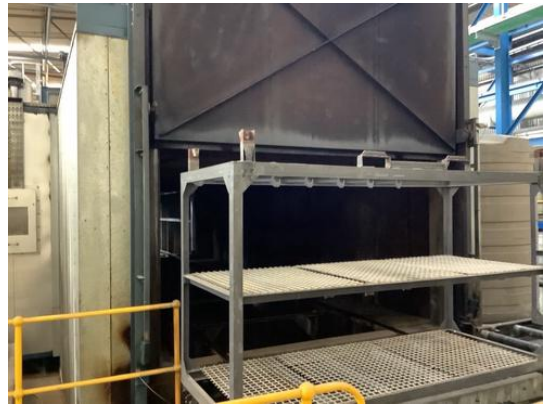
Photo 10

Surfaces which exceed 1,0 metre in width will obstruct the water discharged from the sprinklers above which could result in an ignition beneath these surfaces not being controlled or extinguished.

ENCLOSED PAINT LINES, DRYING OVENS AND DRYING ENCLOSURES

Ovens

Sprinkler protection must be provided inside the above structures, sidewall sprinklers, (see para. 3400), may be used for this purpose.

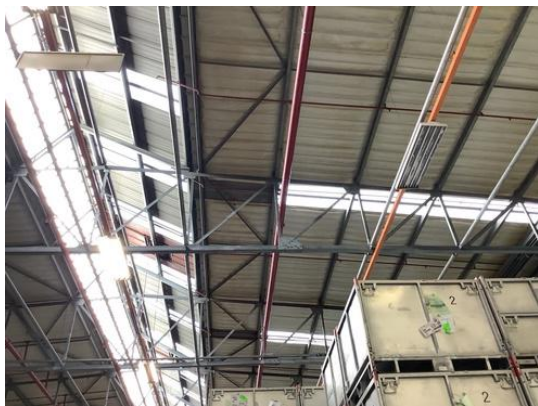
Photo 11

Sprinklers installed beneath open cell surfaces / translucent sheeting.

Various at roof

All sprinklers located beneath open celled floors or stairwells and translucent sheeting must have approved water shields fitted above the sprinklers.
