Inspection of Automatic Sprinkler System

Martinrea SA BE2 East London Industrial
Development Zone

UNC8482

09.05.2024 08:00 SAST

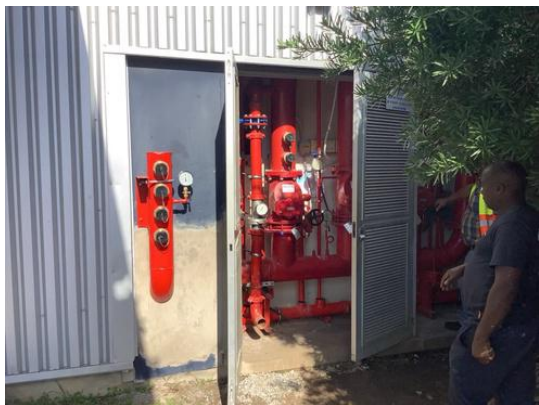
Photo 1

Valve Cabinet 1

Location:

South west corner of building

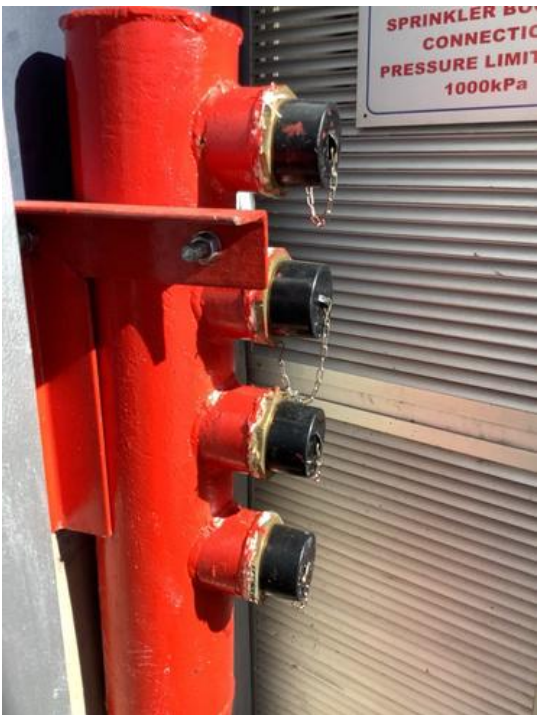
Photo 4

7.8 Fire Brigade Booster Connections Installed Correctly and Accessible

No

It appears that the booster connection piping to the main distribution riser is too long, which may restrict the opening of the booster plunger into the main distribution riser, this will prevent effective boosting of the sprinkler system and must be revised.

Installations must be fitted with fire brigade booster connections which will enable the fire brigade to pump water into the installation using their own equipment.

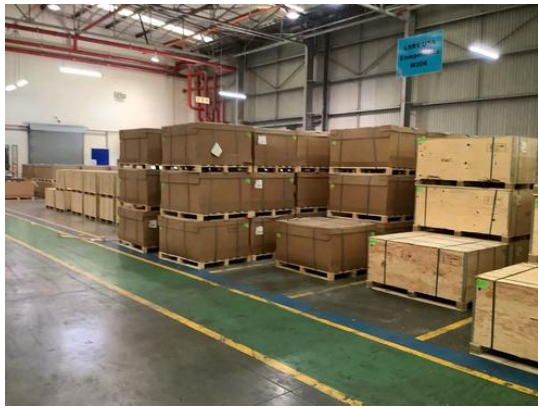
Photo 5

Free Standing Block Storage and aisle widths are not being maintained.

No block of storage shall exceed 150 m² of floor area and shall be surrounded by aisle widths of not less than 2,4 m.

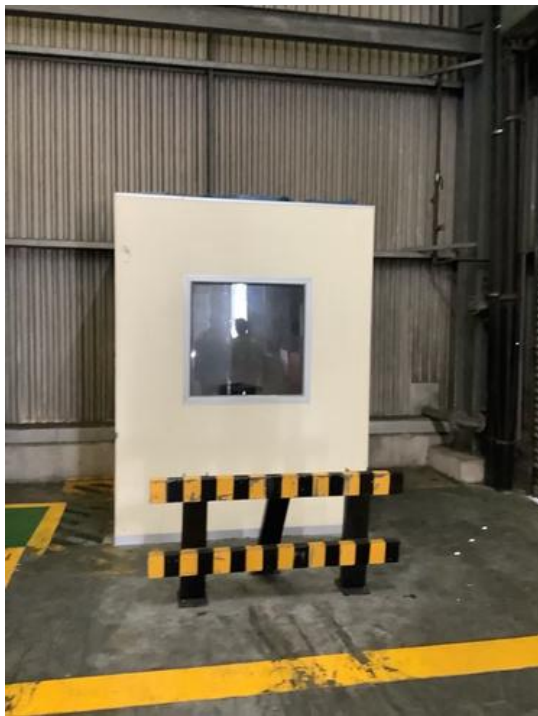
Photo 7

Enclosed structures not sprinkler protected.

A fire originating within an unprotected area will burn in an uncontrolled manner without alerting the sprinkler system unit until such time as it breaks out of the structure. The subsequent release of heat will operate multiple sprinklers at roof level above the fire area and remote from it causing massive damage.

Prefab office

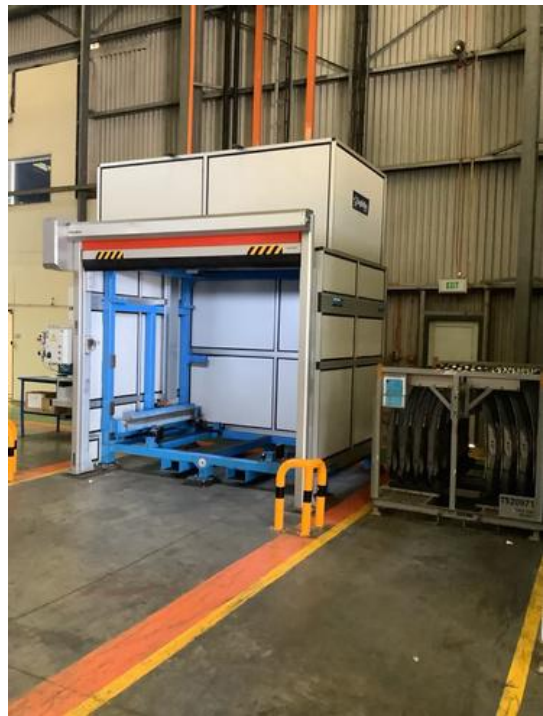
Photo 8

Enclosed structures not sprinkler protected.

A fire originating within an unprotected area will burn in an uncontrolled manner without alerting the sprinkler system unit until such time as it breaks out of the structure. The subsequent release of heat will operate multiple sprinklers at roof level above the fire area and remote from it causing massive damage.

Engrotech enclosure

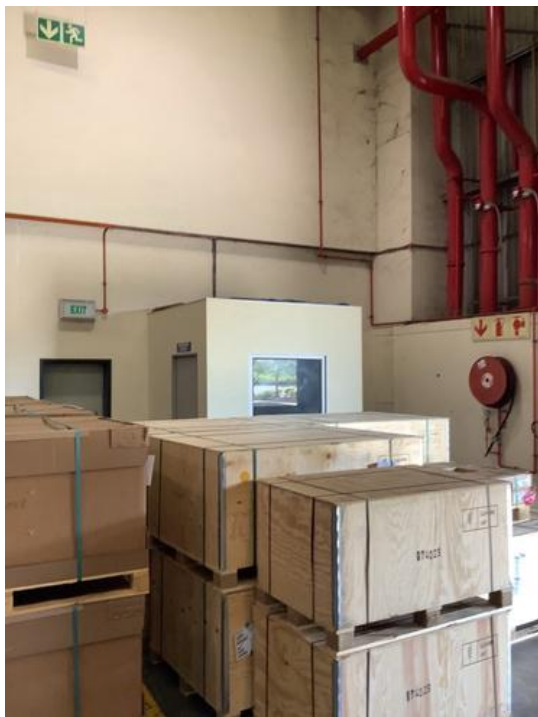
Photo 9

Enclosed structures not sprinkler protected.

A fire originating within an unprotected area will burn in an uncontrolled manner without alerting the sprinkler system unit until such time as it breaks out of the structure. The subsequent release of heat will operate multiple sprinklers at roof level above the fire area and remote from it causing massive damage.

Receiving office

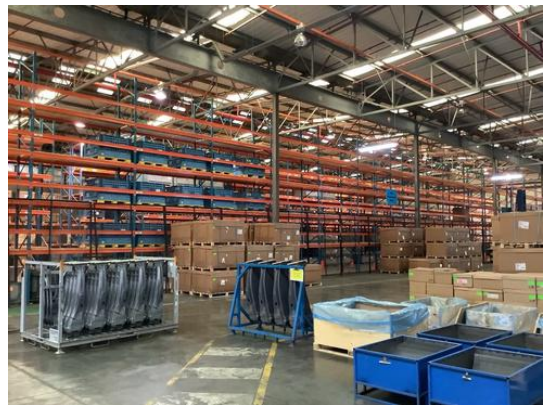
Photo 10

This especially to the exposure from the unprotected racks on the Linde Weimann side.

Storage too close to building.

Racks/shelves not protected at Linde Wieman section

Drencher heads required which are purpose made sprinklers designed to spray water over a surface to provide protection against fire exposure. It is not acceptable to use standard sprinkler heads with the fusible elements removed for the purpose of providing wall or face wetting. The drencher system must extend along the walls of the protected building to a distance of 15.0 metres beyond each end of the stored goods. The feed for the drenchers must be taken from the underside of the valves and not from the downstream side of the installation. The stop valve controlling the drencher installation shall be located near to the sprinkler control valves, but must be at least 10,0 metres from the goods stored or from the area where they are expected to operate.

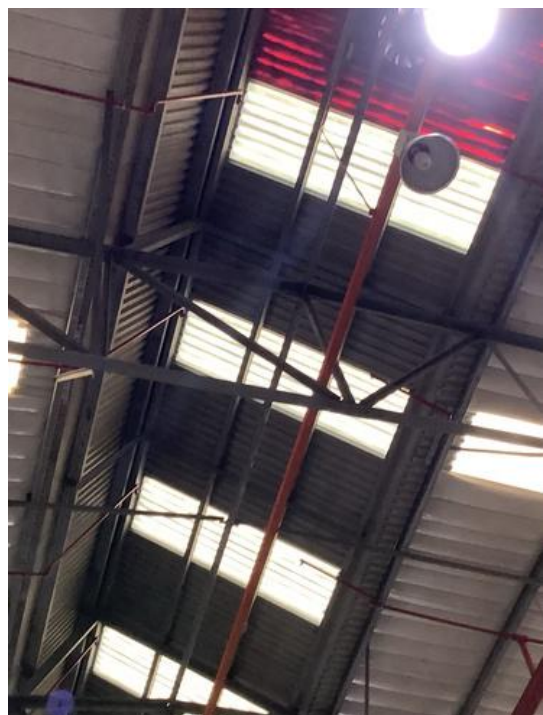
Photo 12

Sprinklers installed beneath open cell surfaces / translucent sheeting.

Roof

All sprinklers located beneath open celled floors or stairwells and translucent sheeting must have approved water shields fitted above the sprinklers.
