Inspection of Automatic Sprinkler System

BE 2 - Linde & Wiemann East London
Industrial Development Zone

UNC.8481

09.05.2024 12:31 SAST

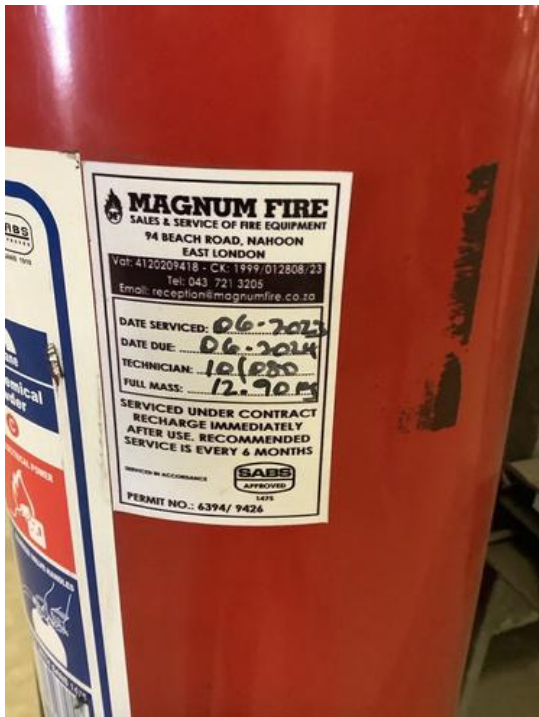
Photo 1

Clear access to the hand fire appliances must be maintained at all times.

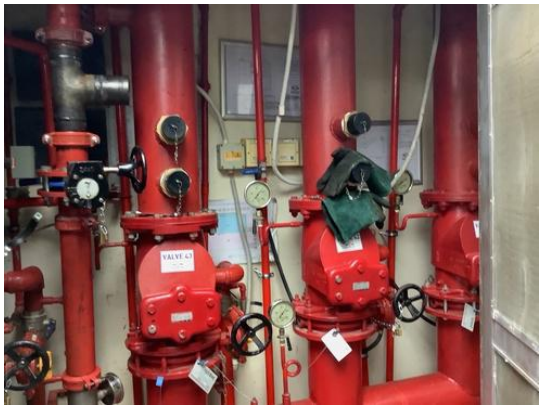
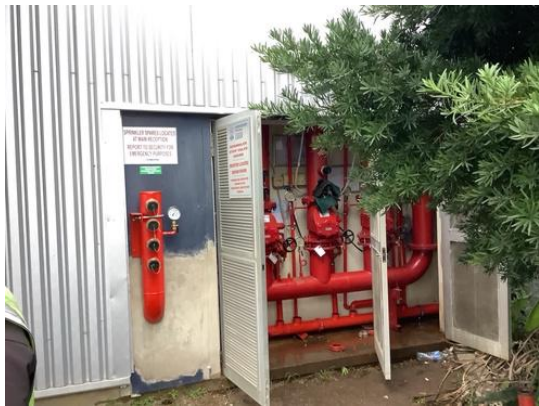
opposite ASP pump house

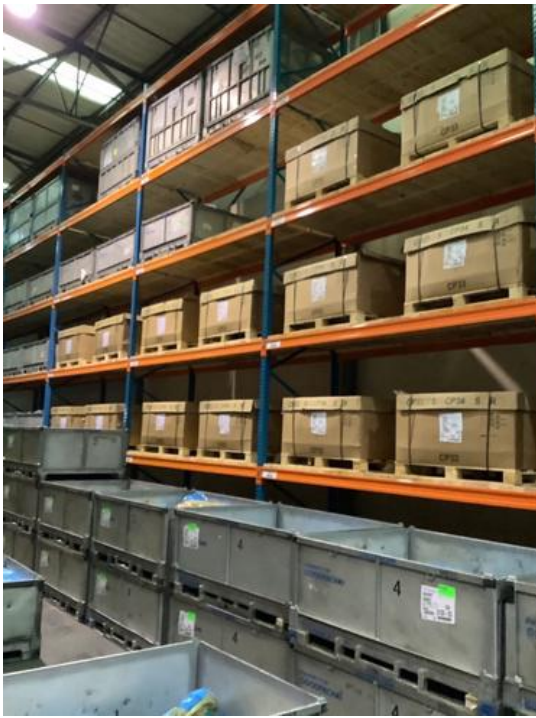
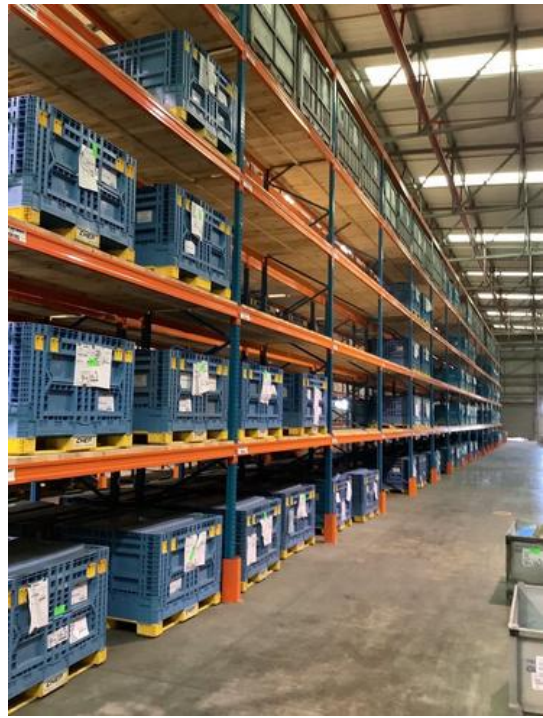
Are the storage heights exceeded.

Yes

The storage heights must be maintained in accordance with the maximum allowable stack heights as detailed in this report. Should this not be possible, intermediate level protection is deemed to be mandatory.

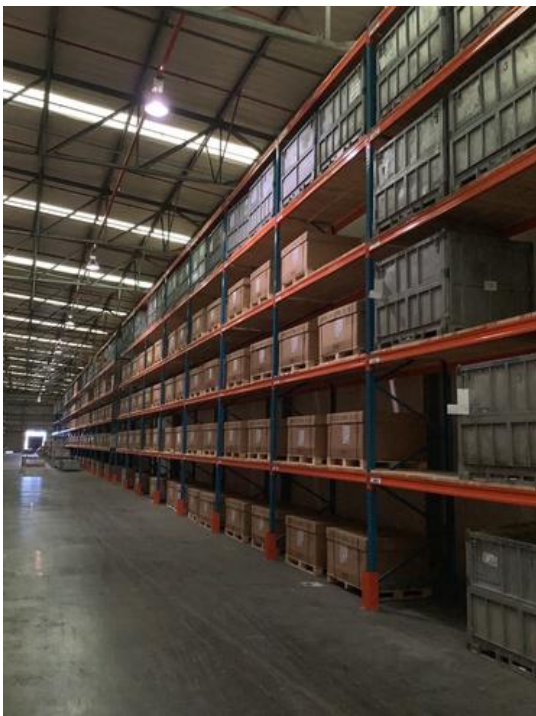
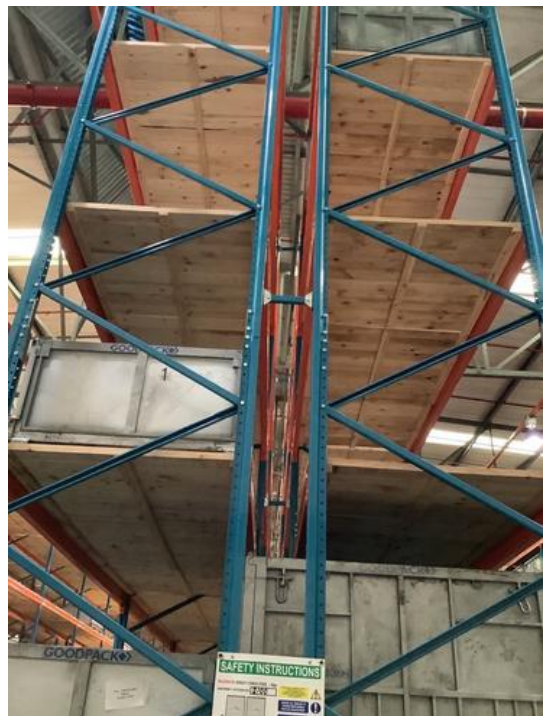
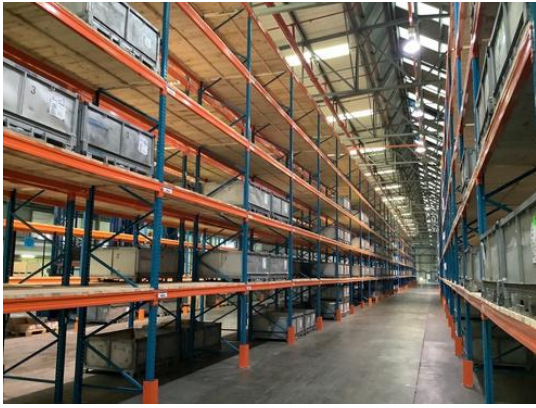
The shelves require intermediate protection

The shelving must be sprinkler protected
