Inspection of Automatic Sprinkler System

AW8 Yanfeng East London Industrial
Development Zone

UNC.8475

09.05.2024 08:00 SAST

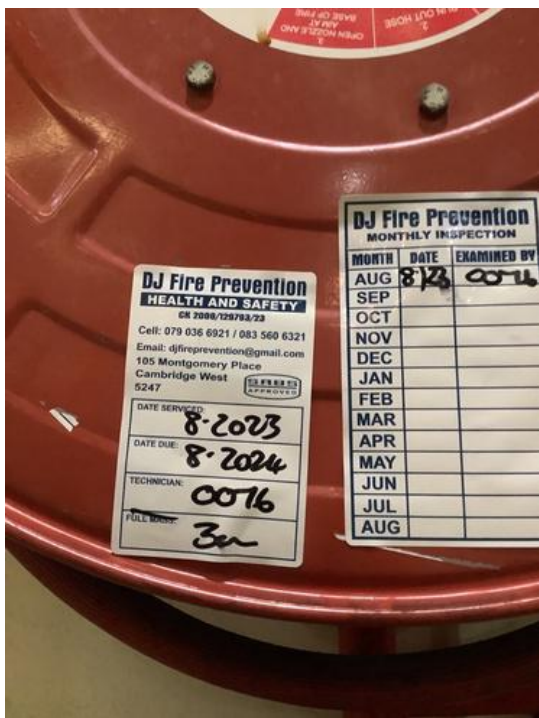
Photo 1

Clear access to the hand fire appliances must be maintained at all times.

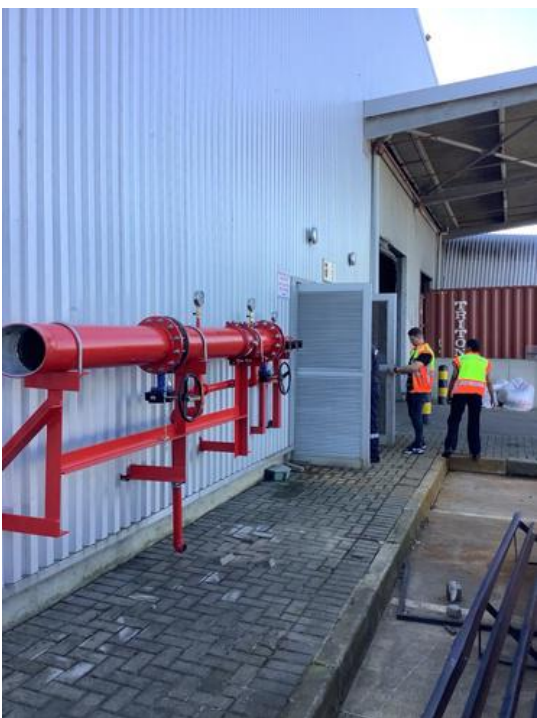
Photo 2

East side of building

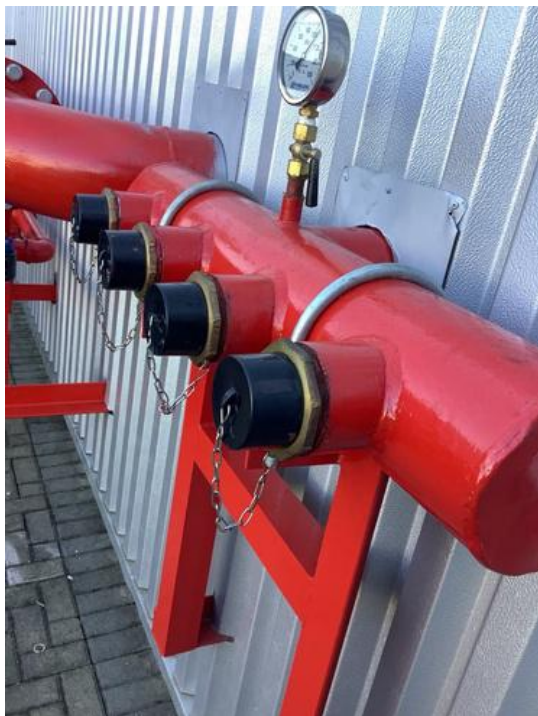
No

It appears that the booster connection piping to the main distribution riser is too long, which may restrict the opening of the booster plunger into the main distribution riser, this will prevent effective boosting of the sprinkler system and must be revised.

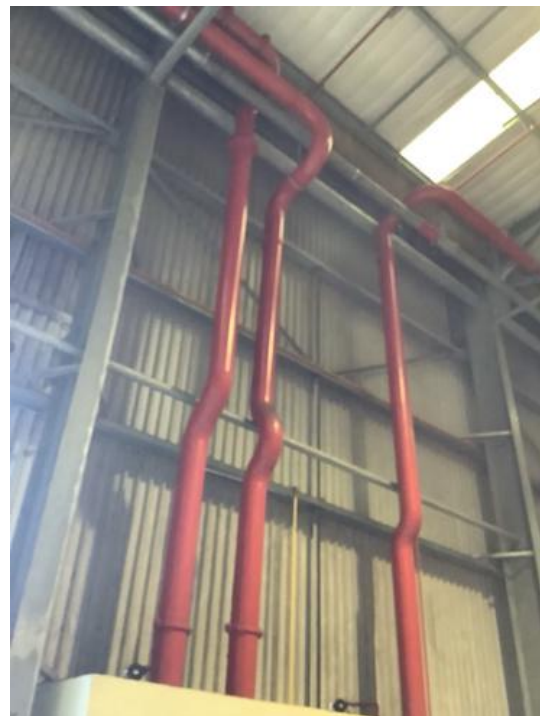
No

The riser main must be properly supported in accordance with the rules.

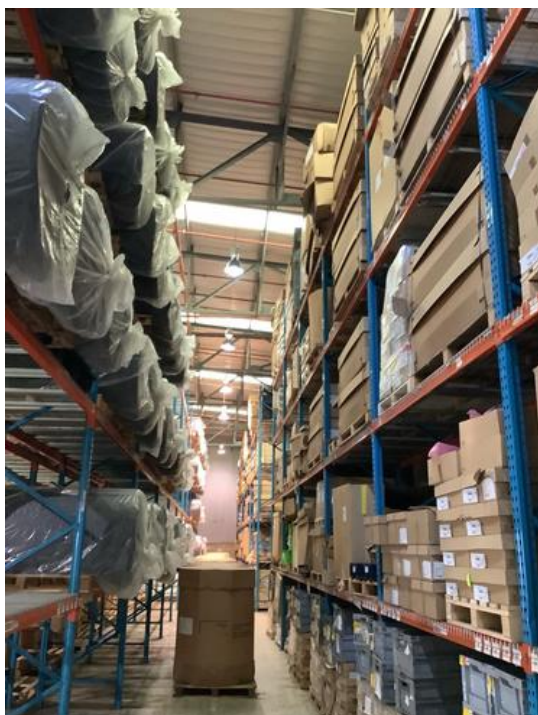
Photo 15

Yes

The storage heights must be maintained in accordance with the maximum allowable stack heights as detailed in this report. Should this not be possible, intermediate level protection is deemed to be mandatory.
