Inspection of Automatic Sprinkler System

CW1 International Automotive
Components East London Industrial
Development Zone

UNC8478

09.05.2024 08:00 SAST

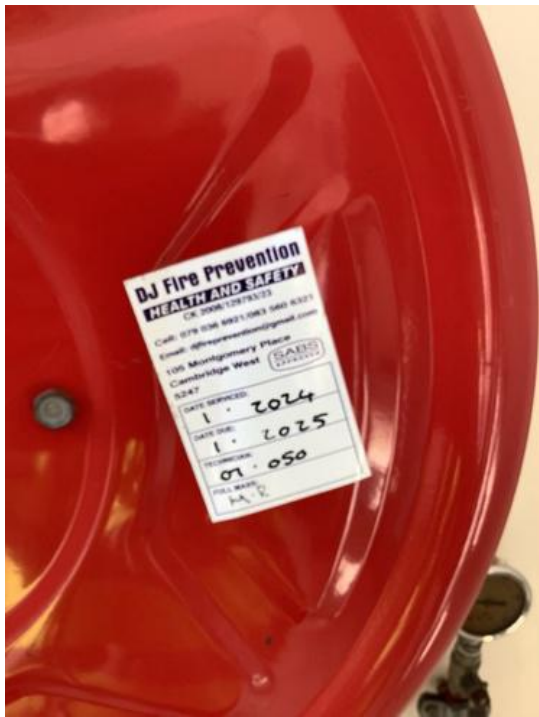
Photo 1

Clear access to the hand fire appliances must be maintained at all times.

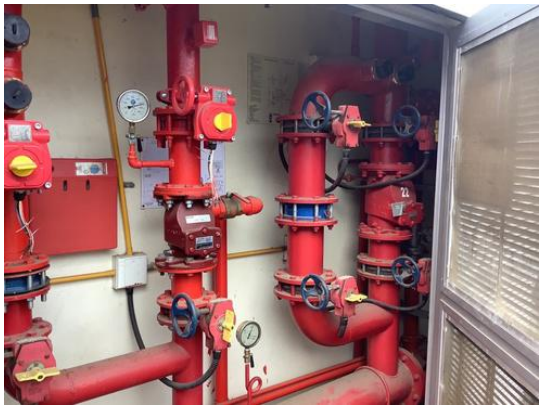
Photo 2

North west corner of building

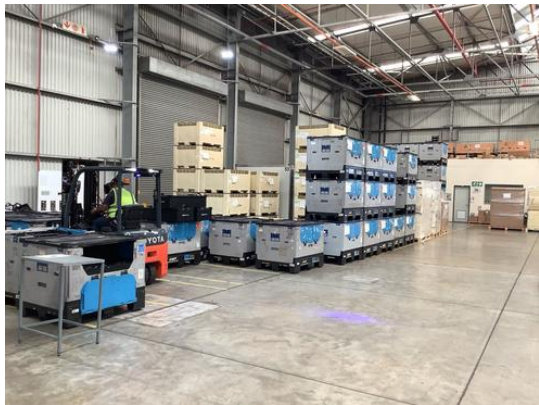
Photo 3

Free Standing Block Storage and aisle widths are not being maintained.

No block of storage shall exceed 150 m² of floor area and shall be surrounded by aisle widths of not less than 2,4 m.

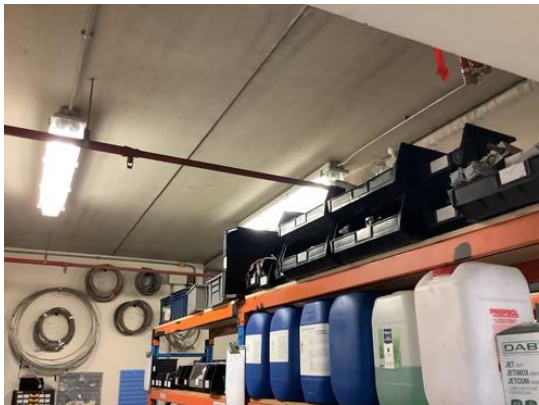
Photo 4

Are the required clearances being maintained.

No

In all High Hazard areas a clear space of not less than 1,0 metre must be maintained between top of stored goods and sprinkler deflector.

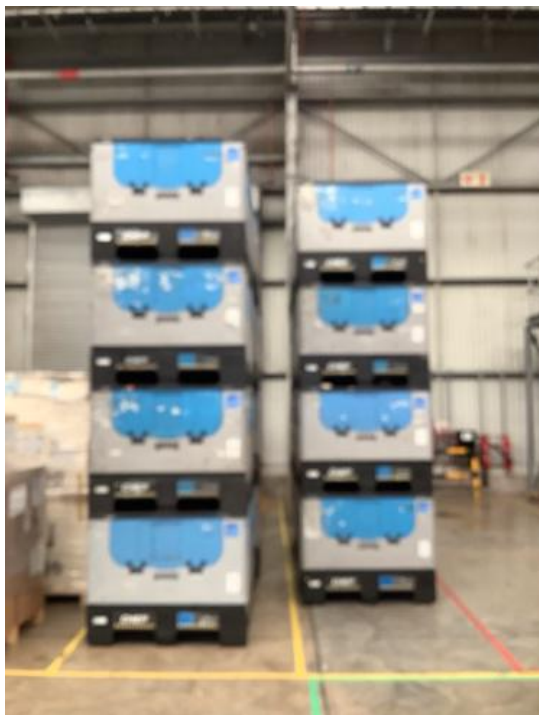
Photo 5

Are the storage heights exceeded.

Yes

The storage heights must be maintained in accordance with the maximum allowable stack heights as detailed in this report. Should this not be possible, intermediate level protection is deemed to be mandatory.

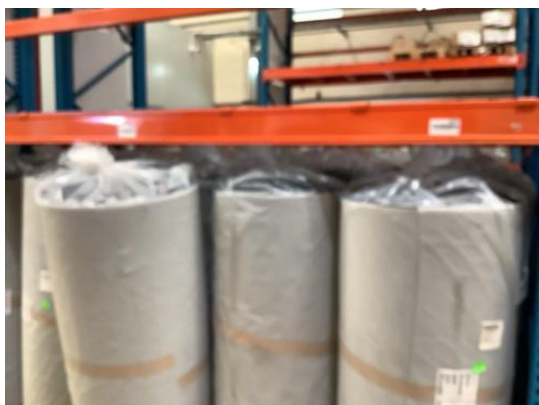
Photo 7

The clearance between the top of storage and the sprinkler deflector is not being maintained.

Rack CB

A minimum clearance of 150 mm (10th Edition) and 100 mm (11th Edition) must be maintained between the top of storage and the sprinkler deflector.

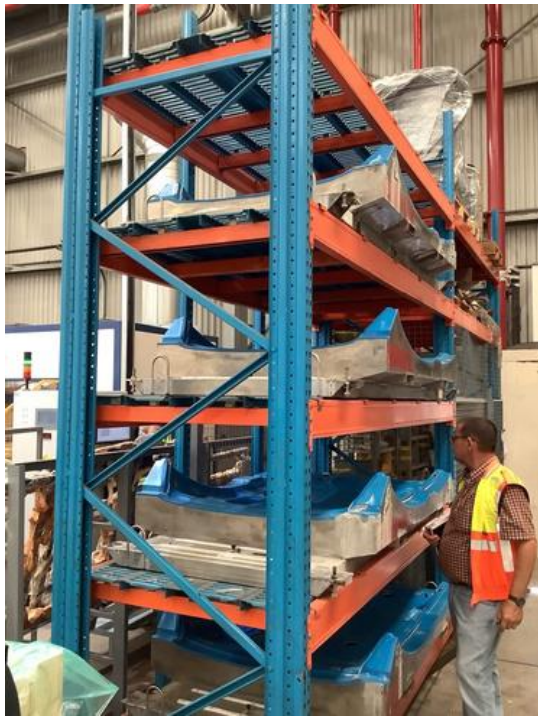
Photo 9

Shelves exceed 1,0 metre in width.

The shelves must be reduced to a maximum width of 1,0 metre or intermediate sprinkler protection will be mandatory at each shelf tier level.

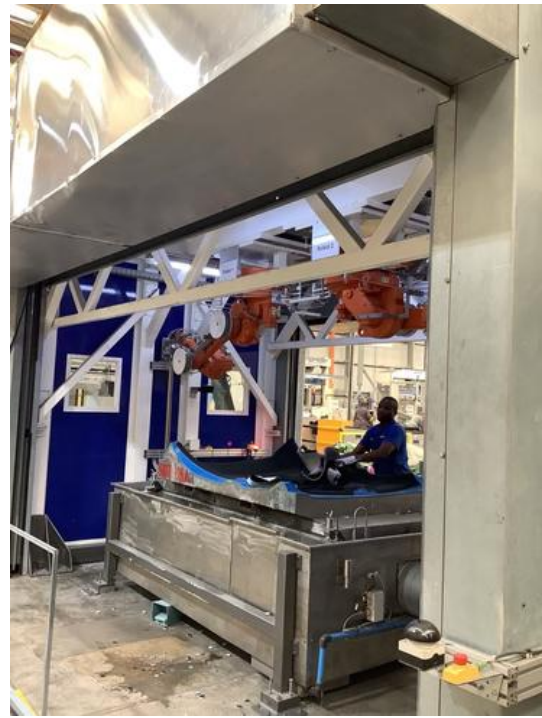
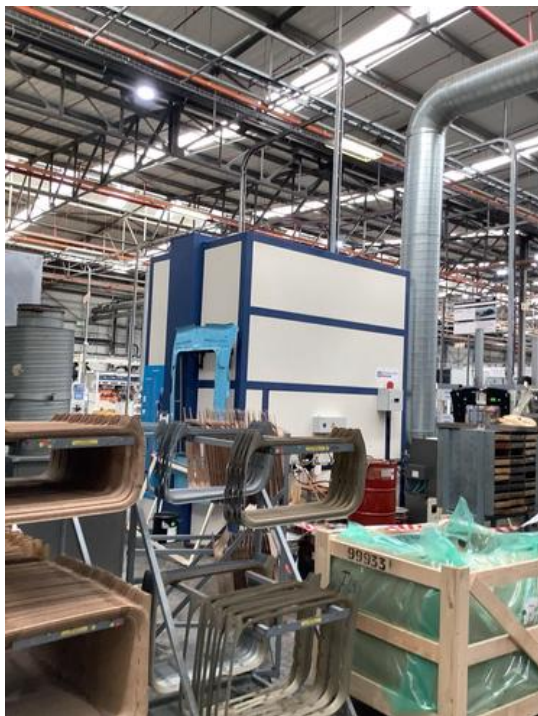
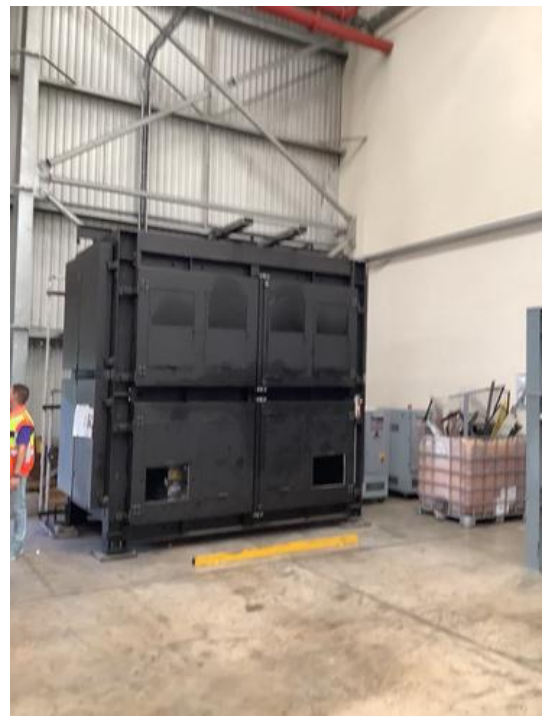
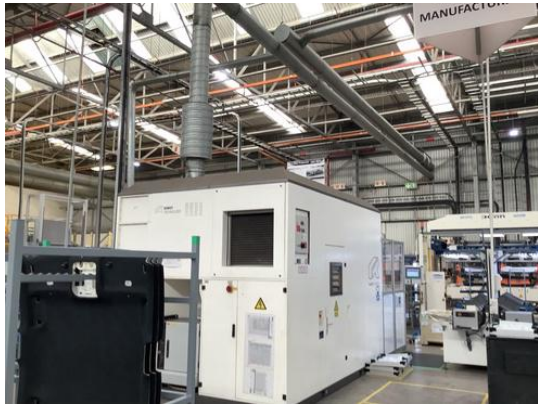
Enclosed structures not sprinkler protected.

A fire originating within an unprotected area will burn in an uncontrolled manner without alerting the sprinkler system unit until such time as it breaks out of the structure. The subsequent release of heat will operate multiple sprinklers at roof level above the fire area and remote from it causing massive damage.

Glue application booths
Ovens
Extraction canopies

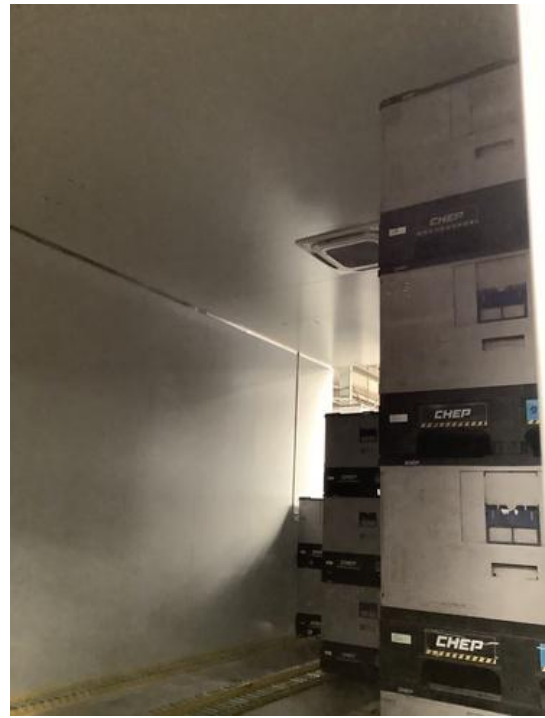
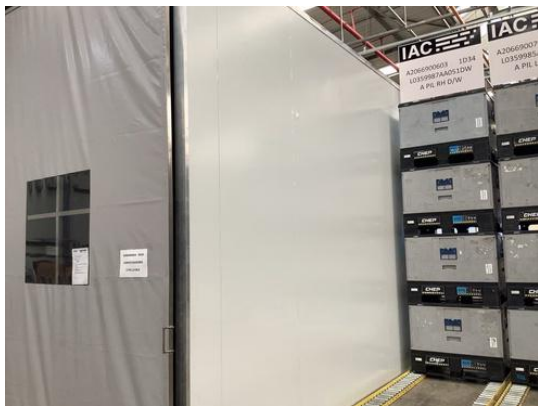
Portion of premises sprinkler protected with communicating sections that are not.

Partial protection can lead to a fire originating in the protected area radiating heat into the unprotected portion of the premises and starting secondary fires. The heat from these fires radiates or spreads back into the protected area causing excessive sprinkler operation.

Conversely, a fire originating in the unprotected portion will radiate heat or spread into the protected portion rapidly causing unnecessary sprinkler operation and overwhelming the sprinkler system installed.

New cold room

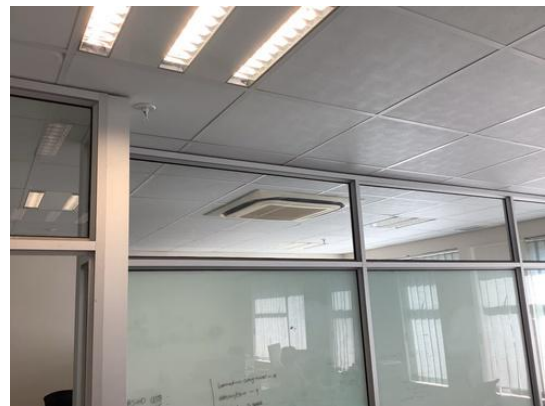
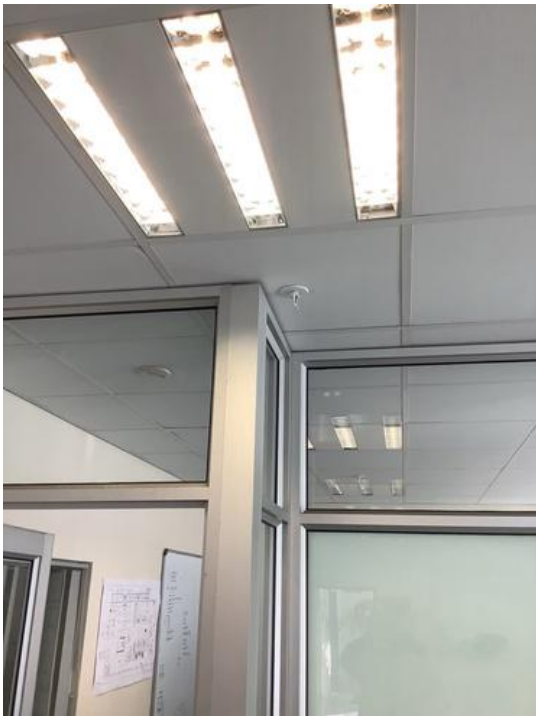
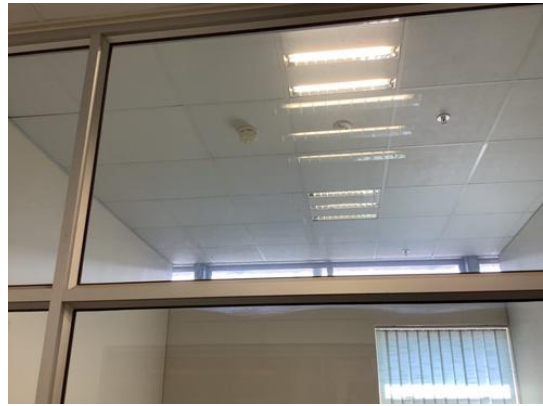
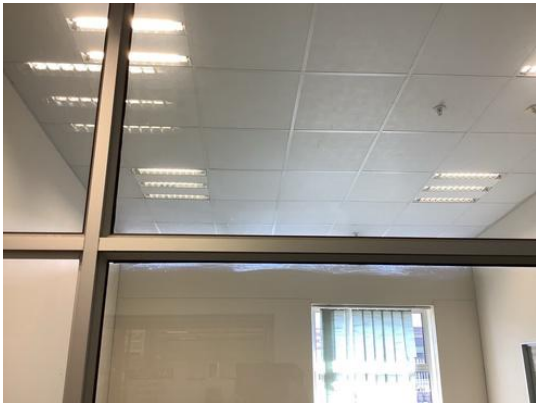
Sprinklers are out of effective working distance.

Sprinkler spaced to close to a wall or partitioning - the minimum distance a sprinkler may be from a wall or partition shall not be less than 150 mm.

Ground floor offices
Two first floor offices

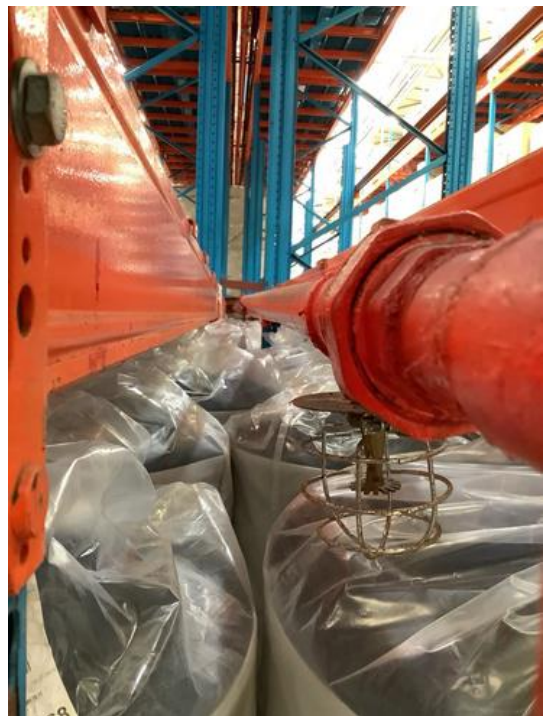
Photo 20

Intermediate Sprinkler
Protection

Rack BC

**The range pipe must be lowered so that the sprinkler
deflectors protrude a minimum distance of 25 mm beneath
the horizontal beam of the rack and/or shelf.**
