Inspection of Automatic Sprinkler System

D-Fence Building East London Industrial
Development Zone

UNC.8801

08.05.2024 15:05 SAST

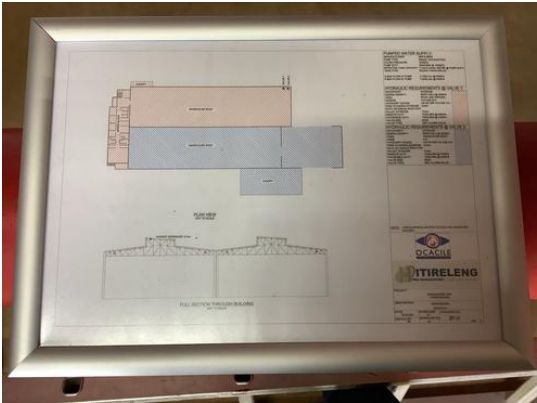
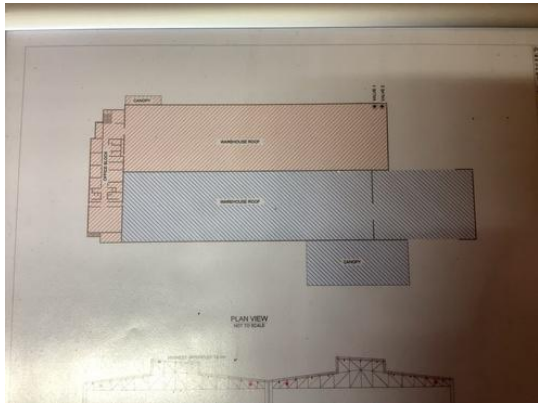
| 7.4 Block Plan Installed | Yes |

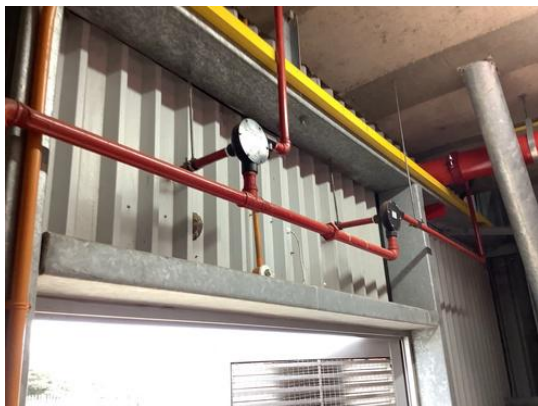
Photo 11

The water motor alarm drain pipes discharge into a common manifold. This must be revised so that the drain pipes are taken separately to waste.

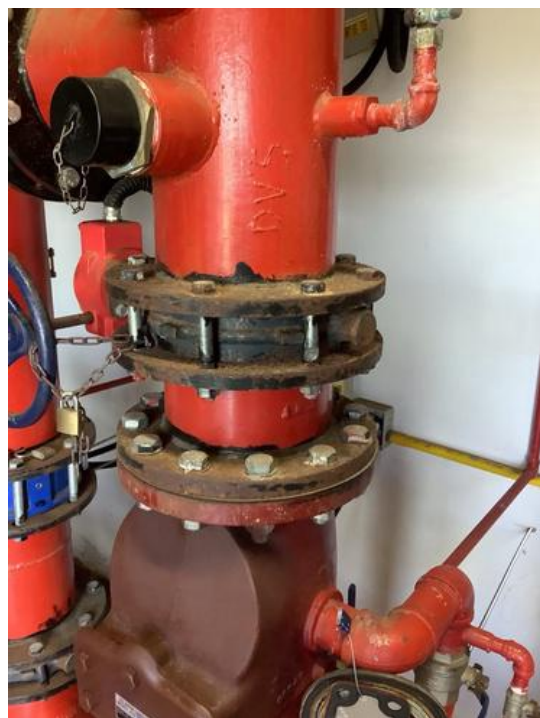
Photo 12

Corrosion is evident on the sprinkler pipe work and must be addressed by your installer.

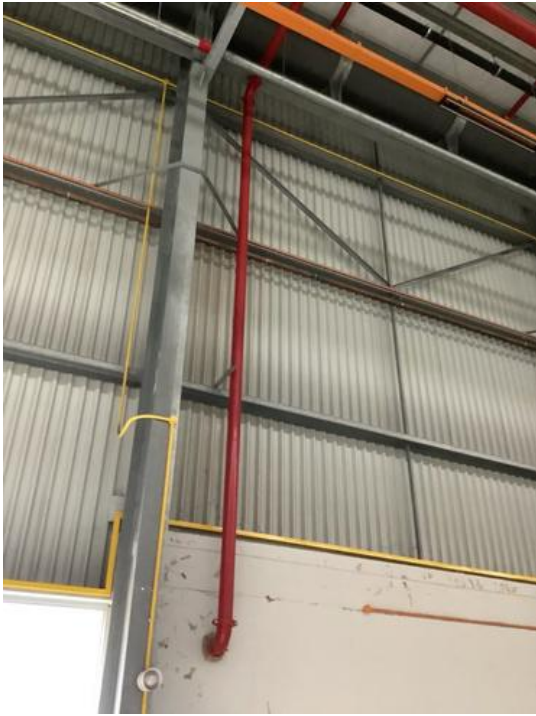
Photo 13

Distribution rise/drop pipes shall be secured directly to the building structure or by hangers securing horizontal distribution pipes within 300 mm of the riser.

Dropper to attached building

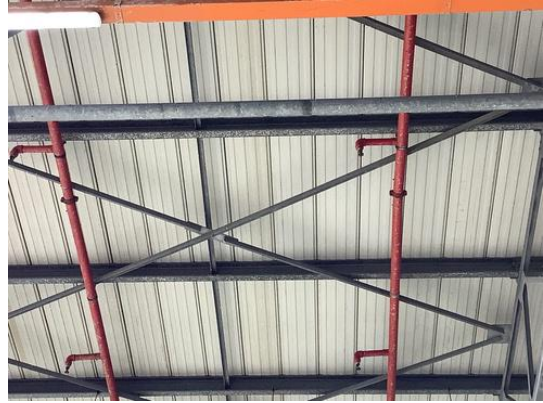
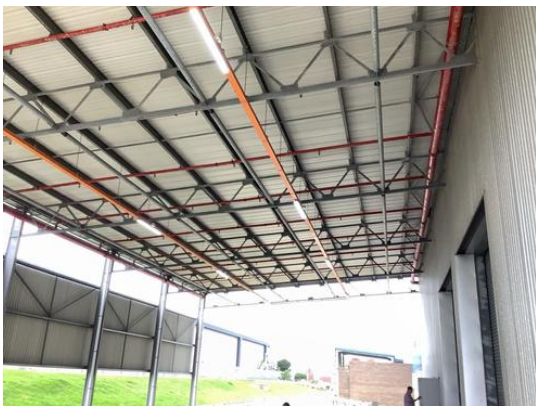
Corrosion is evident on the sprinkler pipe work and must be addressed by your installer.

Canopies particularly on the clampons

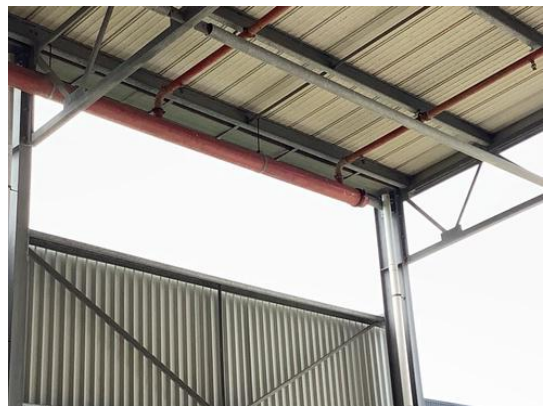
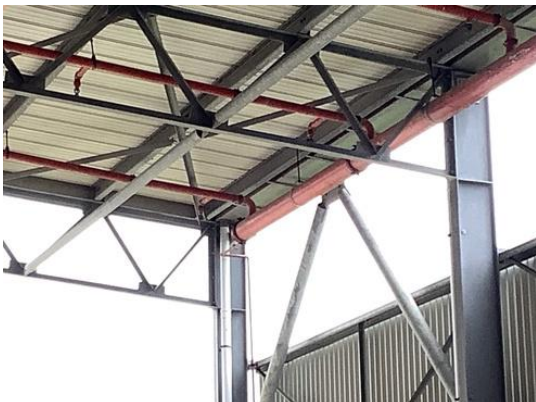
Terminal hangers on distribution pipes are exceeding the maximum distance of 450 mm from the end of the distribution pipe.

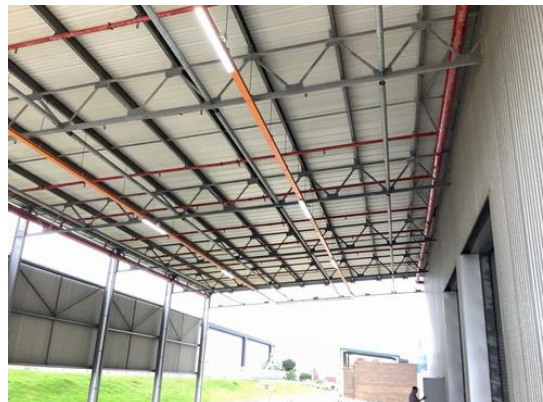
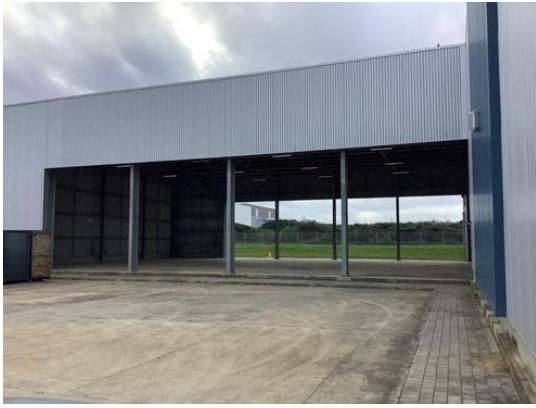
The installation of ESFR sprinklers in the canopies of this building are a non-compliance but will be accepted on this occasion on provision that these canopies are not allocated as storage areas. Only load and offload process to take place under these canopies.

Before a new tenant is placed in this building the landlord must verify with the installer that the ESFR system installed is suitable for the new process/storage.
