Inspection of Automatic Sprinkler System

AW6 Molan Pino East London Industrial Development Zone

UNC8474

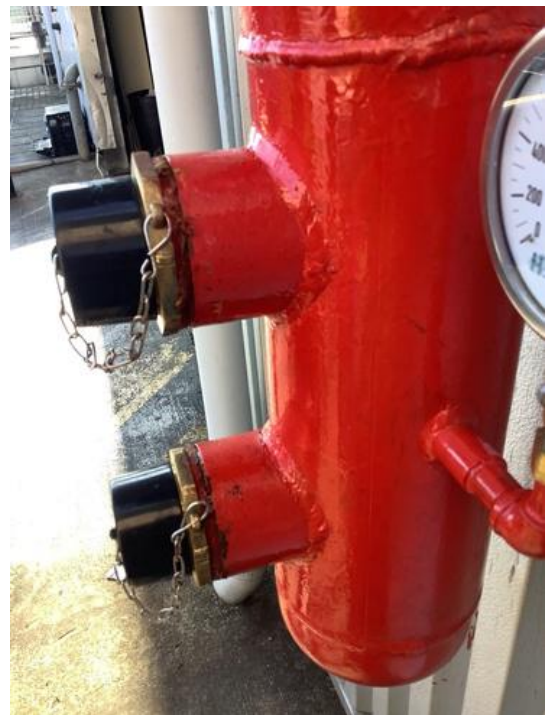
Photo 6

No

It appears that the booster connection piping to the main distribution riser is too long, which may restrict the opening of the booster plunger into the main distribution riser, this will prevent effective boosting of the sprinkler system and must be revised.

Installations must be fitted with fire brigade booster connections which will enable the fire brigade to pump water into the installation using their own equipment.

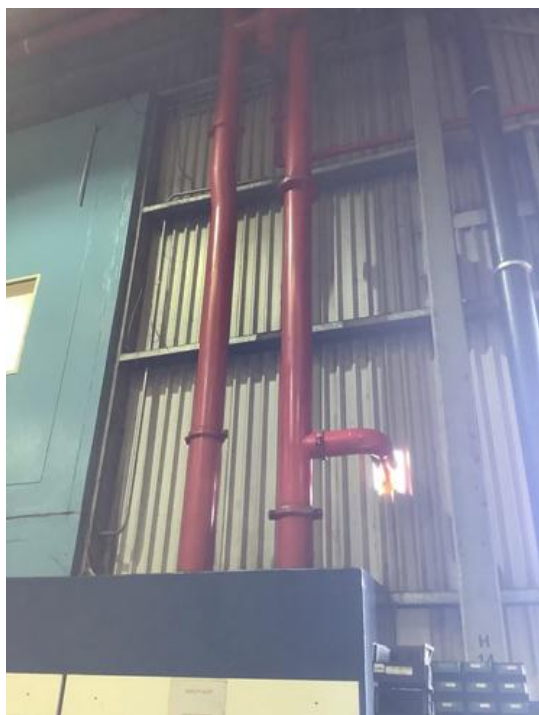
Photo 7

No

The riser main must be properly supported in accordance with the rules.

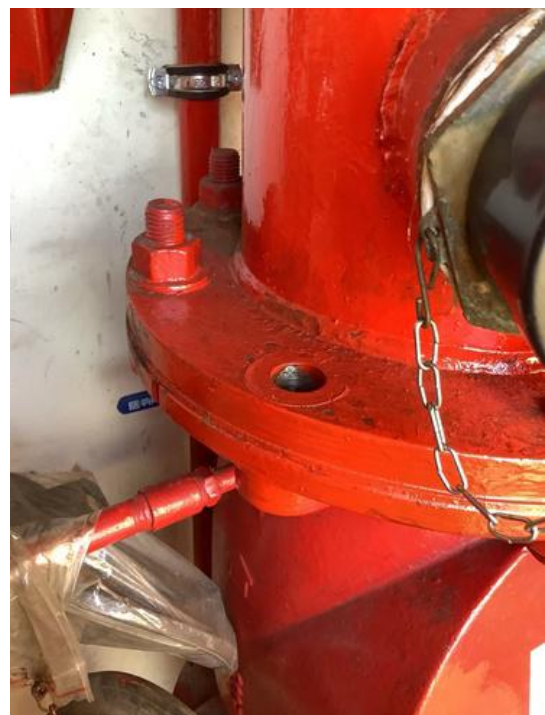
Photo 8

7.17 Flanges Short Bolted	No
7.18 Loose / Missing Bolts, Nuts & Washers	Yes

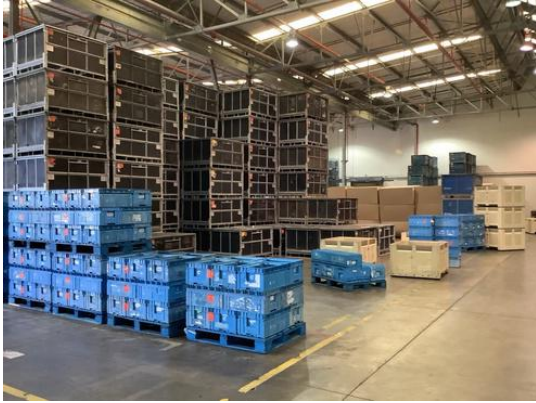
Photo 9

Free Standing Block Storage and aisle widths are not being maintained.

No block of storage shall exceed 150 m² of floor area and shall be surrounded by aisle widths of not less than 2,4 m.

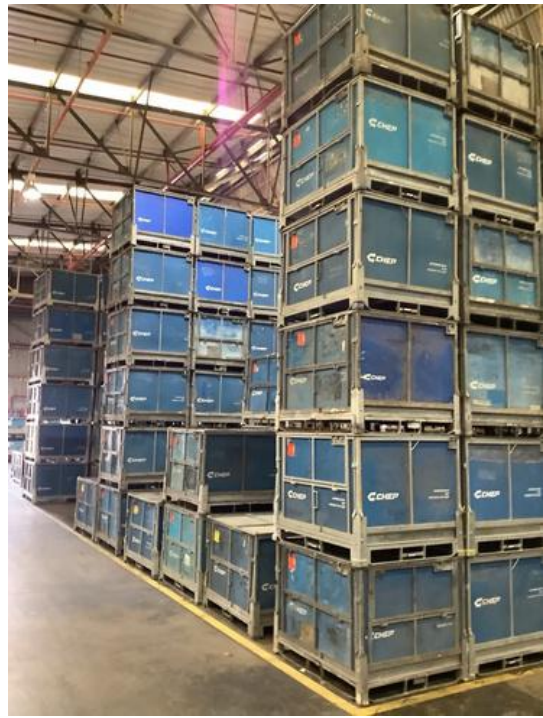
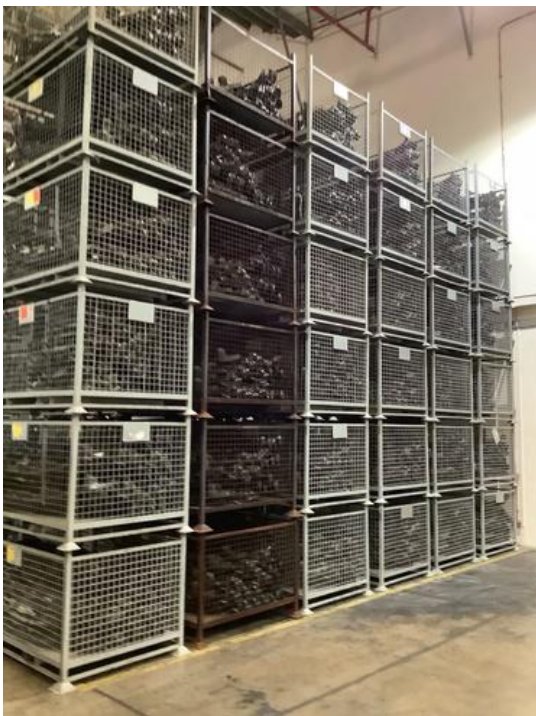
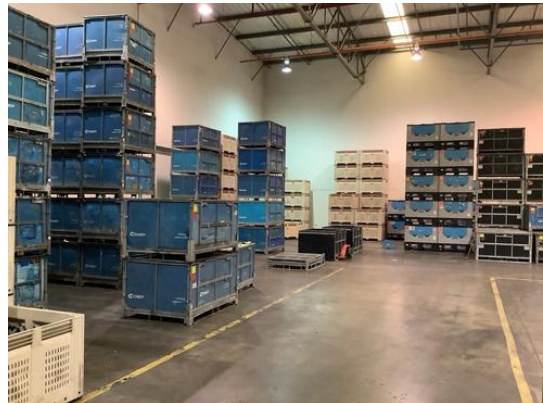
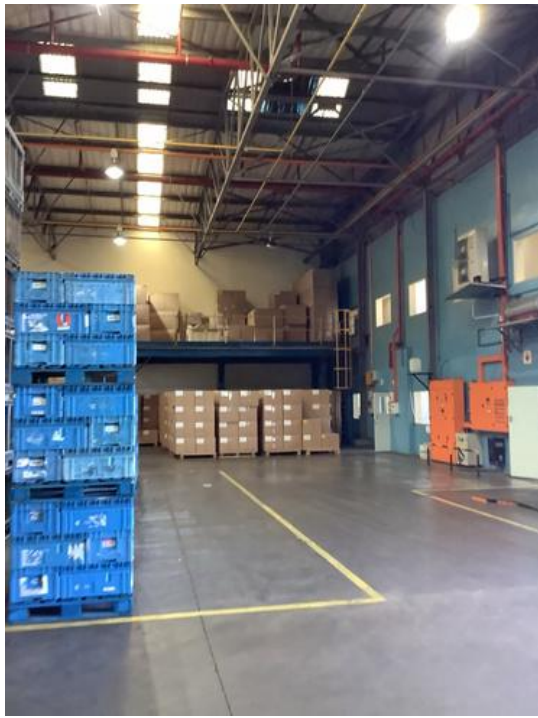
Are the storage heights exceeded.

Yes

The storage heights must be maintained in accordance with the maximum allowable stack heights as detailed in this report. Should this not be possible, intermediate level protection is deemed to be mandatory.

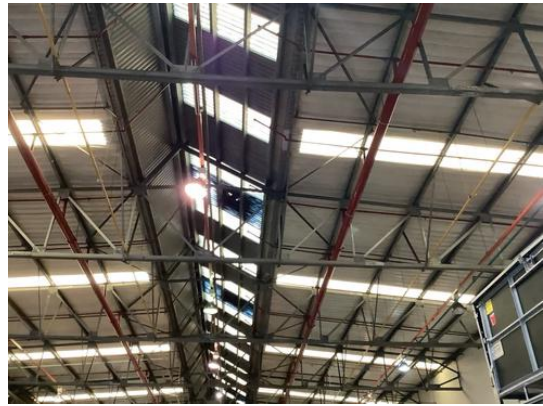
Photo 14

Sprinklers installed beneath open cell surfaces / translucent sheeting.

At roof where applicable

All sprinklers located beneath open celled floors or stairwells and translucent sheeting must have approved water shields fitted above the sprinklers.

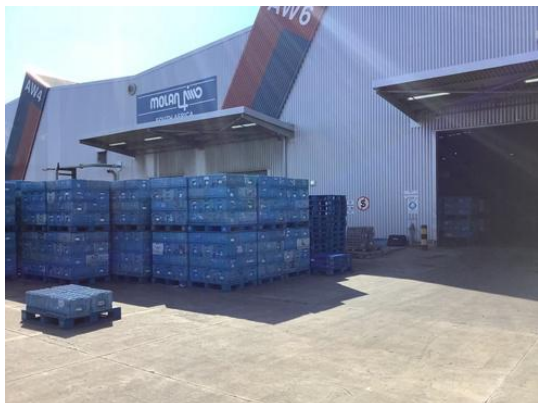
Photo 15

Storage too close to building.

At loading bay

Drencher heads required which are purpose made sprinklers designed to spray water over a surface to provide protection against fire exposure. It is not acceptable to use standard sprinkler heads with the fusible elements removed for the purpose of providing wall or face wetting. The drencher system must extend along the walls of the protected building to a distance of 15.0 metres beyond each end of the stored goods. The feed for the drenchers must be taken from the underside of the valves and not from the downstream side of the installation. The stop valve

controlling the drencher installation shall be located near to the sprinkler control valves, but must be at least 10,0 metres from the goods stored or from the area where they are expected to operate.

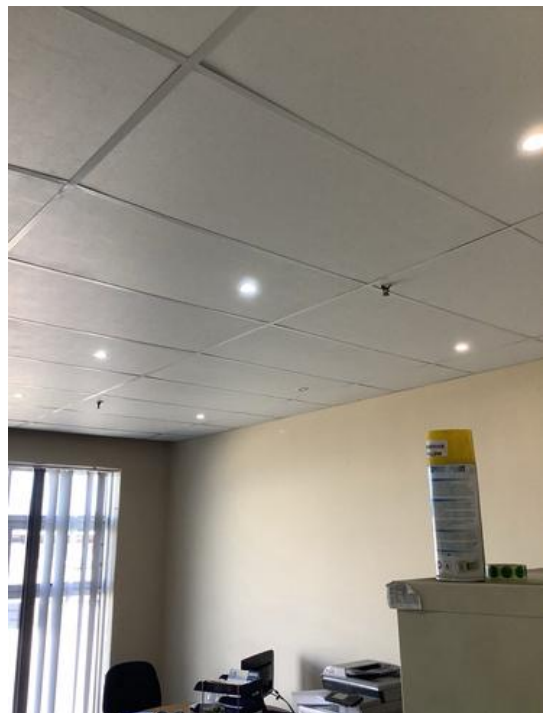
Photo 16

The missing/damaged escutcheon plates must be replaced.

Warehouse office

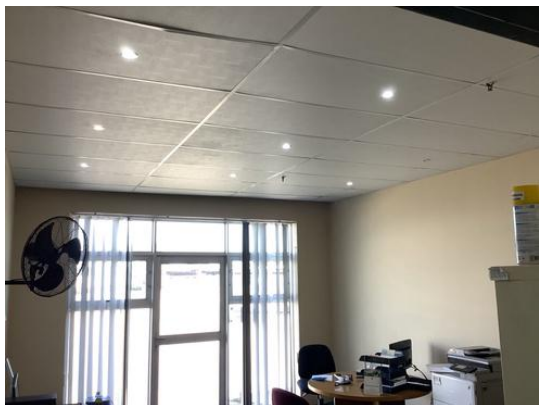
Photo 17

Sprinklers are out of effective working distance.

Warehouse office
