Inspection of Automatic Sprinkler System

Feltex Automotive - East London
Industrial Development Zone - AE4

UNC.10604

11.07.2024 14:38 SAST

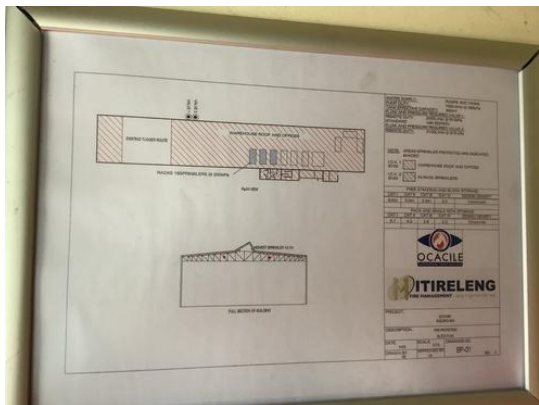
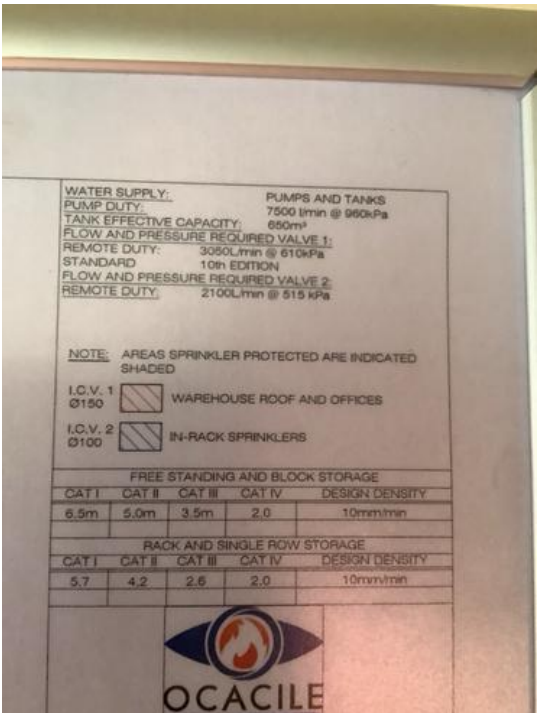
7.4.2 Are the correct installation details recorded on the block plan

No

A block plan must be provided with the following indicated thereon:

The flows and pressures for the remote and favorable areas of operation recorded on the block plans must reflect the maximum pressure (Pmax) and the maximum flow (Qmax) respectively.

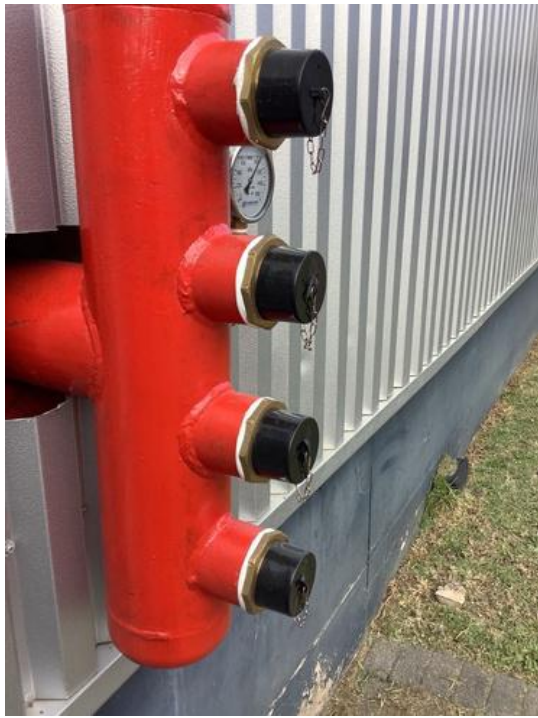
Photo 5

It appears that the booster connection piping to the main distribution riser is too long, which may restrict the opening of the booster plunger into the main distribution riser, this will prevent effective boosting of the sprinkler system and must be revised.

Installations must be fitted with fire brigade booster connections which will enable the fire brigade to pump water into the installation using their own equipment.

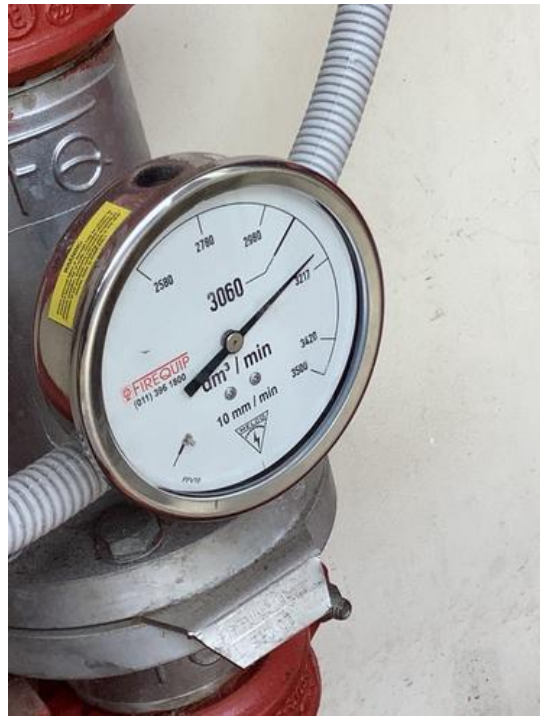
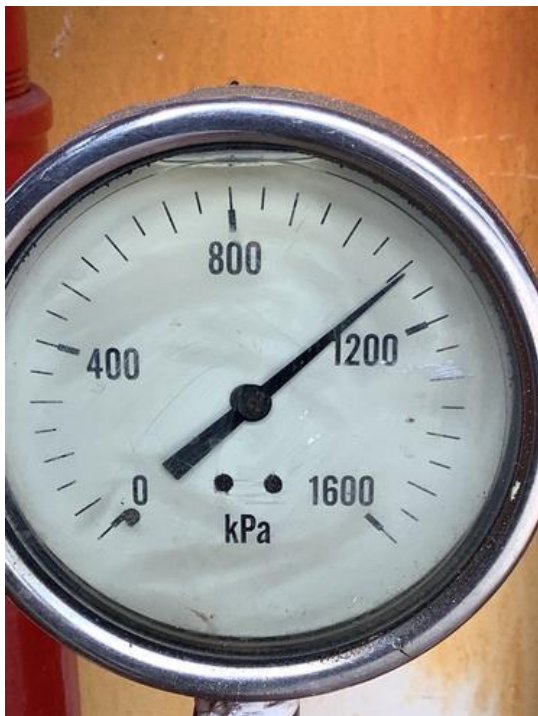
Recorded Flow and Pressure	3050 l/min @ 1100 kPa
7.15 Correct Pressure Gauges Installed	Yes
7.16 Correct Gauge Cocks Installed	Yes
7.17 Flanges Short Bolted	No
7.18 Loose / Missing Bolts, Nuts & Washers	No
7.19 False Alarm Prevention Pump Installed	N/A
7.20 Drain & Test Pipes Installed Correctly	Yes

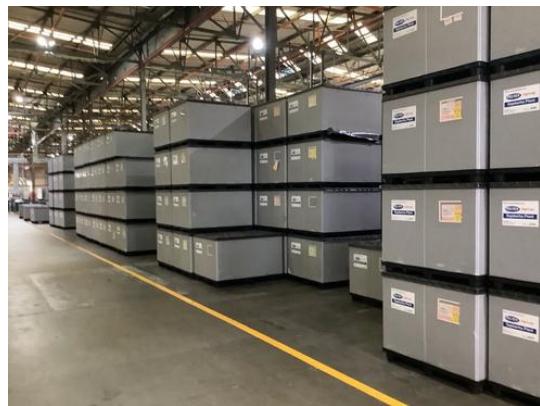
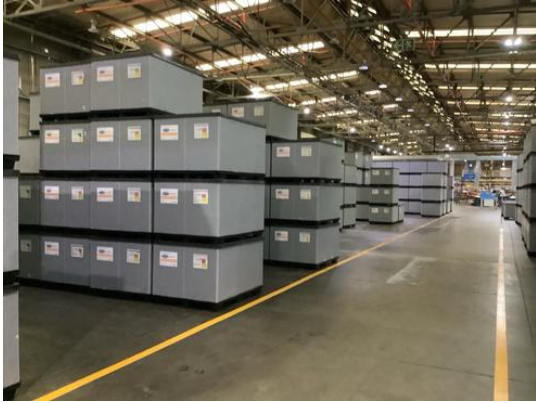
Free Standing Block Storage and aisle widths are not being maintained.

No block of storage shall exceed 150 m² of floor area and shall be surrounded by aisle widths of not less than 2,4 m.

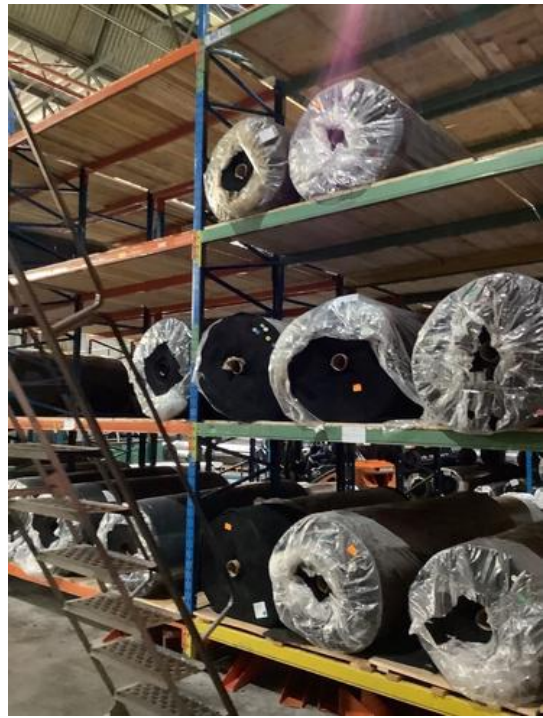
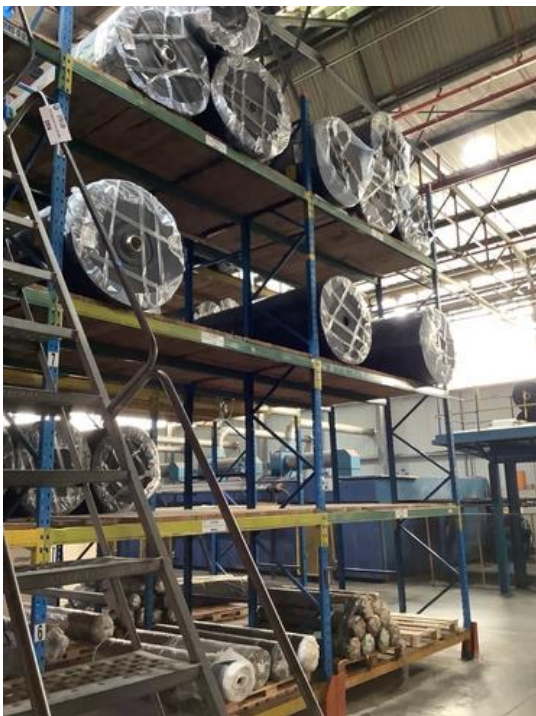
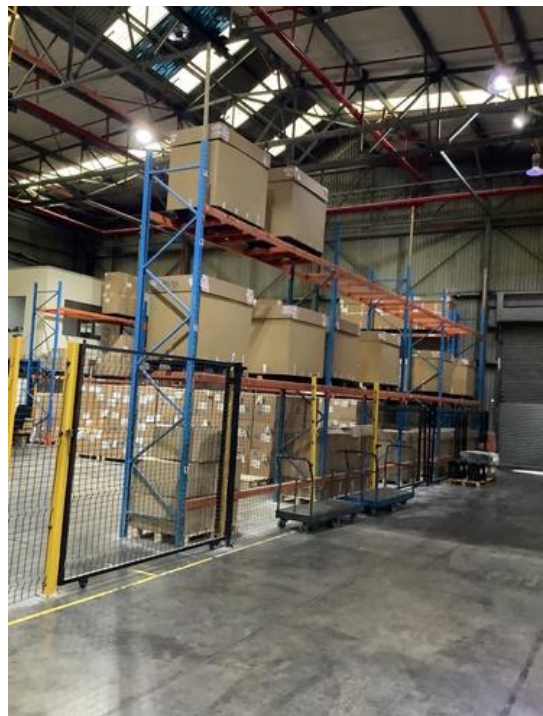
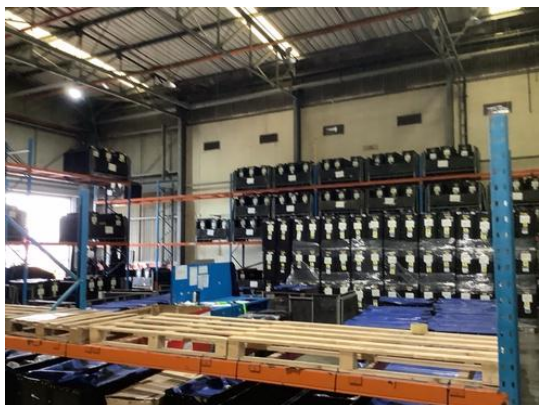
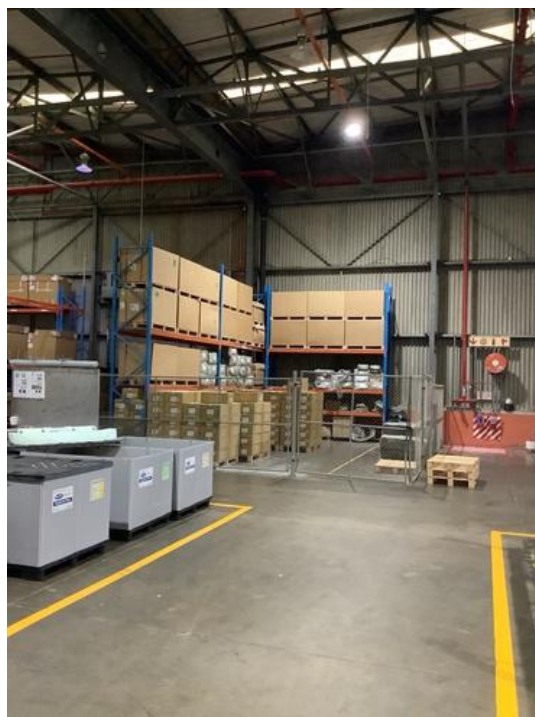
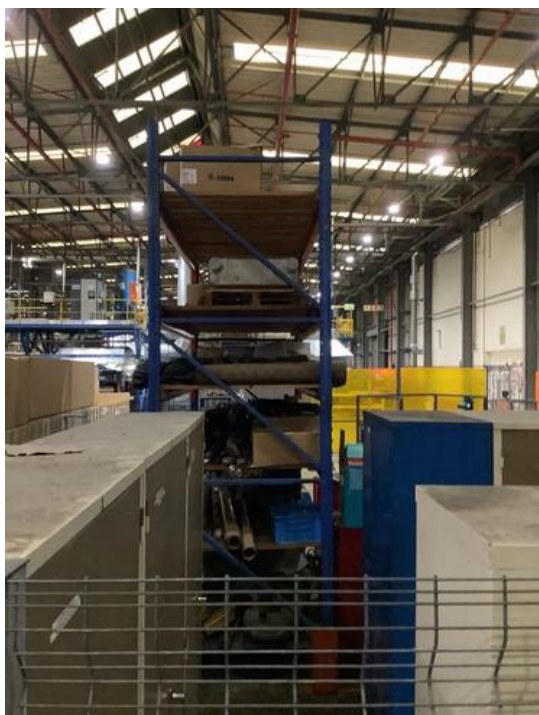
Are the storage heights exceeded.

Yes

The storage heights must be maintained in accordance with the maximum allowable stack heights as detailed in this report. Should this not be possible, intermediate level protection is deemed to be mandatory.

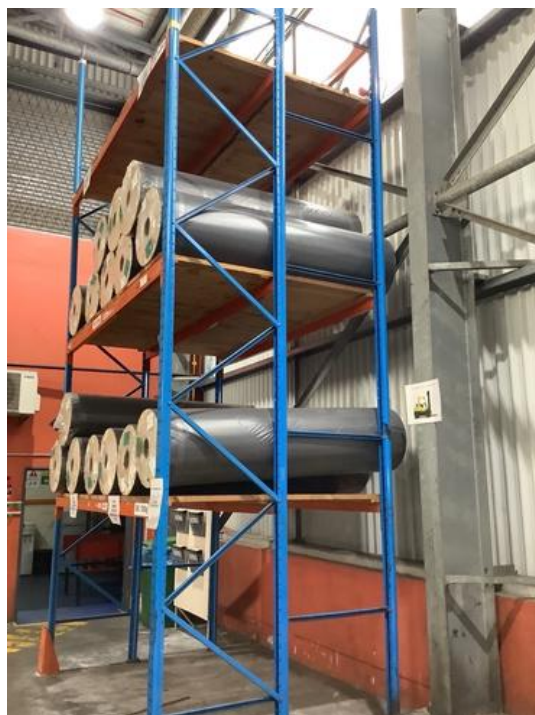
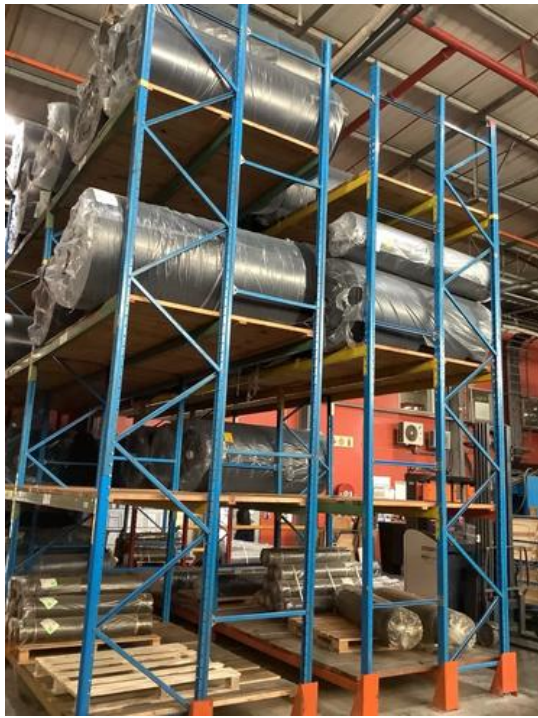
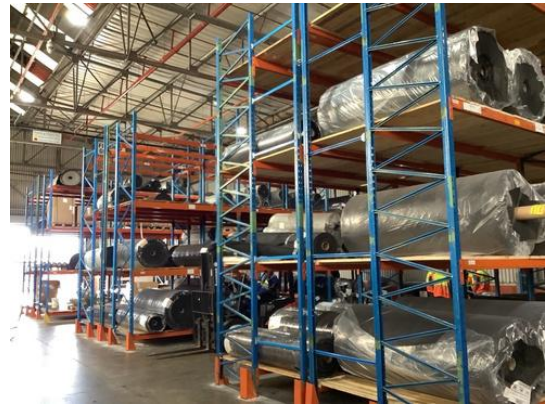
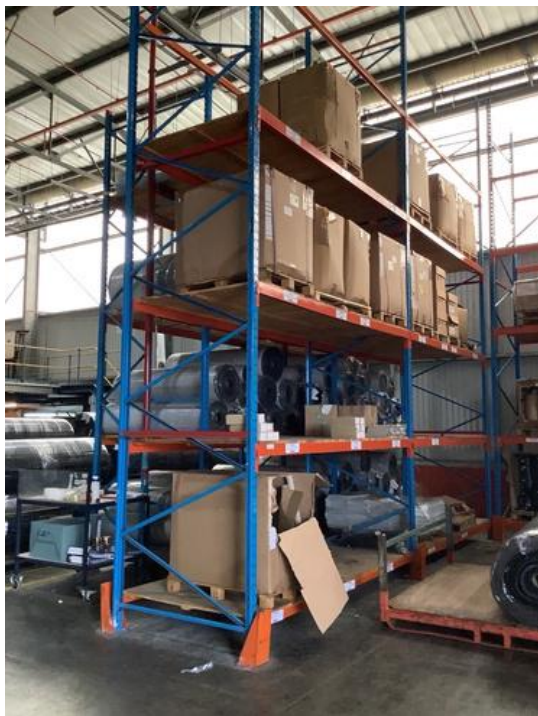
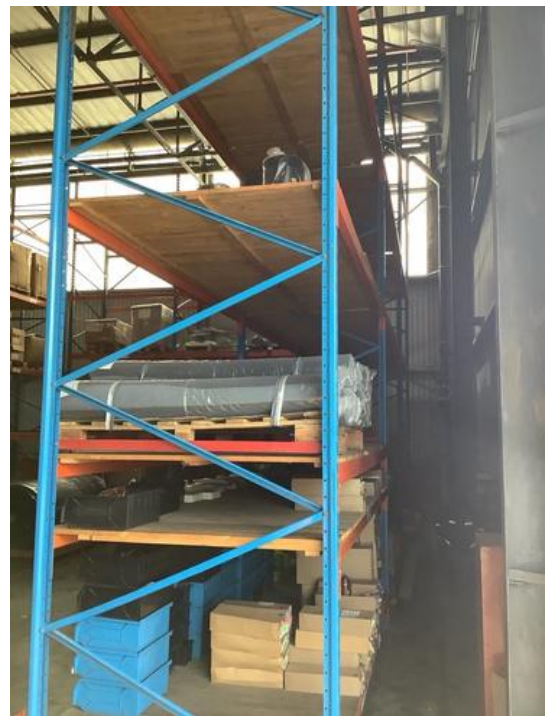
Quarantine store
Trim workshop

Shelves exceed 1,0 metre in width.

The shelves must be reduced to a maximum width of 1,0 metre or intermediate sprinkler protection will be mandatory at each shelf tier level.

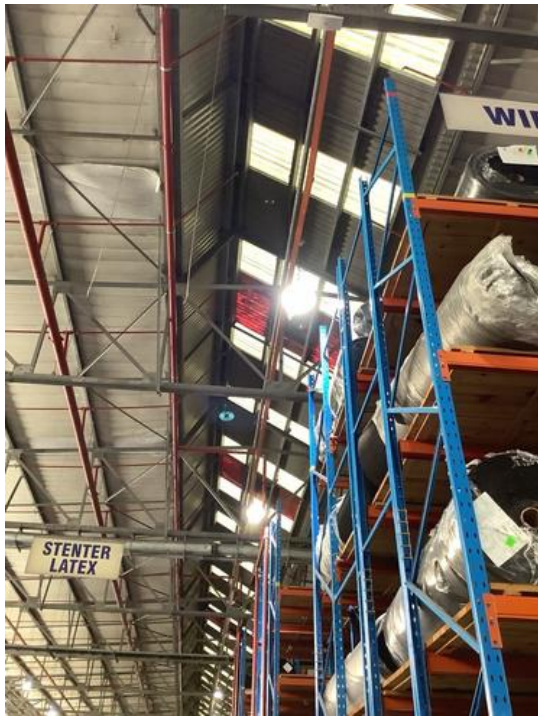
Photo 21

Sprinklers installed beneath open cell surfaces / translucent sheeting.

Various at roof

All sprinklers located beneath open celled floors or stairwells and translucent sheeting must have approved water shields fitted above the sprinklers.

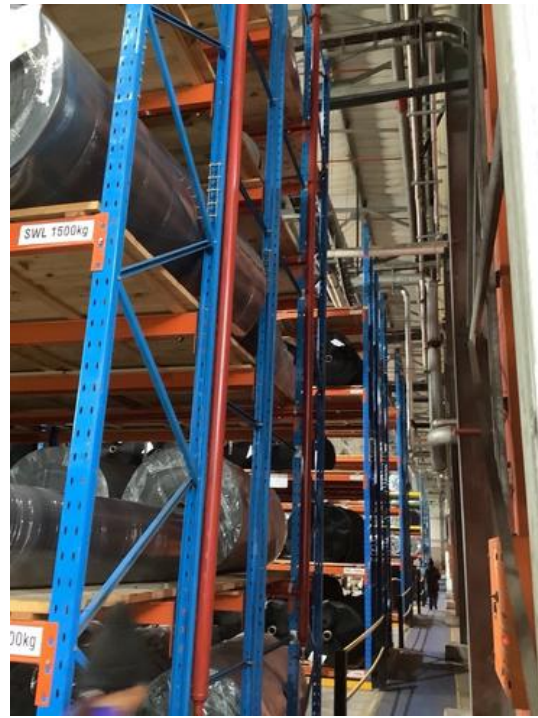
Photo 22

Droppers to shelves

The sprinkler pipe work must be correctly supported.

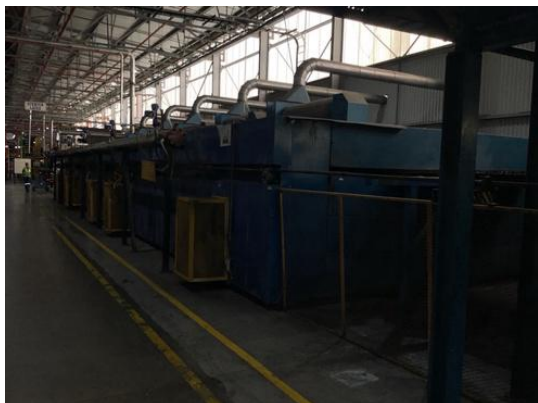
Photo 23

Portion of premises sprinkler protected with communicating sections that are not.

Partial protection can lead to a fire originating in the protected area radiating heat into the unprotected portion of the premises and starting secondary fires. The heat from these fires radiates or spreads back into the protected area causing excessive sprinkler operation.

Stenter oven

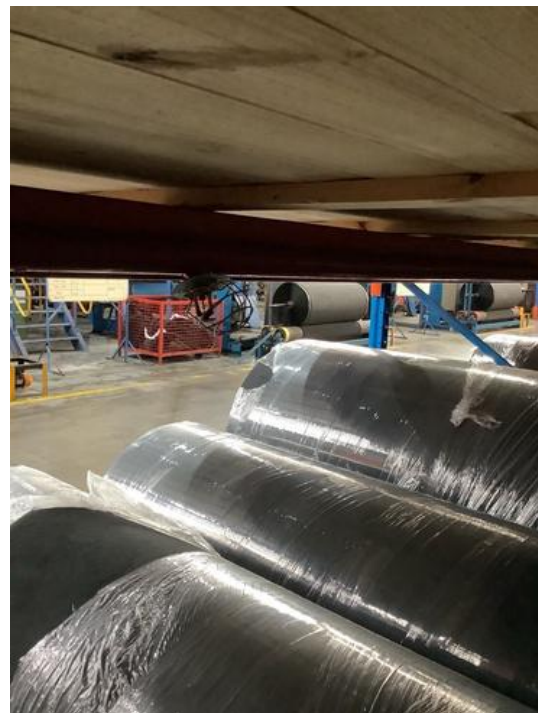
Photo 24

Sprinkler guards damaged or missing.

carpet rack at roller door

The range pipe must be lowered so that the sprinkler deflectors protrude a minimum distance of 25 mm beneath the horizontal beam of the rack and/or shelf.

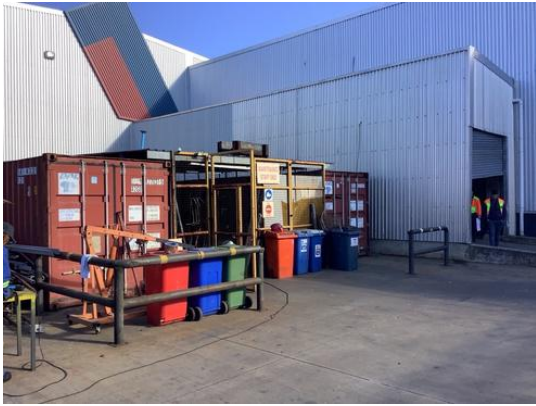
Photo 25

Adjacent building within 10,0 metres / 15,0 of the sprinkler protected building.

Maintenance workshop and containers

Any detached building in the Ordinary Hazard or Extra Light Hazard class, any part of which is within 10,0 m of a protected building, must itself be sprinkler protected.

Any detached building in the Extra High Hazard class, any part of which is within 15,0 m of a protected building, must itself be sprinkler protected.

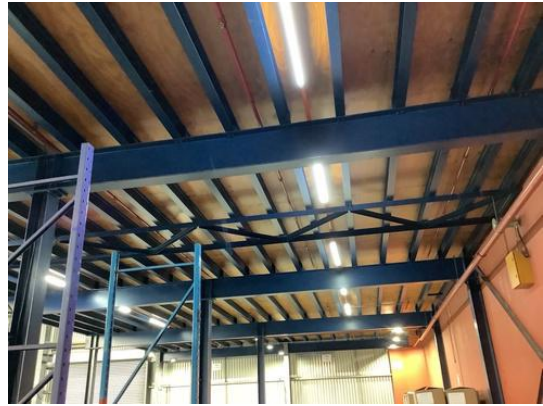
Photo 26

Mezzanine. Only a recommendation for tenth edition systems

Fast response, upright spray pattern sprinklers with an operating temperature of 68 °C shall be used for the protection of the underside of the mezzanine floor. The sprinklers must be fitted with approved water shields and sprinkler guards so as to prevent mechanical damage. This must be rectified by your installer.

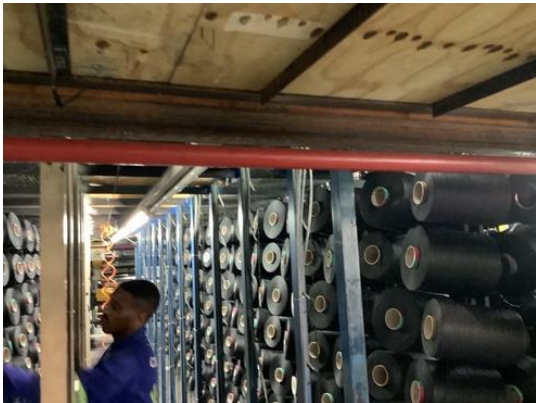
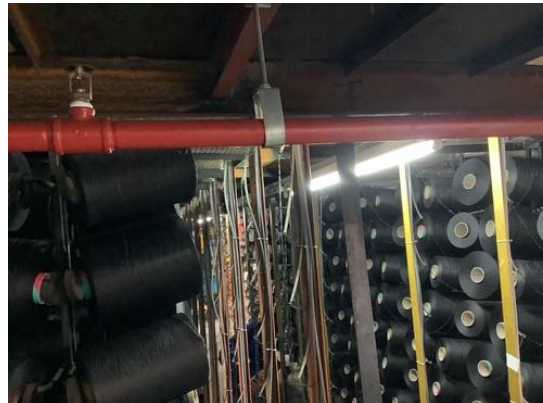
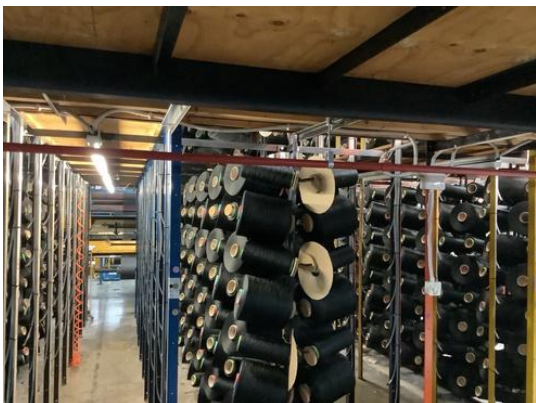
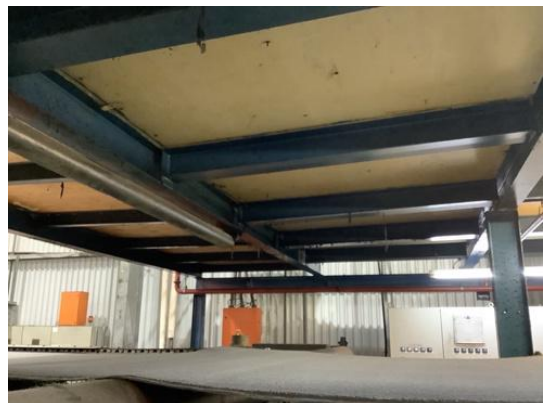
Under carpet machine platforms

Sprinklers are out of effective working distance.

Sprinkler protection must be extended in order to provide correct coverage.

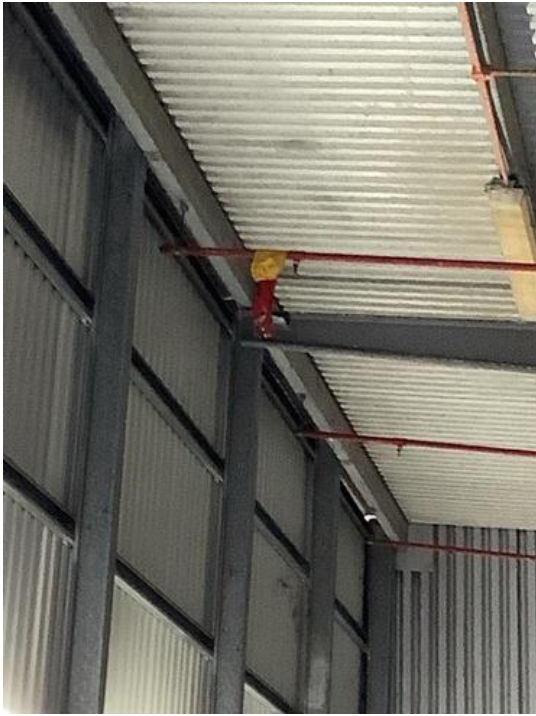
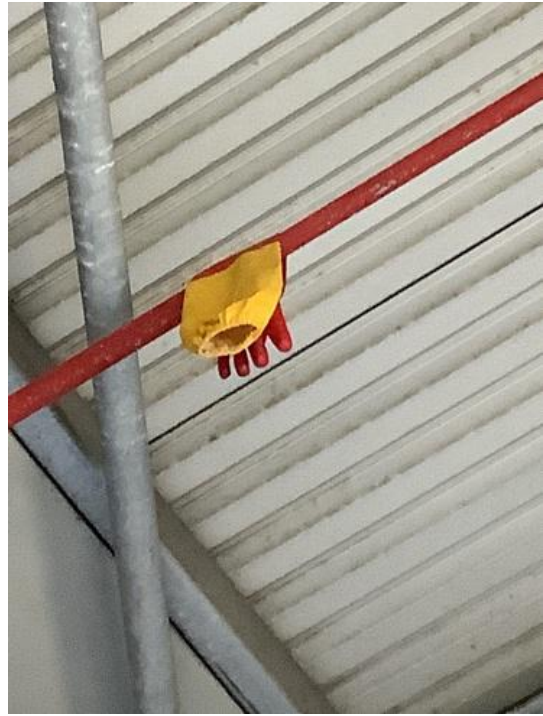
Canopy to Tugger

Distribution pattern of sprinklers affected.

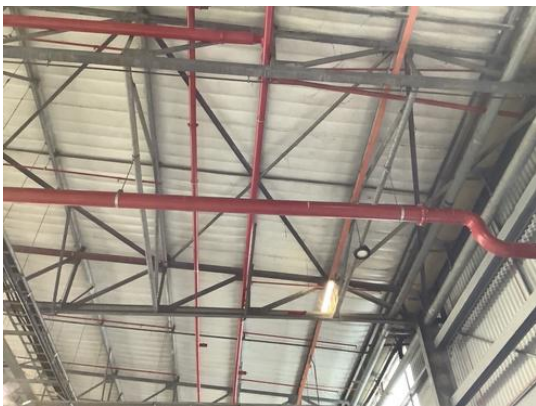
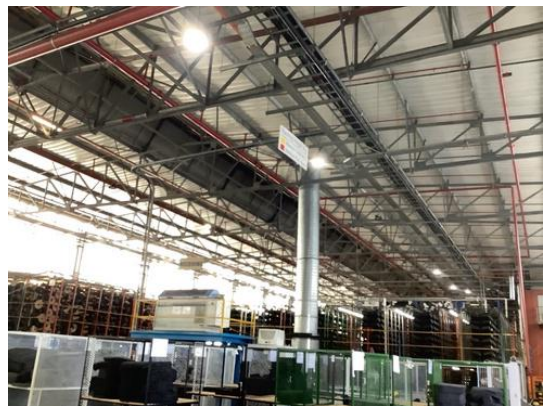
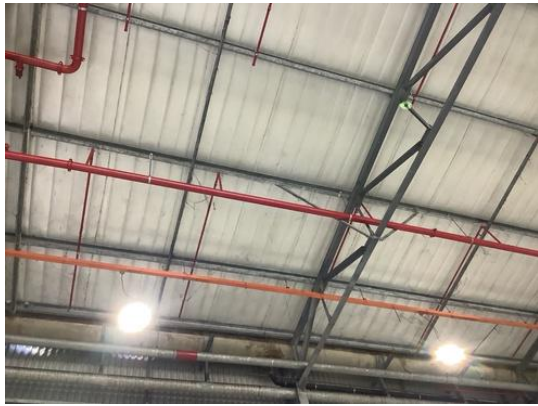
Main feed
Distribution main

Belt-to-belt hangers utilized.

The sprinkler pipe work must be correctly supported.

Belt-to-belt hangers must be removed and the pipe work correctly supported.

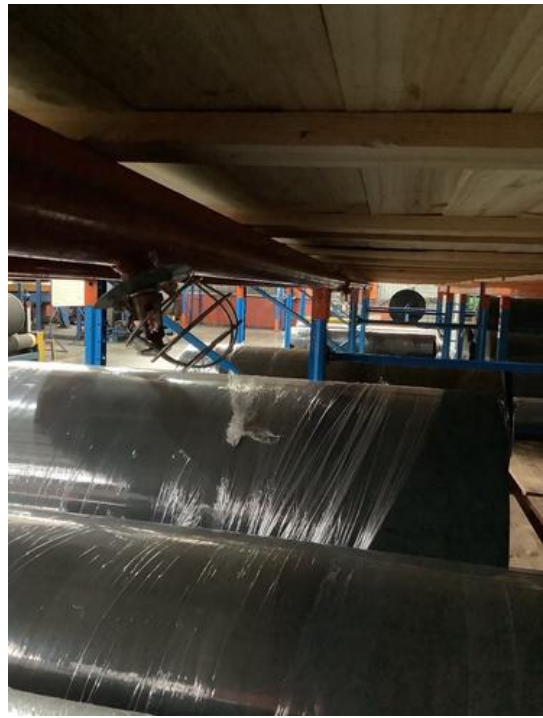
Photo 36

carpet rack at roller door

Sprinkler heads must be correctly aligned.

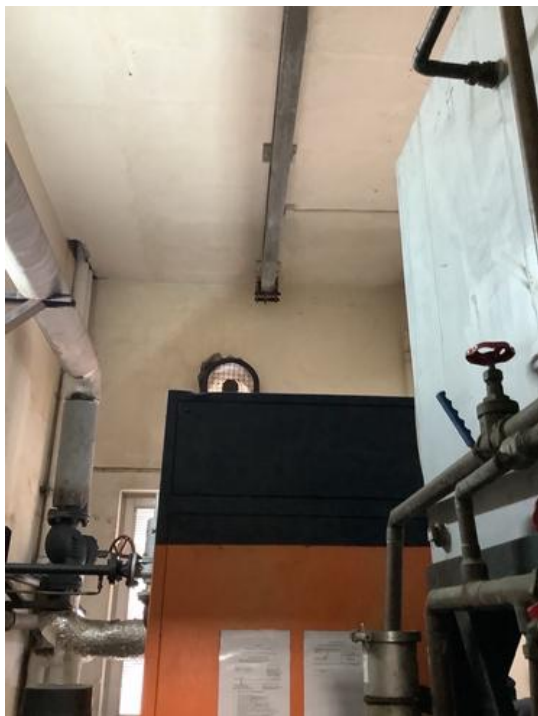
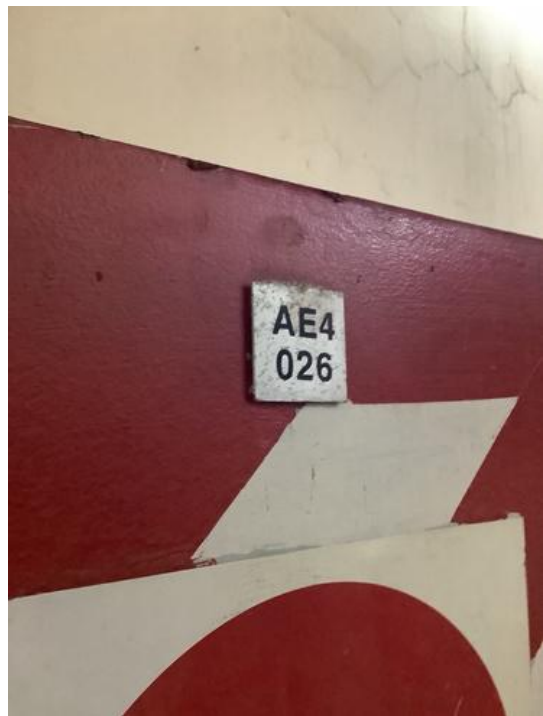
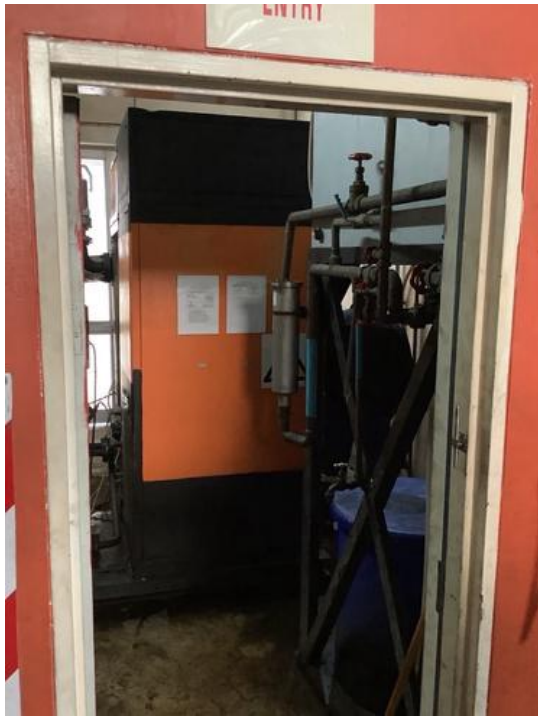
Room O26

Separation between protected and unprotected areas.

Window openings must be of wired glass or heat-tempered construction.

Cut off sprinklers required above the windows on the unprotected side.

Door openings within the separating wall must be either Class D or Class B fire rated doors with cut off sprinklers installed on the unprotected side.

All fire resisting doors must be fitted with automatic devices capable of closing them from any set position and of holding doors open. Manual movements of the doors must not be prevented by the automatic device.
