Inspection of Automatic Sprinkler System

East London Industrial Development
Zone - Draeger

UNC.9918

18.06.2024 14:44 SAST

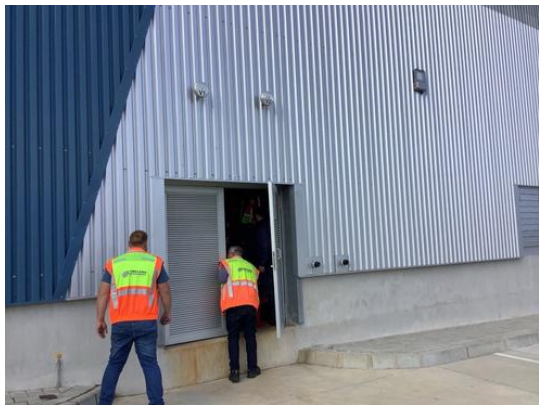
Photo 1

Right of loading canopy

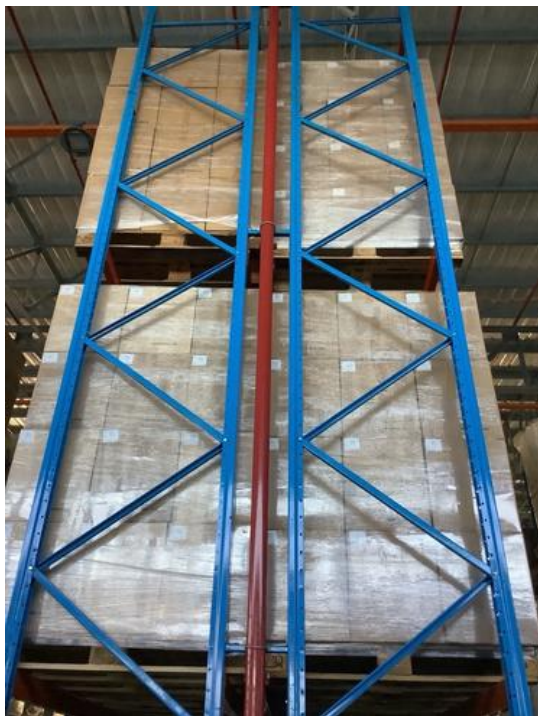
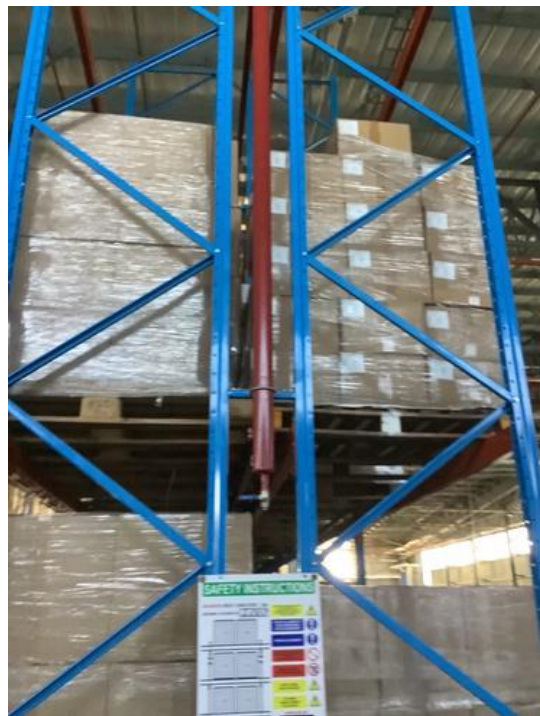
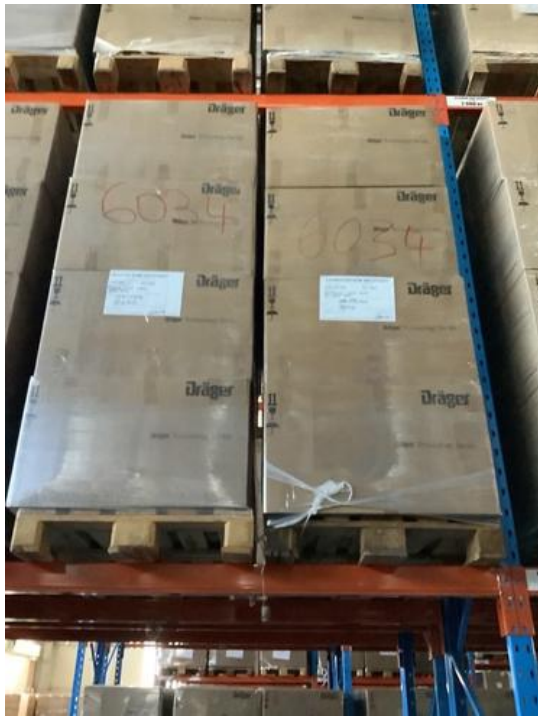
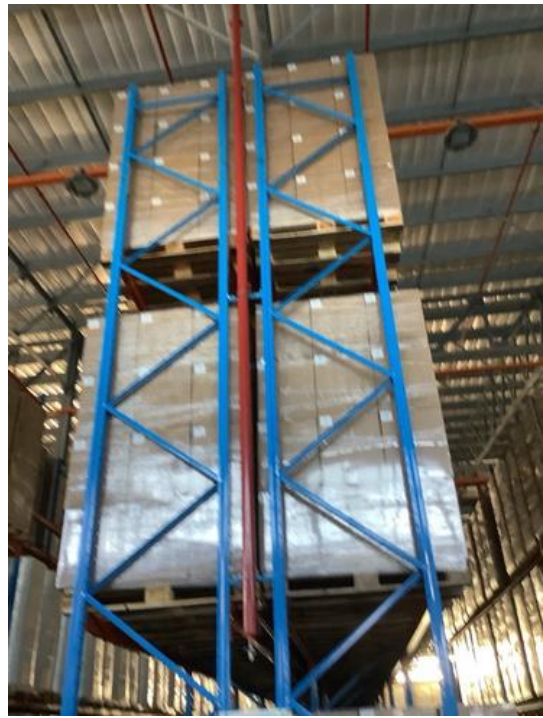
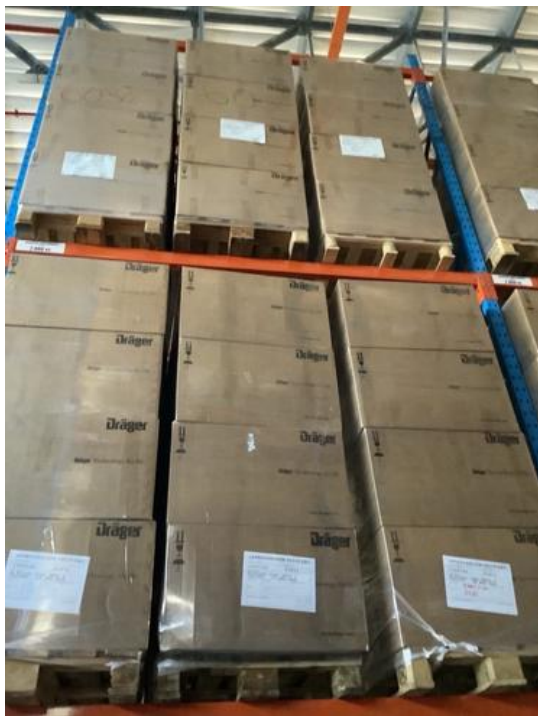
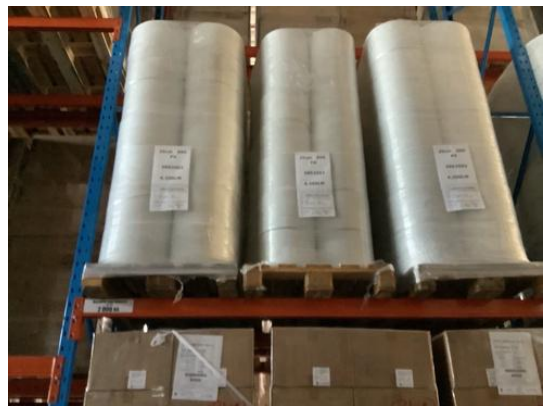
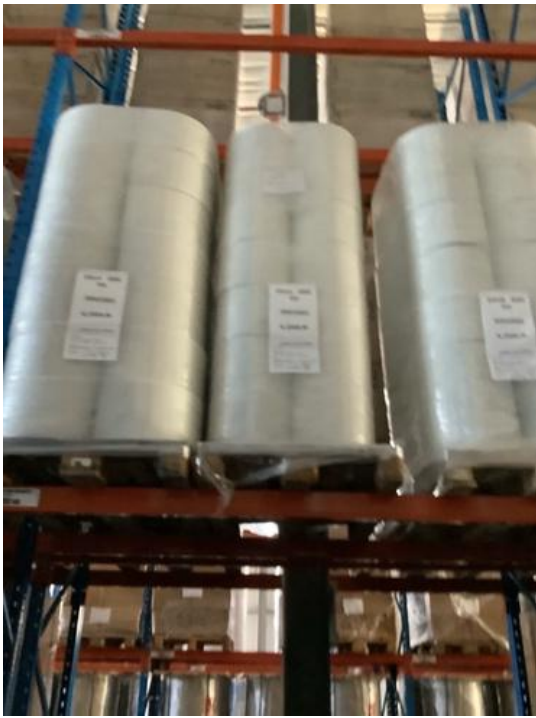
The longitudinal and/or transverse flue spaces are not being maintained

The minimum longitudinal and transverse flue spaces shall not be less than 150 mm.

Various racks

The clearance certificate is issued with the understanding that the storage issued as highlighted in sections 8&9 of this report are addressed immediately. As discussed on site the rack sprinkler spacing must suit either standard pallets or Euro pallets. If this is not possible then each rack must be converted to shelving as long as the sprinkler spacing allows this.

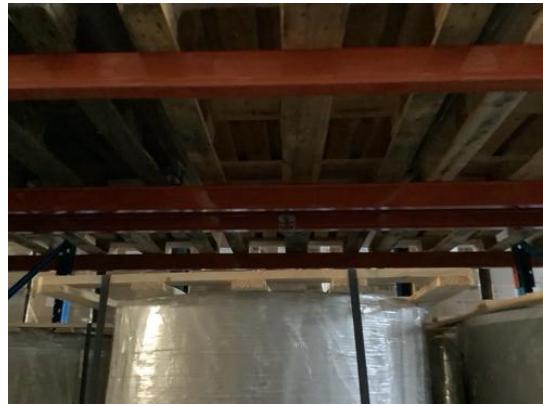
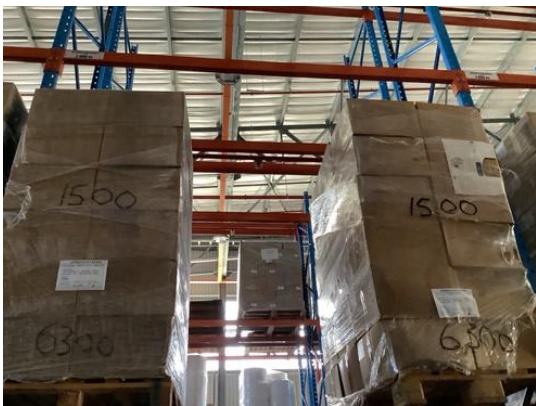
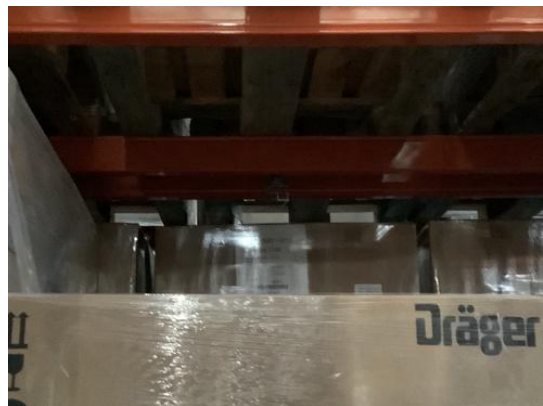
Intermediate Sprinkler Protection

Sprinklers do not line up with the transverse flue spaces, the system must be redesigned to accommodate the stacking arrangements.

1. Various
