Inspection of Automatic Sprinkler System

East London Industrial Development
Zone - SOS Cheese Factory

UNC.10601

20.06.2024 08:46 SAST

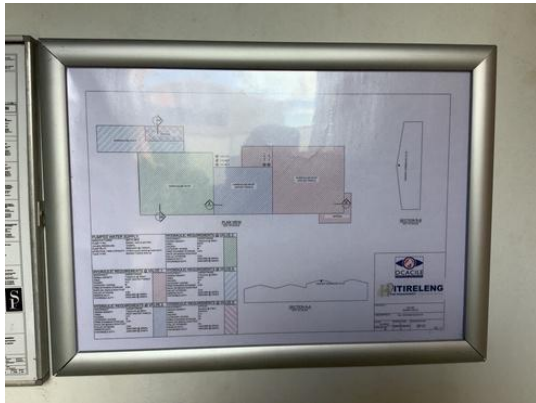
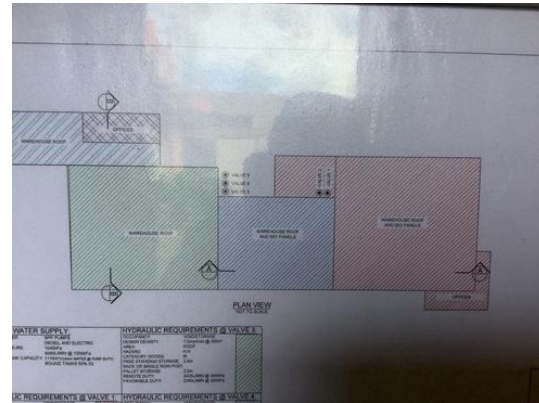
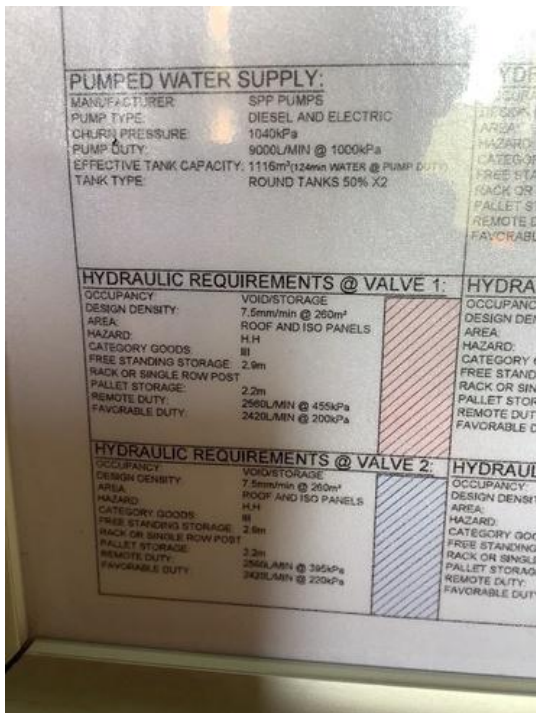
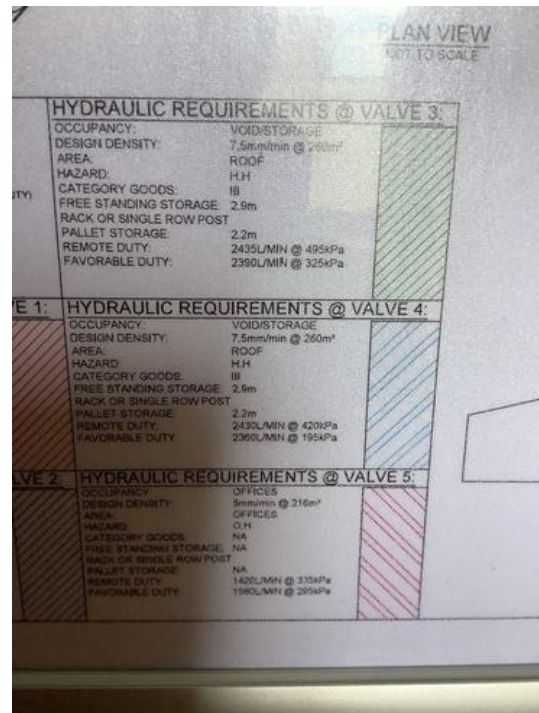
7. Installation Control Valve(s)	
7.1 Sprinkler control valves accessible	Yes
Valve Cabinet	
Valve Cabinet 1	
Location:	
Opposite right of security gate	
Number of Alarm Valves Installed	2 x 150mm. Valve 4 feeds SOS

7.2 Sprinkler Valve Location Plate Installed	Yes
7.3 Fire Brigade Booster Pressure Limitation Plate	Yes
7.4 Block Plan Installed	Yes
7.4.1 Is the block plan labelled in accordance with the areas fed by the sprinkler control valve assemblies	Yes

7.4.2 Are the correct installation details recorded on the block plan	Yes
<div>

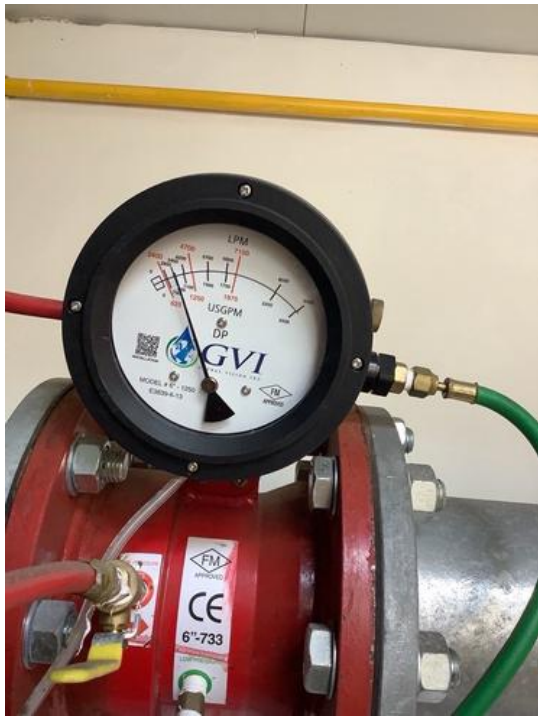
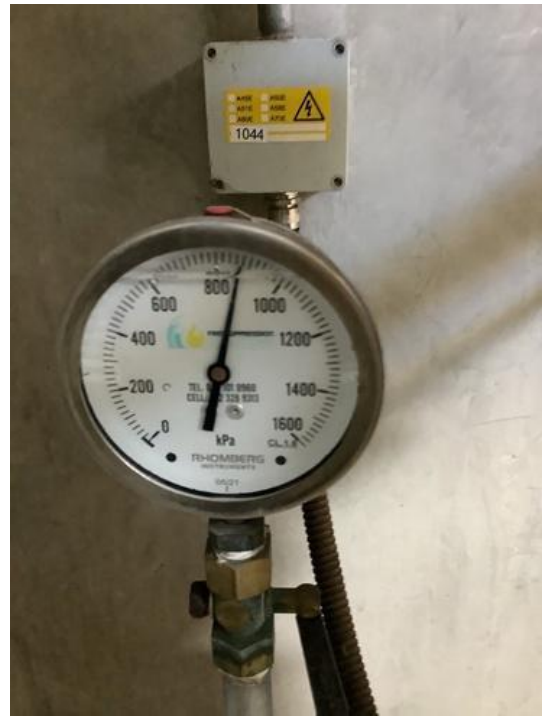
Photo 5	Photo 6
Flow Test Results	Pass
Recorded Flow and Pressure	2700 l/min @ 900 kPa
7.15 Correct Pressure Gauges Installed	Yes
7.16 Correct Gauge Cocks Installed	Yes
7.17 Flanges Short Bolted	No
7.18 Loose / Missing Bolts, Nuts & Washers	No
7.19 False Alarm Prevention Pump Installed	N/A
7.20 Drain & Test Pipes Installed Correctly	Yes

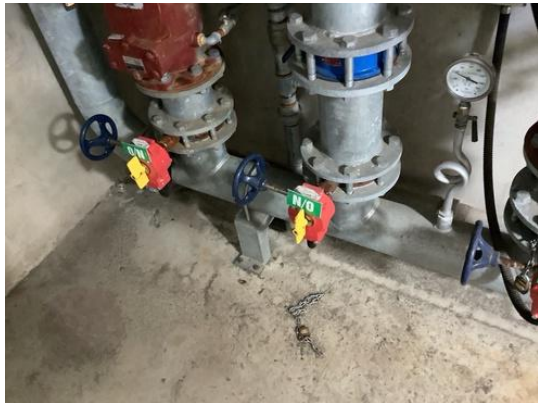
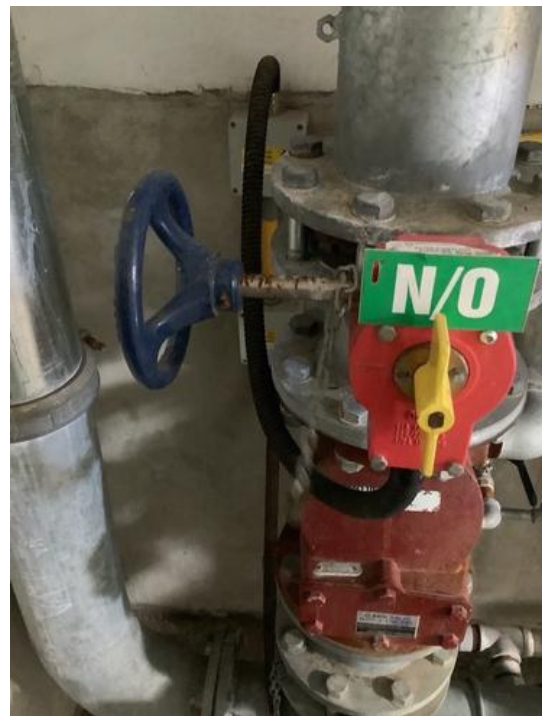
7.27 Are All Valves Secured

No

All valves must be secured in their correct operative positions with light chains and padlocks that are keyed alike.

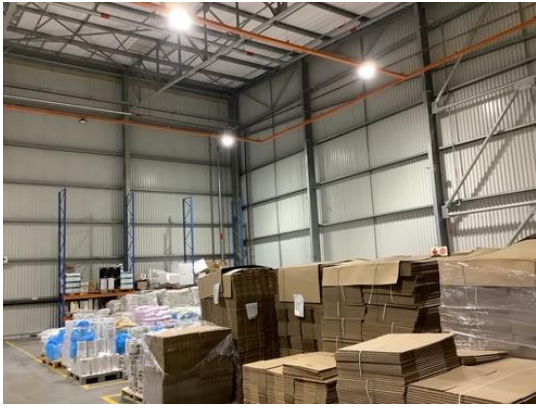
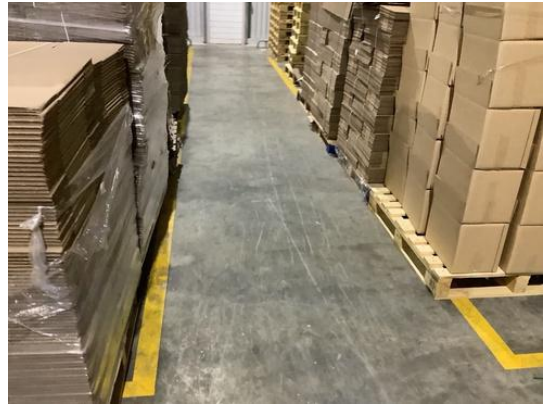
Free Standing Block Storage and aisle widths are not being maintained.

No block of storage shall exceed 150 m² of floor area and shall be surrounded by aisle widths of not less than 2,4 m.

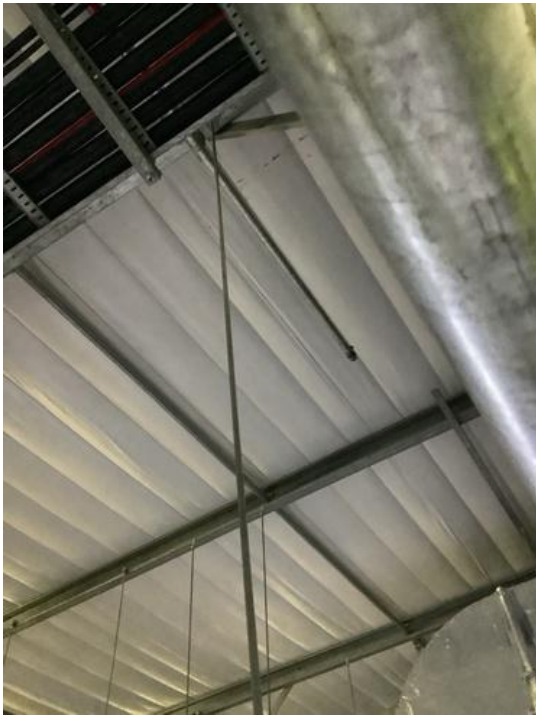
Photo 11

Terminal range pipe hangers are exceeding the maximum distance of 750 mm from the end of the range pipe.

Roof

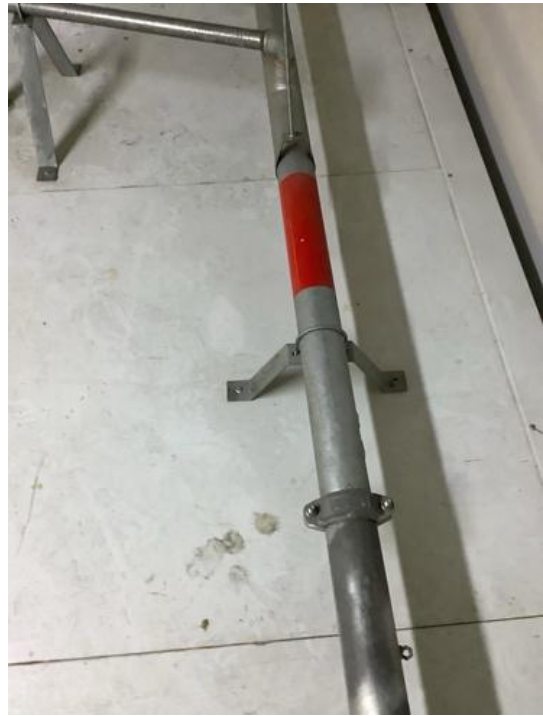
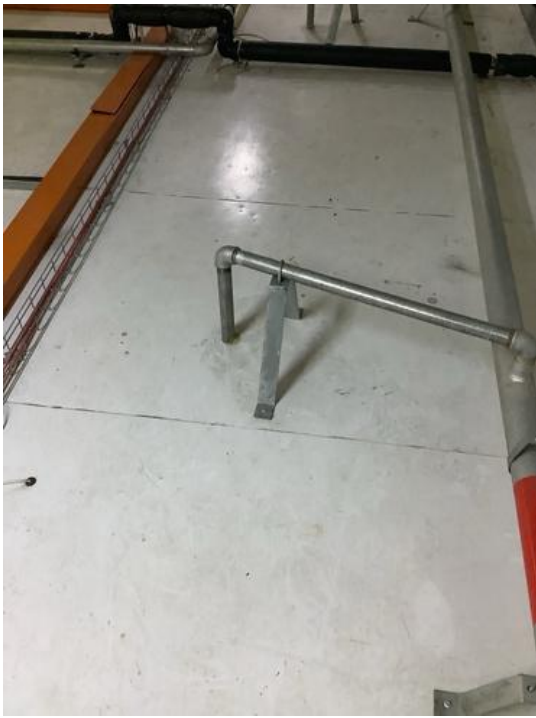
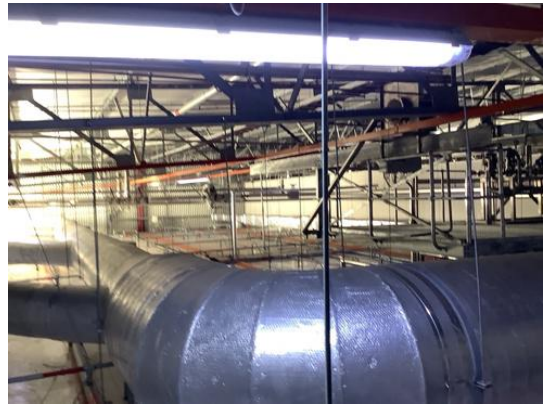
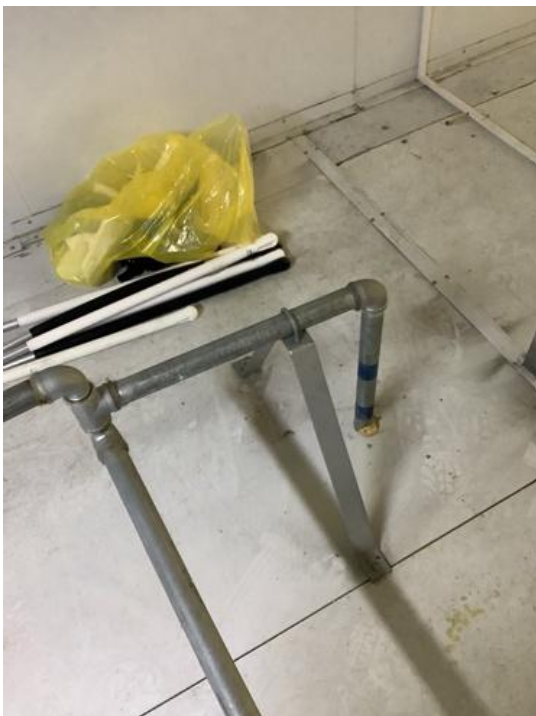
Cold and freezer room composite panel

In the event of collapse of the cold room, the cold room material must drop away from the sprinkler system.

Pipe work must be supported independently from the composite panel, and the dry dropper must not be attached to the fabric of the cold room with mastic or insulating material that permanently bonds the dropper to the refrigerated structure.

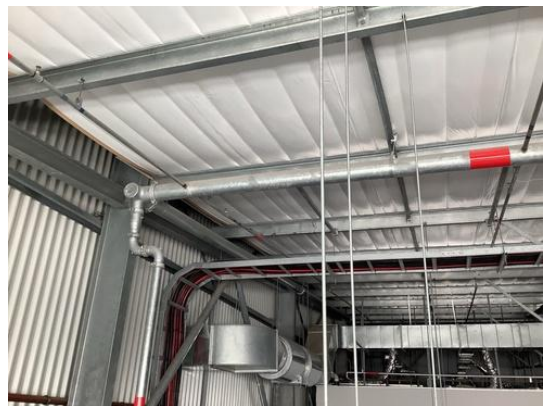
Photo 16

The sprinkler pipe work must be correctly supported.

Roof mains

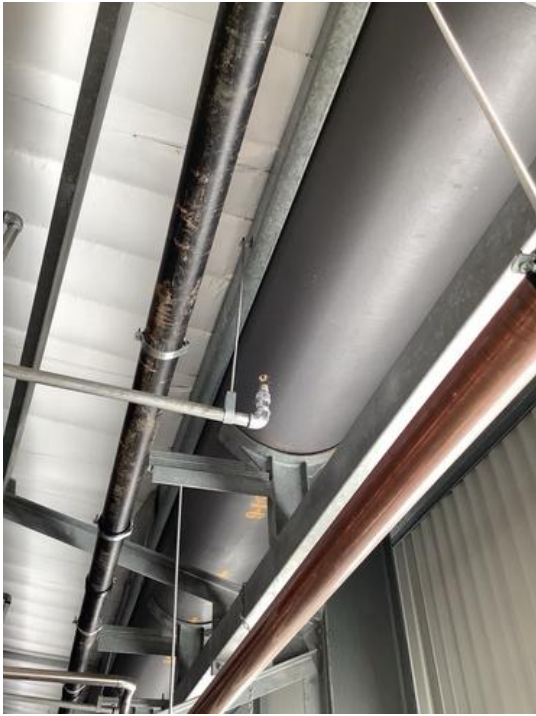
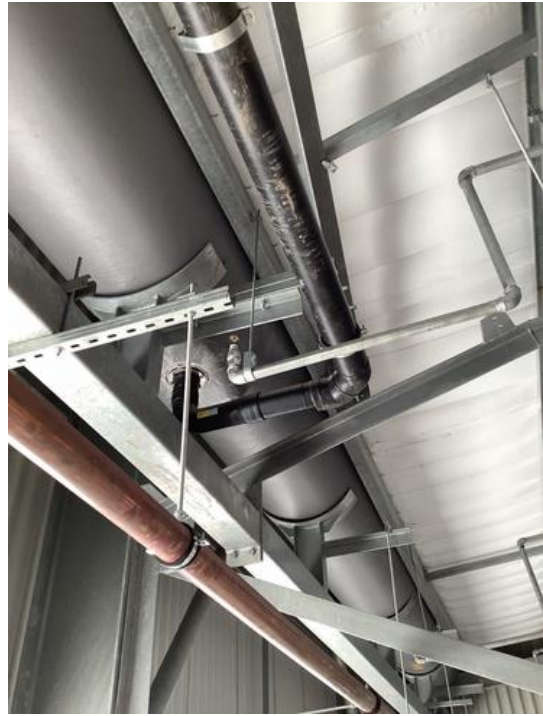
The sprinklers are spaced too far from roof/ceiling level.

Combustible maximum 300 mm / Non-combustible maximum 450 mm.

Roof

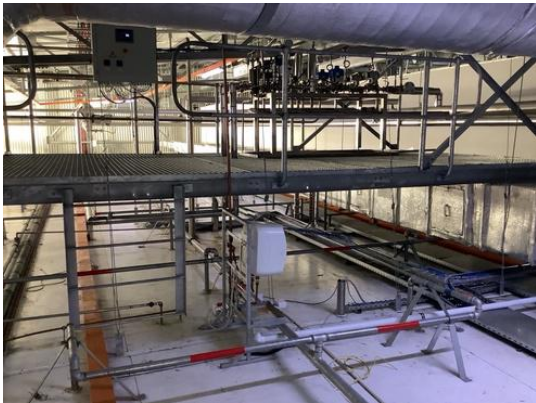
Photo 19

Surfaces exceeding 1,0 metre in width.

Surfaces which exceed 1,0 metre in width will obstruct the water discharged from the sprinklers above which could result in an ignition beneath these surfaces not being controlled or

extinguished.

Control platform

The general obstruction is classed as 1,000 mm therefore sprinkler protection is required beneath any such obstruction which includes, but is not limited to;

Walkways, solid or open grid, and Work tables.

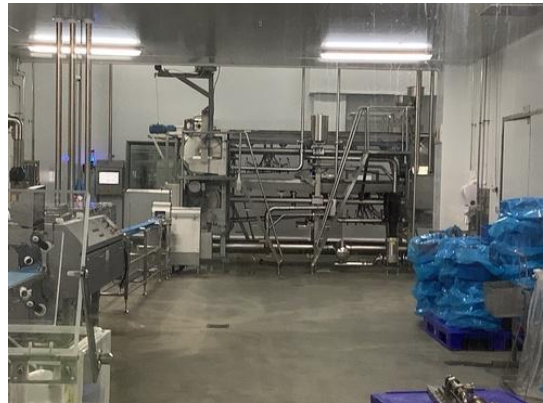
Photo 20

Surfaces exceeding 1,0 metre in width.

Surfaces which exceed 1,0 metre in width will obstruct the water discharged from the sprinklers above which could result in an ignition beneath these surfaces not being controlled or extinguished.

Start of casting line

The general obstruction is classed as 1,000 mm therefore sprinkler protection is required beneath any such obstruction which includes, but is not limited to;

Walkways, solid or open grid, and Work tables.

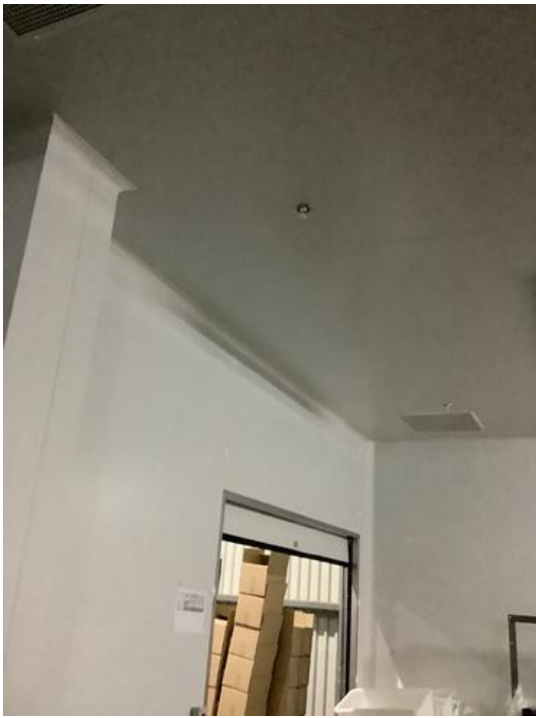
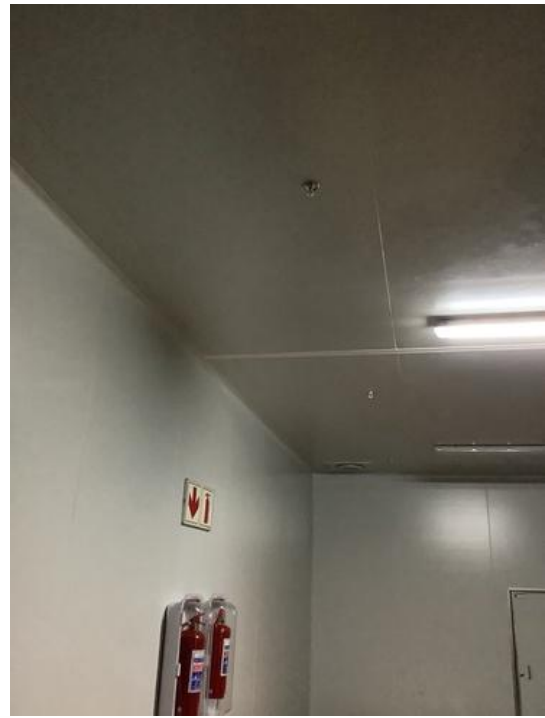
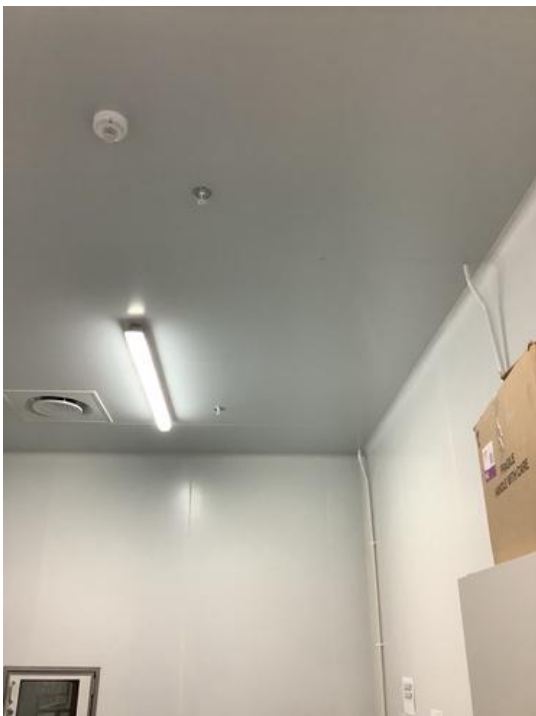
Sprinklers exceed 600 mm from walls of a cold room or freezer (11th Edition).

Various ground floor

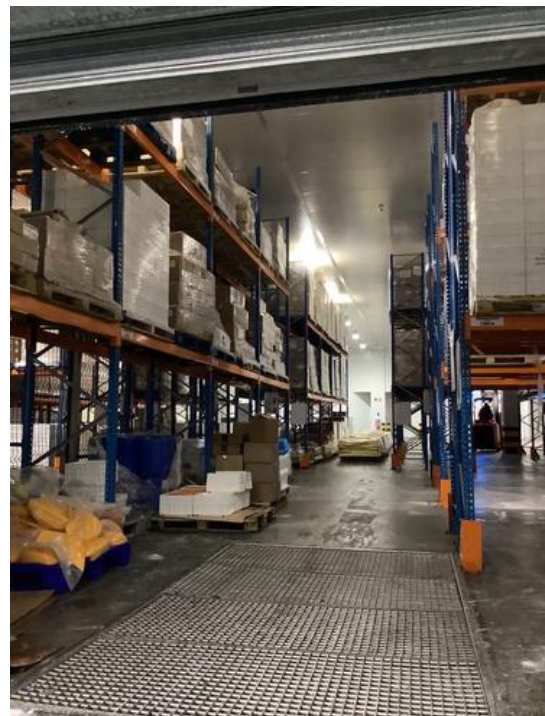
Photo 24

This is in relation to the adjacent cold room that is unprotected

Portion of premises sprinkler protected with communicating sections that are not.

Partial protection can lead to a fire originating in the protected area radiating heat into the unprotected portion of the premises and starting secondary fires. The heat from these fires radiates or spreads back into the protected area causing excessive sprinkler operation.

Conversely, a fire originating in the unprotected portion will radiate heat or spread into the protected portion rapidly causing unnecessary sprinkler operation and overwhelming the sprinkler system installed.

Adjacent cold room
