# Inspection of Automatic Sprinkler System

East London Industrial Development  
Zone - AE8 vacant

UNC.10603

19.06.2024 09:01 SAST

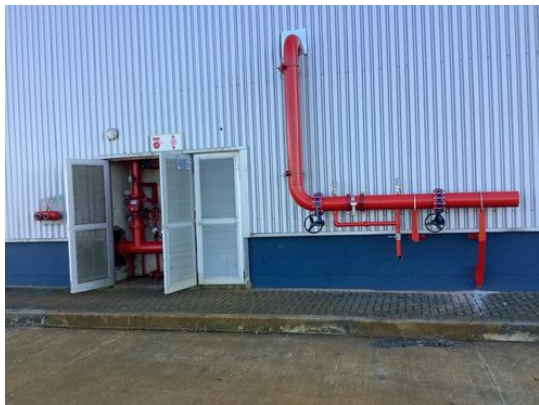
Photo 1

South West corner

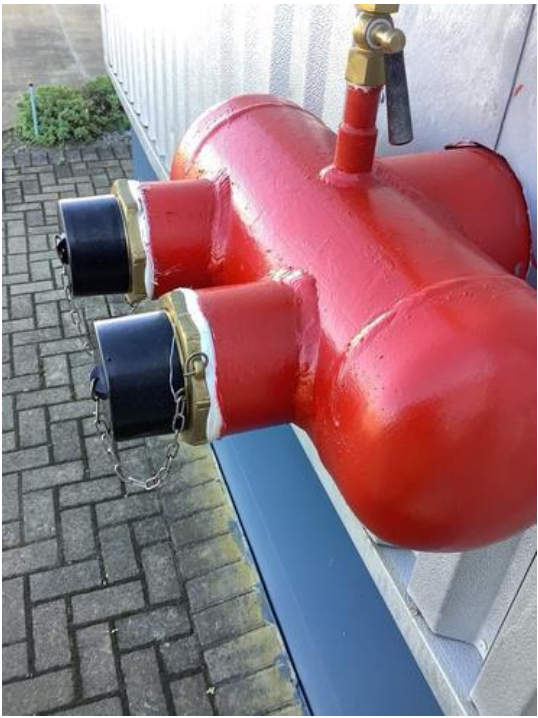
Photo 6

## 7.8 Fire Brigade Booster Connections Installed Correctly and Accessible

No

It appears that the booster connection piping to the main distribution riser is too long, which may restrict the opening of the booster plunger into the main distribution riser, this will prevent effective boosting of the sprinkler system and must be revised.

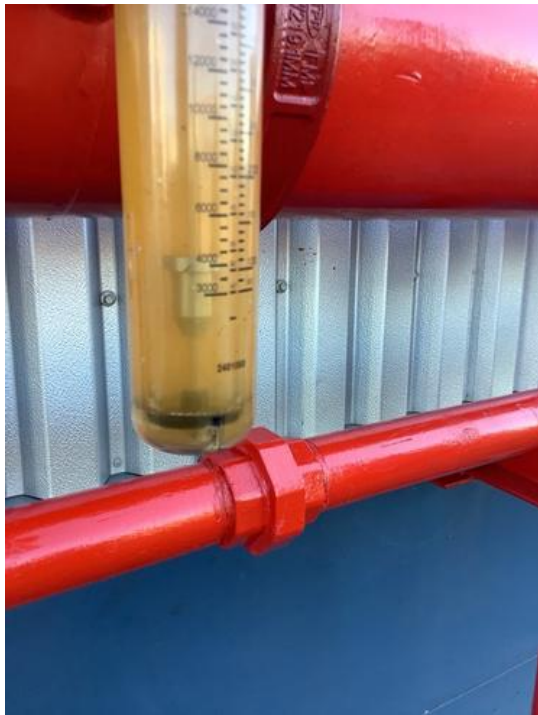
Photo 7

## 7.14 Flow Measuring Device Installed.

4000 l/min @ 1000 kPa

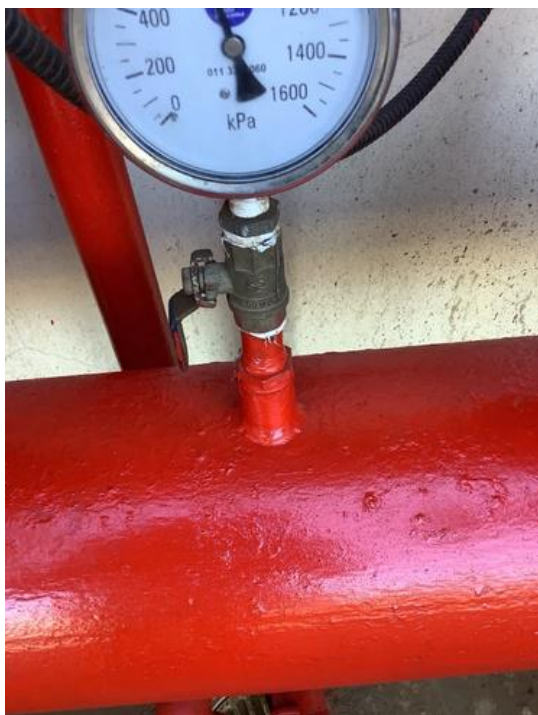
Photo 9

## 7.16 Correct Gauge Cocks Installed

No

All pressure gauges fitted to a sprinkler system shall be fitted with an isolating gauge cock with bleed to be able to confirm gauge operation back to zero and enable each pressure gauge to be readily removed without interruption of the installation water supplies.

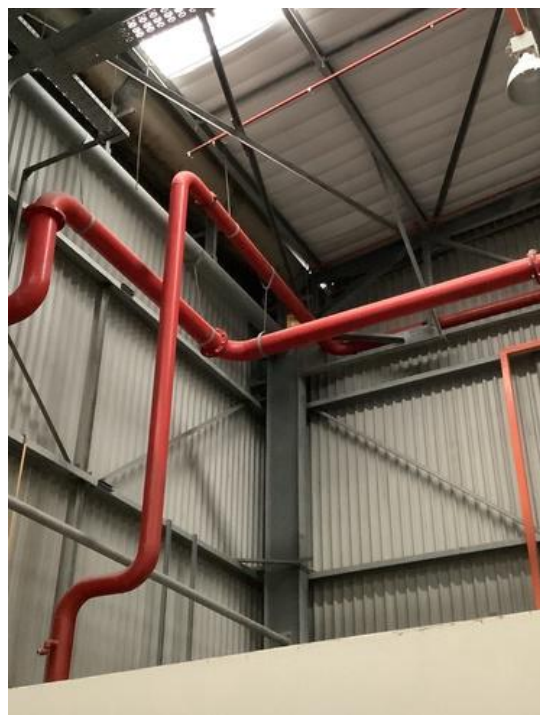
Photo 10

**The sprinkler pipe work must be correctly supported.**

**Belt-to-belt hangers utilized.**

Main feed  
Distribution main

Belt-to-belt hangers must be removed and the pipe work correctly supported.

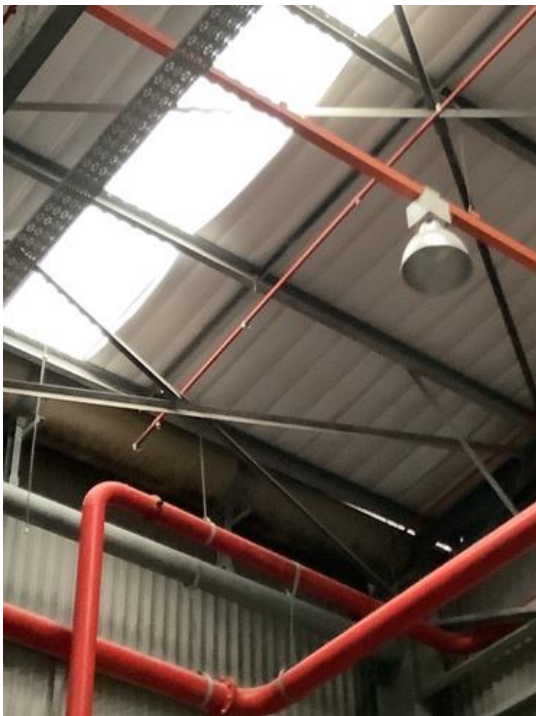
Photo 13

**Hangers have come adrift and must be re-fixed to their original positions.**

Various on ranges

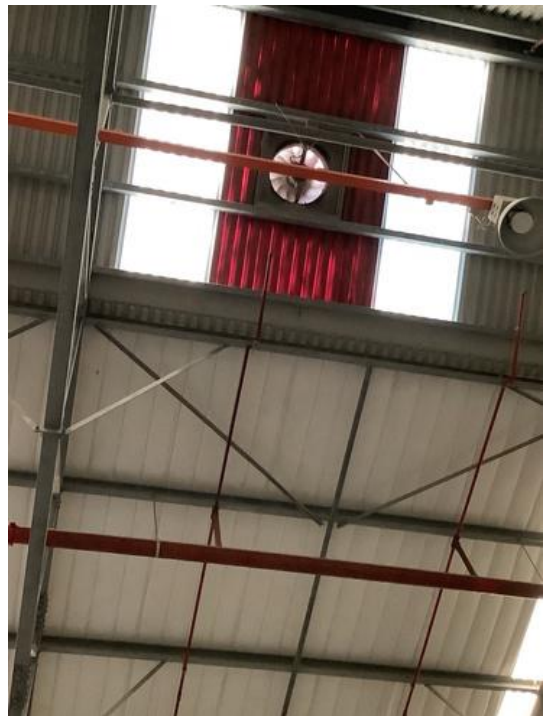
Photo 14

**Sprinklers installed beneath open cell surfaces / translucent sheeting.**

Roof monitors

All sprinklers located beneath open celled floors or stairwells and translucent sheeting must have approved water shields fitted above the sprinklers.
