Inspection of Automatic Sprinkler System

East London Industrial Development
Zone - AE6 vacant

UNC.10602

19.06.2024 08:49 SAST

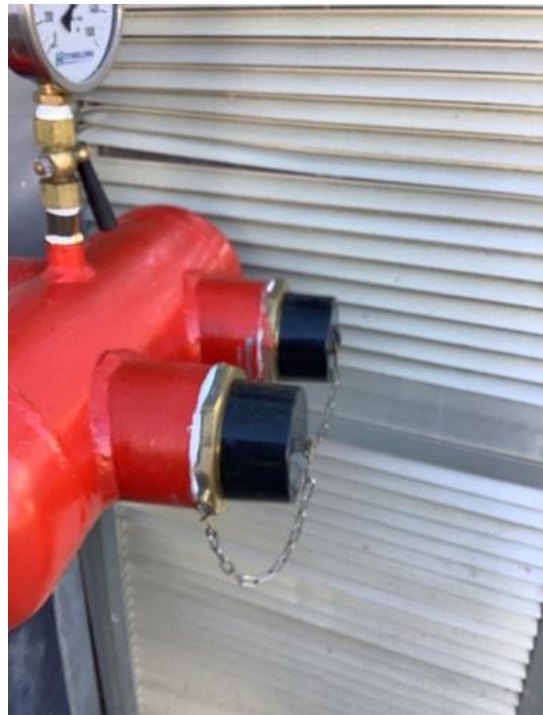
Photo 6

No

It appears that the booster connection piping to the main distribution riser is too long, which may restrict the opening of the booster plunger into the main distribution riser, this will prevent effective boosting of the sprinkler system and must be revised.

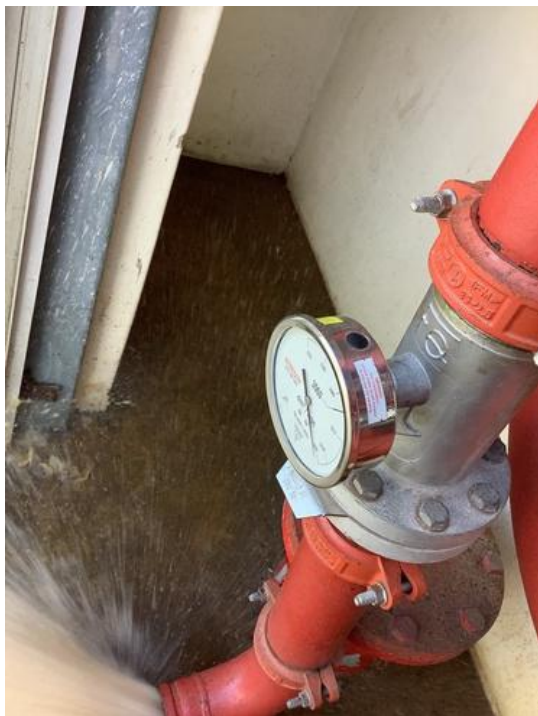
Photo 7

Pass

3500 l/min @ 940 kPa

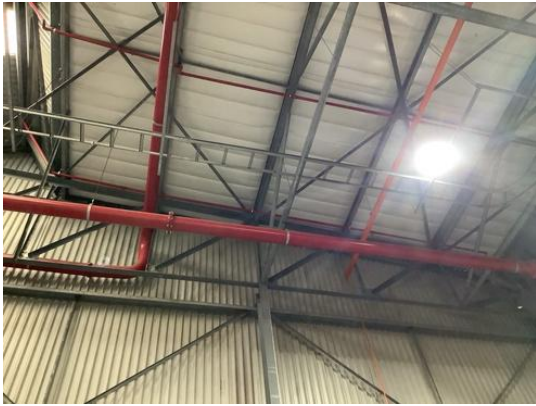
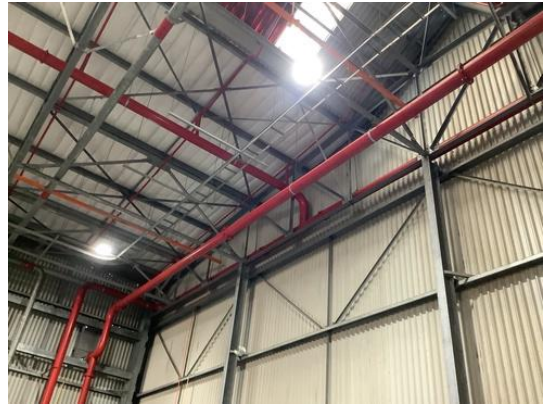
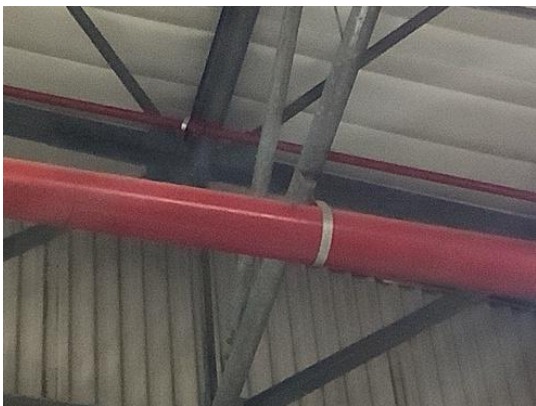
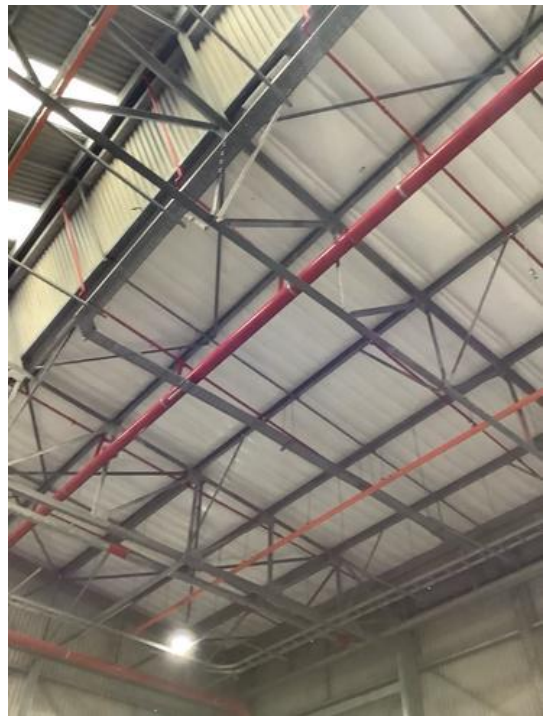
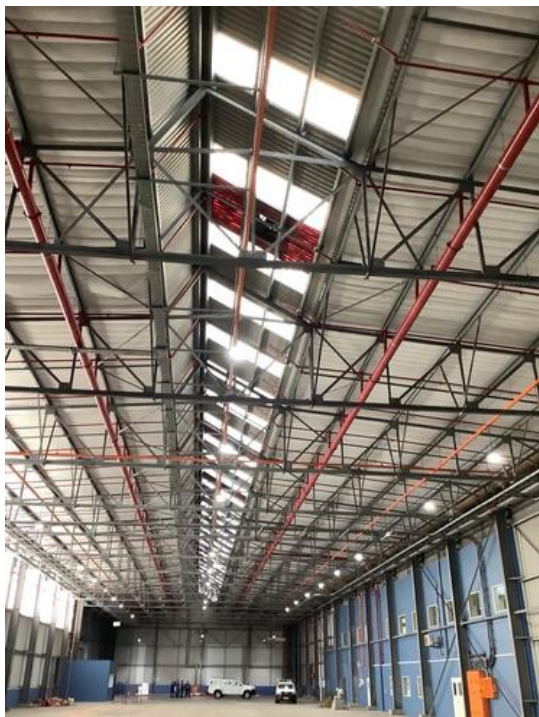
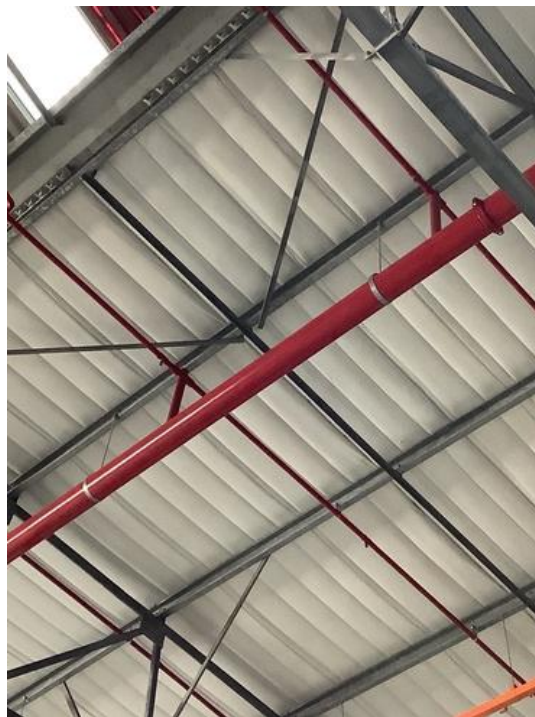
Pipe Support

The sprinkler pipe work must be correctly supported.

Belt-to-belt hangers utilized.

Main feed
Distribution main

Belt-to-belt hangers must be removed and the pipe work correctly supported.
