# Inspection of Automatic Sprinkler System

AW9 Yanfeng East London Industrial  
Development Zone

UNC.10605

09.05.2024 08:00 SAST

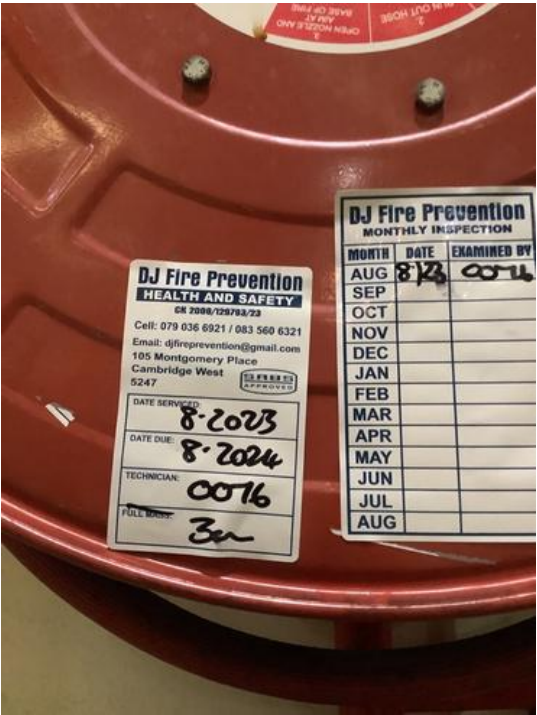
Photo 1

Clear access to the hand fire appliances must be maintained at all times.

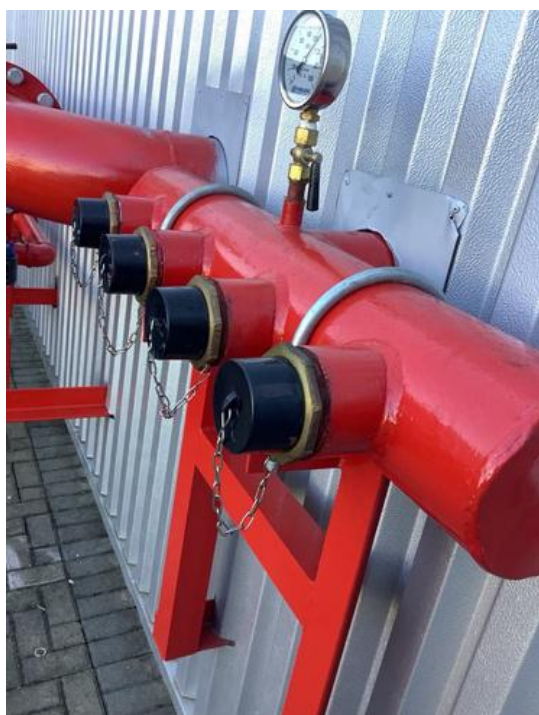
Photo 7

It appears that the booster connection piping to the main distribution riser is too long, which may restrict the opening of the booster plunger into the main distribution riser, this will prevent effective boosting of the sprinkler system and must be revised.

Installations must be fitted with fire brigade booster connections which will enable the fire brigade to pump water into the installation using their own equipment.

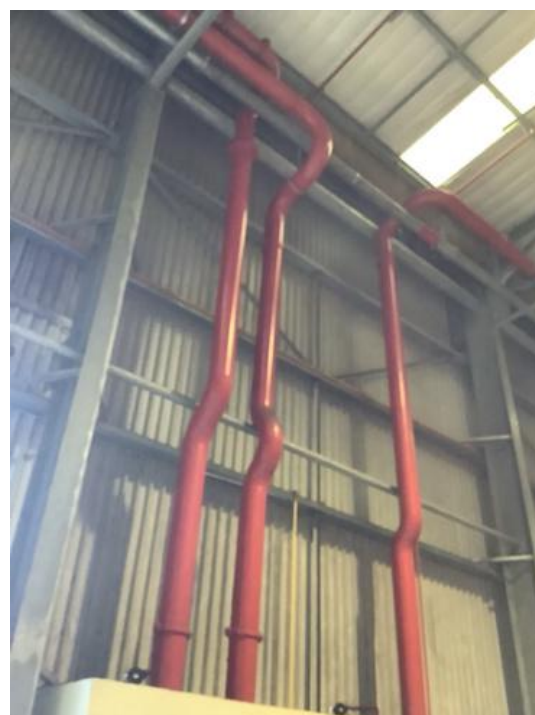
Photo 8

No

The riser main must be properly supported in accordance with the rules.

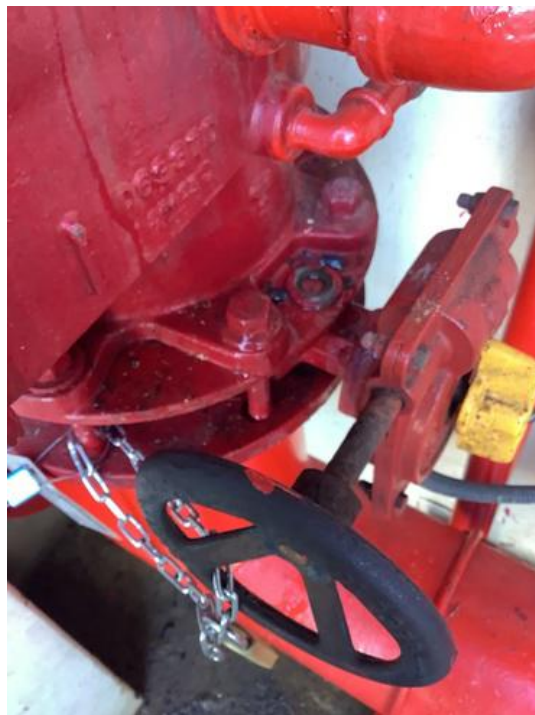
Photo 14

**7.17 Flanges Short Bolted**

The bolts for these flanges must be removed and replaced with the correctly sized bolts so as to ensure that at least two full thread pitches past the chamfer protrude beyond the nut.

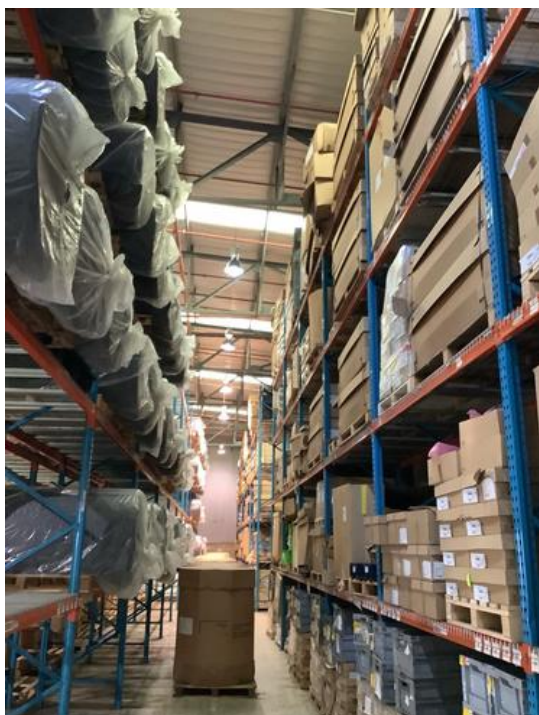
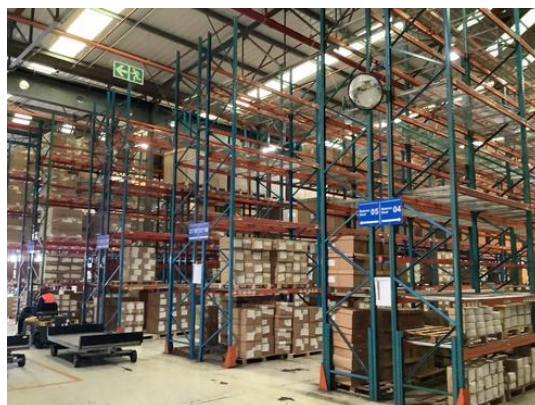
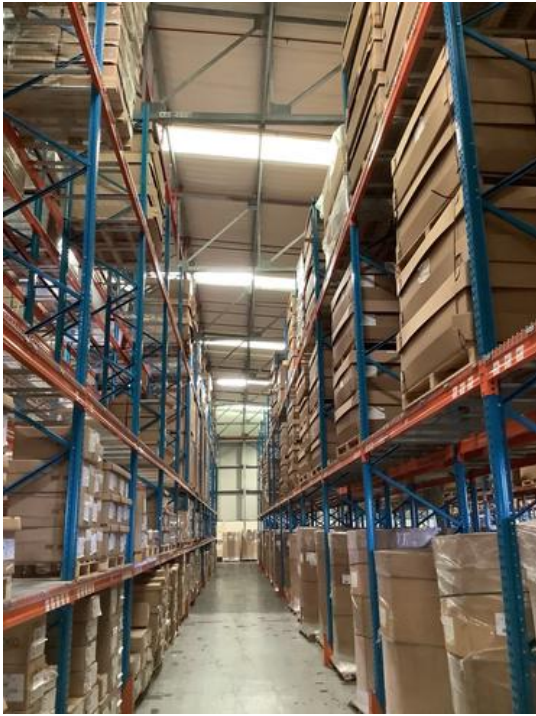
Are the storage heights exceeded.

Yes

The storage heights must be maintained in accordance with the maximum allowable stack heights as detailed in this report. Should this not be possible, intermediate level protection is deemed to be mandatory.

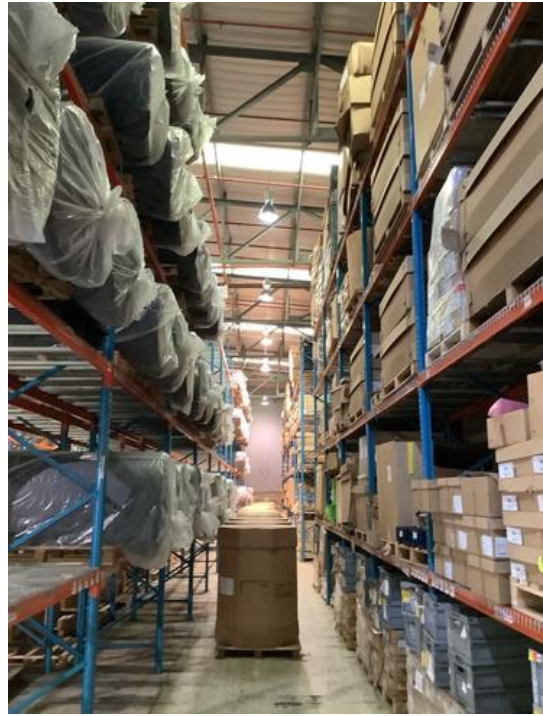
Photo 18

Storage is taking place within the Aisles.

Storage must not take place within the aisles as this will increase the fire area. A fire will spread in a uncontrolled manner.

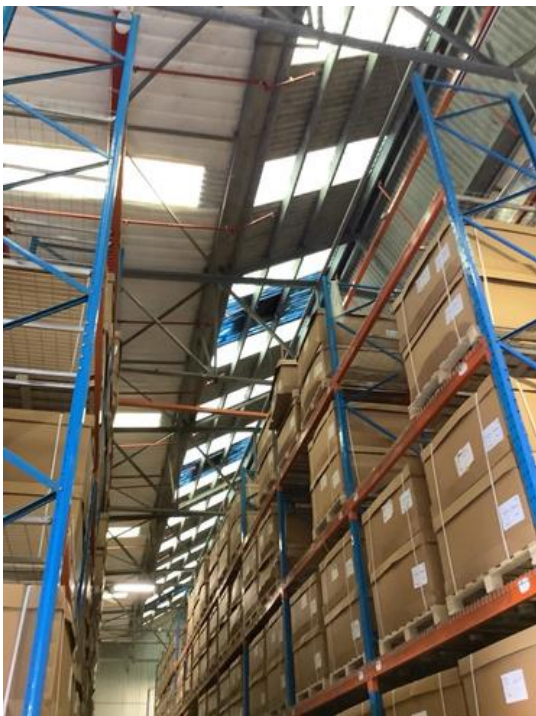
Photo 19

**Sprinklers installed beneath open cell surfaces / translucent sheeting.**

Roof

All sprinklers located beneath open celled floors or stairwells and translucent sheeting must have approved water shields fitted above the sprinklers.

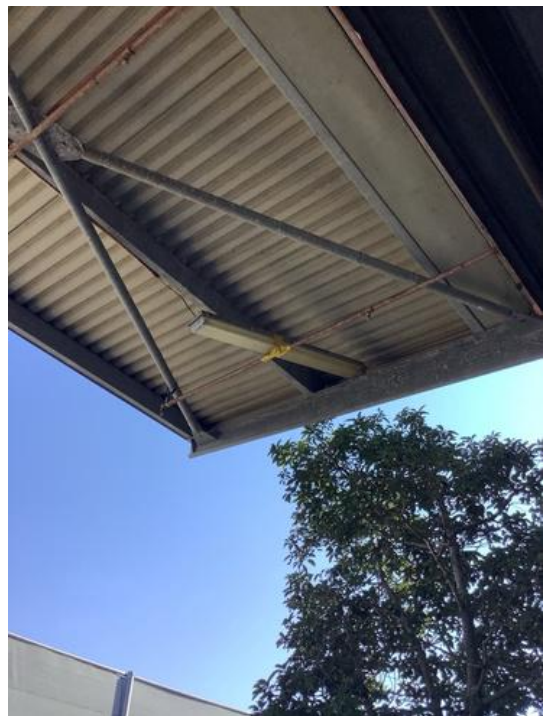
Photo 20

**Electrical Cable or other services attached to sprinkler pipework.**

Back canopy AW9

All electrical cables or any other services attached to the sprinkler pipe work must be removed and independently supported.
