Inspection of Automatic Sprinkler System

East London Industrial Development -
Also - HS1

UNC.9499

18.06.2024 11:24 SAST

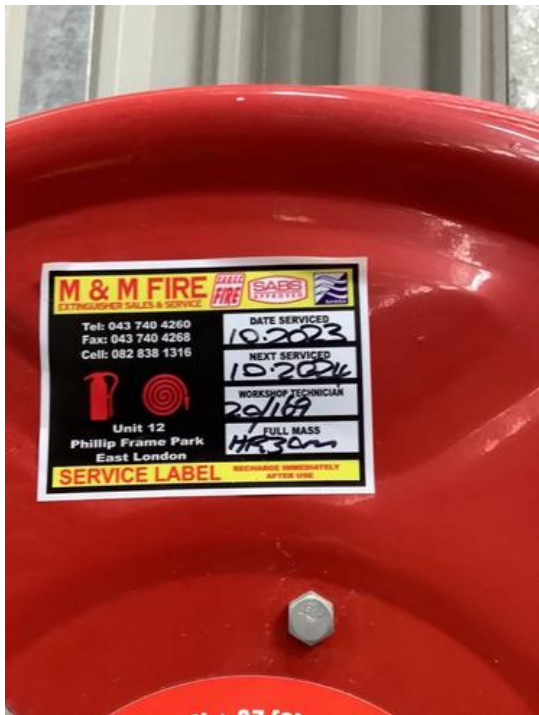
Photo 1

Clear access to the hand fire appliances must be maintained at all times.

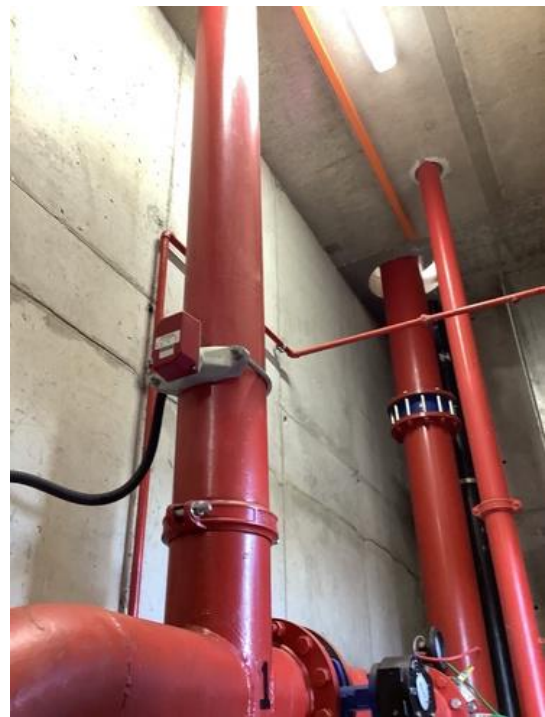
Photo 6

No

The flow switch must be fitted downstream from the alarm valve with a 25mm test pipe installed at least 2 pipe diameters downstream of the flow switch.

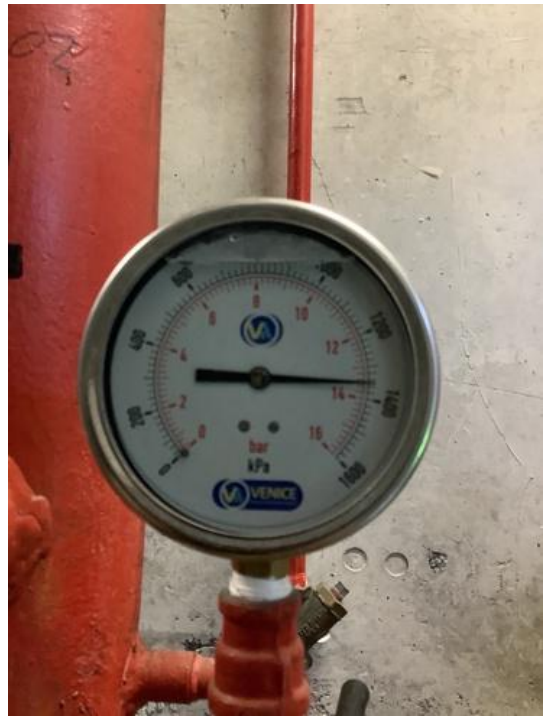
Photo 10

The system pressure has exceeded the maximum allowable pressure of 1200 kPa, this must be investigated and rectified by your installer.

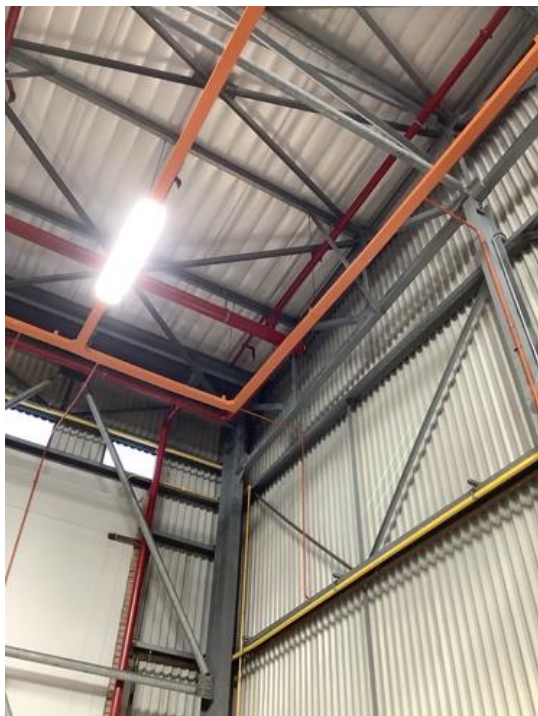
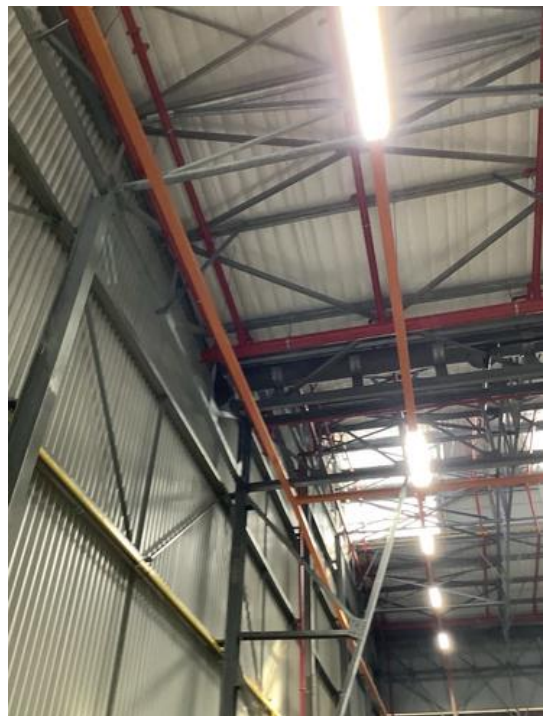
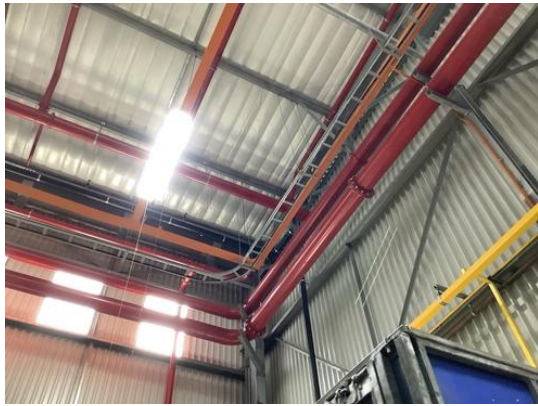
Pipe Support

Terminal hangers on distribution pipes are exceeding the maximum distance of 450 mm from the end of the distribution pipe.

Roof

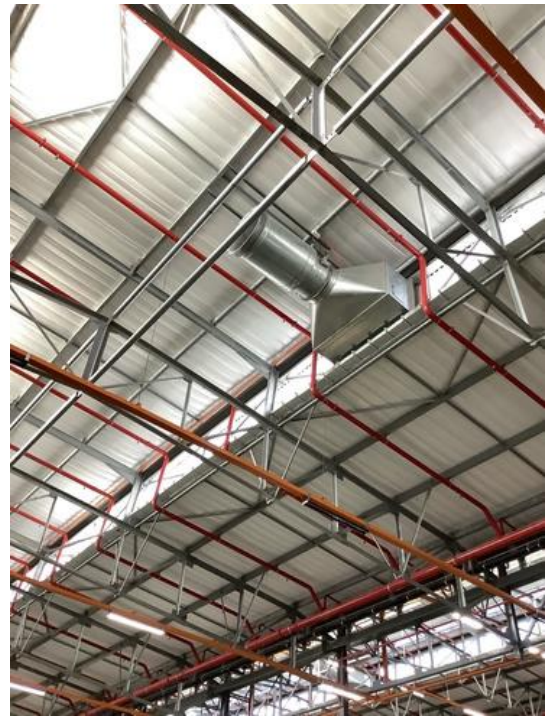
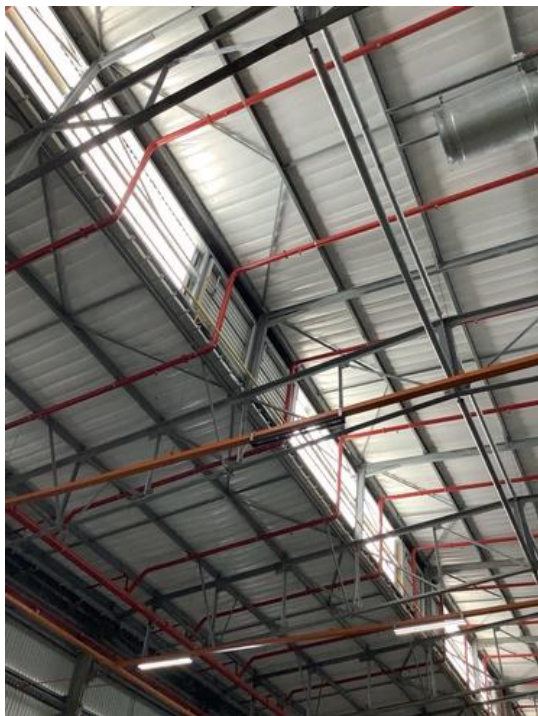
ESFR Mechanical Ventilation (to be verified)

Ventilation has been installed in conjunction with ESFR sprinkler protection.

It is imperative that the mechanical vents do not open automatically in a fire situation as the ESFR sprinkler system will be adversely effected which could result in the ESFR system failure.

It is important that the mechanical vents be manually operated and that the Fire Chief in charge of operations during a fire be able to make the decision whether it should be opened or remain closed.

It might also be advisable to zone the mechanical vents so as to have the option of opening all the vents at the same time or only certain zones.

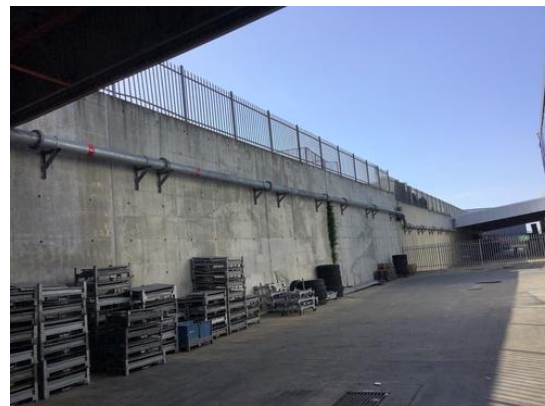
Photo 16

Exposed / unprotected pipe work

Sprinkler pipe work must pass through a sprinkler protected area or be encased in a 2 hour fire rated enclosure.

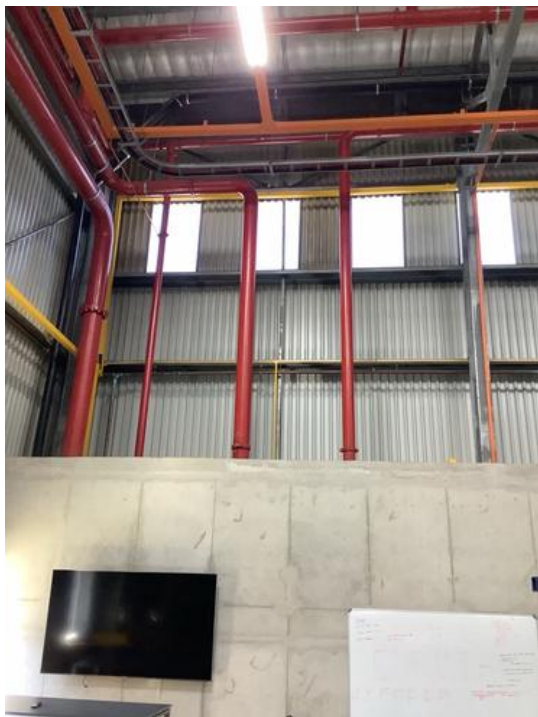
Photo 17

The sprinkler pipe work must be correctly supported.

Distribution rise/drop pipes shall be secured directly to the building structure or by hangers securing horizontal distribution pipes within 300 mm of the riser.

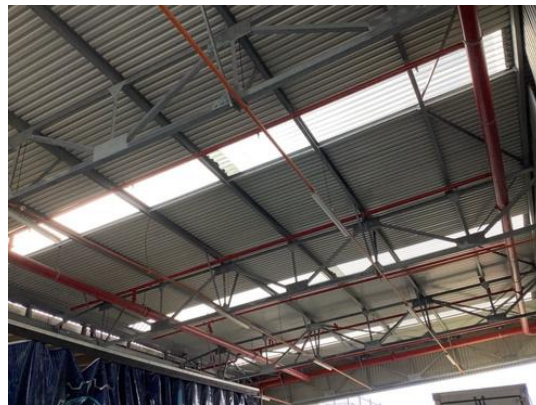
Photo 18

Combustible roof insulation or sheeting may not be used in conjunction with ESFR protection

ESFR sprinklers can only be located beneath non-combustible surfaces. Combustible translucent sheeting, may in the event of a fire negatively impact the operation of the ESFR installation.

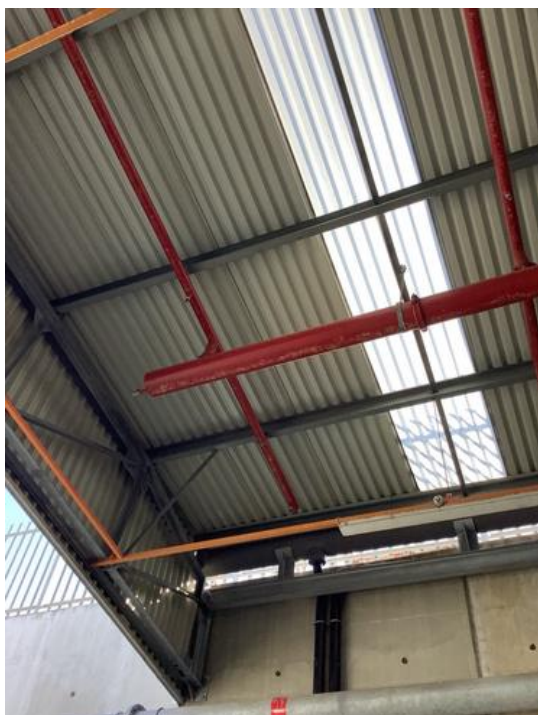
Photo 19

Terminal hangers on distribution pipes are exceeding the maximum distance of 450 mm from the end of the distribution pipe.

Main feed
