# Inspection of Automatic Sprinkler System

BE 4 - Linde & Wiemann East London  
Industrial Development Zone

UNC.10623

09.05.2024 12:21 SAST

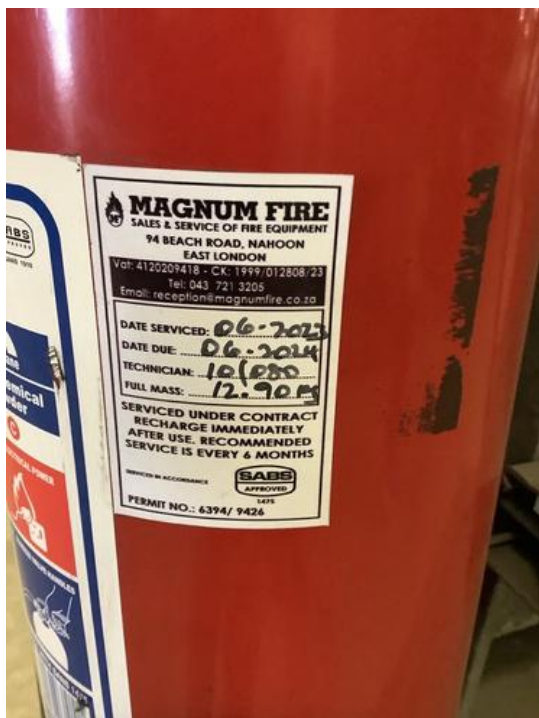
Photo 1

Clear access to the hand fire appliances must be maintained at all times.

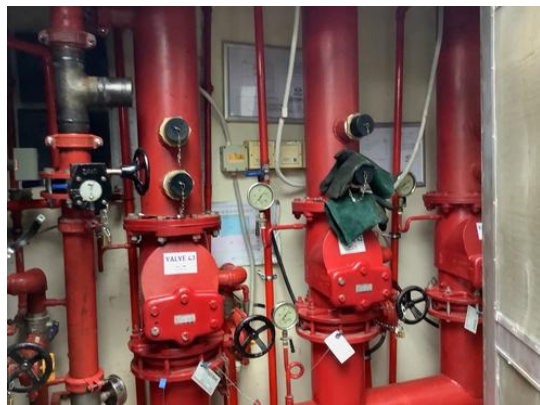
Photo 2

East wall BE5 DSV and opposite ASP pump house

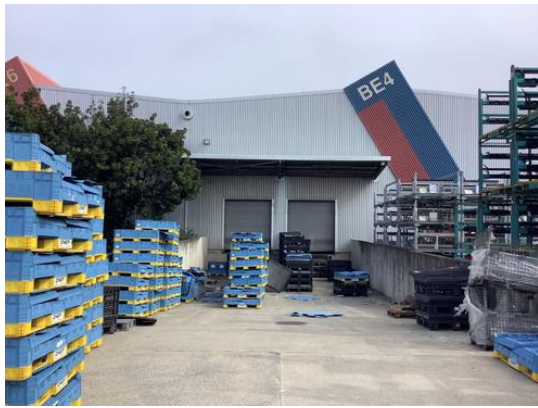
Photo 9

**Storage too close to building.**

Loading area

Drencher heads required which are purpose made sprinklers designed to spray water over a surface to provide protection against fire exposure. It is not acceptable to use standard sprinkler heads with the fusible elements removed for the purpose of providing wall or face wetting. The drencher system must extend along the walls of the protected building to a distance of 15.0 metres beyond each end of the stored goods. The feed for the drenchers must be taken from the underside of the valves and not from the downstream side of the installation. The stop valve controlling the drencher installation shall be located near to the sprinkler control valves, but must be at least 10,0 metres from the goods stored or from the area where they are expected to operate.

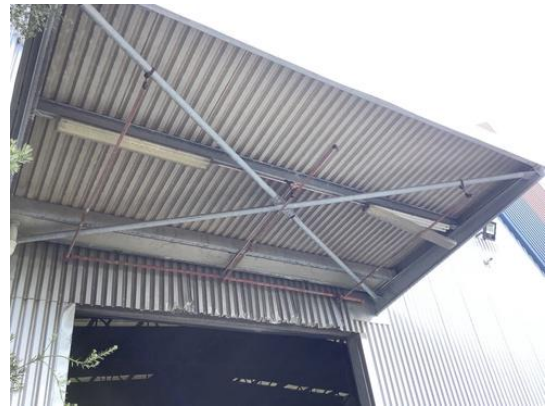
Photo 10

Corrosion is evident on the sprinkler pipe work and must be addressed by your installer.

Canopies
