Inspection of Automatic Sprinkler System

East London Industrial Development
Zone - Bushveld Energy

UNC.9855

18.06.2024 14:52 SAST

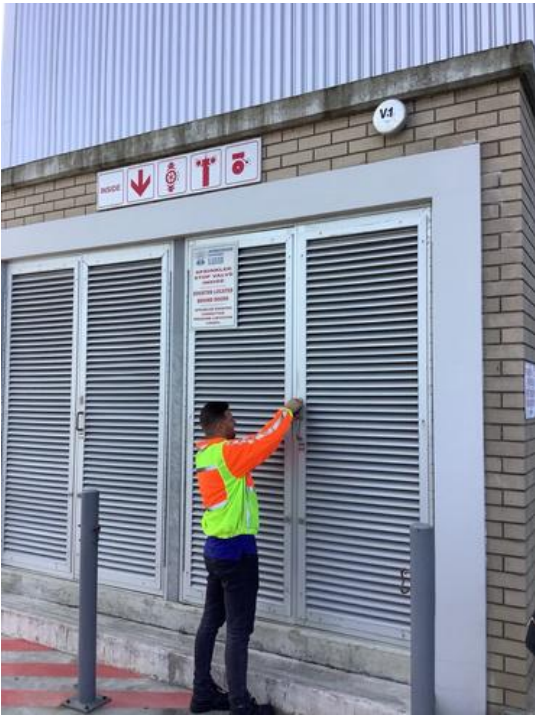
Photo 1

Valve Cabinet 1

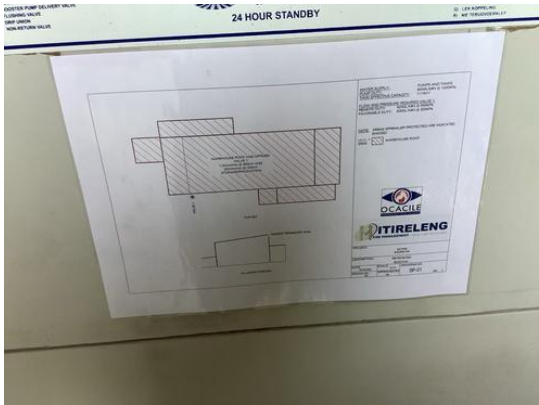
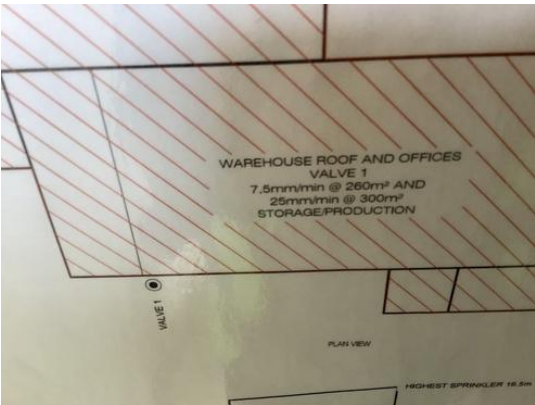
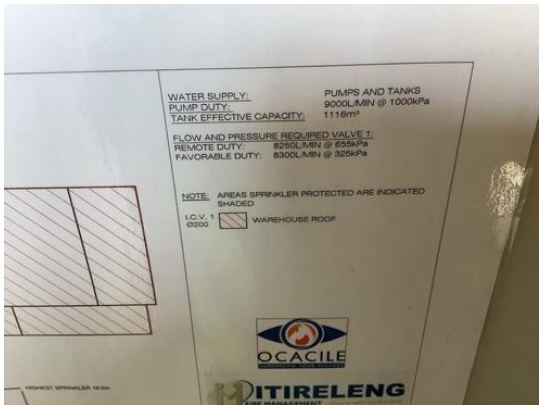
7.4.2 Are the correct installation details recorded on the block plan

No

The storage section on the left of the building has a higher design density. This must be indicated on the block plan

A block plan must be provided with the following indicated thereon:

The flows and pressures for the remote and favorable areas of operation recorded on the block plans must reflect the maximum pressure (Pmax) and the maximum flow (Qmax) respectively.

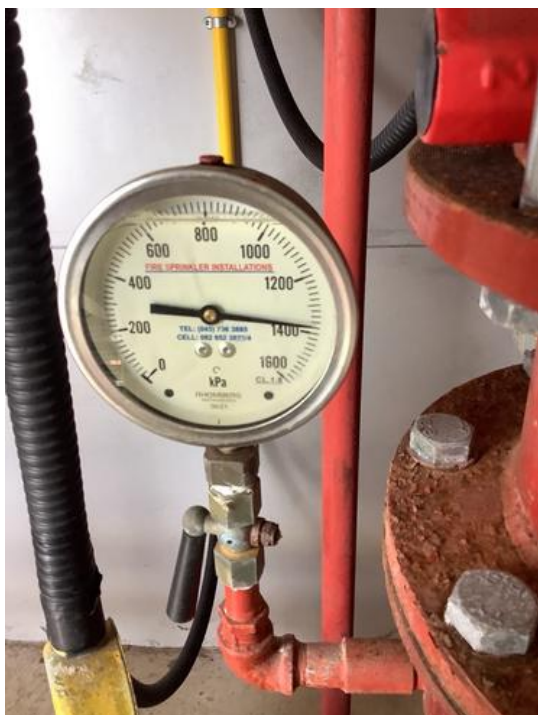
Photo 7

7.24 ASIB Overhaul Date Tag No

New Installation

The installation control valves must be overhauled three years after date of installation by an ASIB approved and registered installer, and once every 3 years thereafter. An ASIB valve overhaul date tag must be attached to the valve set after completion of the overhaul.

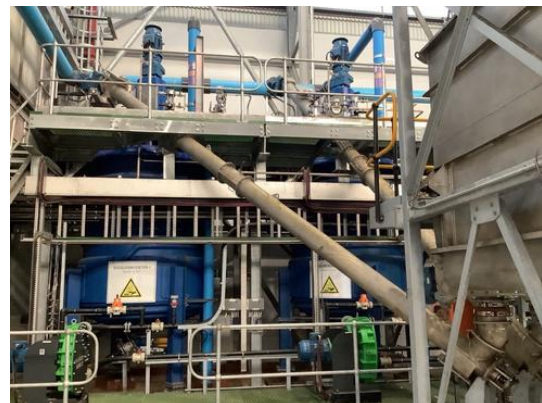
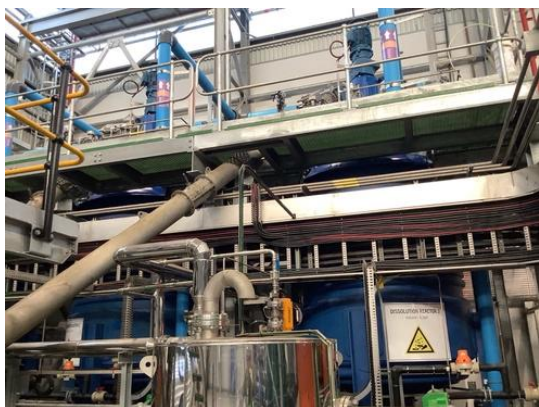
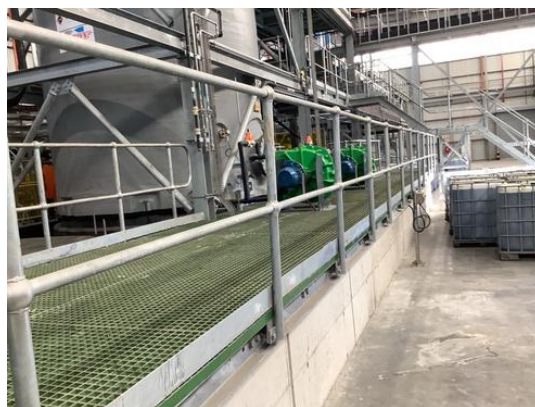
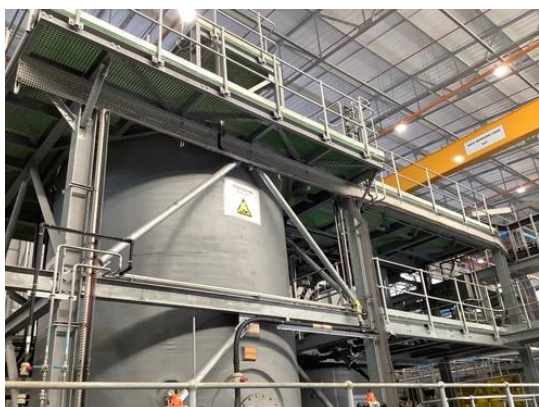
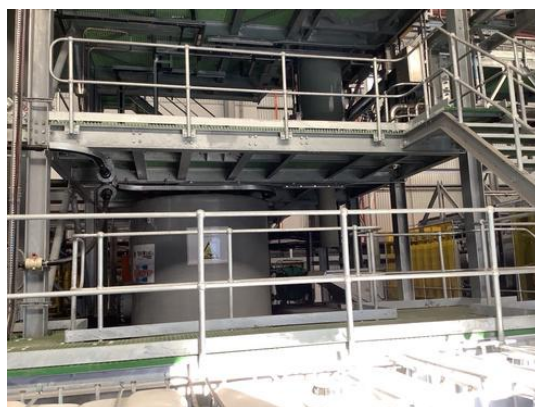
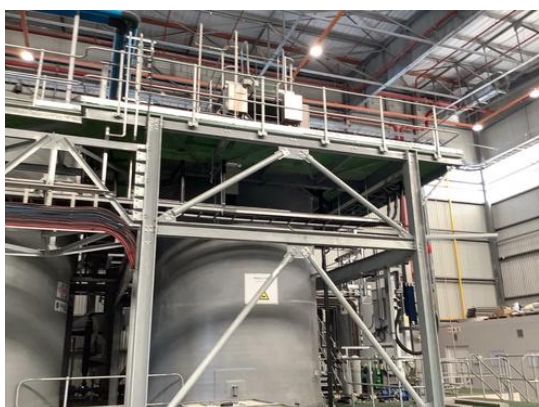
Surfaces exceeding 1,0 metre in width.

Surfaces which exceed 1,0 metre in width will obstruct the water discharged from the sprinklers above which could result in an ignition beneath these surfaces not being controlled or extinguished.

The general obstruction is classed as 1,000 mm therefore sprinkler protection is required beneath any such obstruction which includes, but is not limited to;

Walkways, solid or open grid, and Work tables.

All areas that are wider than a meter and any enclosures.

The platforms and walkways as highlighted in section 9 must be attended to.
