# Inspection of Automatic Sprinkler System

BW2 Seraphim Solar East London  
Industrial Development Zone

UNC.10622

09.05.2024 08:00 SAST

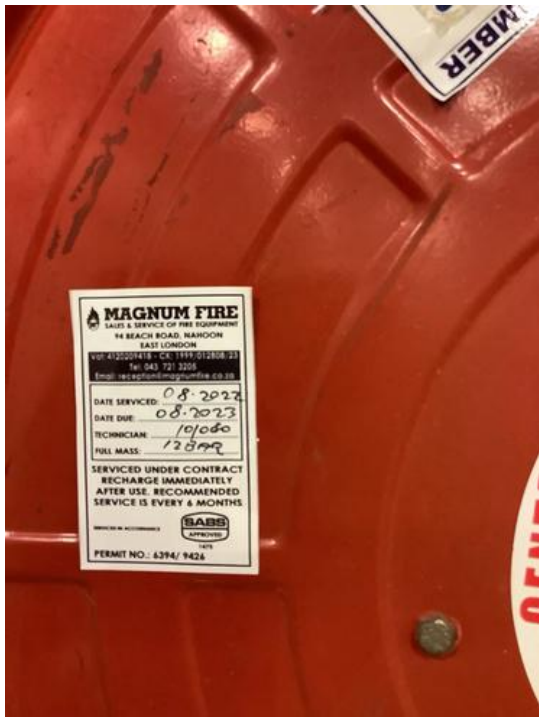
Photo 1

Are the hand fire appliances due for their service.

Yes

Clear access to the hand fire appliances must be maintained at all times.

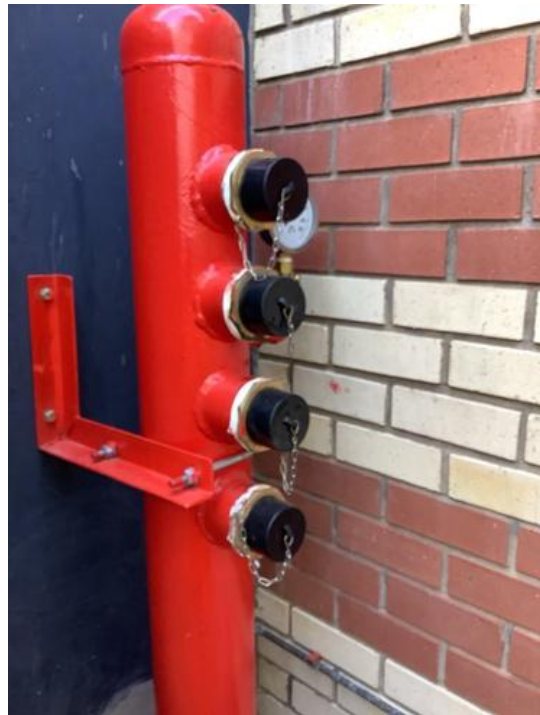
Photo 10

### 7.8 Fire Brigade Booster Connections Installed Correctly and Accessible

No

**It appears that the booster connection piping to the main distribution riser is too long, which may restrict the opening of the booster plunger into the main distribution riser, this will prevent effective boosting of the sprinkler system and must be revised.**

Installations must be fitted with fire brigade booster connections which will enable the fire brigade to pump water into the installation using their own equipment.

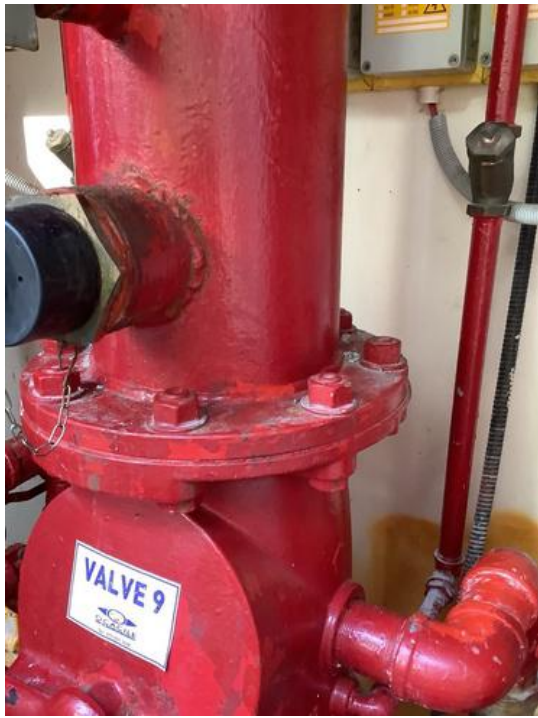
Photo 13

<b>7.16 Correct Gauge Cocks Installed</b>	Yes
<b>7.17 Flanges Short Bolted</b>	Yes
  <p>Photo 13</p>	
<p>The bolts for these flanges must be removed and replaced with the correctly sized bolts so as to ensure that at least two full thread pitches past the chamfer protrude beyond the nut.</p>	
<b>7.18 Loose / Missing Bolts, Nuts &amp; Washers</b>	No
<b>7.19 False Alarm Prevention Pump Installed</b>	N/A
<b>7.20 Drain &amp; Test Pipes Installed Correctly</b>	No
<p><b>The water motor alarm drain pipes discharge into a common manifold. This must be revised so that the drain pipes are taken separately to waste.</b></p> <p style="text-align: right;"><input checked="" type="checkbox"/></p>	
<p>7.21 Weekly tests of the installation control valves alarm bell must be carried out with the alarms sounding for at least thirty seconds.</p> <p>All water pressure gauge readings must be checked and recorded.</p> <p>The testing and records should be carried out by a member of staff delegated to do this.</p>

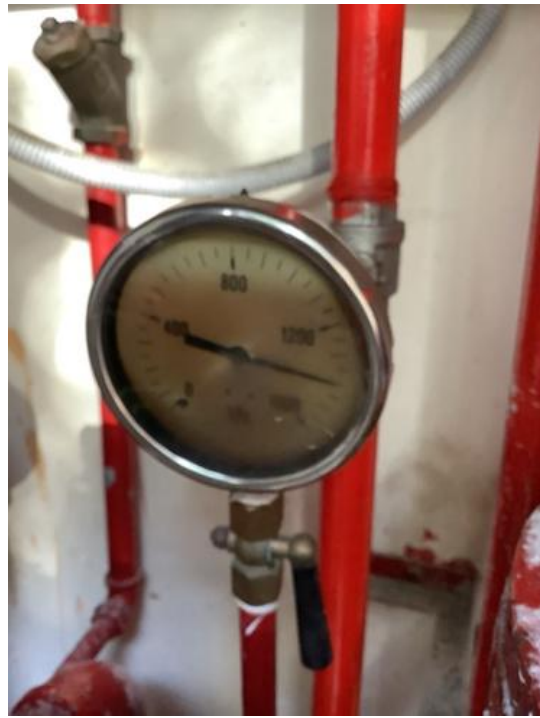
Photo 14

Item No. 6.6.8. Maximum 1200 kPa churn pressure exceeded.

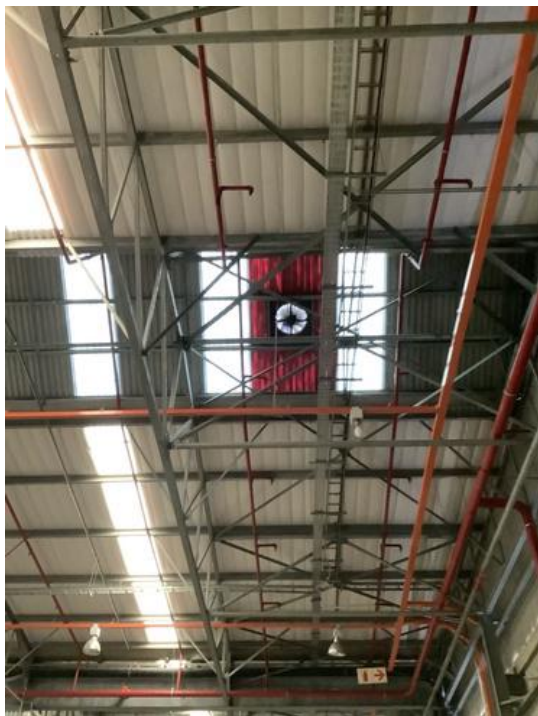
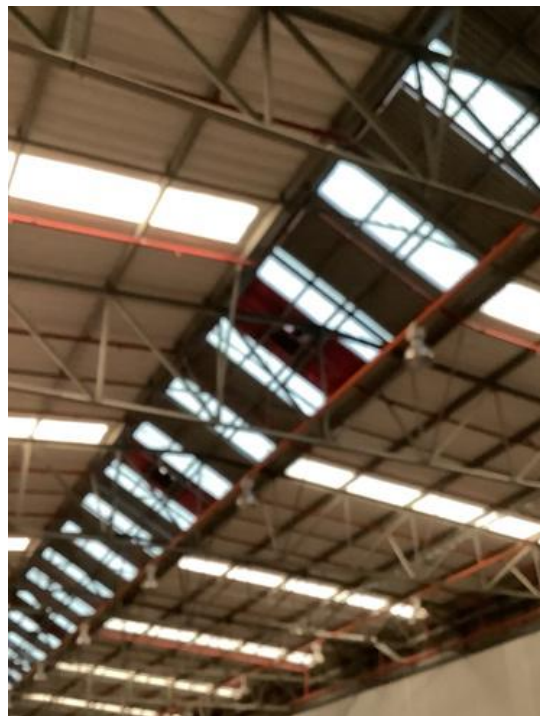
ventilation has been installed in conjunction with ESFR sprinkler protection. Mechanical ventilation is accepted.

It is imperative that the mechanical vents do not open automatically in a fire situation as the ESFR sprinkler system will be adversely effected which could result in the ESFR system failure.

The effect of the ventilators installed in the roof may be considered as open ventilation. Their effect on the operation of the installed ESFR installation would be unknown. In order to have the finding satisfied, the OEM would need to be contacted and asked to define the ventilators in respect of ESFR operation and confirm them as an acceptable roof ventilation service. Any Clearance ASIB awards the site would exclude the potential negative impact the ventilators may have on the protection installed.

It is important that the mechanical vents be manually operated and that the Fire Chief in charge of operations during a fire be able to make the decision whether it should be opened or remain closed.

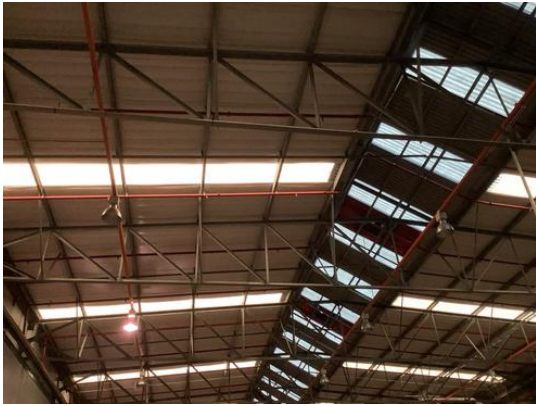
Photo 17

Maximum roof angle exceeded.

The maximum roof angle of 9,5 degrees for effective ESFR protection appears to have been exceeded, this must be investigated and addressed by your installer.

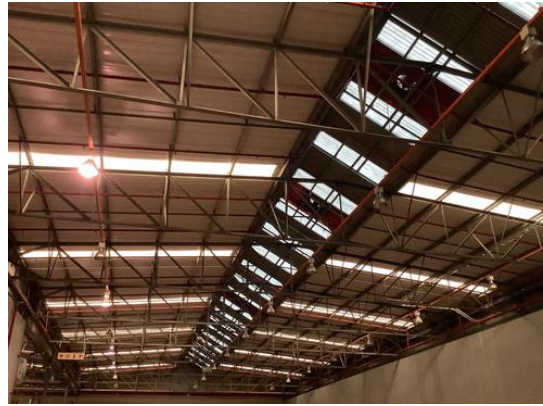
Photo 18

Combustible roof sheeting/insulation is not acceptable above ESFR protection

ESFR sprinklers can only be located beneath non-combustible surfaces. Combustible translucent sheeting, may in the event of a fire negatively impact the operation of the ESFR installation. Heads or sheets would require to be relocated appropriately in order to satisfy this item.

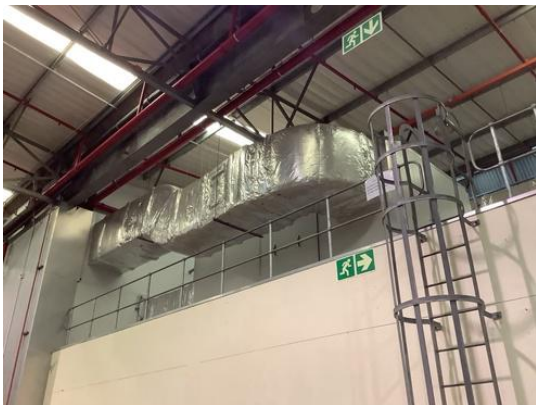
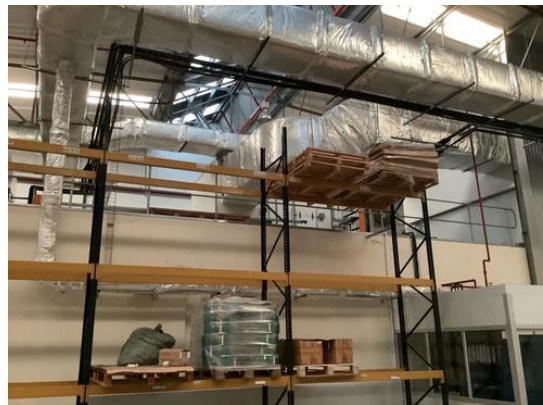
#### Surfaces exceeding 1,0 metre in width.

Surfaces which exceed 1,0 metre in width will obstruct the water discharged from the sprinklers above which could result in an ignition beneath these surfaces not being controlled or extinguished.

**These must be sprinkler protected on their underside if, in the case of square or rectangular trunking, ducts or cable trays they exceed:**

800 mm in width and are closer than 150 mm from a wall, or 1,000 mm on width and are further than 150 mm from a wall.

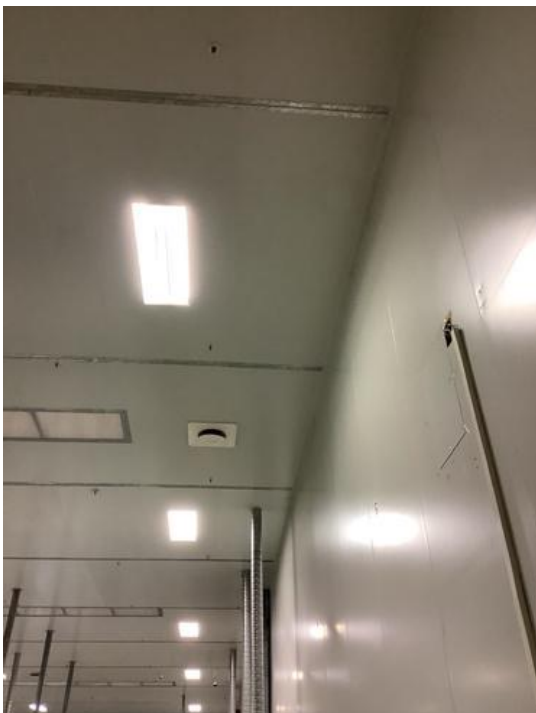
Photo 21

Sprinklers exceed 600 mm from walls of a cold room or freezer (11th Edition).

Main hall back wall

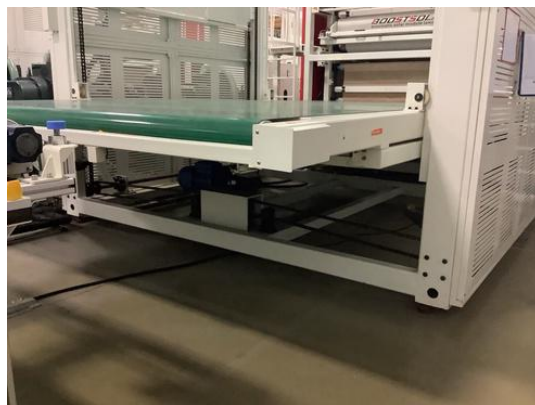
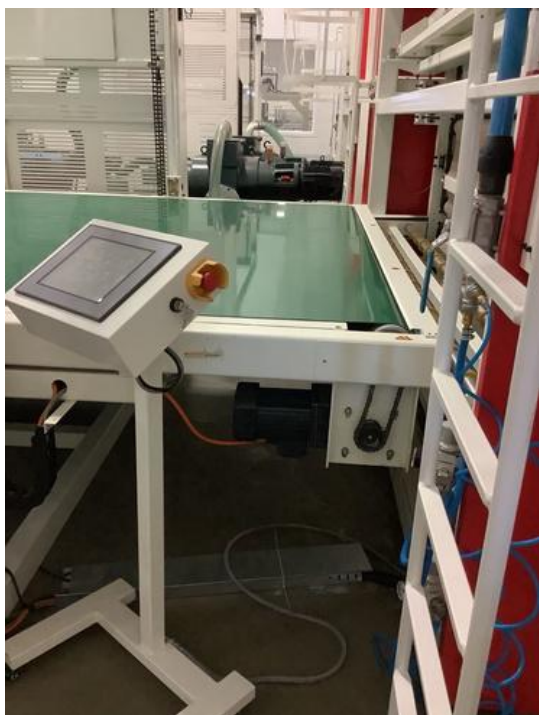
**Surfaces exceeding 1,0 metre in width.**

Surfaces which exceed 1,0 metre in width will obstruct the water discharged from the sprinklers above which could result in an ignition beneath these surfaces not being controlled or extinguished.

Conveyors in laminating room

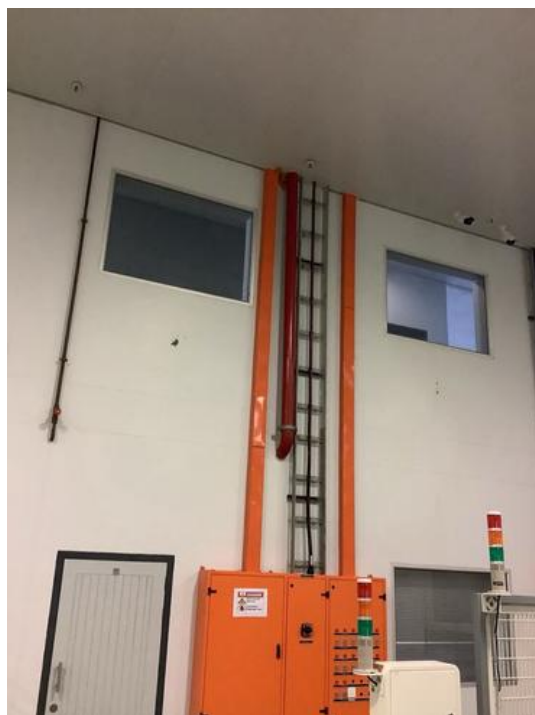
Photo 26

**Distribution rise/drop pipes shall be secured directly to the building structure or by hangers securing horizontal distribution pipes within 300 mm of the riser.**

Dropper to offices

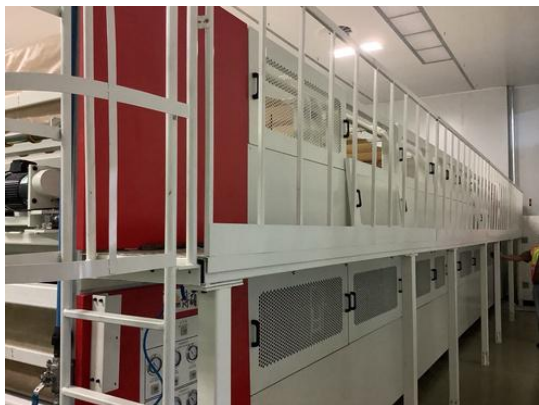
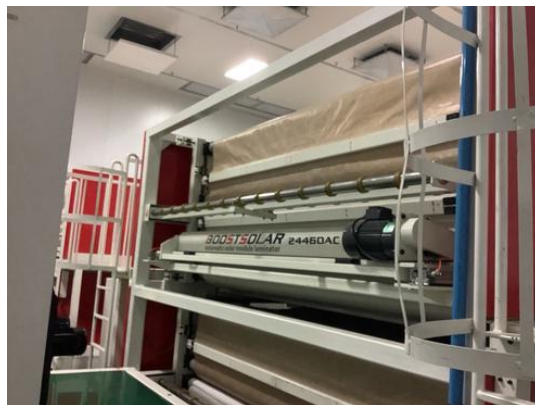
T must be determined if sprinkler protection can be installed in the laminating machines
