Inspection of Automatic Sprinkler System

East London Industrial Development
Zone - ASP Pump House

UNC.9478

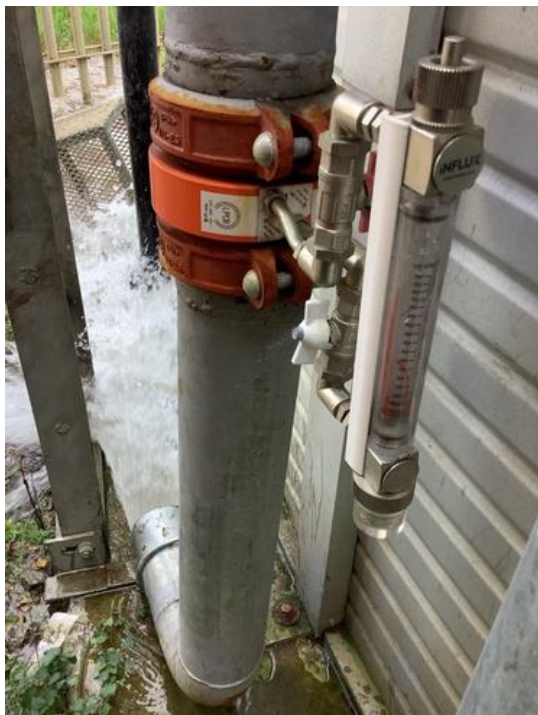
Photo 4

5.2 Tank Infill

Recorded

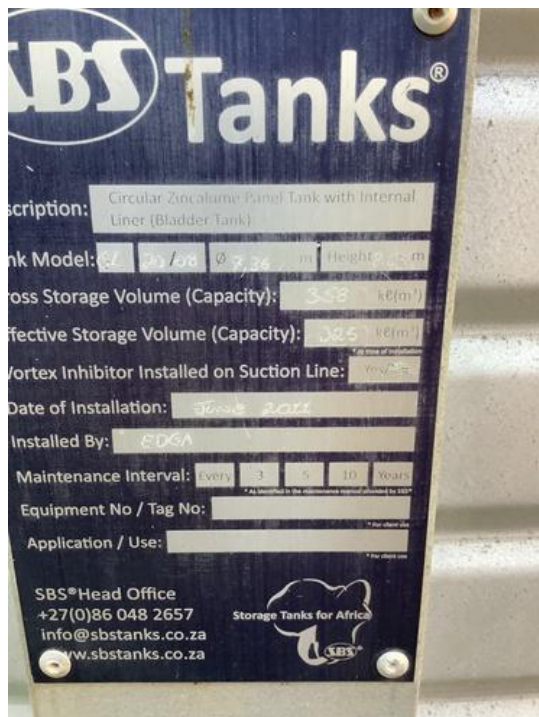
Photo 5

5.3 Tank Information Plate Installed

Yes

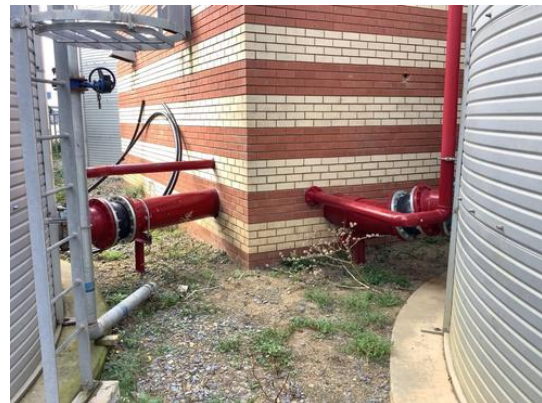
Photo 6

► Tank Type	Bladder
Dimensions Circular	
7,36 x 8,43 high	
Vortex Inhibitor	
Yes	
Gross Storage Capacity (m³)	
355 x 2 = 710	
Effective Storage Capacity (m³)	
325 x 2 = 650	
Dedicated or Combined Tank	Dedicated
5.4 Foundation Type	Separate
Flexible Coupling Installed on Suction Line	Yes
5.5 Infill Valves Accessible	Yes
5.6 Suction Isolating Valves Secured in the Open Position	Yes
5.7 Tank Suction Piping Correctly Supported	Yes
5.8 Infill Isolating Valves Secured in the Open Position.	Yes
5.9 Drain valves secured in the Closed Position.	Yes
5.10 Flanges / Equipment Short Bolted	No
5.11 Loose / Missing Bolts, Nuts & Washers	No
Non - Compliance	
Item	
Item 1	
► Description	Other

Where a balance tank is retrofitted in order to make up the minimum amount of stored water, the feed from the tank may not be directly connected into the primary tanks suction line but shall connect directly into the primary suction tanks or subdivisions.

The feed pipe from the balance tank leading into the primary tanks shall be sized one diameter larger than

the suction line feeding the fire pumps.

The valves and flexible couplings shall be arranged so as to allow maintenance to be carried out without isolating the entire water supply.

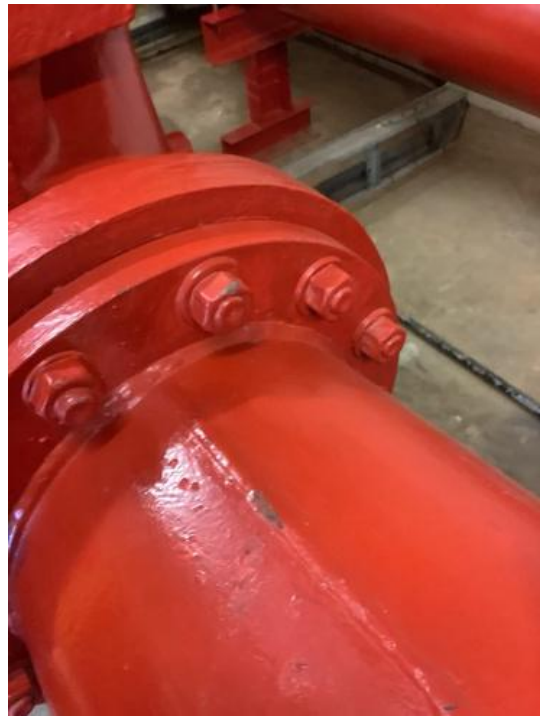
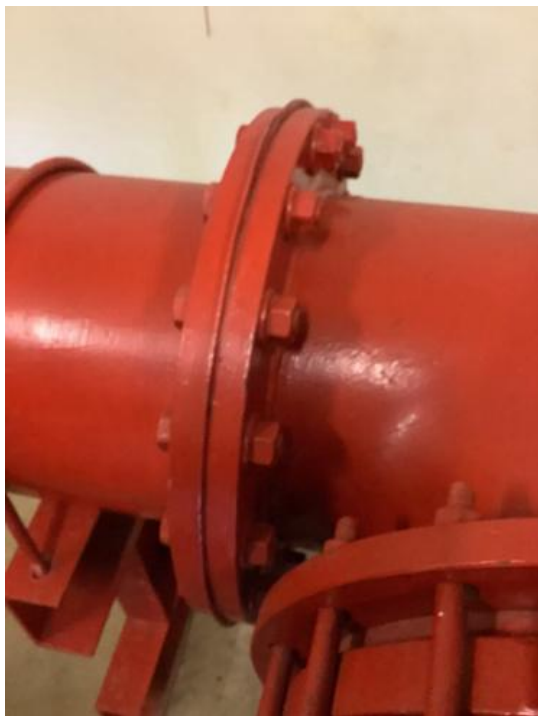
6.2.3 Mechanical Ventilation Installed	Yes
6.2.4 Hour Meters Installed	Yes
None on the electric pump	
6.2.5 Correct Pressure Gauges Installed	Yes
6.2.6 Correct Suction Pressure Gauge Installed.	Yes
6.2.7 Correct Gauge Cocks Installed	Yes
6.2.8 Specify Flow Measuring Device.	Direct Reading Flow Meter
6.2.9 Flanges / Equipment Short Bolted	Yes

We recommend that the bolts for these flanges be removed and replaced with the correctly sized bolts so as to ensure that at least two full thread pitches past the chamfer protrude beyond the nut.

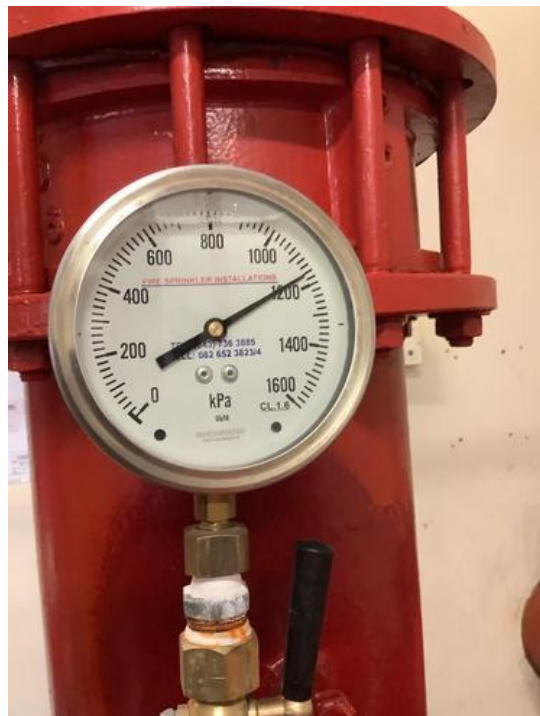
Photo 14	
6.9.6 Flow Test Recorded	
7500 l/min @ 1120 kPa

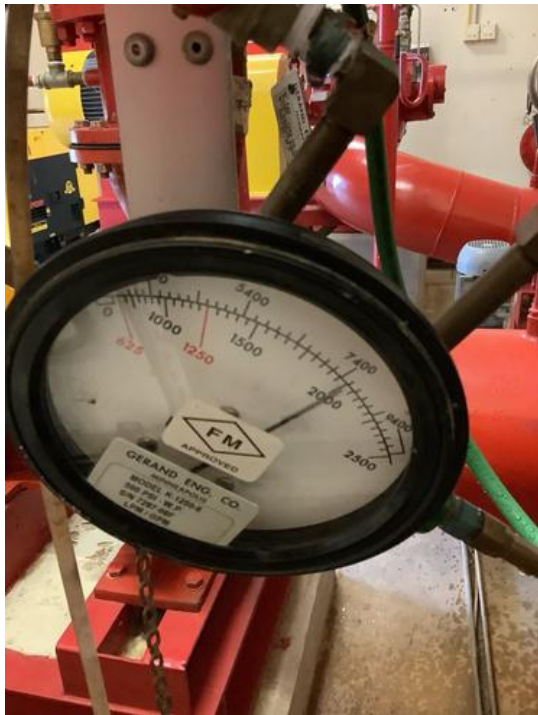
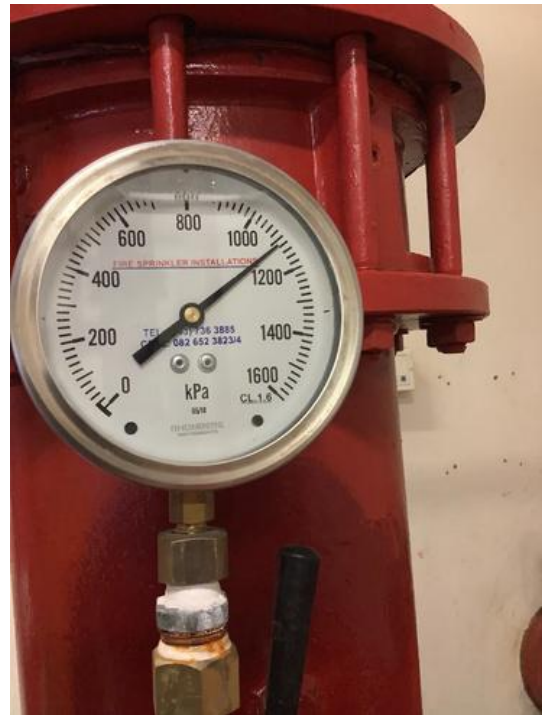
Photo 15 Photo 16	
6.9.7 Pump Flow Test	Passed
6.9.8 Hour Meter After Test	
Not installed

The Electric motor driven pump must be tested for at least 10 minutes every week in accordance

with the minimum requirements.

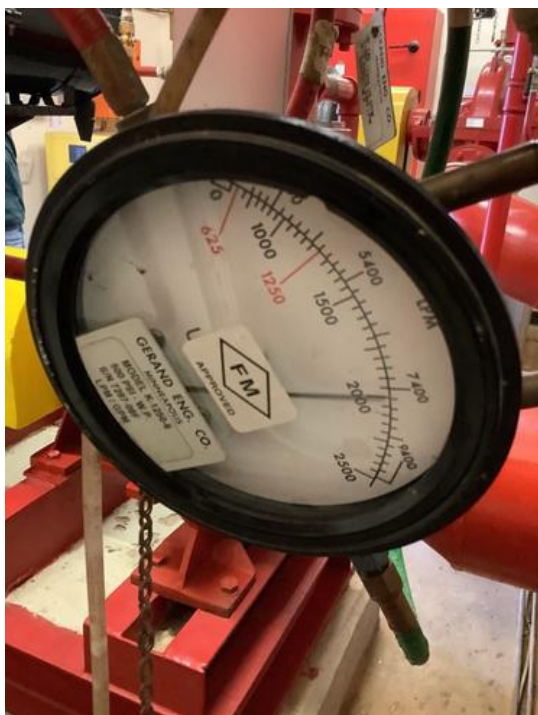
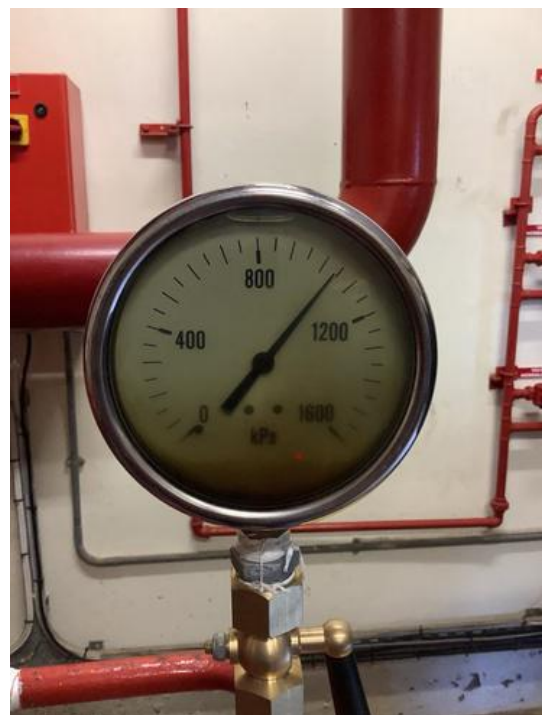
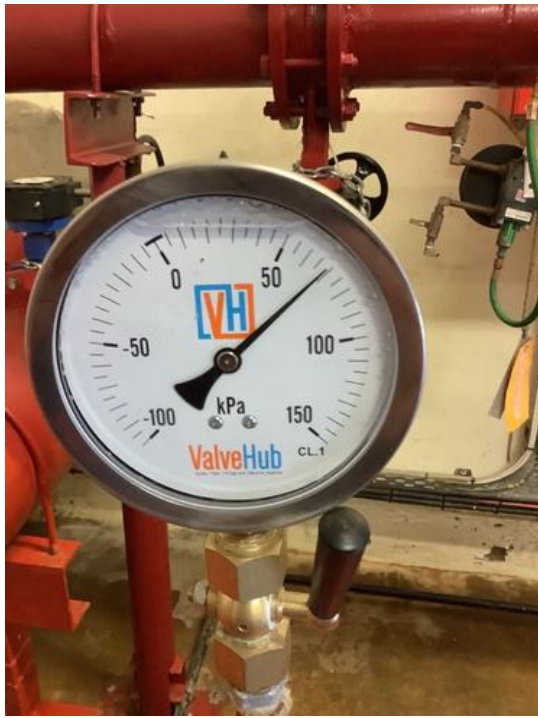
6.6.10 Pump Flow Test

Passed

The diesel engine driven pump must be tested for at least 30 minutes every week in accordance with the minimum requirements.

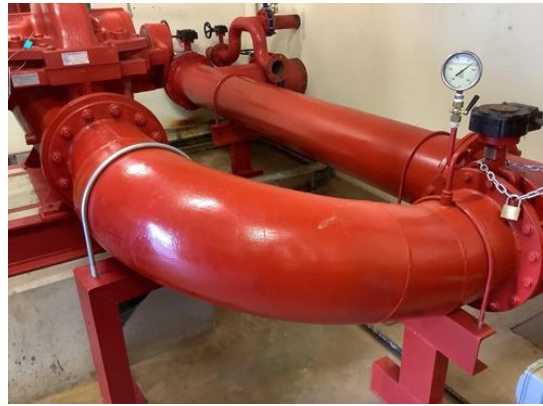
Photo 20

Electric pump only

The suction line inclines slightly towards the pump.

Suction line inclines towards the pump. Suction lines must be laid truly horizontal or must fall towards the pump for pumps under positive head conditions. In order to prevent any air becoming trapped within this pipework, we recommend that an automatic air release valve be installed.

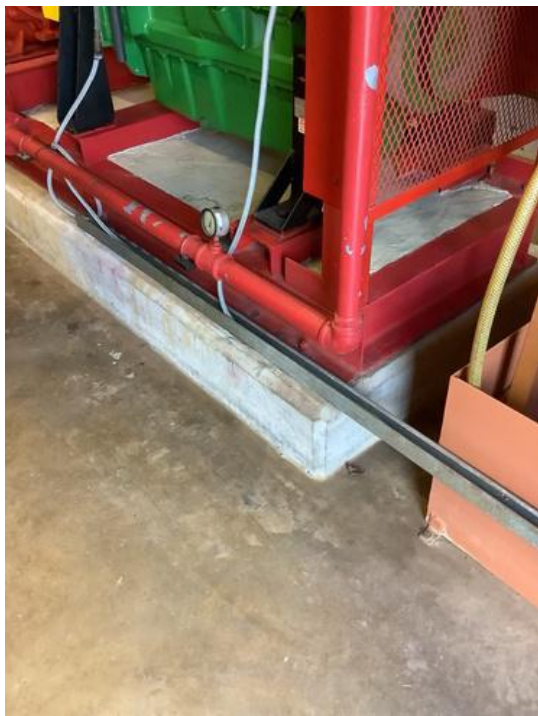
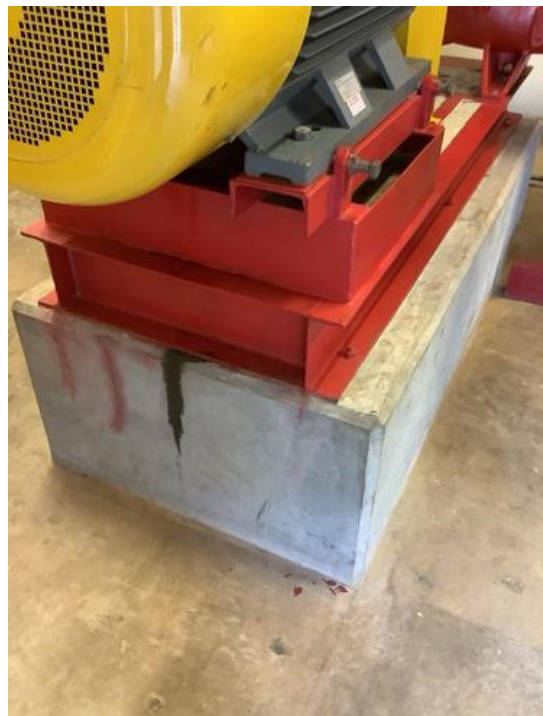
It was noted that the plinth foundation is incorrectly sized
