Inspection of Automatic Sprinkler System

East London Industrial Development
Zone - Building HW1 - Ebor

UNC.9262

18.06.2024 10:39 SAST

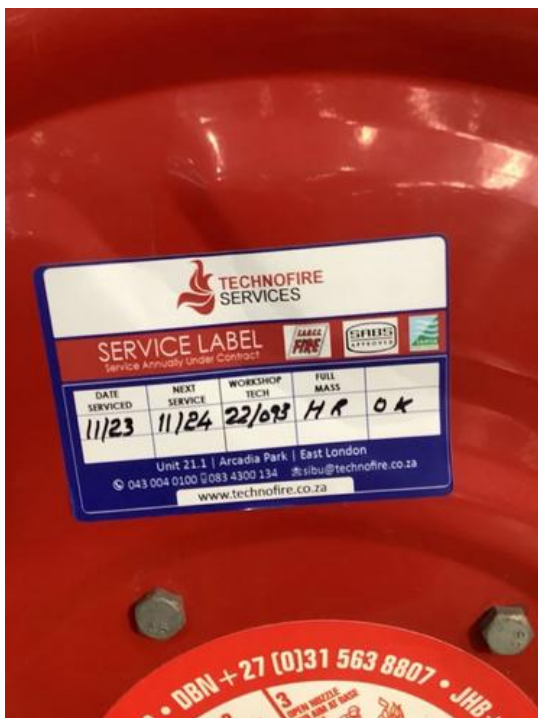
Photo 1

Clear access to the hand fire appliances must be maintained at all times.

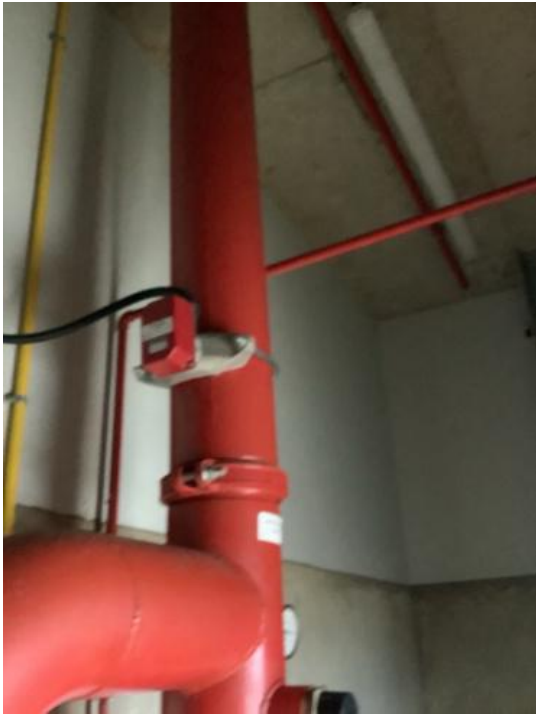
Photo 7

The flow switch must be fitted downstream from the alarm valve with a 25mm test pipe installed at least 2 pipe diameters downstream of the flow switch.

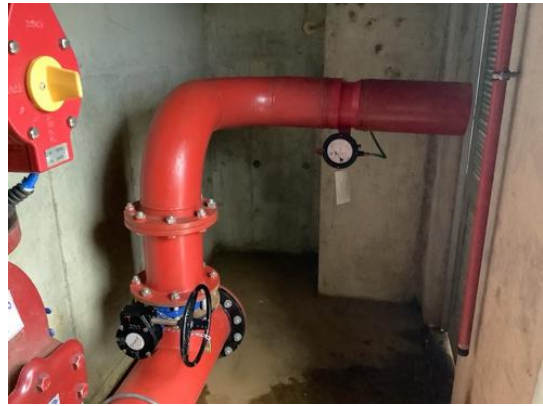
Photo 8

Not installed as per manufacturer's specifications.
This must be corrected

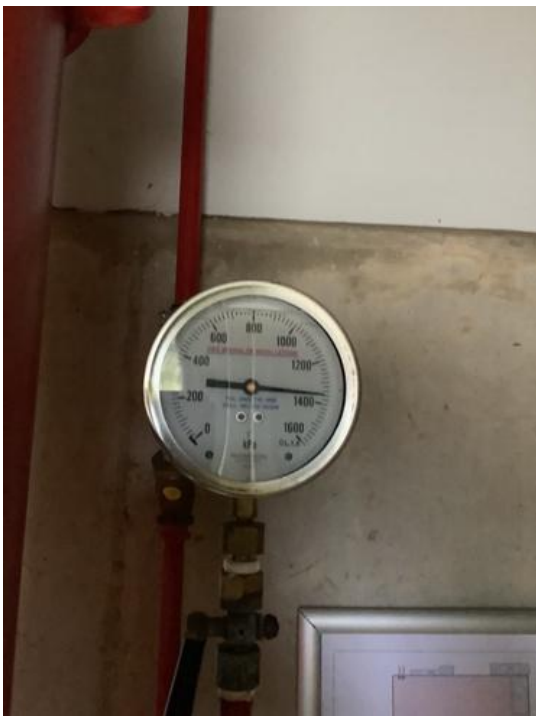
Photo 9

1160

1380

The system pressure has exceeded the maximum allowable pressure of 1200 kPa, this must be investigated and rectified by your installer.

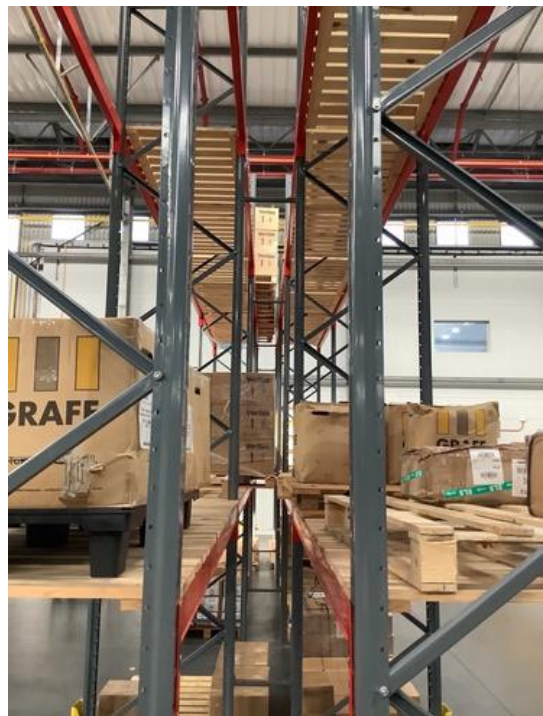
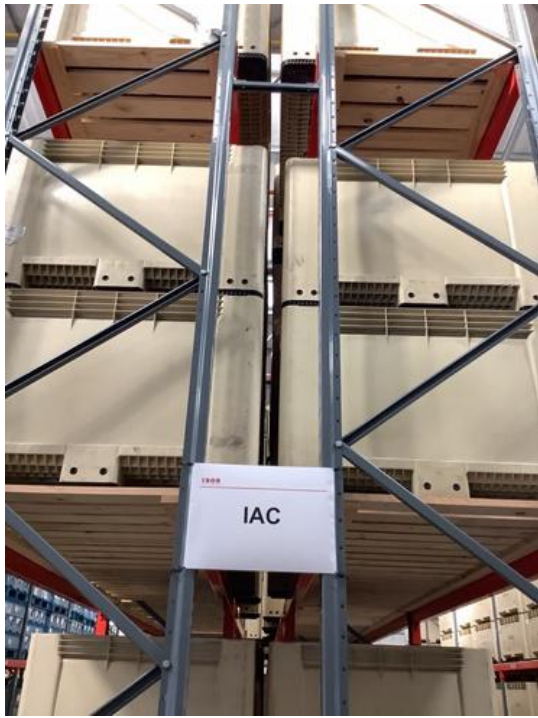
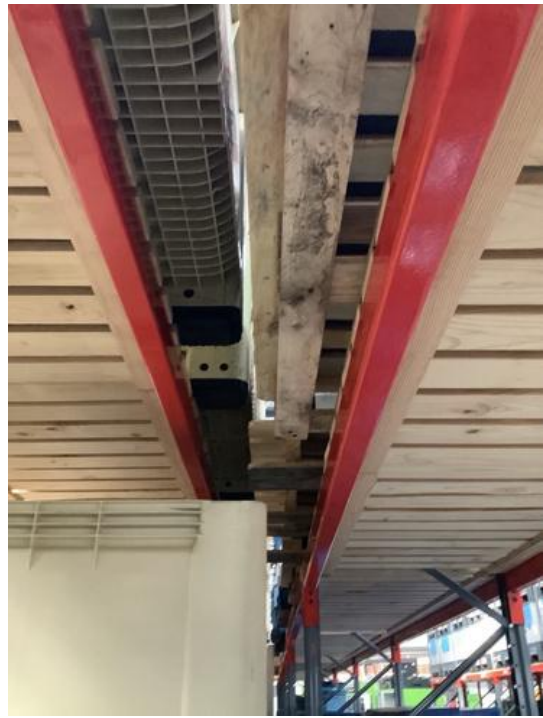
The longitudinal and/or transverse flue spaces are not being maintained

The minimum longitudinal and transverse flue spaces shall not be less than 150 mm.

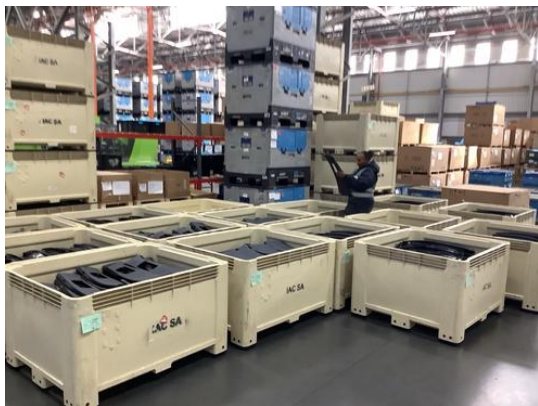
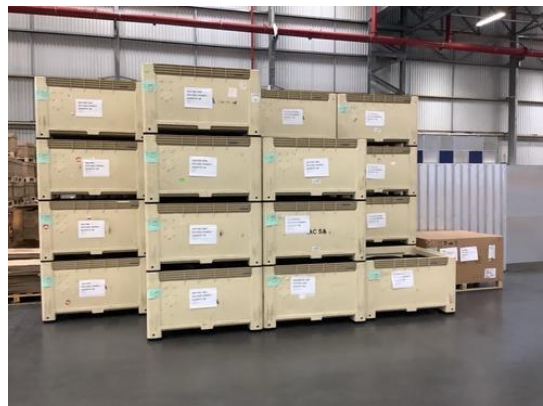
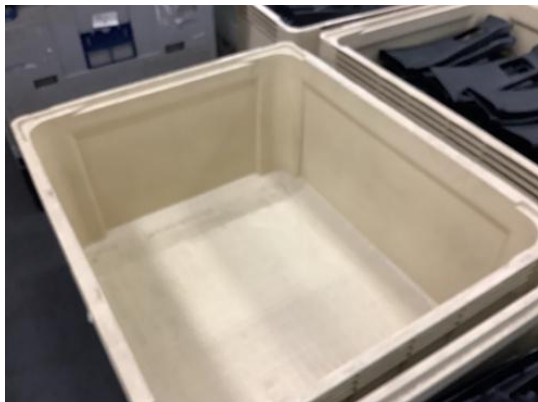
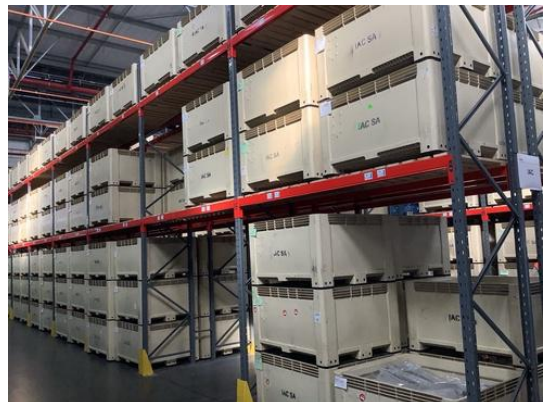
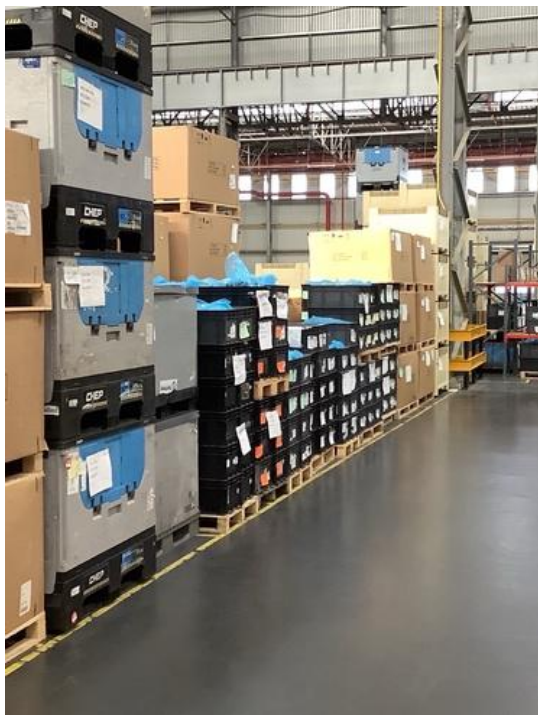
Any closed bottom storage must have covers placed over the top

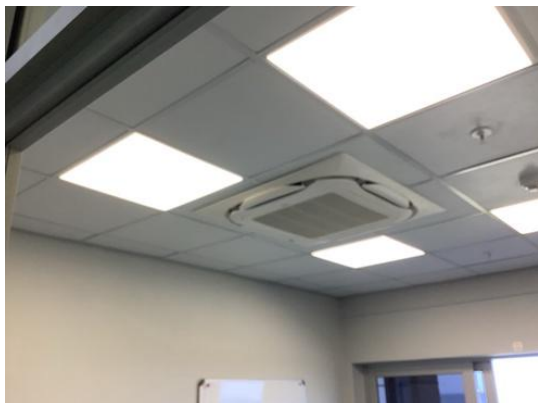
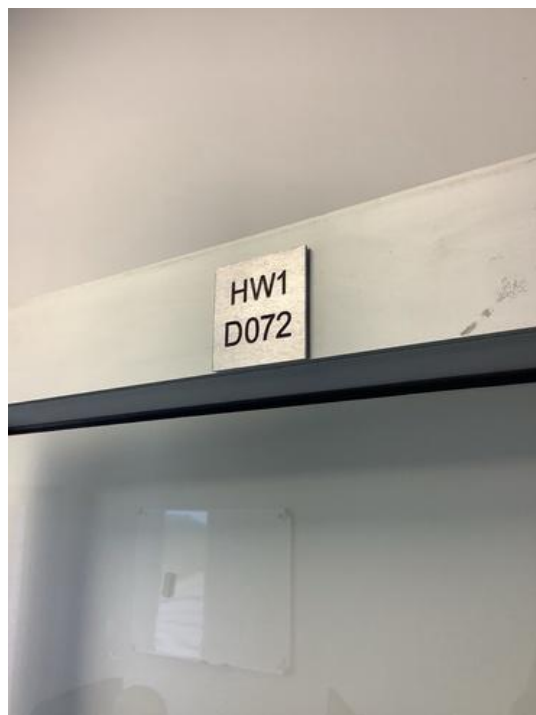
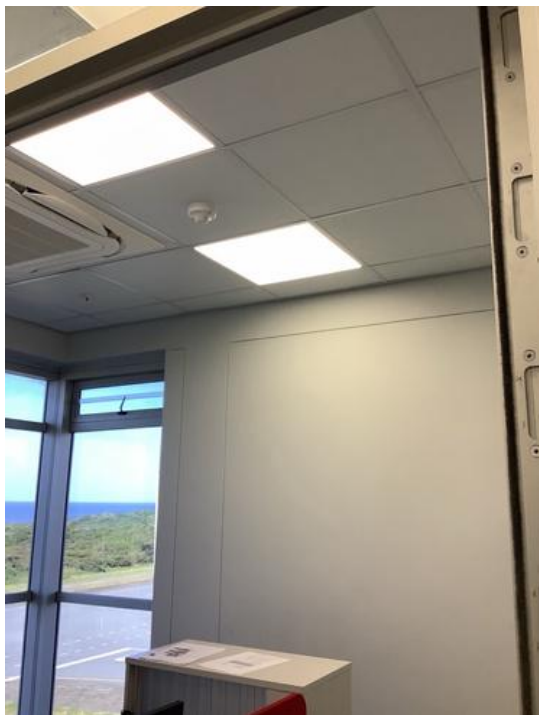
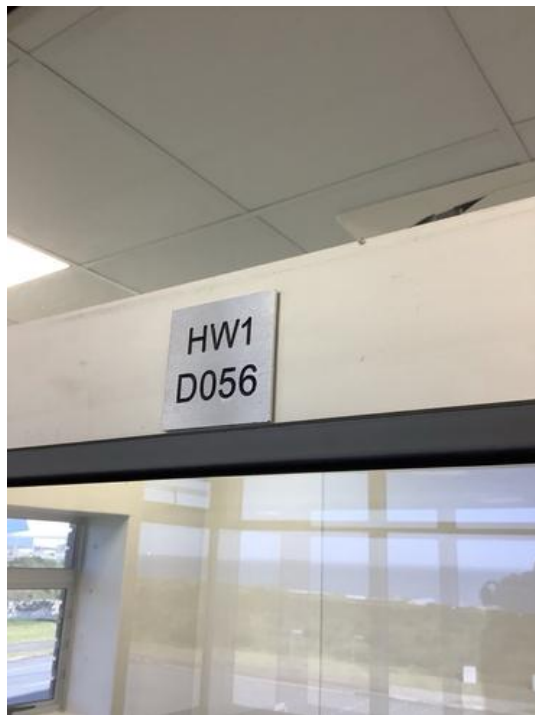
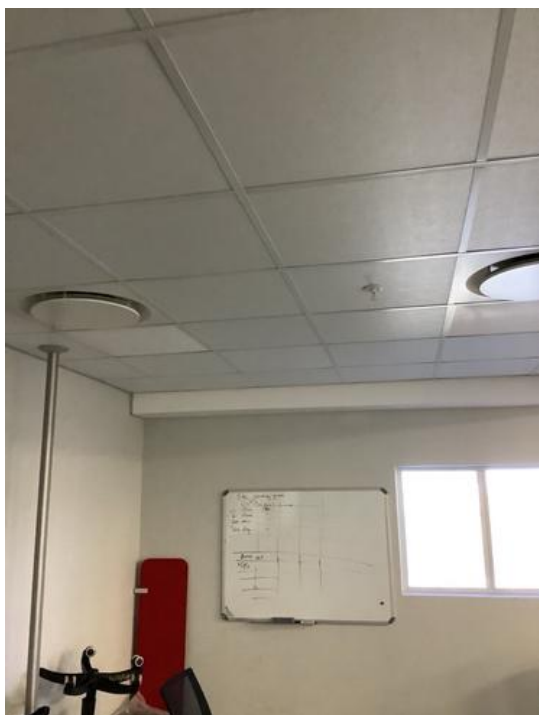
Sprinklers are out of effective working distance.

Various upstairs

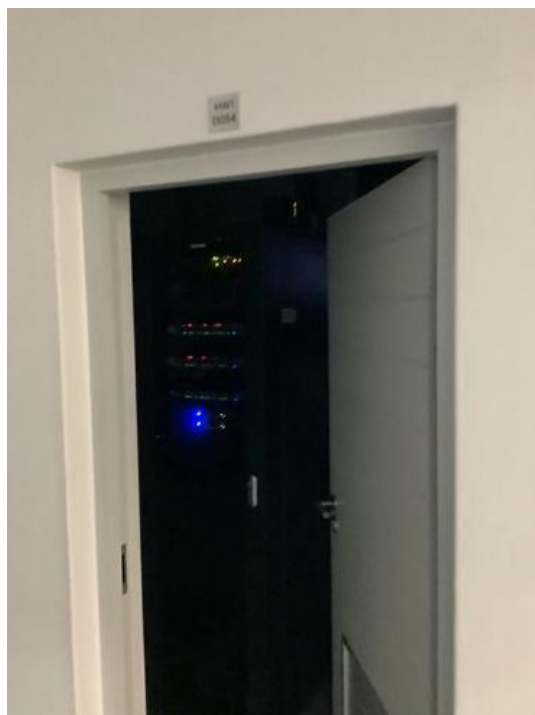
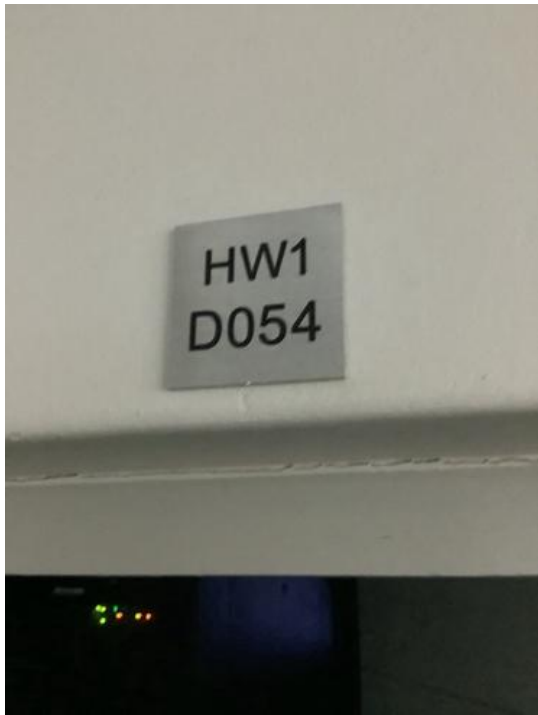
Portion of premises sprinkler protected with communicating sections that are not.

Partial protection can lead to a fire originating in the protected area radiating heat into the unprotected portion of the premises and starting secondary fires. The heat from these fires radiates or spreads back into the protected area causing excessive sprinkler operation.

Conversely, a fire originating in the unprotected portion will radiate heat or spread into the protected portion rapidly causing unnecessary sprinkler operation and overwhelming the sprinkler system installed.

Server room

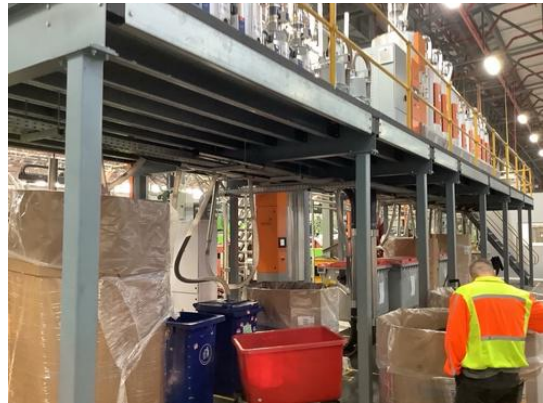
Photo 26

Surfaces exceeding 1,0 metre in width.

Surfaces which exceed 1,0 metre in width will obstruct the water discharged from the sprinklers above which could result in an ignition beneath these surfaces not being controlled or extinguished.

Vacuum platform

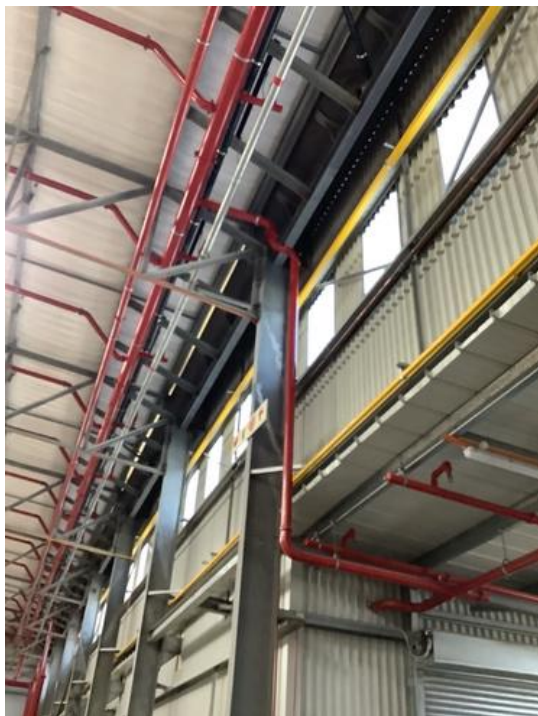
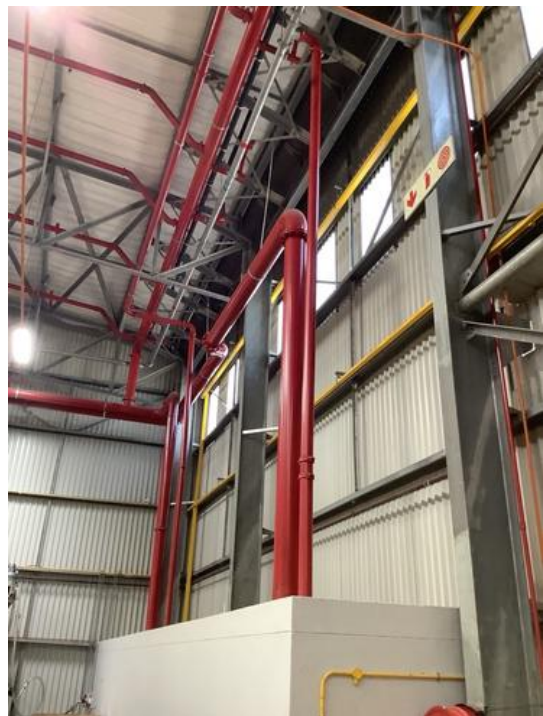
Distribution rise/drop pipes shall be secured directly to the building structure or by hangers securing horizontal distribution pipes within 300 mm of the riser.

Dropper to canopy
Risers from valves

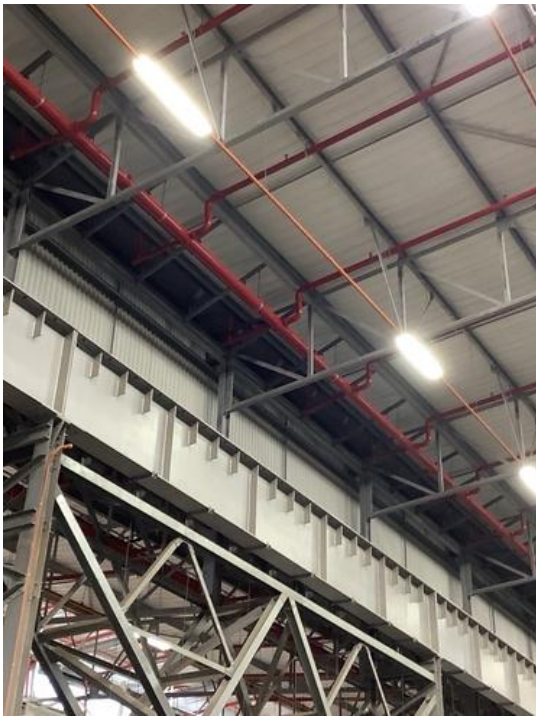
Photo 29

Terminal range pipe hangers are exceeding the maximum distance of 750 mm from the end of the range pipe.

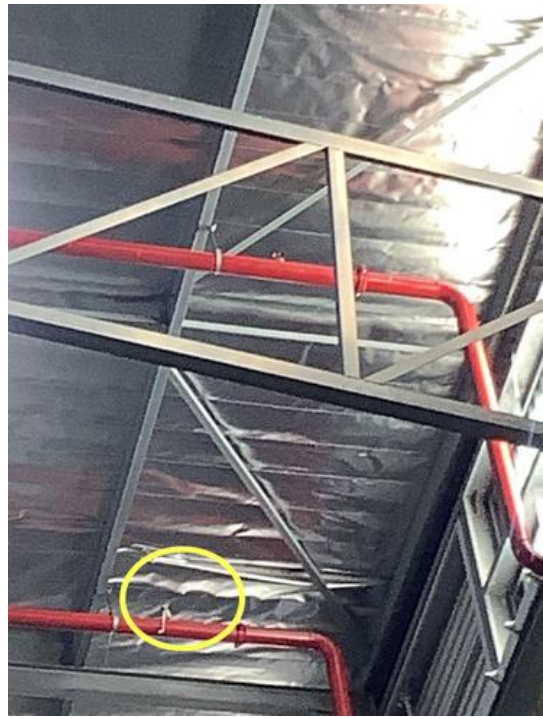
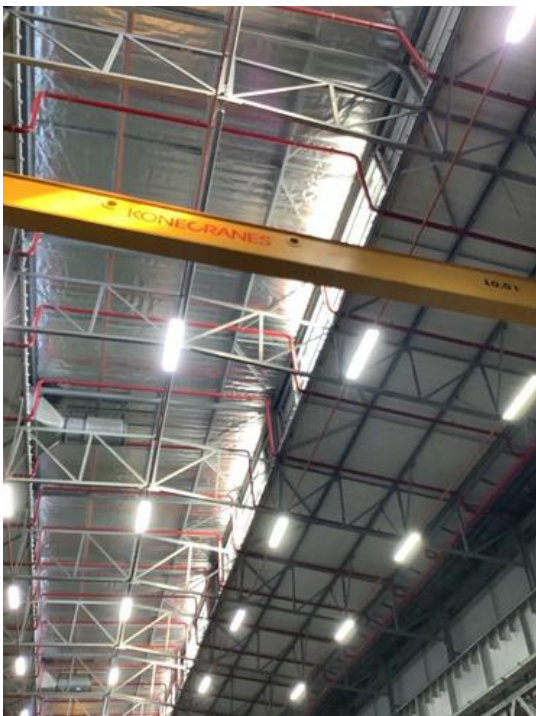
Distribution pattern of sprinklers affected.

Middle roof monitor above crane

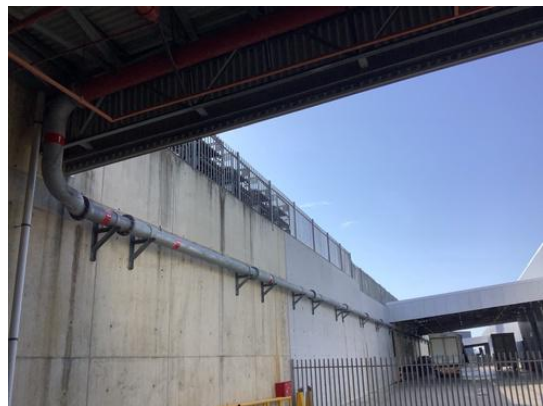
Photo 32

Exposed / unprotected pipe work

Sprinkler pipe work must pass through a sprinkler protected area or be encased in a 2 hour fire rated enclosure.

Main feed

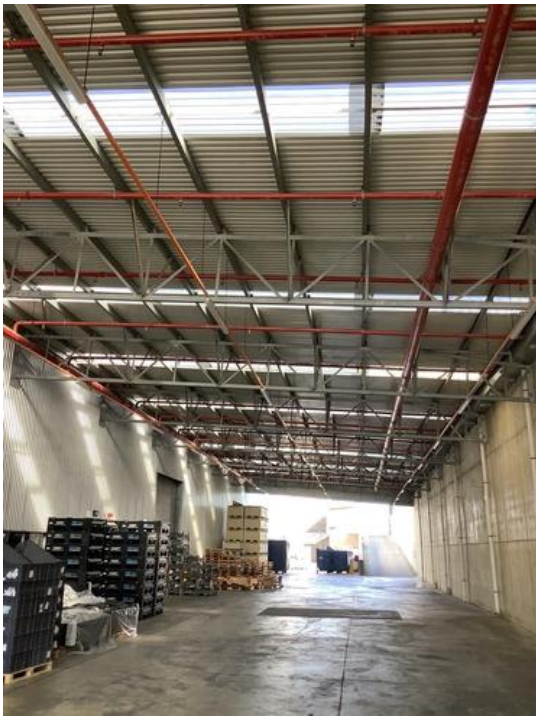
Photo 33

The installation of ESFR sprinklers in the canopies of this building are a non-compliance but will be accepted on this occasion on provision that these canopies are not allocated as storage areas. Only load and offload process to take place under these canopies.

Loading canopy

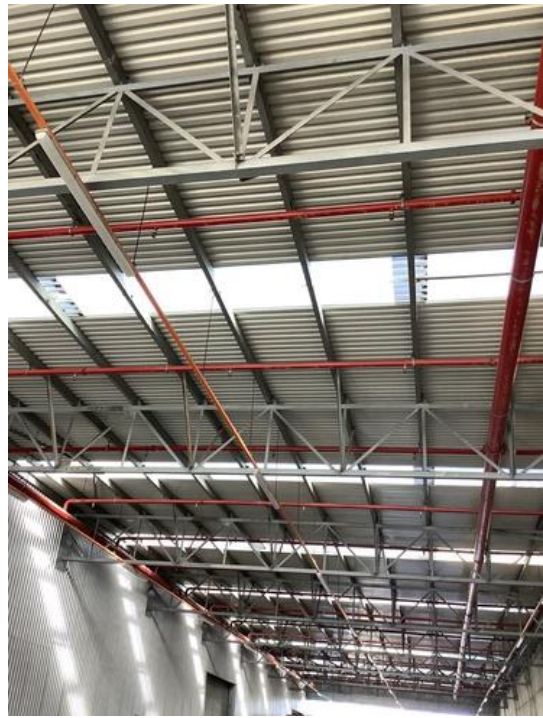
Photo 34

Combustible roof insulation or sheeting may not be used in conjunction with ESFR protection

ESFR sprinklers can only be located beneath non-combustible surfaces. Combustible translucent sheeting, may in the event of a fire negatively impact the operation of the ESFR installation.

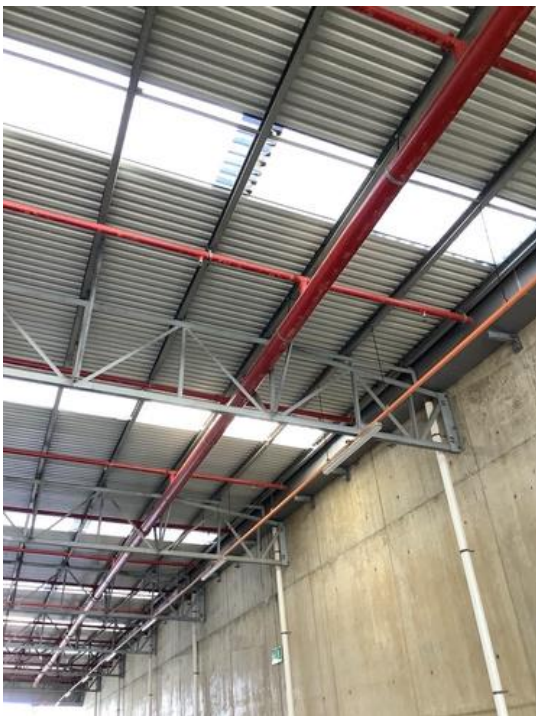
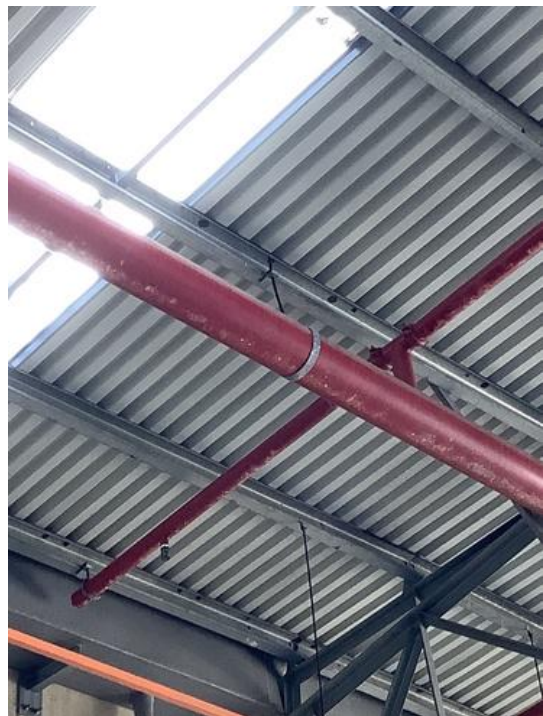
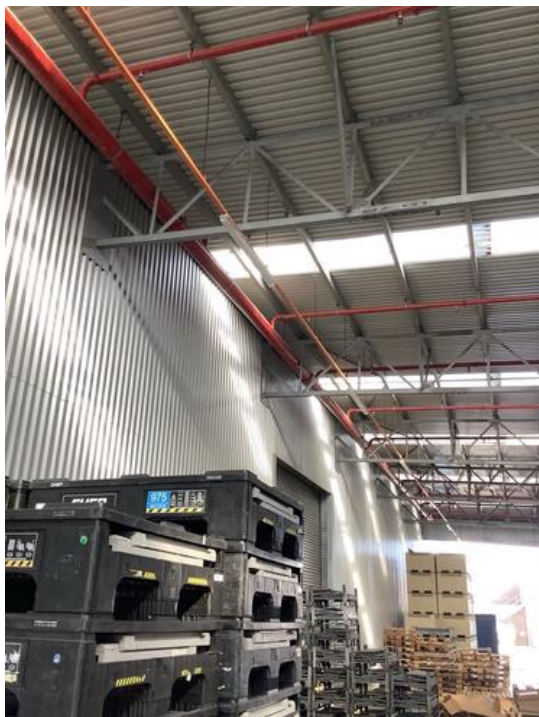
The sprinkler pipe work must be correctly supported.

Distribution main
