Inspection of Automatic Sprinkler System

East London Industrial Development
Zone - Auria - Building GE1

UNC..9084

18.06.2024 12:37 SAST

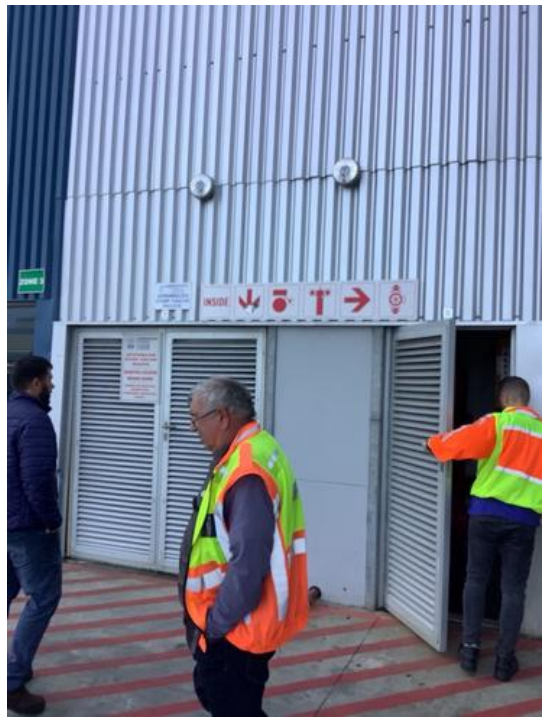
Photo 2

South side

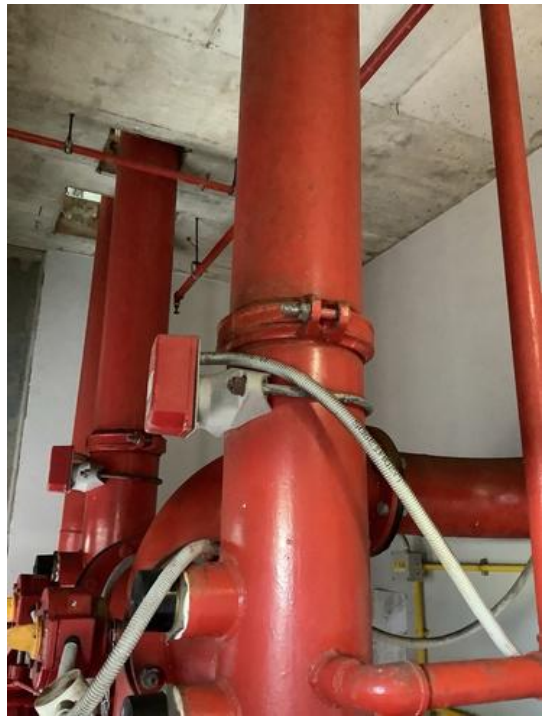
Photo 4

7.10 Flow Switch Installed Correctly

No

The flow switch must be fitted downstream from the alarm valve with a 25mm test pipe installed at least 2 pipe diameters downstream of the flow switch.

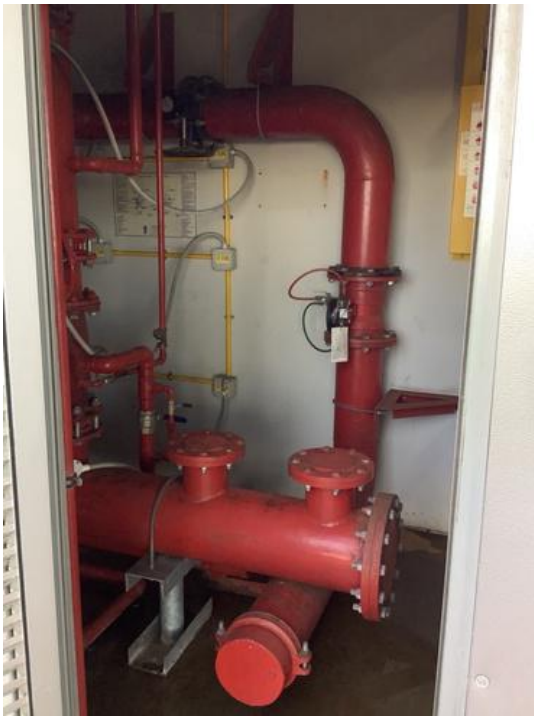
Photo 5

Fail

Not installed as per manufacturer's specifications. To be corrected

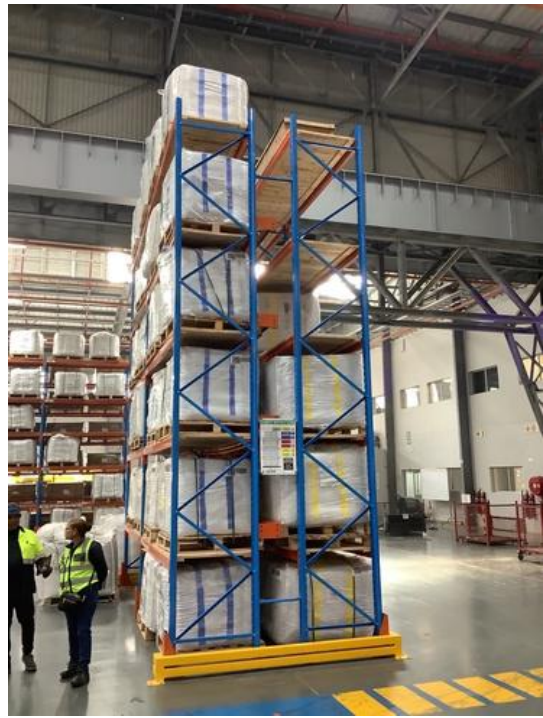
Photo 6

Are the storage heights exceeded.

Yes

The storage heights must be maintained in accordance with the maximum allowable stack heights as detailed in this report. Should this not be possible, intermediate level protection is deemed to be mandatory.

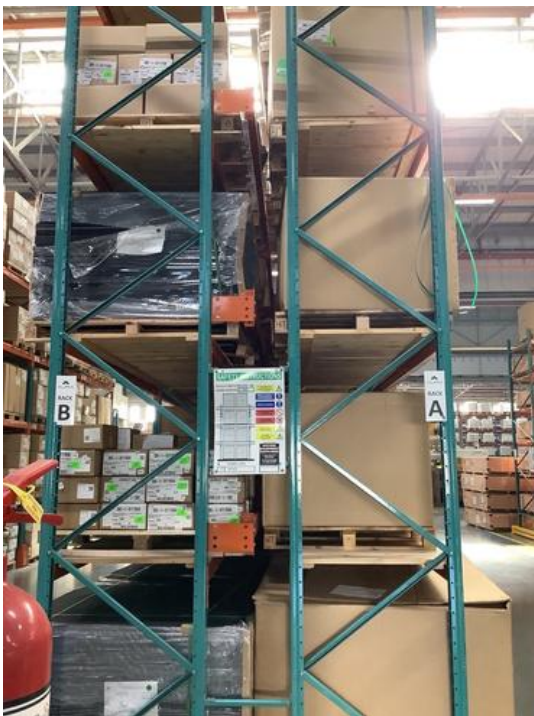
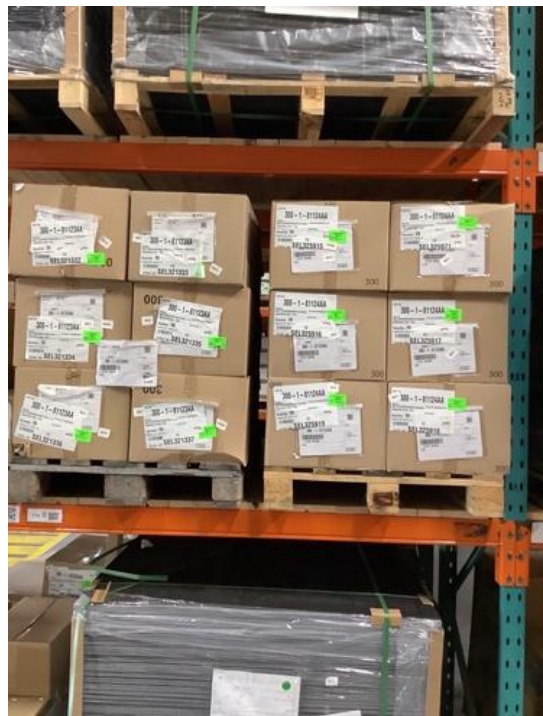
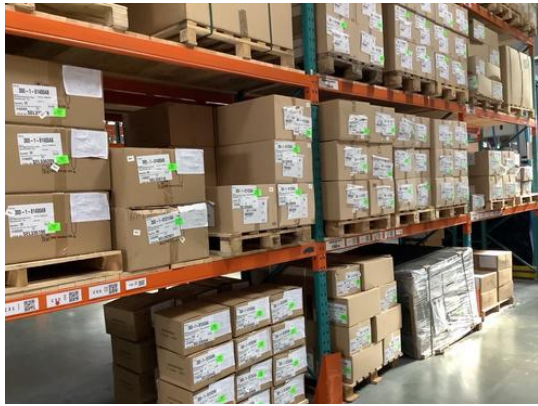
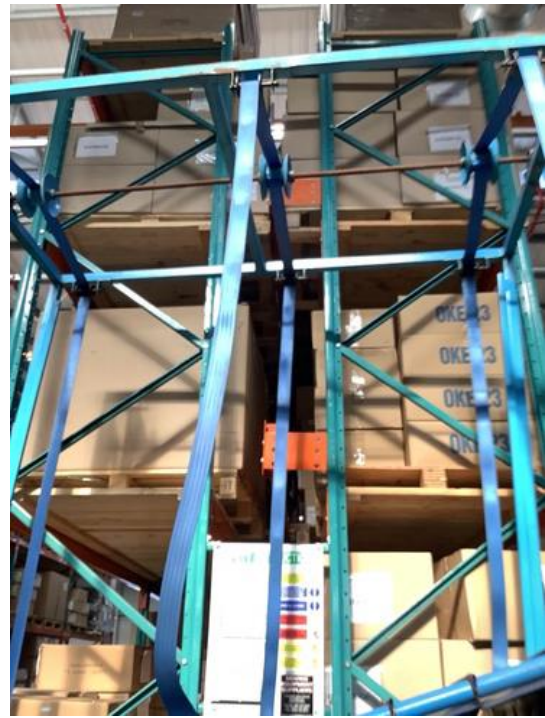
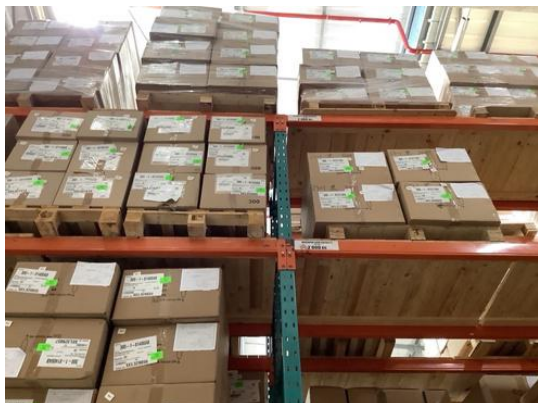
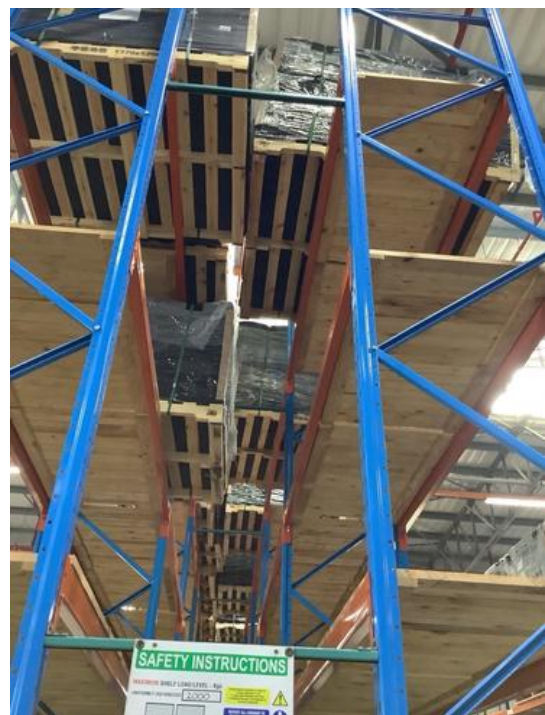
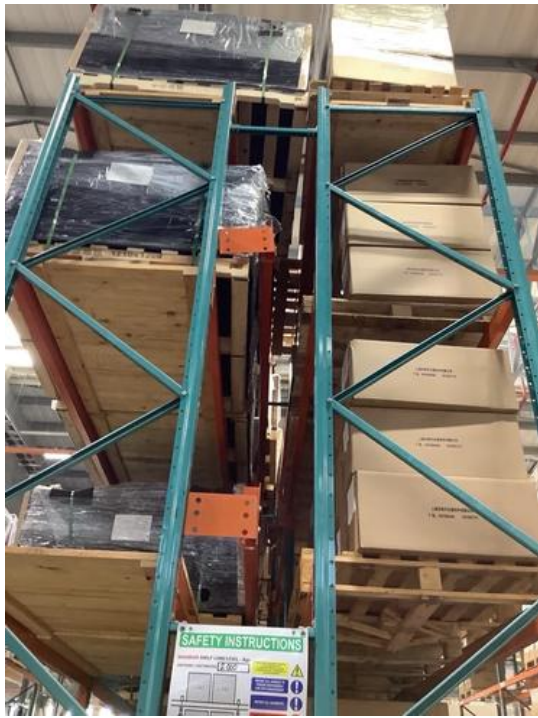
The longitudinal and/or transverse flue spaces are not being maintained

Racks

The minimum longitudinal and transverse flue spaces shall not be less than 150 mm.

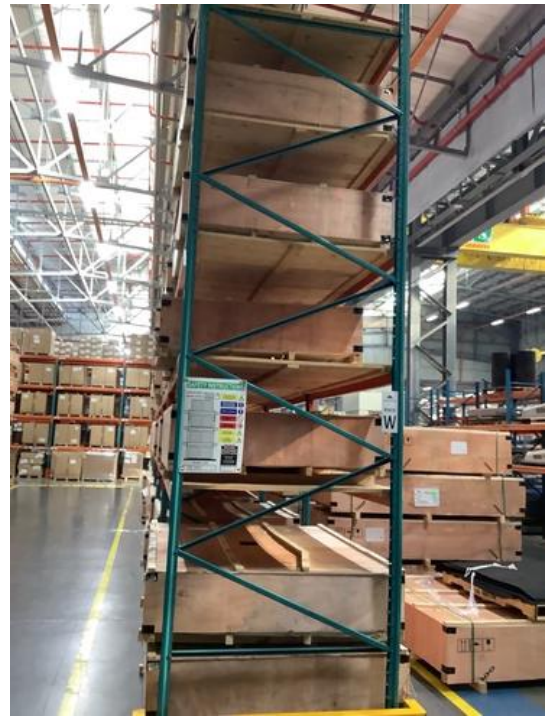
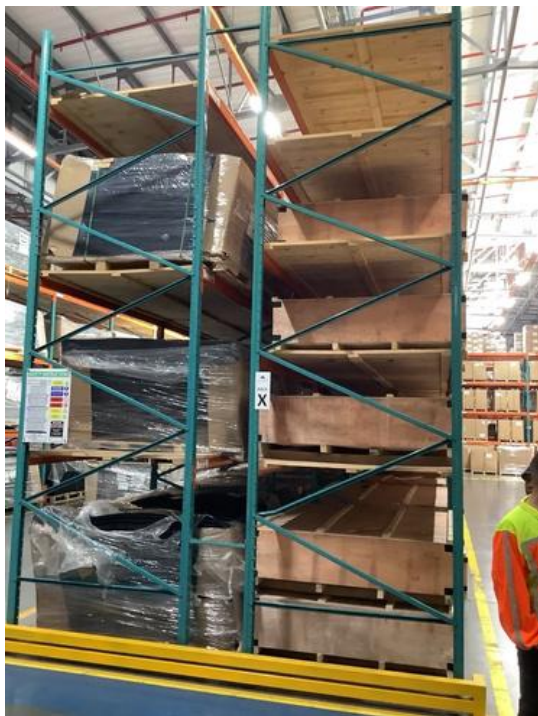
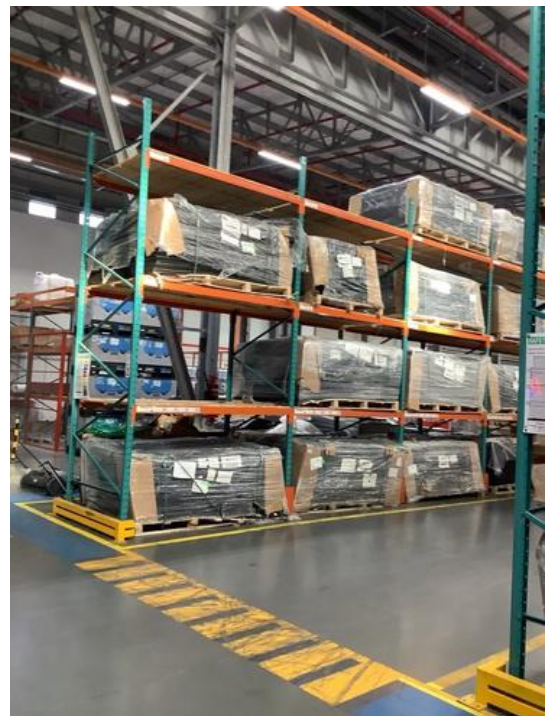
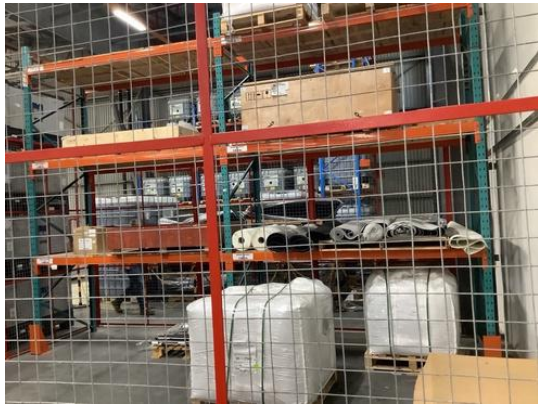
Shelves exceed 1,0 metre in width.

Warehouse

The shelves must be reduced to a maximum width of 1,0 metre or intermediate sprinkler protection will be mandatory at each shelf tier level.

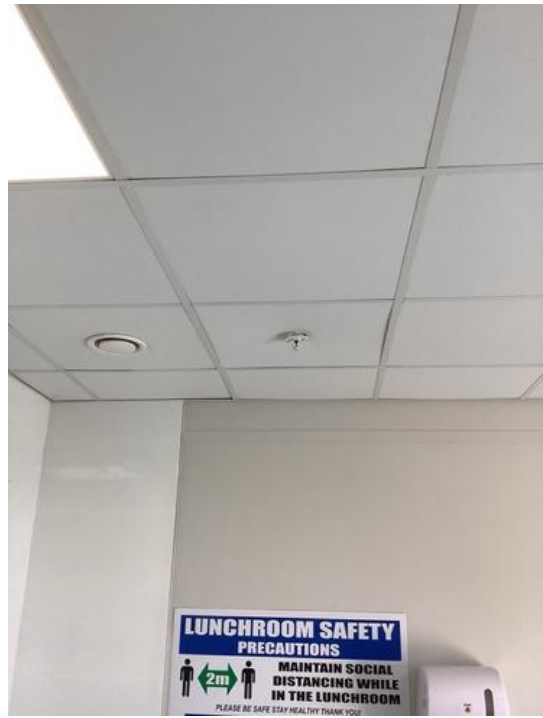
Photo 18

Sprinklers dropped below level of the ceiling.

Kitchen

Sprinklers must be re-fixed to their original intended operating position. The hanger supporting it must be checked and, if necessary, re-secured.

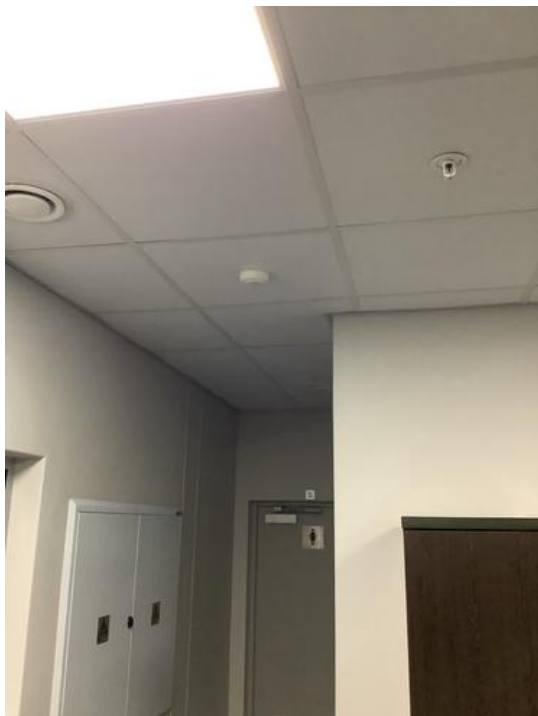
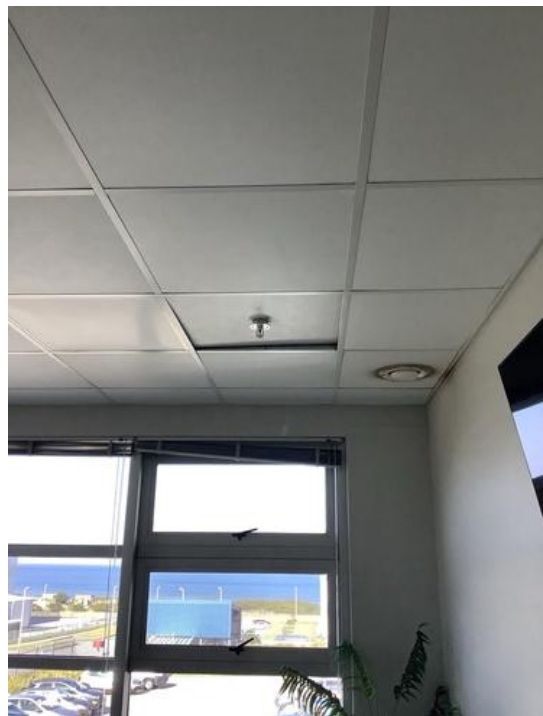
Sprinkler Spacing

Outside toilets
Boardroom

Sprinkler protection must be extended in order to provide correct coverage.

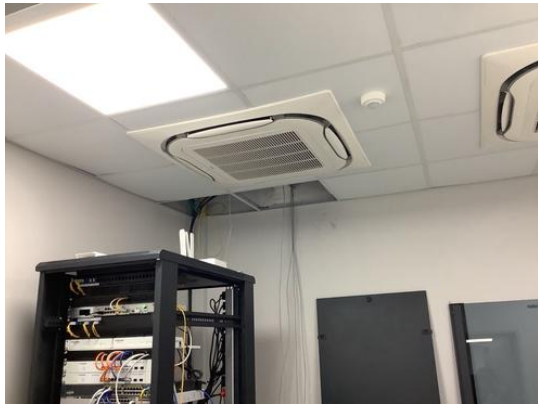
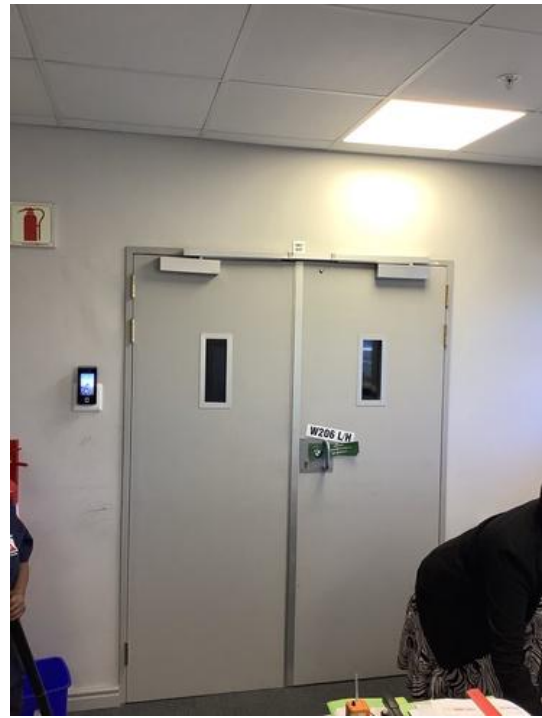
Portion of premises sprinkler protected with communicating sections that are not.

Partial protection can lead to a fire originating in the protected area radiating heat into the unprotected portion of the premises and starting secondary fires. The heat from these fires radiates or spreads back into the protected area causing excessive sprinkler operation.

Conversely, a fire originating in the unprotected portion will radiate heat or spread into the protected portion rapidly causing unnecessary sprinkler operation and overwhelming the sprinkler system installed.

Server room. It does have a 2 hour fire door fitted.

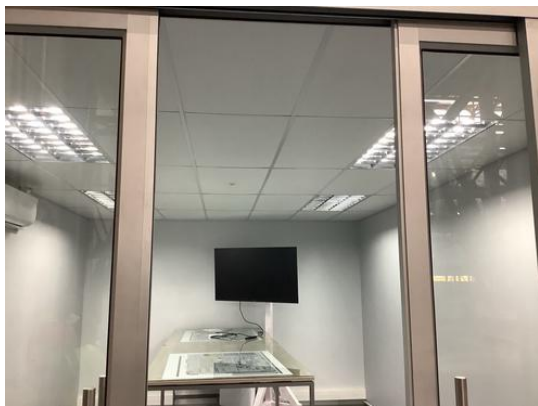
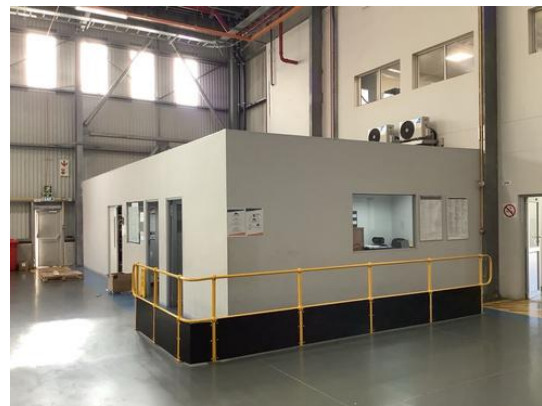
Portion of premises sprinkler protected with communicating sections that are not.

Partial protection can lead to a fire originating in the protected area radiating heat into the unprotected portion of the premises and starting secondary fires. The heat from these fires

radiates or spreads back into the protected area causing excessive sprinkler operation.

Conversely, a fire originating in the unprotected portion will radiate heat or spread into the protected portion rapidly causing unnecessary sprinkler operation and overwhelming the sprinkler system installed.

Warehouse offices/spares store and meeting room

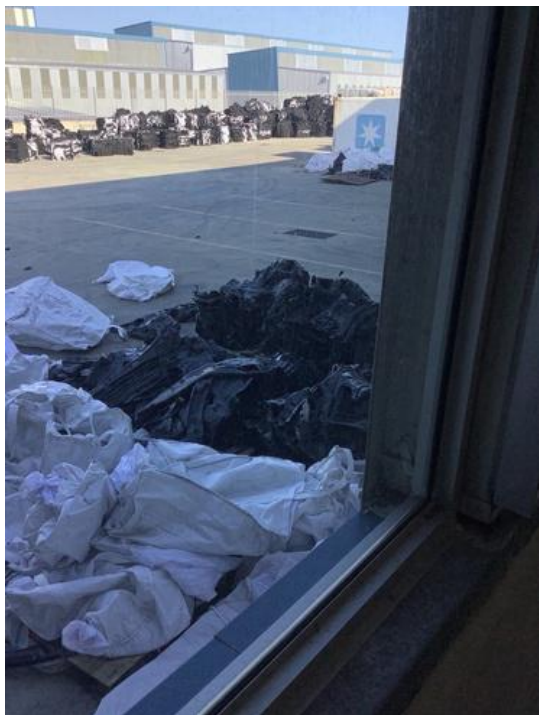
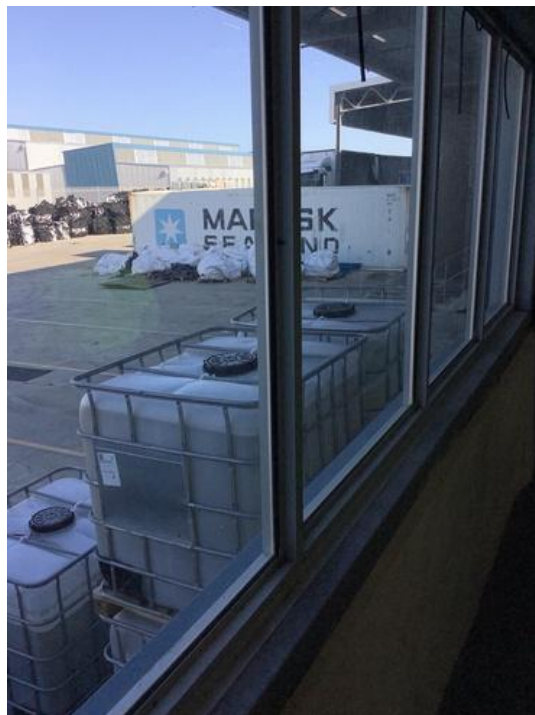
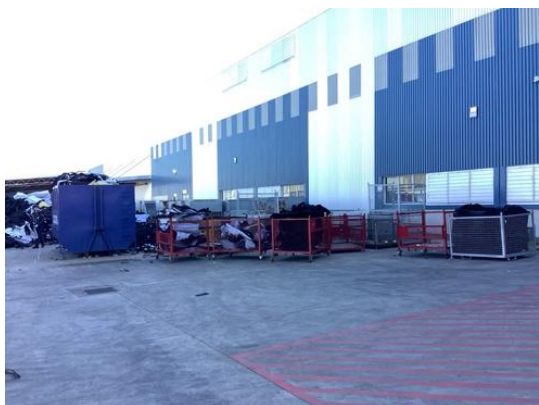
Storage too close to building.

Between canopy and transformer room

Drencher heads required which are purpose made sprinklers designed to spray water over a surface to provide protection against fire exposure. It is not acceptable to use standard sprinkler heads with the fusible elements removed for the purpose of providing wall or face wetting. The drencher system must extend along the walls of the protected building to a distance of 15.0 metres beyond each end of the stored goods. The feed for the drenchers must be taken from the underside of the valves and not from the downstream side of the installation. The stop valve controlling the drencher installation shall be located near to the sprinkler control valves, but must be at least 10,0 metres from the goods stored or from the area where they are expected to operate.

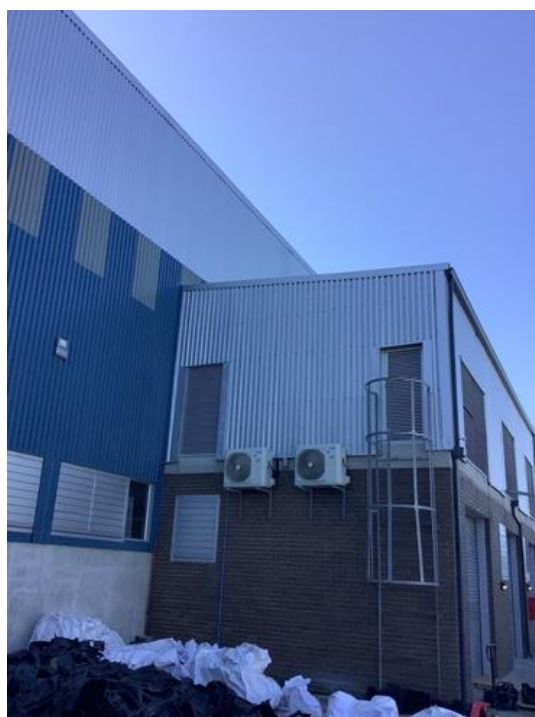
Photo 28

Portion of premises sprinkler protected with communicating sections that are not.

Partial protection can lead to a fire originating in the protected area radiating heat into the unprotected portion of the premises and starting secondary fires. The heat from these fires radiates or spreads back into the protected area causing excessive sprinkler operation.

Conversely, a fire originating in the unprotected portion will radiate heat or spread into the protected portion rapidly causing unnecessary sprinkler operation and overwhelming the sprinkler system installed.

Plant rooms. To be Verified

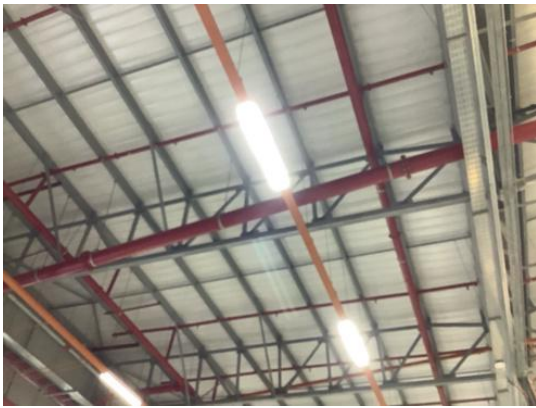
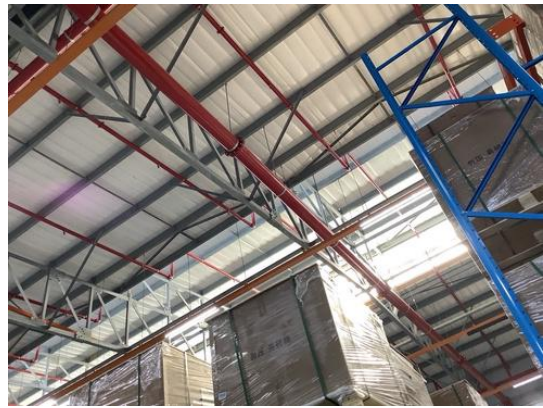
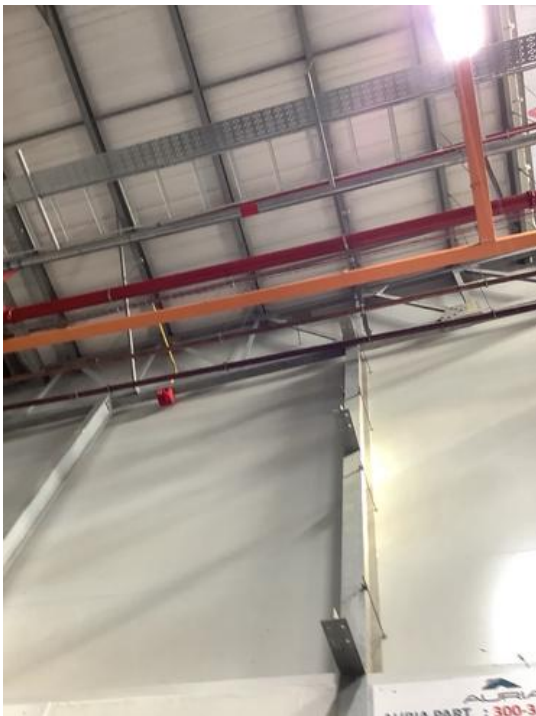
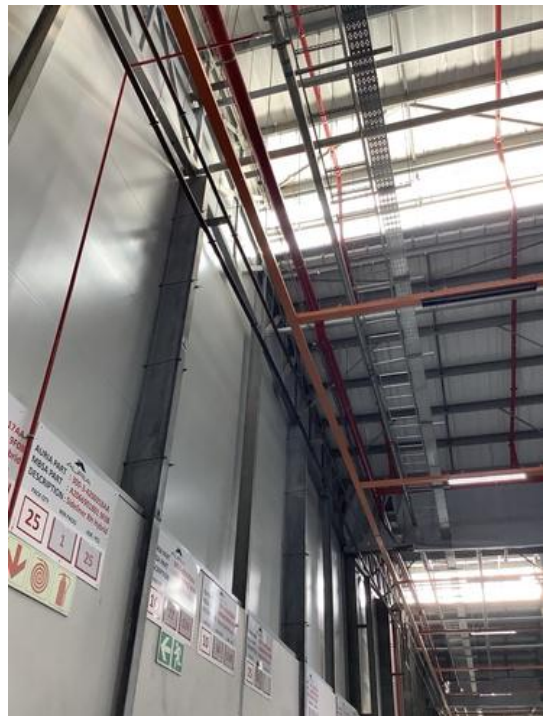
Pipe Support

Main feed
Distribution mains

The sprinkler pipe work must be correctly supported.

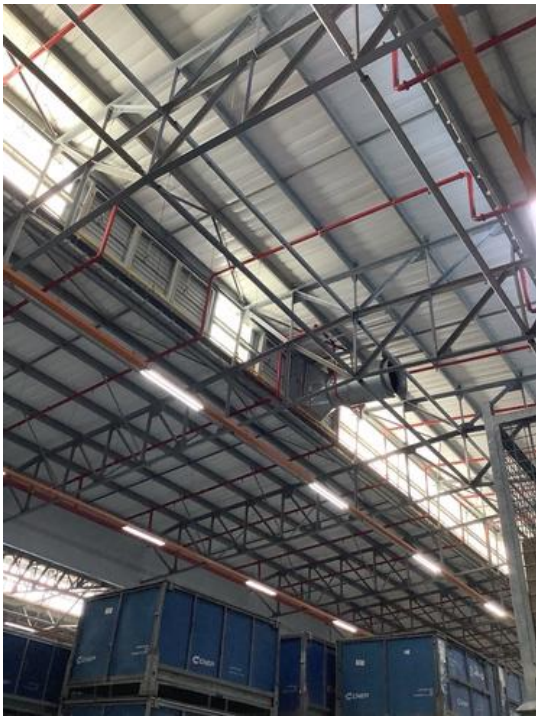
Photo 33

ESFR Mechanical Ventilation (to be verified

Ventilation has been installed in conjunction with ESFR sprinkler protection.

It is imperative that the mechanical vents do not open automatically in a fire situation as the ESFR sprinkler system will be adversely effected which could result in the ESFR system failure.

Roof

It is important that the mechanical vents be manually operated and that the Fire Chief in charge of operations during a fire be able to make the decision whether it should be opened or remain closed.

It might also be advisable to zone the mechanical vents so as to have the option of opening all the vents at the same time or only certain zones.

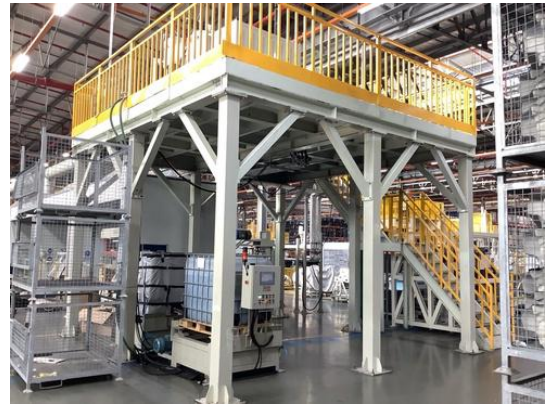
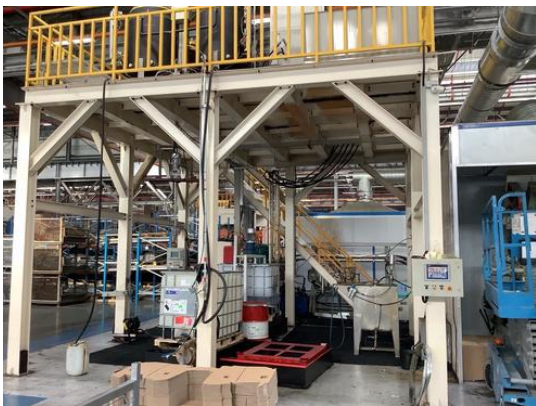
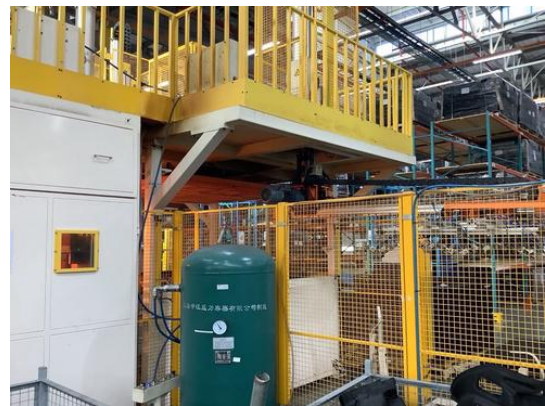
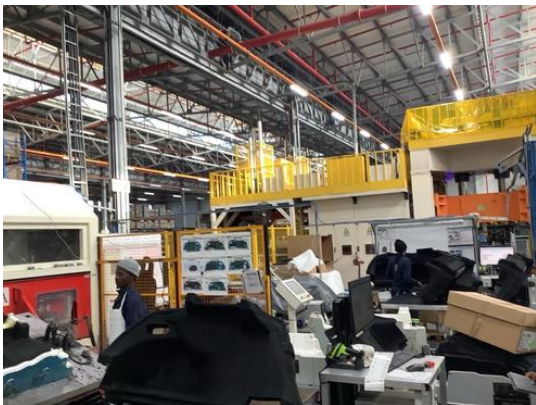
Surfaces exceeding 1,0 metre in width.

Surfaces which exceed 1,0 metre in width will obstruct the water discharged from the sprinklers above which could result in an ignition beneath these surfaces not being controlled or extinguished.

The general obstruction is classed as 1,000 mm therefore sprinkler protection is required beneath any such obstruction which includes, but is not limited to;

Walkways, solid or open grid, and Work tables.

Mezzanine platforms

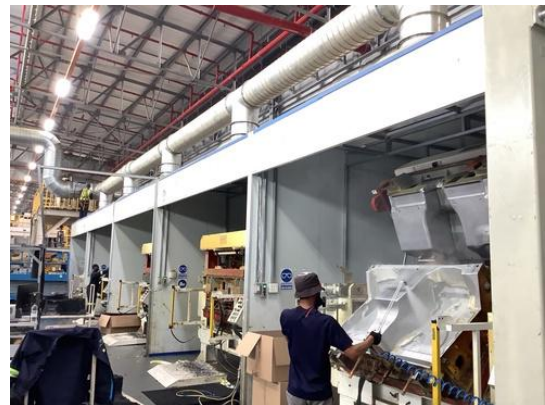
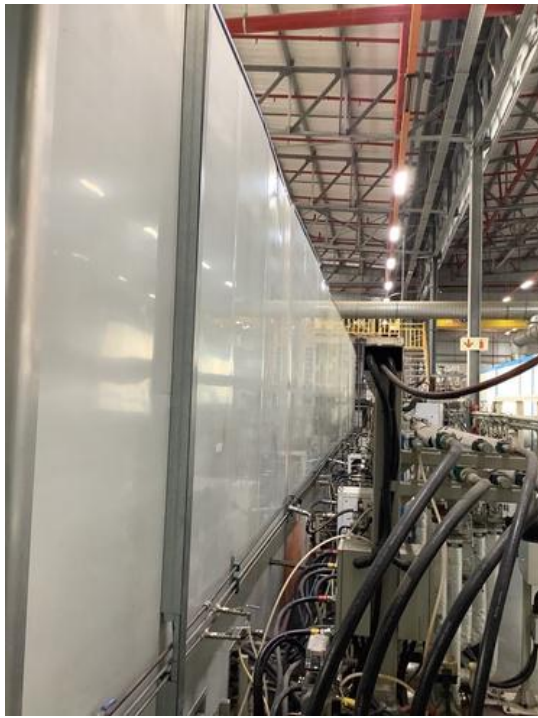
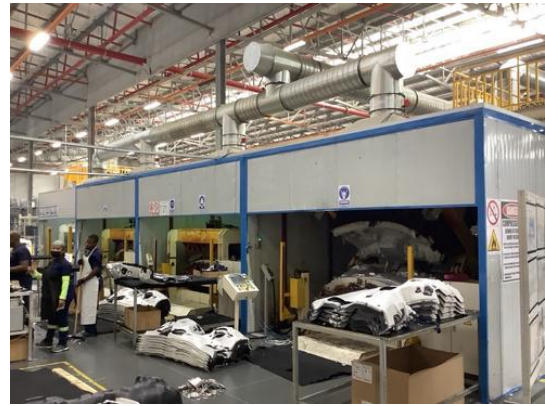
Extraction Canopies.

Assembly bays

Extraction canopies where these are designed to extract grease laden vapours or heat through a ventilation system must be fully sprinkler protected, inclusive of exhaust ducts and exhaust plenum chambers, using 141° Celsius operating temperature spray pattern type nozzles unless alternative protection is installed.

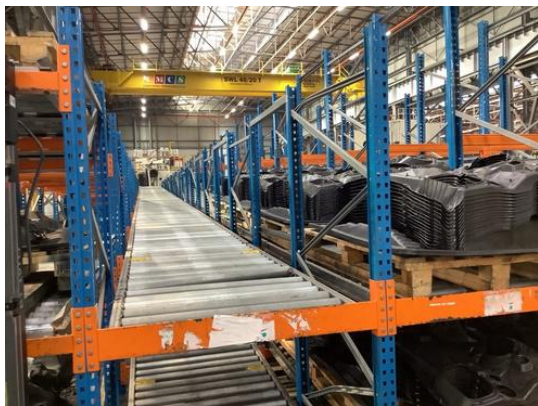
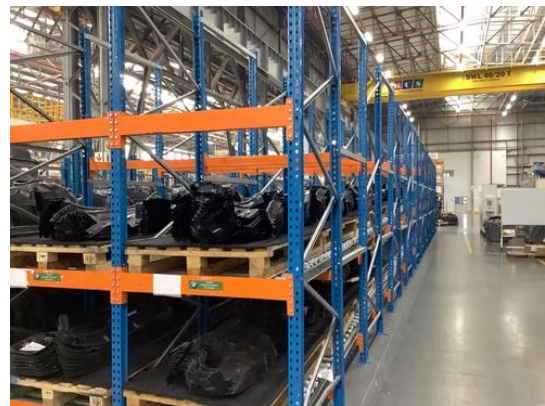
Surfaces exceeding 1,0 metre in width.

Surfaces which exceed 1,0 metre in width will obstruct the water discharged from the sprinklers above which could result in an ignition beneath these surfaces not being controlled or extinguished.

Push through racks
