# Inspection of Automatic Sprinkler System

Yekani - East London Industrial  
Development Zone

UNC.8029

08.05.2024 12:26 SAST

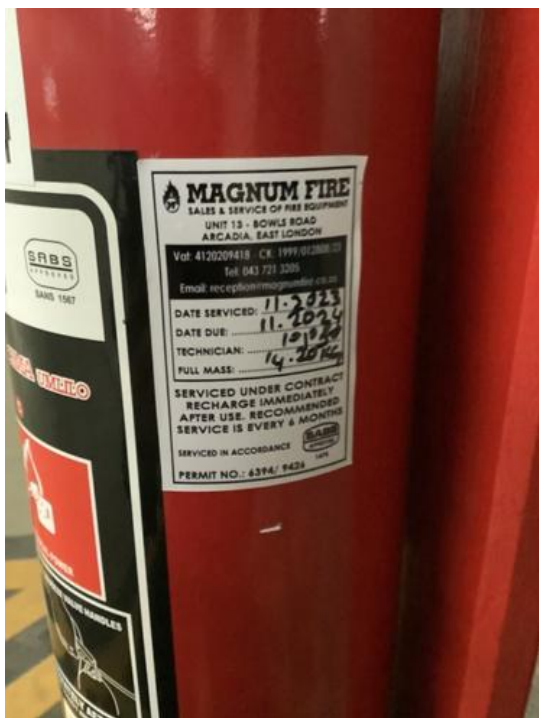
Photo 1

Clear access to the hand fire appliances must be maintained at all times.

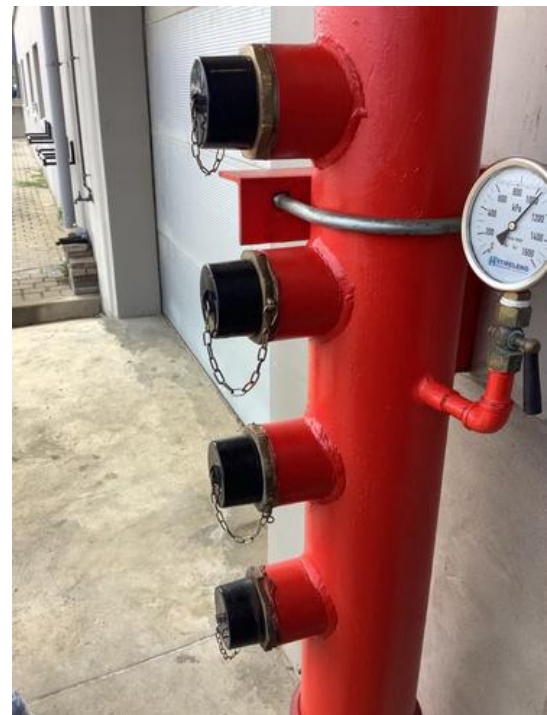
Photo 10

No

It appears that the booster connection piping to the main distribution riser is too long, which may restrict the opening of the booster plunger into the main distribution riser, this will prevent effective boosting of the sprinkler system and must be revised.

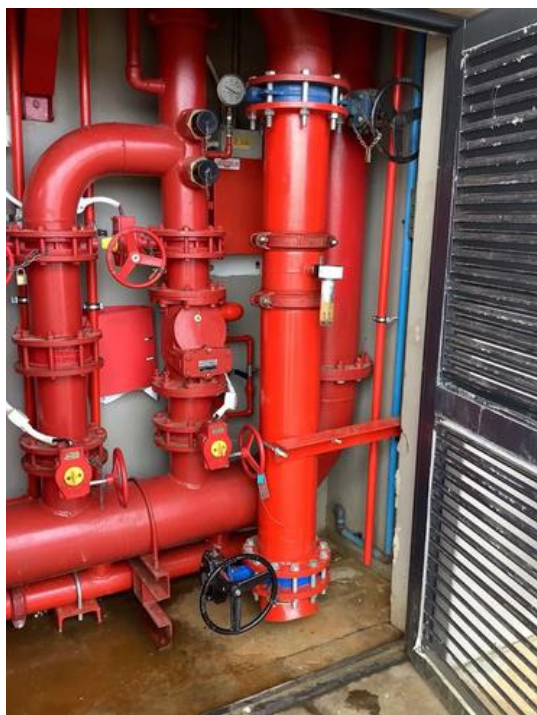
Photo 11

Fail

Could not test. Needs to be rerouted to enable testing

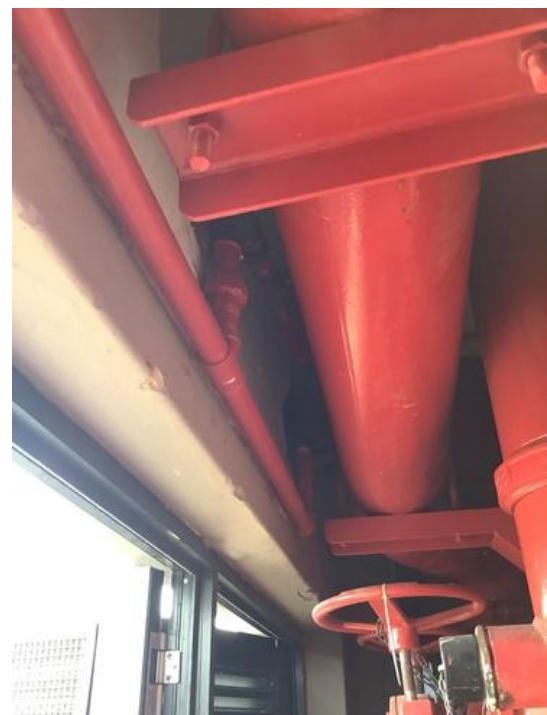
Photo 12

The water motor alarm drain pipes discharge into a common manifold. This must be revised so that the drain pipes are taken separately to waste.

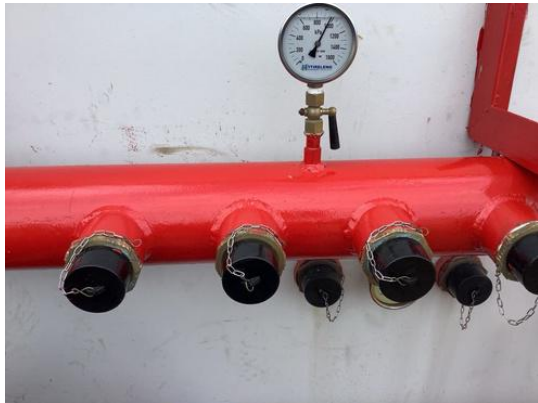
Photo 17

**It appears that the booster connection piping to the main distribution riser is too long, which may restrict the opening of the booster plunger into the main distribution riser, this will prevent effective boosting of the sprinkler system and must be revised.**

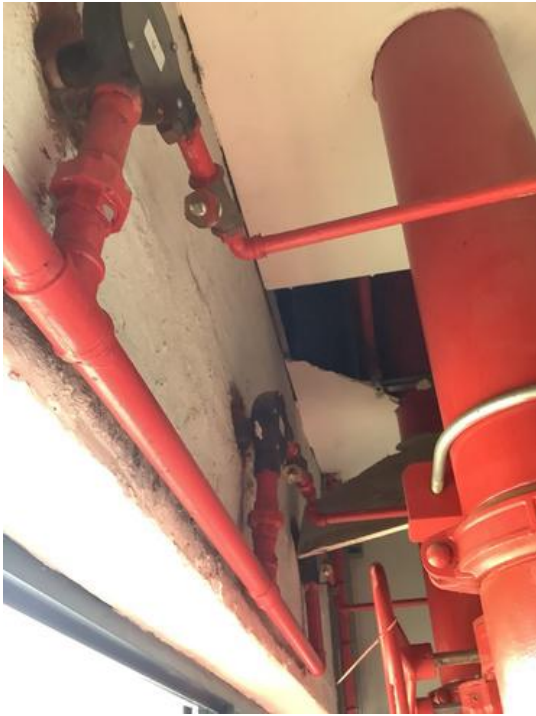
Photo 21

**The water motor alarm drain pipes discharge into a common manifold. This must be revised so that the drain pipes are taken separately to waste.**

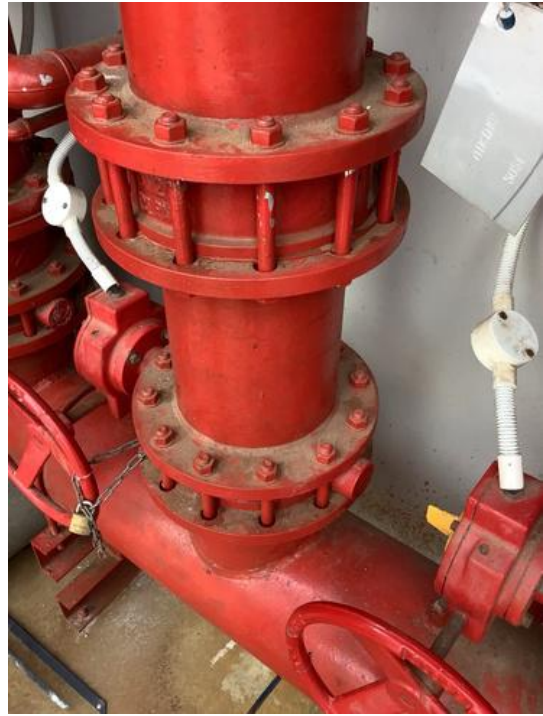
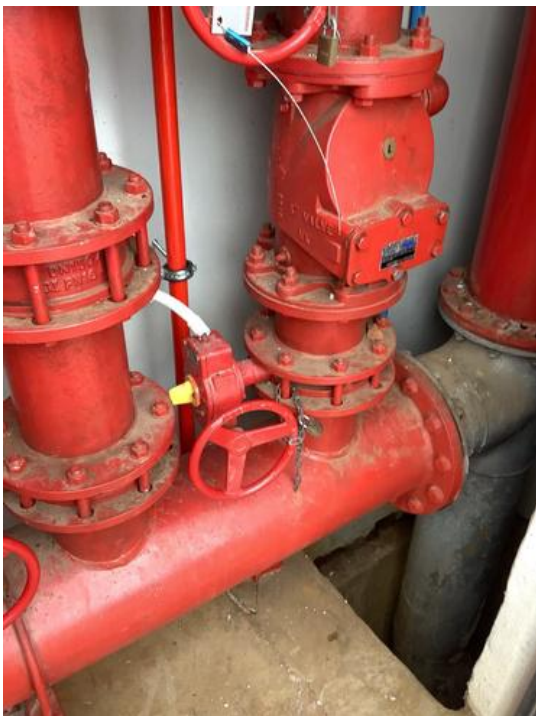
The incorrect bolt sizes have been used on the flanges in both valve chambers. This must be addressed by your installer

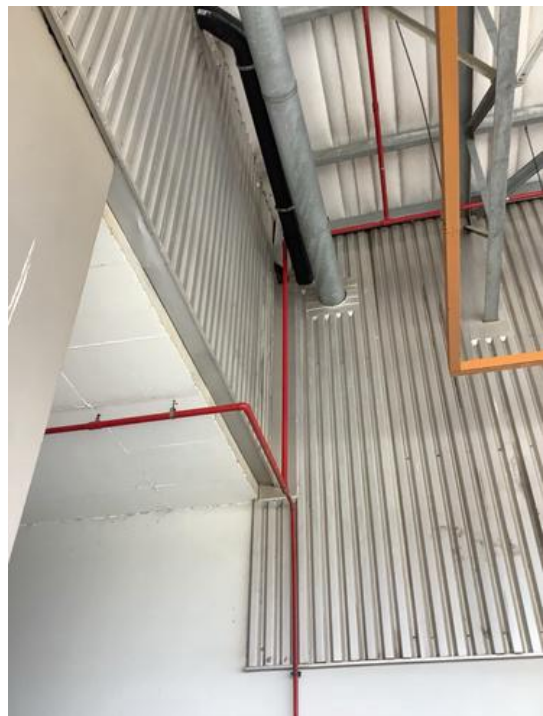
Photo 24

**Distribution rise/drop pipes shall be secured directly to the building structure or by hangers securing horizontal distribution pipes within 300 mm of the riser.**

Dropper to fire escape at generator room

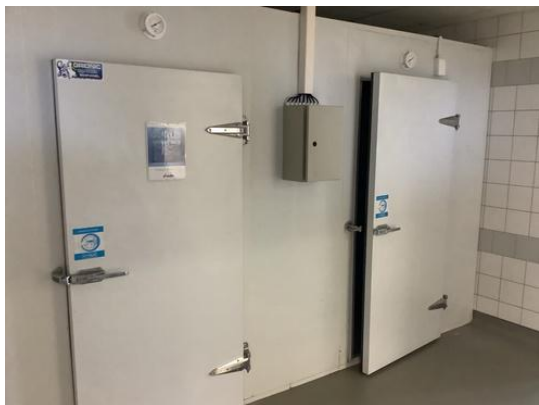
Photo 25

##### **Enclosed structures not sprinkler protected.**

A fire originating within an unprotected area will burn in an uncontrolled manner without alerting the sprinkler system unit until such time as it breaks out of the structure. The subsequent release of heat will operate multiple sprinklers at roof level above the fire area and remote from it causing massive damage.

Fridge and freezer in canteen kitchen

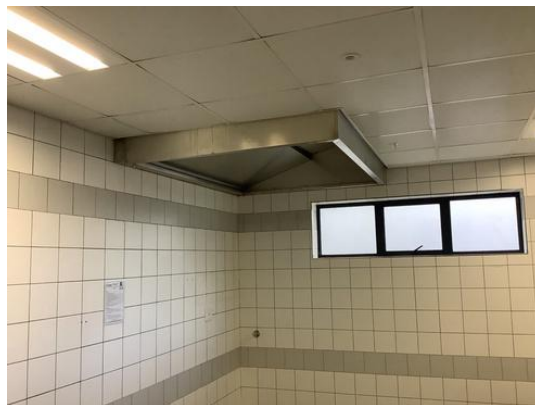
Photo 26

Extraction canopies where these are designed to extract grease laden vapours or heat through a ventilation system must be fully sprinkler protected, inclusive of exhaust ducts and exhaust plenum chambers, using 141° Celsius operating temperature spray pattern type nozzles unless alternative protection is installed.

Kitchen

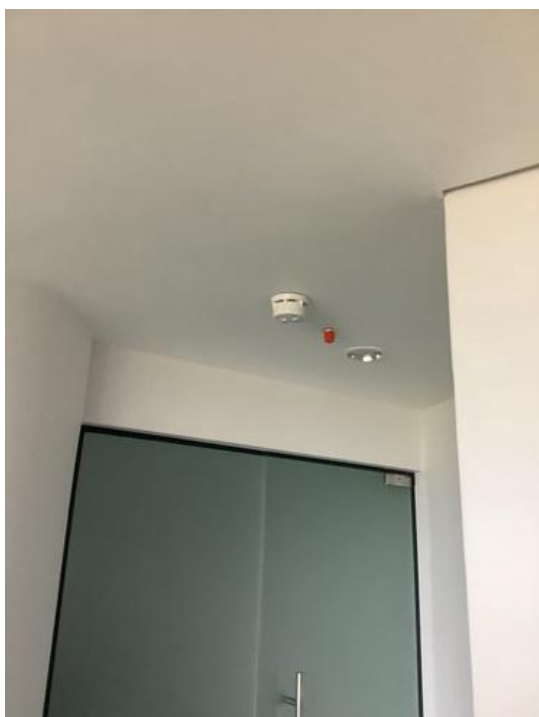
Photo 27

**The protective covers must be removed from sprinklers.**

Room OB130

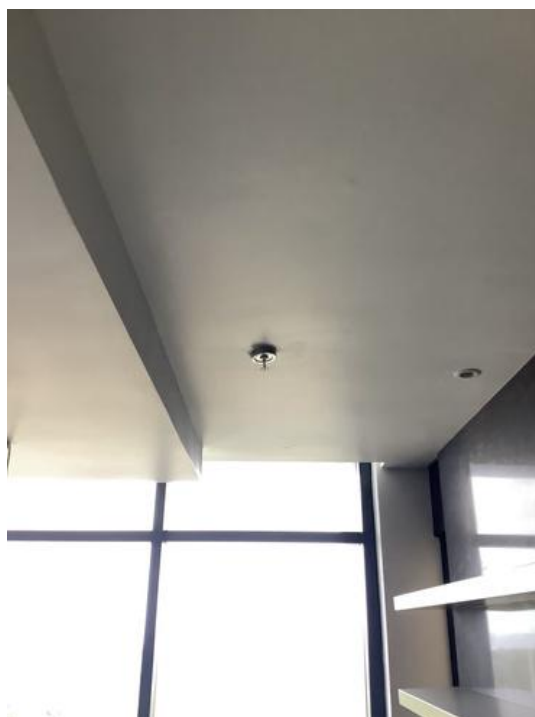
Photo 28

**Sprinklers dropped below level of the ceiling.**

Room OB130

Sprinklers must be re-fixed to their original intended operating position. The hanger supporting it must be checked and, if necessary, re-secured.

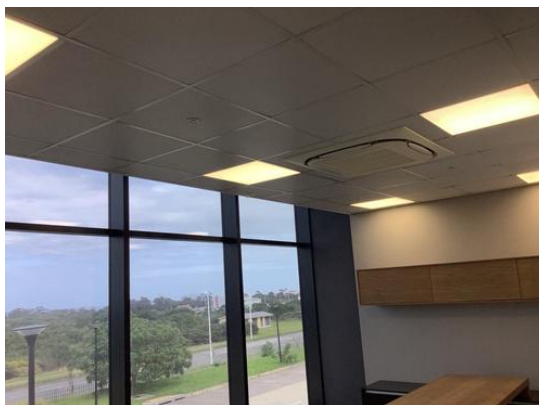
Photo 29

**Sprinklers spaced too far apart. (The protection must be revised in this area so that the following spacing is achieved: Sprinklers must be spaced a maximum of 4,0 meters apart. Each sprinkler must cover a maximum area of 12 m<sup>2</sup>)**

Room OB118

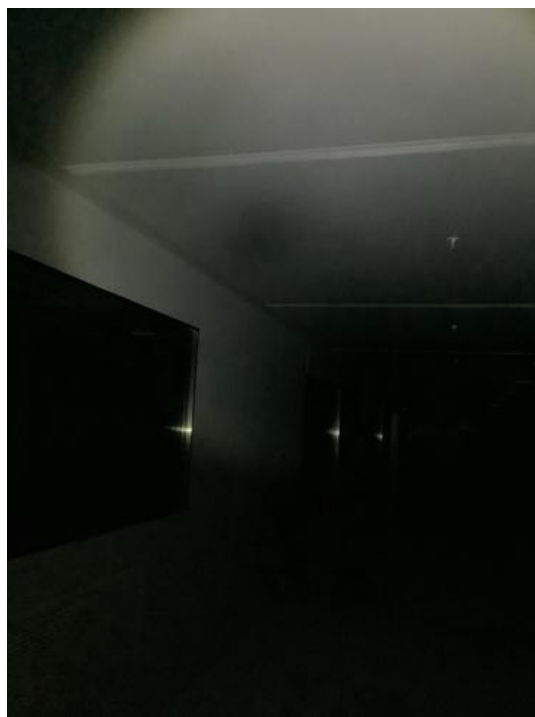
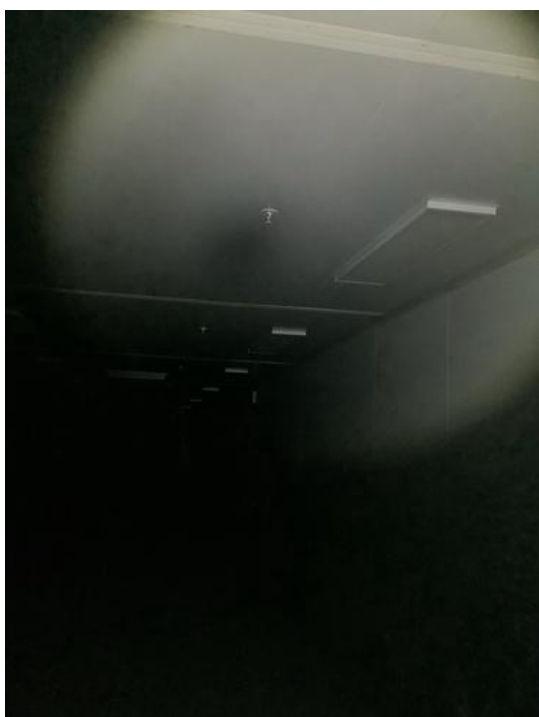
**Sprinklers exceed 600 mm from walls of a cold room or freezer (11th Edition).**

Various where ISO panels are installed

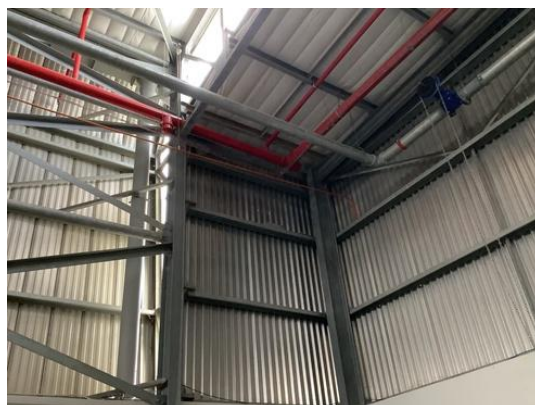
Photo 32

**Terminal hangers on distribution pipes are exceeding the maximum distance of 450 mm from the end of the distribution pipe.**

Far right corner from office

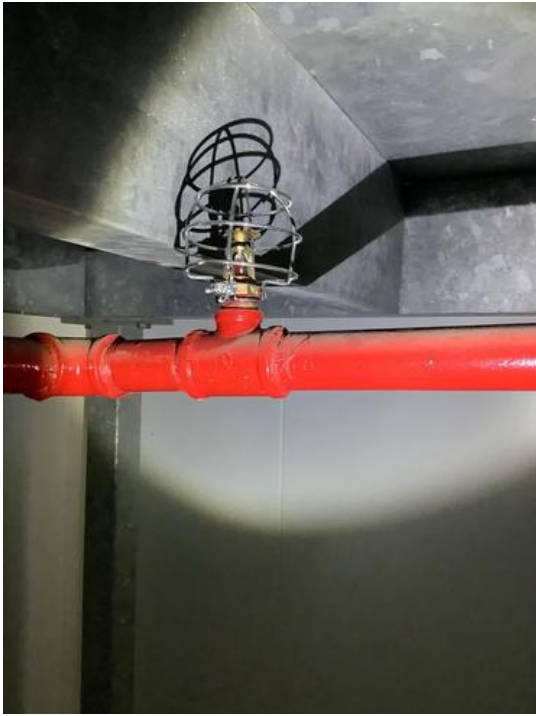
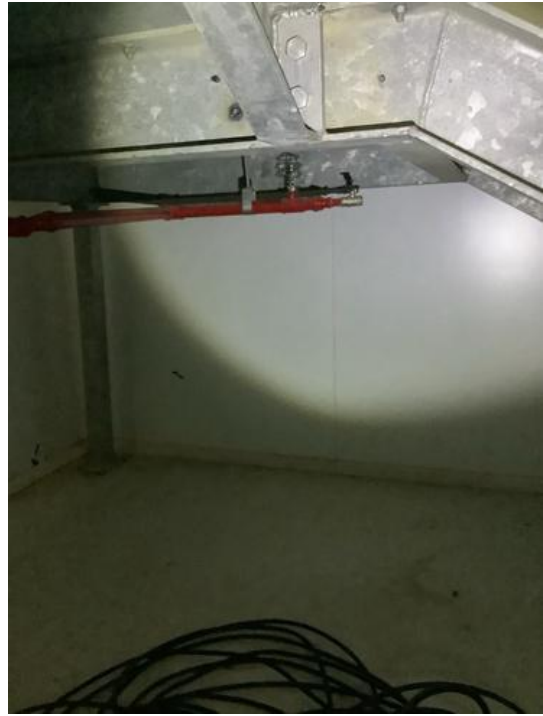
**Pendent spray pattern sprinklers installed in the upright position.**

Enter stairs to ceilings

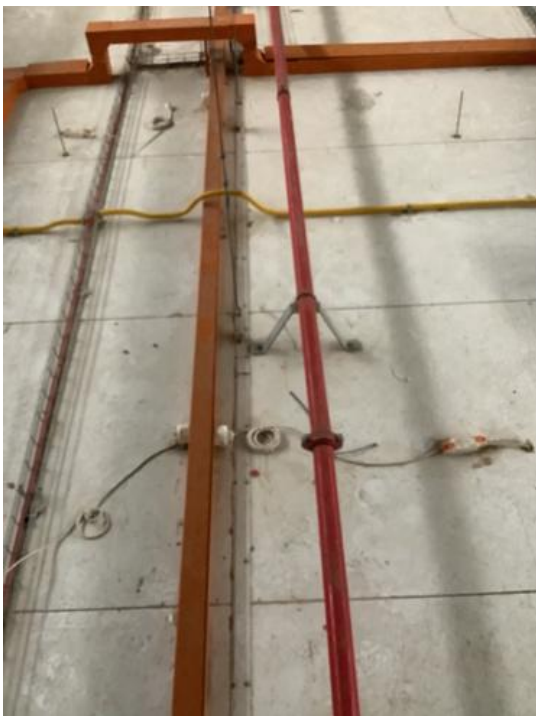
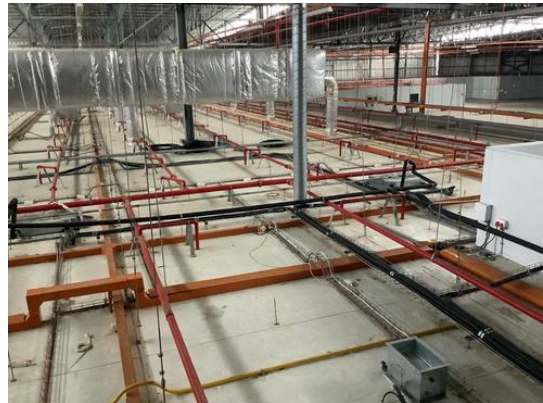
**The sprinkler pipe work must be correctly supported.**

Composite panel ceiling protection

Pipe work must be supported independently from the composite panel, and the dry dropper must not be attached to the fabric of the cold room with mastic or insulating material that permanently bonds the dropper to the refrigerated structure.  
In the event of collapse of the cold room, the cold room material must drop away from the sprinkler system.

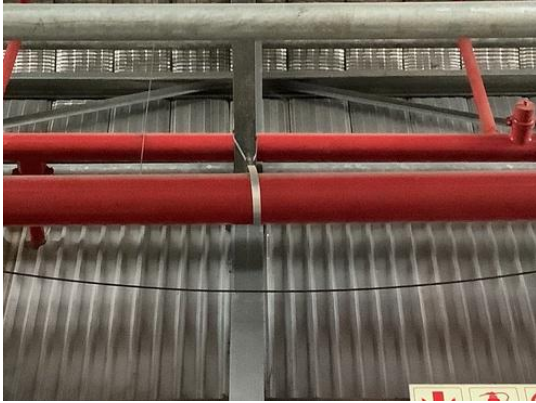
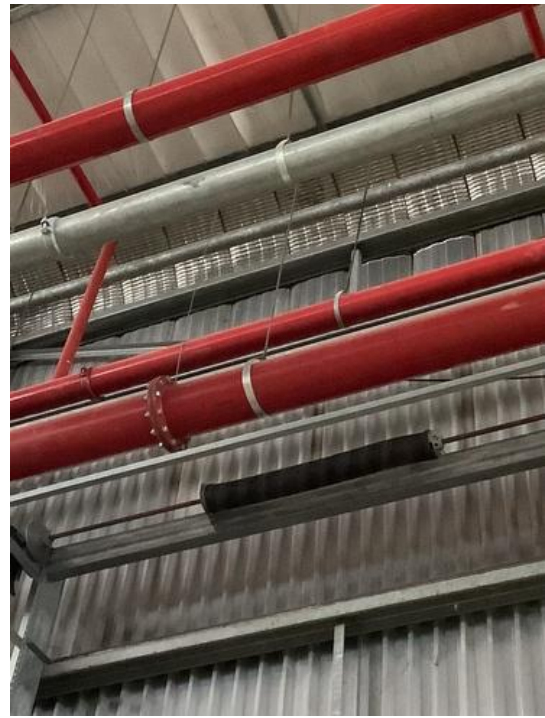
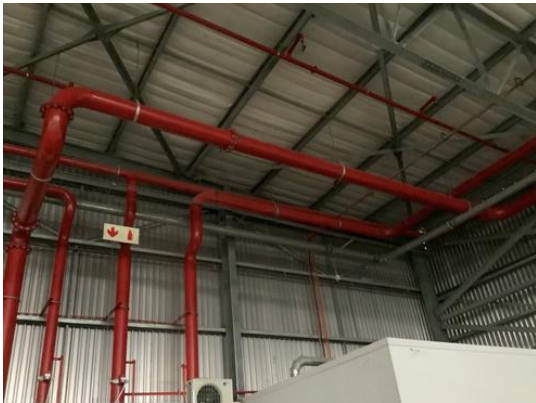
Belt-to-belt hangers utilized.

Main feed to second valve  
It must be verified that the correct threaded rod has been used.

Belt-to-belt hangers must be removed and the pipe work correctly supported.
