Inspection of Automatic Sprinkler System

East London Industrial Development
Zone - Estate Pump House

UNC.9004

08.05.2024 09:22 SAST

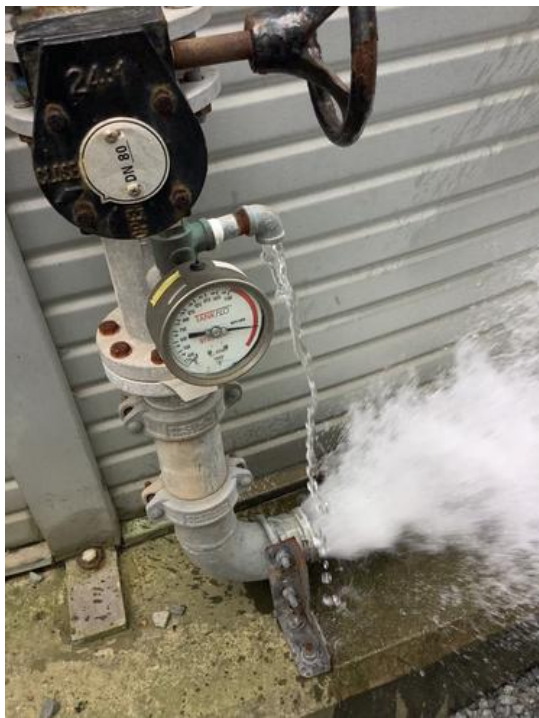
Photo 3

5.2 Tank Infill

Recorded

Infill Rate (l/min)

In excess of 1100 l/min

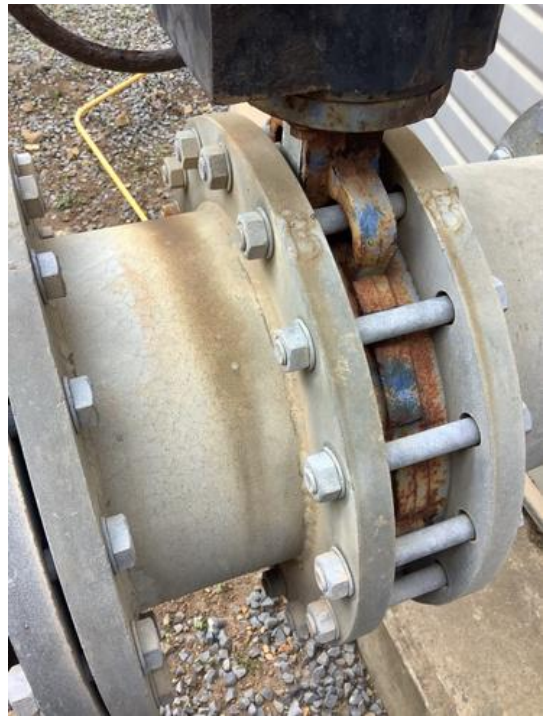
Photo 6

5.10 Flanges / Equipment Short Bolted

Yes

We recommend that the bolts for these flanges be removed and replaced with the correctly sized bolts so as to ensure that at least two full thread pitches past the chamfer protrude beyond the nut.

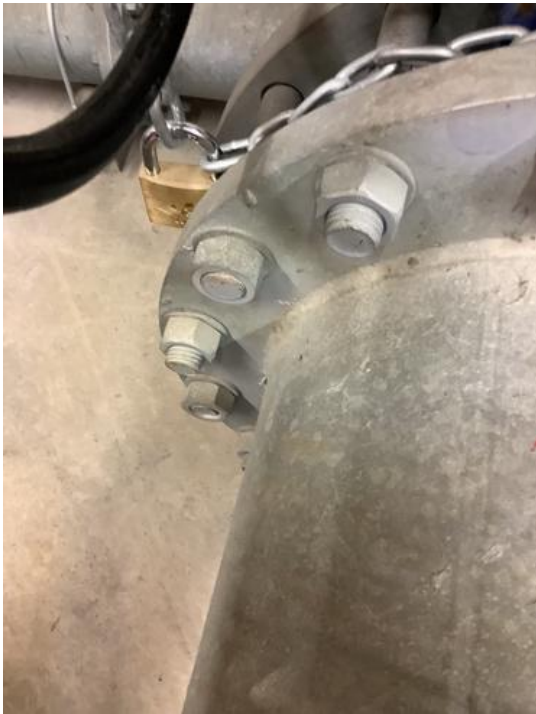
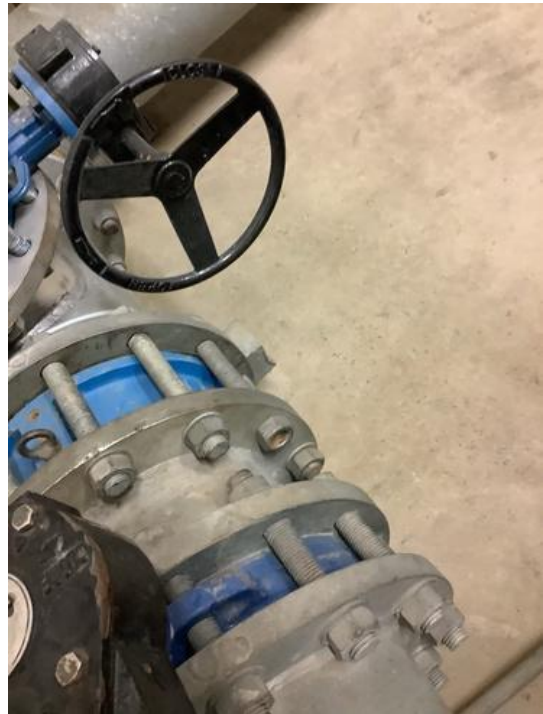
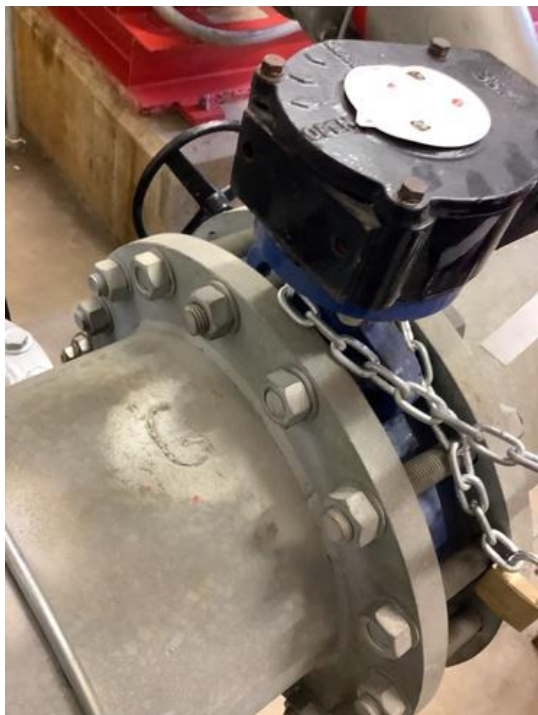
6.2.3 Mechanical Ventilation Installed	Yes
6.2.4 Hour Meters Installed	Yes
6.2.5 Correct Pressure Gauges Installed	Yes
6.2.6 Correct Suction Pressure Gauge Installed.	Yes
6.2.7 Correct Gauge Cocks Installed	Yes
6.2.8 Specify Flow Measuring Device.	Direct Reading Flow Meter
6.2.9 Flanges / Equipment Short Bolted	Yes

Various

We recommend that the bolts for these flanges be removed and replaced with the correctly sized bolts so as to ensure that at least two full thread pitches past the chamfer protrude beyond the nut.

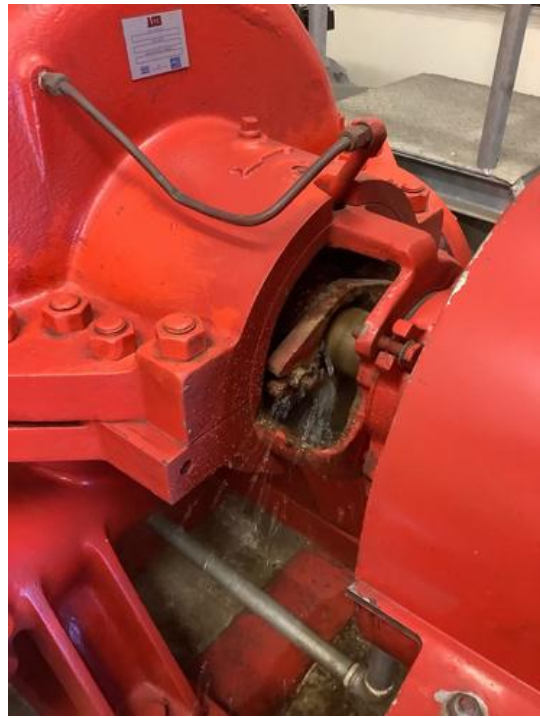
Photo 18

6.5.28 Sight Glass Clean	Yes
6.5.29 Flexible Coupling Correctly Installed	Yes
6.5.30 Glands Condition	Requires Attention
Excessive flow
