Inspection of Automatic Sprinkler System

Yekani - East London Industrial
Development Zone
Pump house and tanks only

UNC.8029

08.05.2024 11:29 SAST

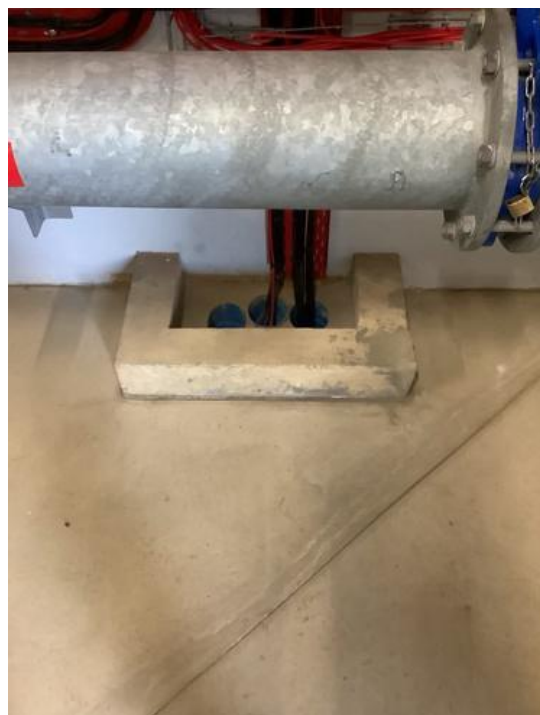
Photo 10

6.2.3 Mechanical Ventilation Installed	Yes
6.2.4 Hour Meters Installed	Yes
6.2.5 Correct Pressure Gauges Installed	Yes
6.2.6 Correct Suction Pressure Gauge Installed.	Yes
6.2.7 Correct Gauge Cocks Installed	Yes
6.2.8 Specify Flow Measuring Device.	Direct Reading Flow Meter
6.2.9 Flanges / Equipment Short Bolted	No
6.2.10 Loose / Missing Bolts, Nuts & Washers	No
6.2.11 Electrical cables positioned 300mm above the finished floor level.	No

Current carrying parts, regardless of voltage, shall be at least 300 mm above finished floor level.

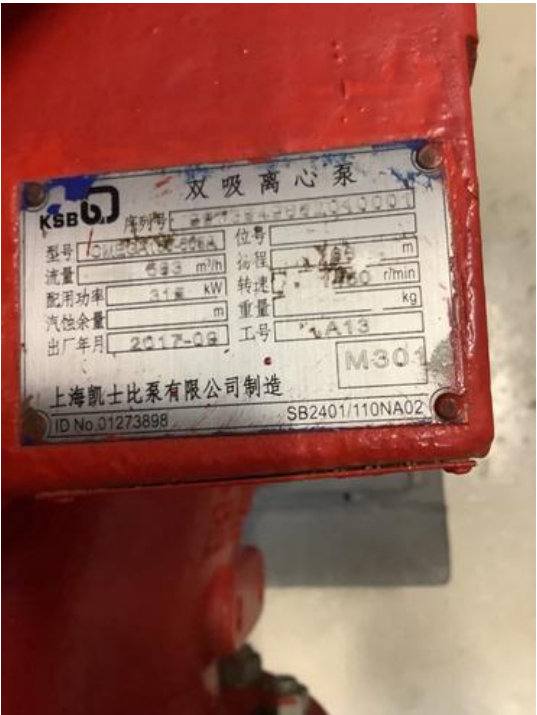
Photo 13

9717 l/min

This differs from the 9000 l/min indicated on the block plan. This must be investigated by your installer

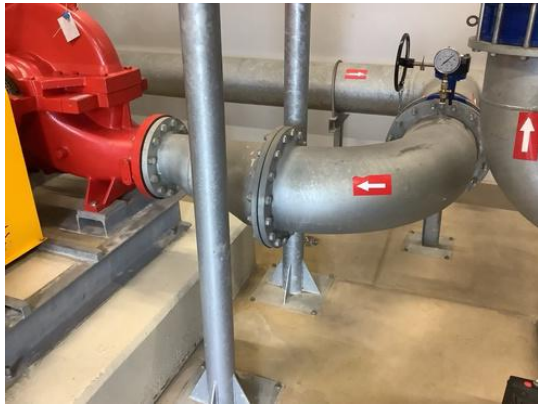
Photo 15

6.8.8 Base Painted	Yes
6.8.9 Delivery Piping Correctly Supported	Yes
6.8.10 Suction Piping Correctly Supported	No
<div data-bbox="183 394 360 568" data-label="Image"> </div> <div data-bbox="177 568 277 595" data-label="Caption"> <p>Photo 15</p> </div> <p>It is recommended that additional support be provided on the pump suction line as close to the pump casing as possible. This is to ensure that there is no strain on the pump casing. If strain is present, it results in axial loading which in turn places excessive wear on the pump resulting in eventual or premature failure. It has been found that some pump and suction alignments have placed excessive strain on the volute of the pump resulting in poor performance.</p> <div data-bbox="1370 759 1404 790" data-label="Image"> </div>

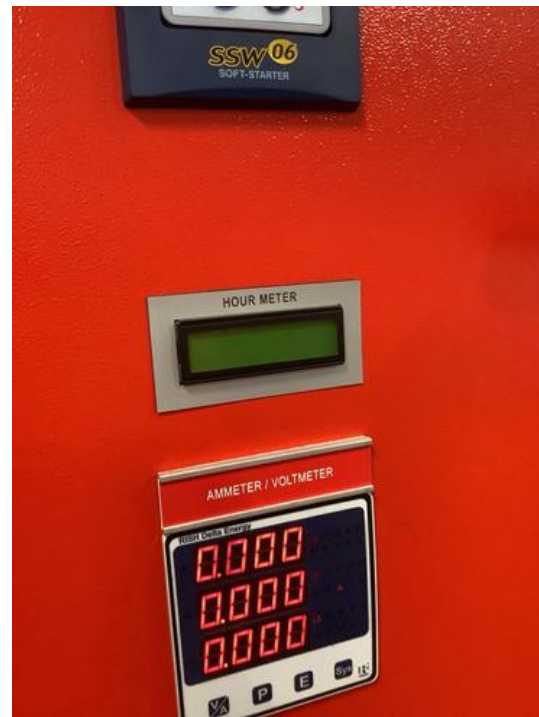
Photo 16

6.8.15 Glands Condition	O.K.
6.9 Electric Motor Driven Pump - Test	
6.9.1 Panel Lamp Test	O.K.
6.9.2 Hour Meter Before Test. Not operational <div data-bbox="183 1628 360 1805" data-label="Image"> </div> <div data-bbox="177 1805 277 1832" data-label="Caption"> <p>Photo 16</p> </div>

Not operational

The Electric motor driven pump must be tested for at least 10 minutes every week in accordance with the minimum requirements.

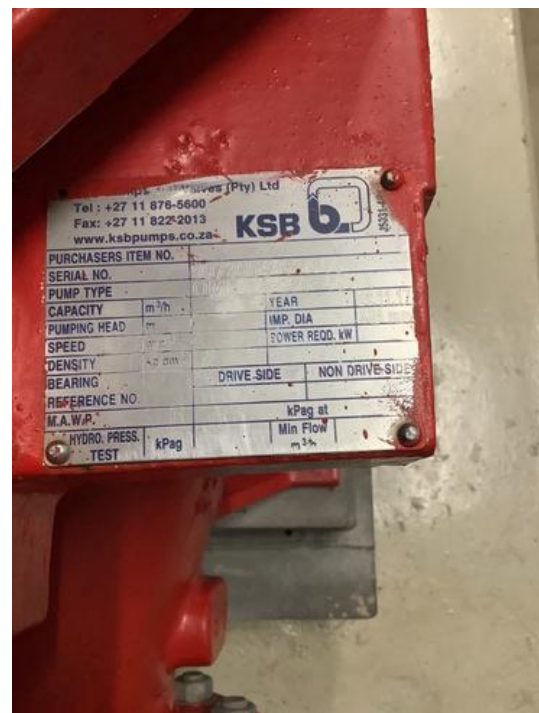
Photo 18

9000 l/min as per block plan

Must be engraved on plate provided

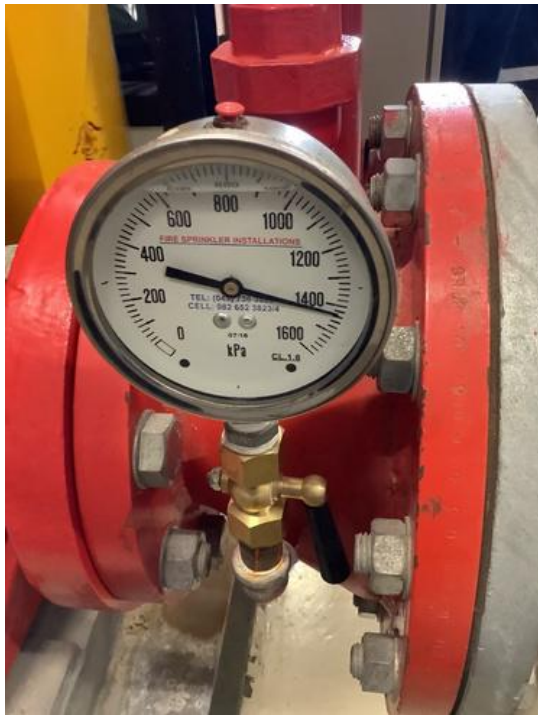
Photo 19	
6.6.9 Flow Test Recorded 9717 l/min @ 1050 - 60 = 990 kPa The correct flow and pressure requirements must be verified and engraved/stamped on the plate provided

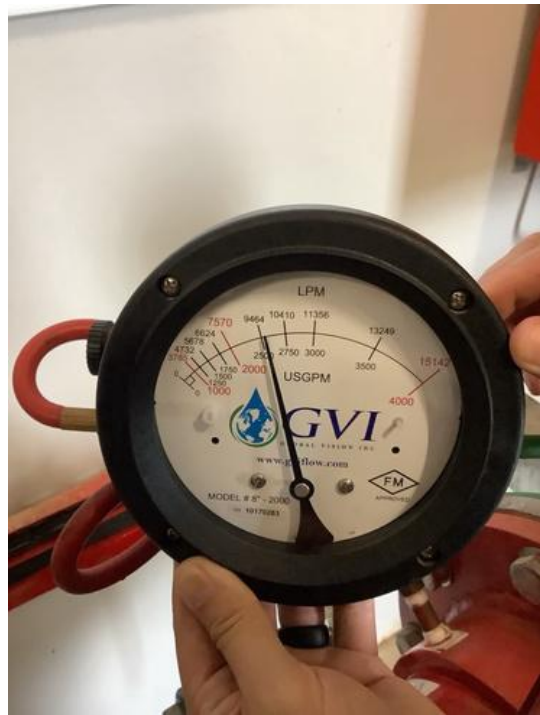
Photo 20

Photo 21	
6.6.10 Pump Flow Test	Passed
6.6.11 Hour Meter After Test 11:40:53	
The diesel engine driven pump must be tested for at least 30 minutes every week in accordance with the minimum requirements.	
6.7 Diesel Engine Driven Pump - Alarms	
6.7.1 Siren Alarm	Sounded
6.7.2 Flashing Light	Operated
6.7.3 Abortive Start Test Successful Would not cycle	Failed

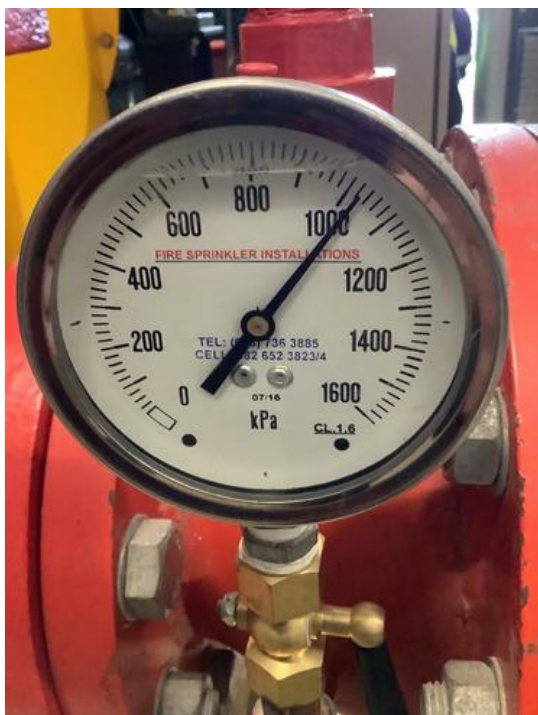
Photo 21

Failed - See Report

This must be investigated by your installer and revised to achieve the correct sequence.

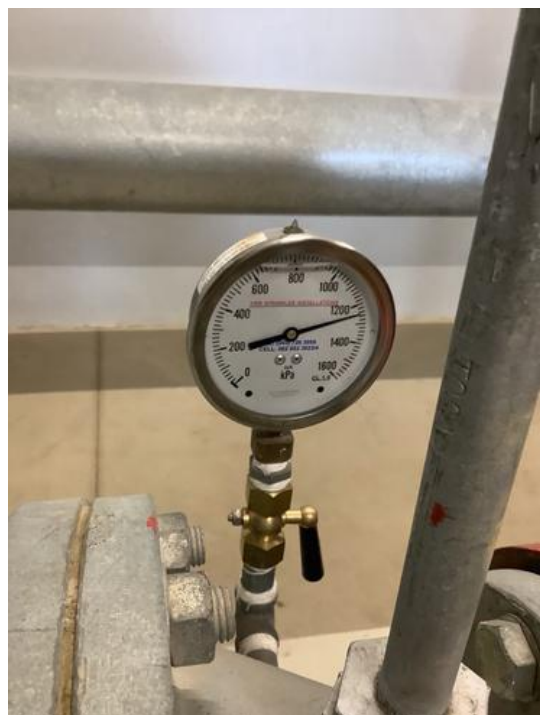
Photo 22

Maximum 1200 kPa

The churn pressure has exceeded the maximum allowable pressure of 1200 kPa, this must be investigated and rectified by your installer. On both pumps.
