Inspection of Automatic Sprinkler System

Sundale Dairy - East London Industrial
Development Zone

UNC.4761

19.06.2024 08:05 SAST

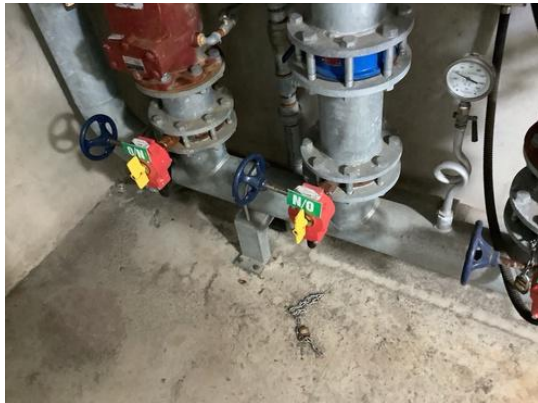
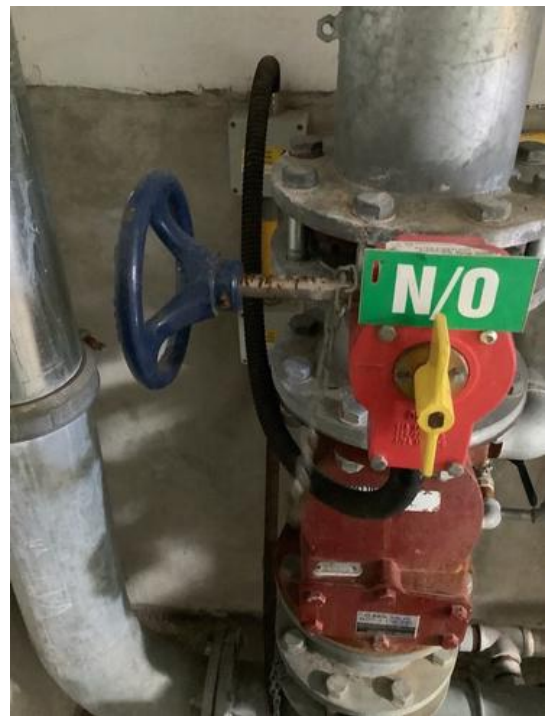
No

All valves must be secured in their correct operative positions with light chains and padlocks that are keyed alike.

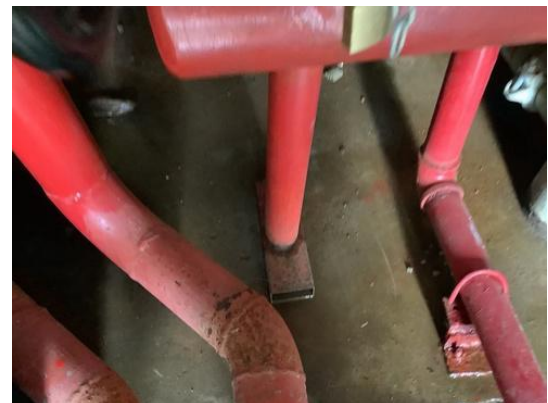
7.11 Manifold Correctly Supported**No**

Not bolted

The valve manifold must be adequately supported.

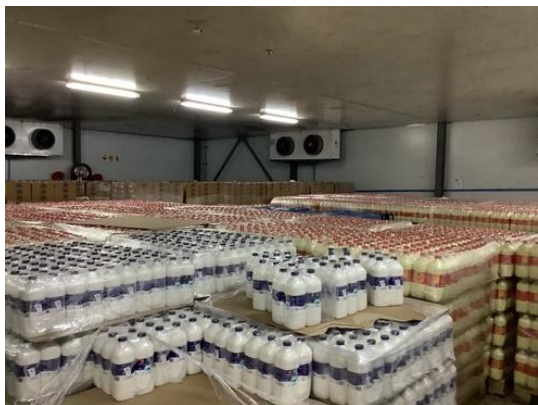
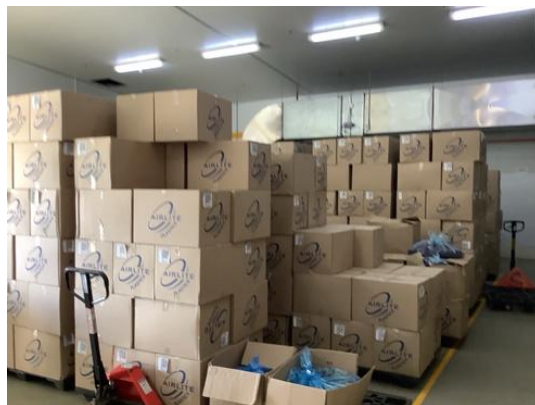
Free Standing Block Storage and aisle widths are not being maintained.

No block of storage shall exceed 150 m² of floor area and shall be surrounded by aisle widths of not less than 2,4 m.

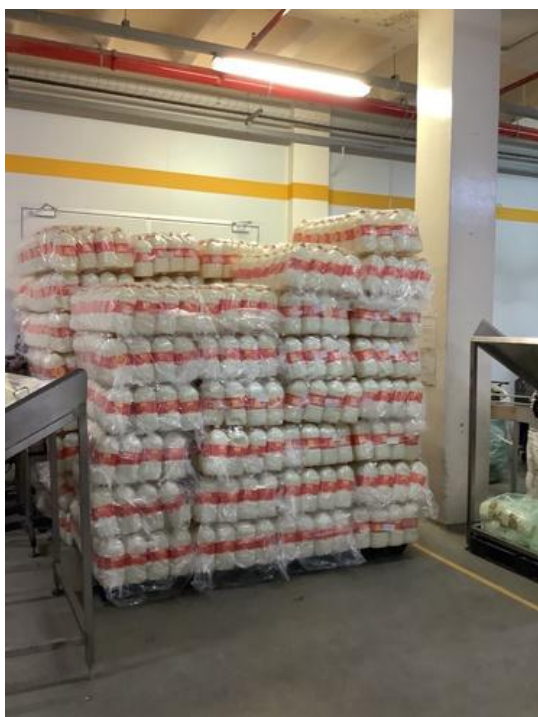
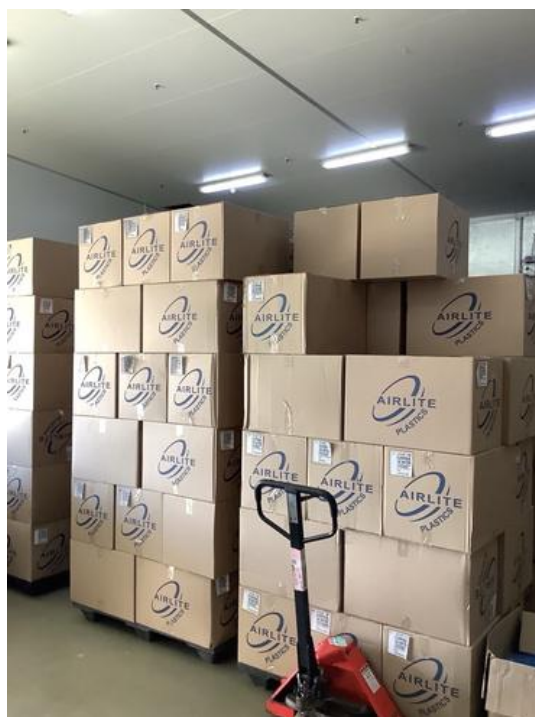
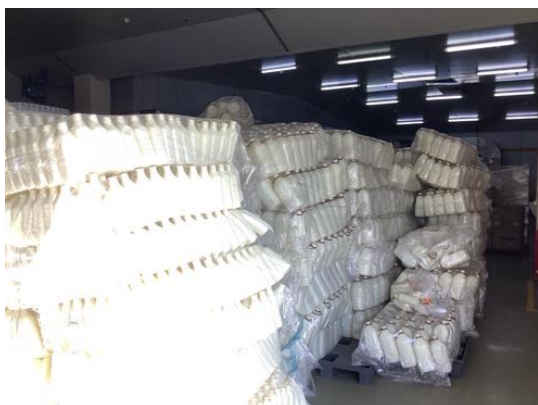
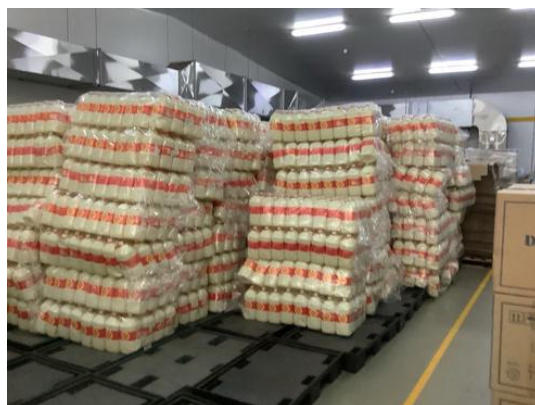
Are the storage heights exceeded.

Yes

The storage heights must be maintained in accordance with the maximum allowable stack heights as detailed in this report. Should this not be possible, intermediate level protection is deemed to be mandatory.

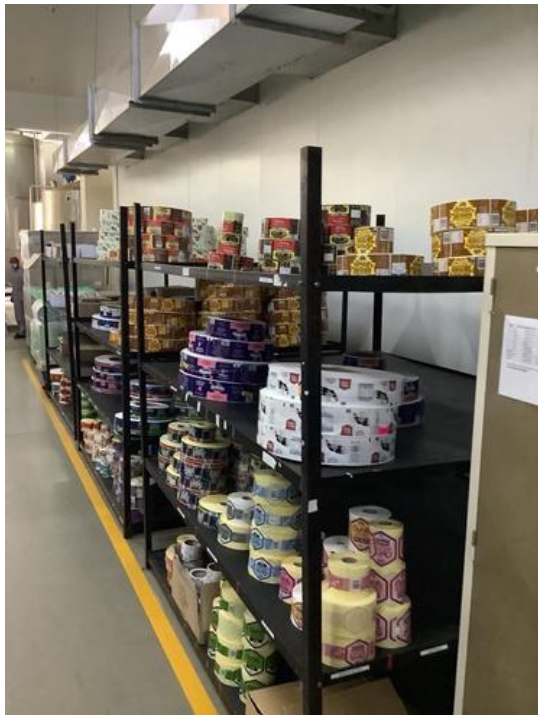
Bottle store label shelves

Shelves exceed 1,0 metre in width.

The shelves must be reduced to a maximum width of 1,0 metre or intermediate sprinkler protection will be mandatory at each shelf tier level.

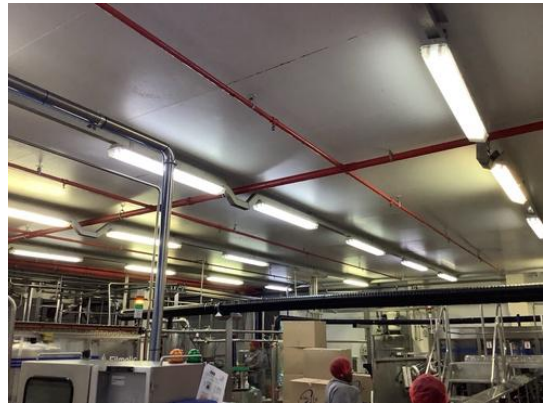
Low level roof packing
Butter room

Corrosion is evident on the sprinkler pipe work and must be addressed by your installer.

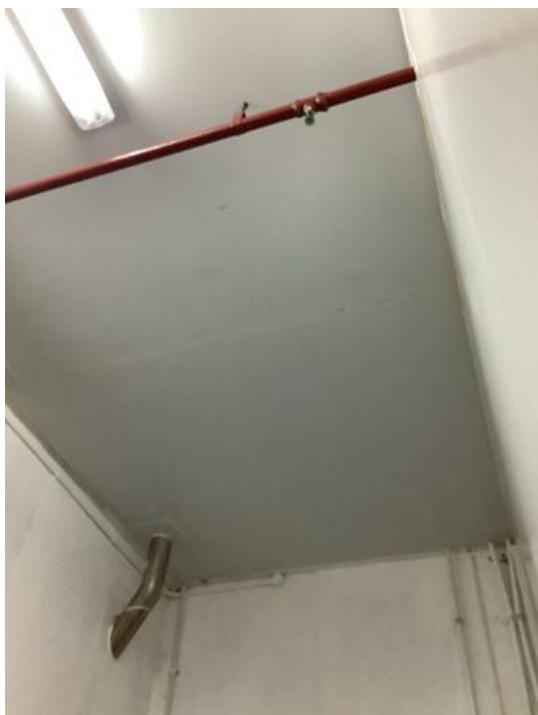
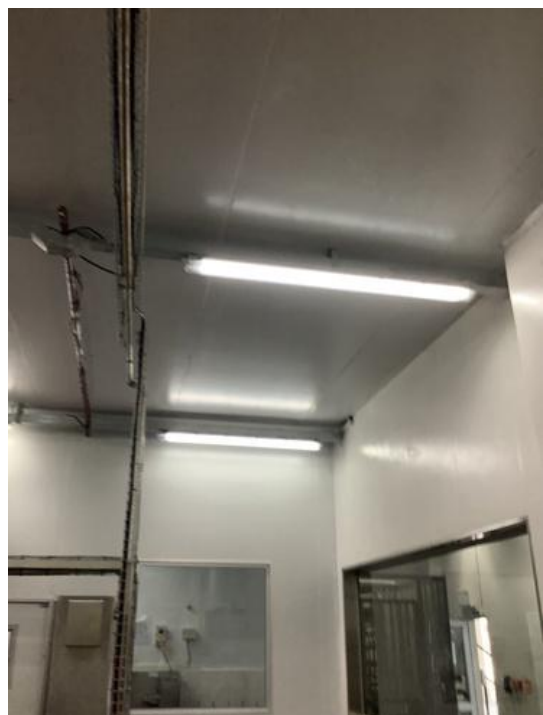
Entrance from reception and butter room

Sprinklers are out of effective working distance.

Sprinkler protection must be extended in order to provide correct coverage.

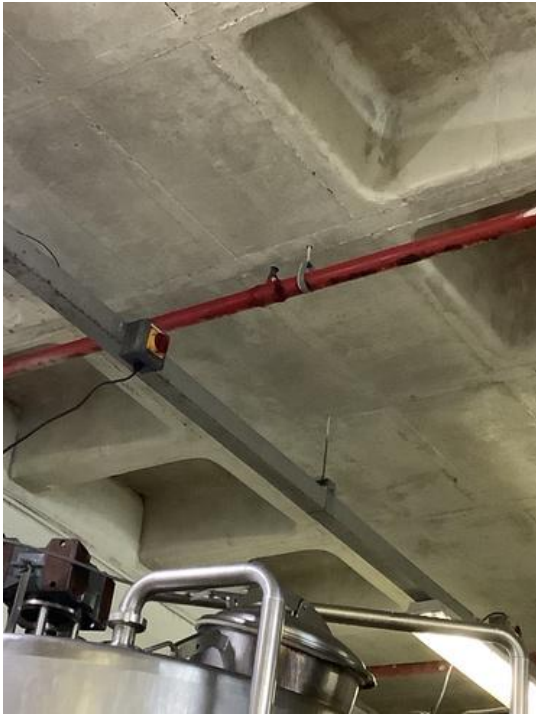
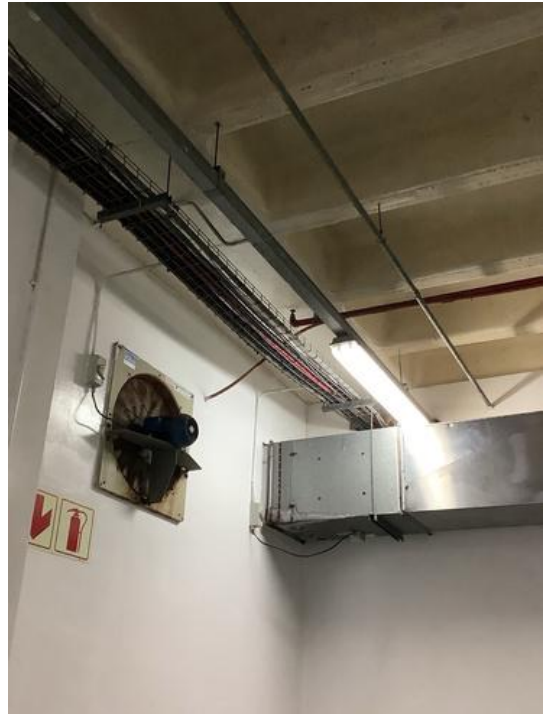
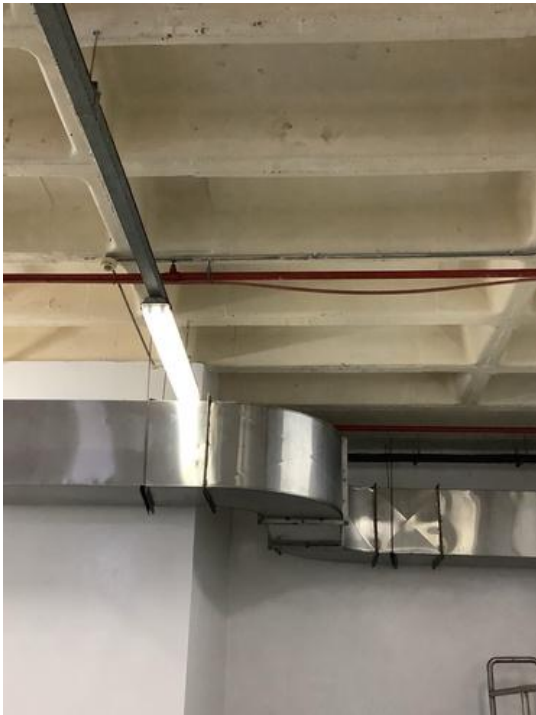
Mixing room
Dry store

Distribution pattern of sprinklers affected.

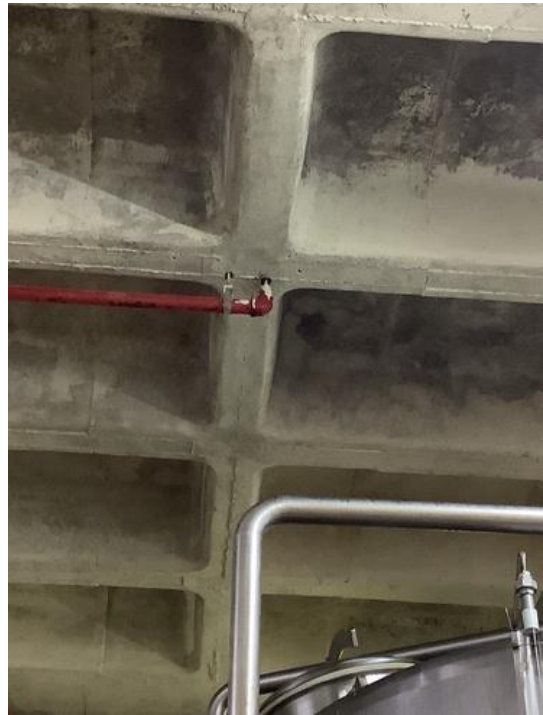
Mixing room
Dry store

Painted sprinklers.

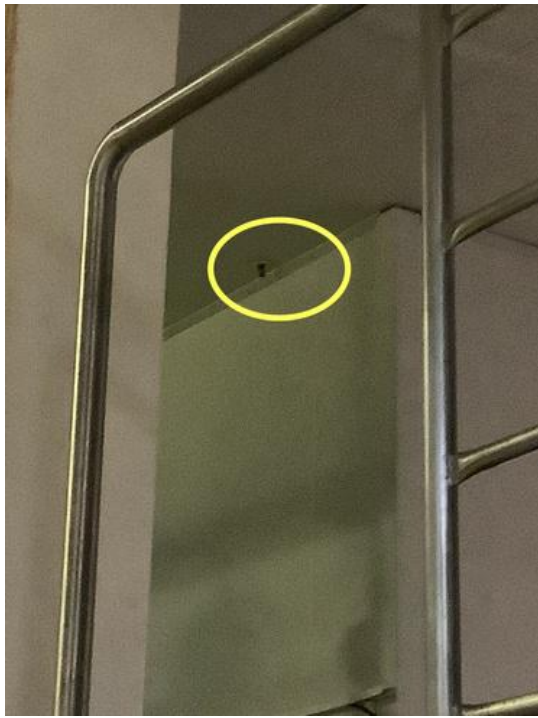
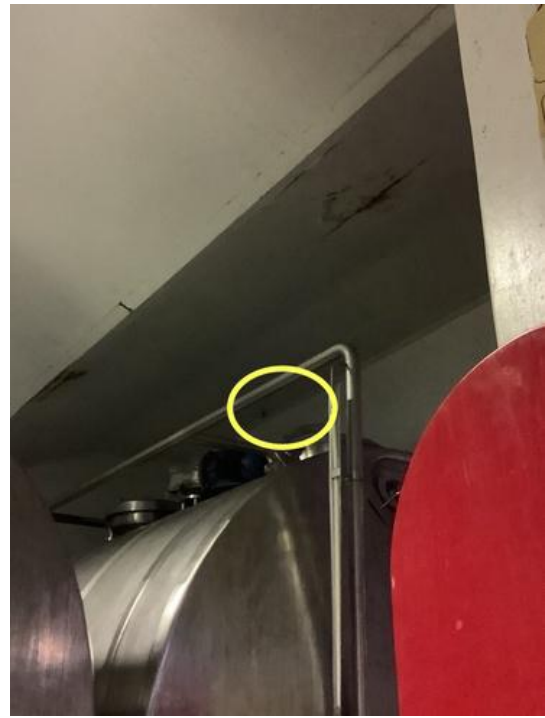
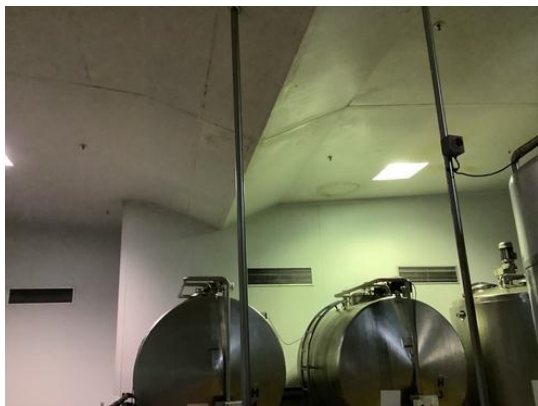
Mezzanine

Sprinklers exceed 1500 mm from walls of a cold room or freezer (10th Edition).

Sprinkler spaced to close to a wall or partitioning - the minimum distance a sprinkler may be from a wall or partition shall not be less than 150 mm. ☒

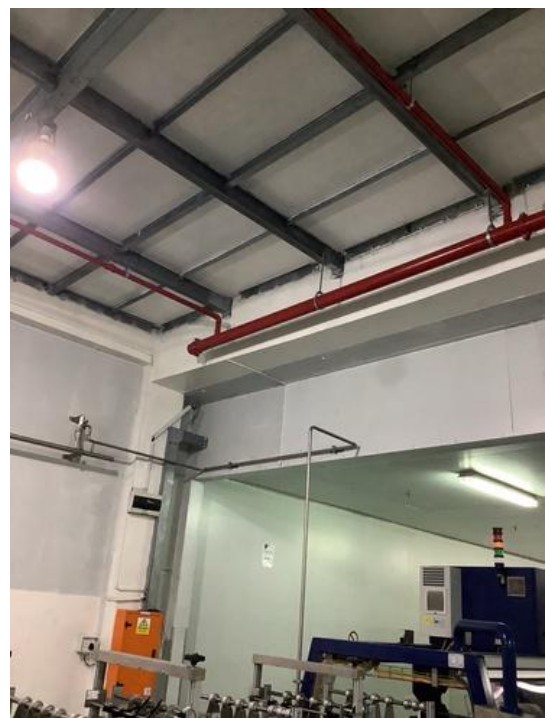
Crating area

Terminal hangers on distribution pipes are exceeding the maximum distance of 450 mm from the end of the distribution pipe. ☒

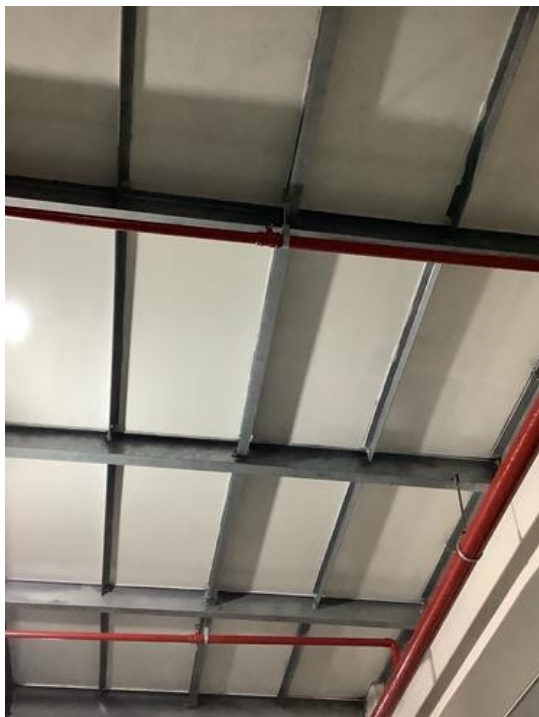
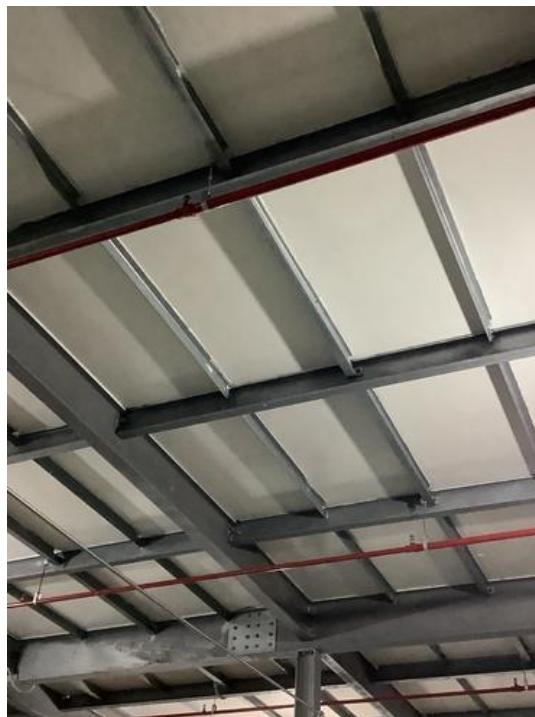
Crating

Distribution pattern of sprinklers affected. ☒

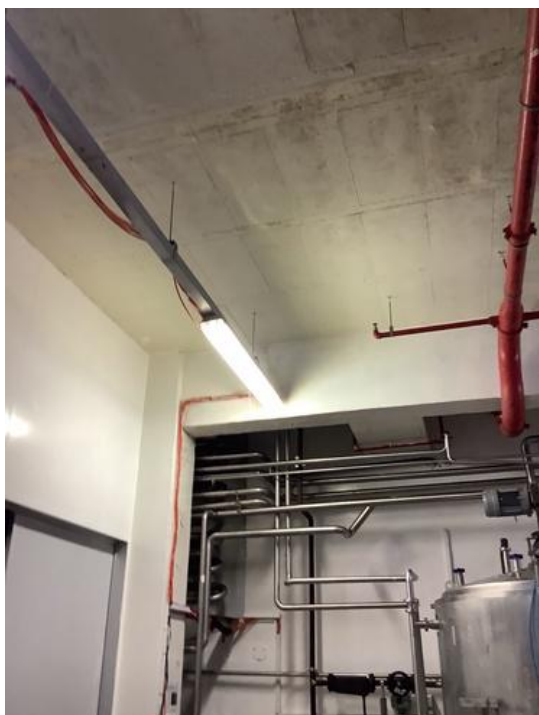
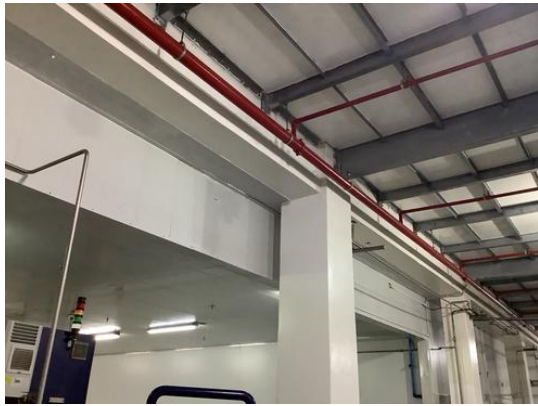
Crating. Low level high level ceiling
Mixing room

Sprinklers are out of effective working distance.

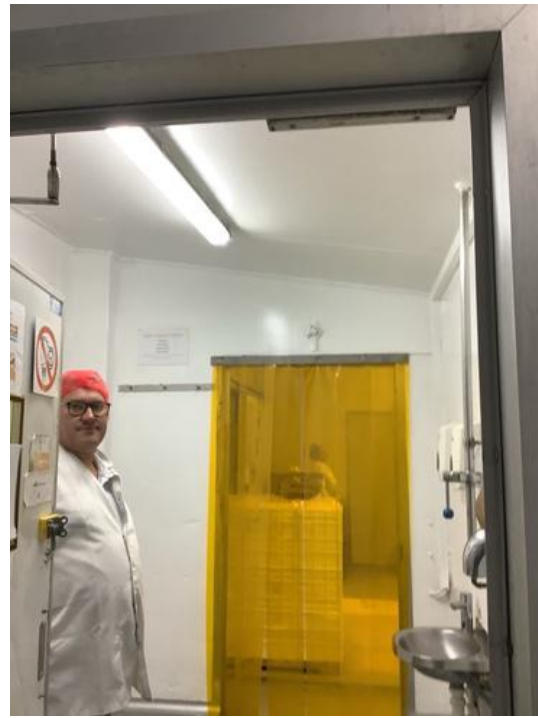
Link tunnel from crating to cut and wrap

Portion of premises sprinkler protected with communicating sections that are not.

Partial protection can lead to a fire originating in the protected area radiating heat into the unprotected portion of the premises and starting secondary fires. The heat from these fires radiates or spreads back into the protected area causing excessive sprinkler operation.

Conversely, a fire originating in the unprotected portion will radiate heat or spread into the protected portion rapidly causing unnecessary sprinkler operation and overwhelming the sprinkler system installed.

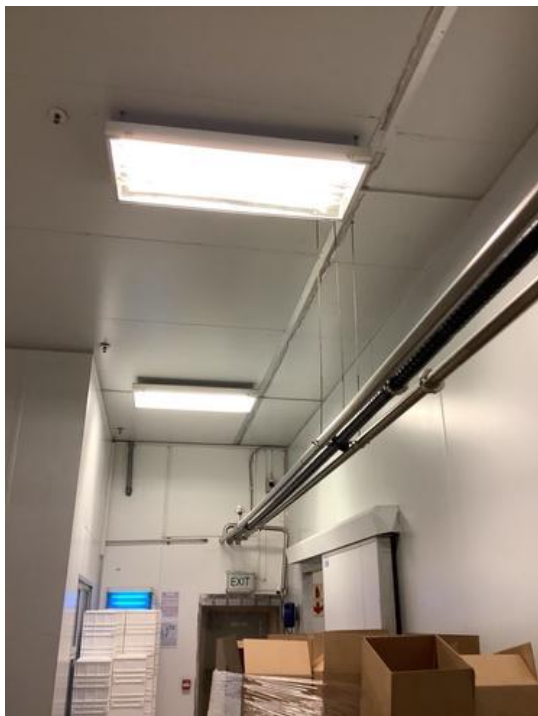
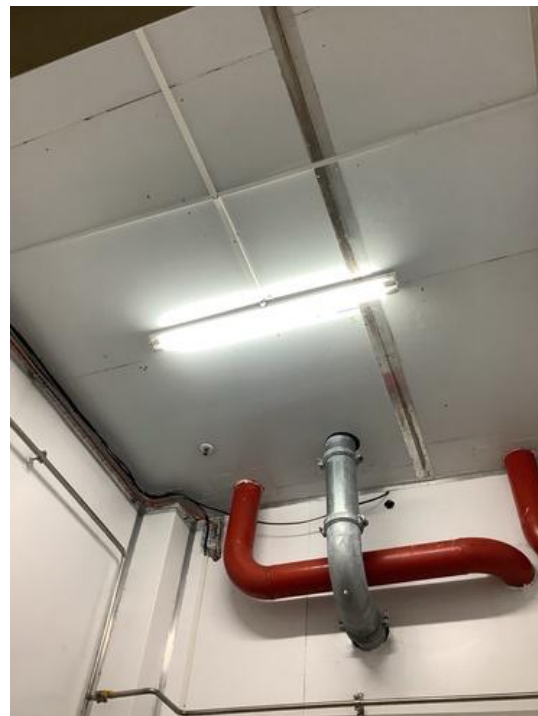
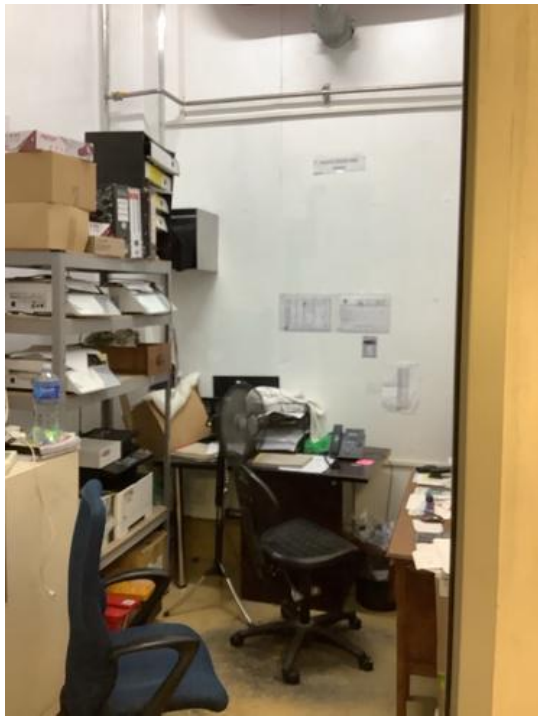
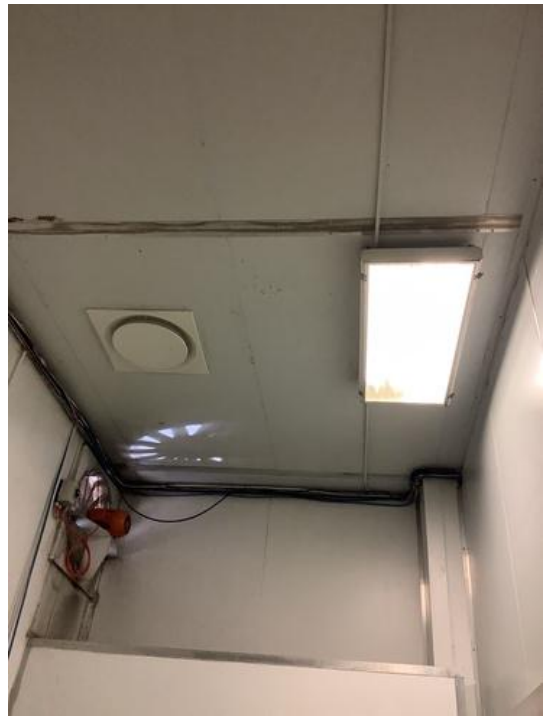
Area at door marked J and office

Sprinklers are out of effective working distance.

Sprinkler protection must be extended in order to provide correct coverage.

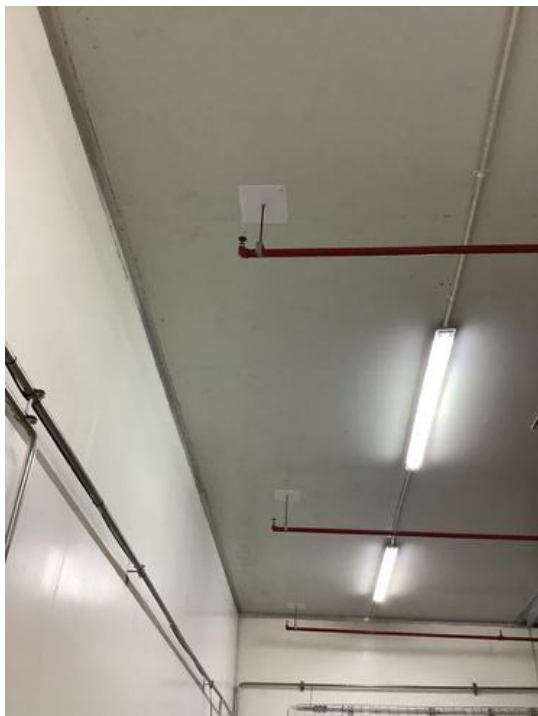
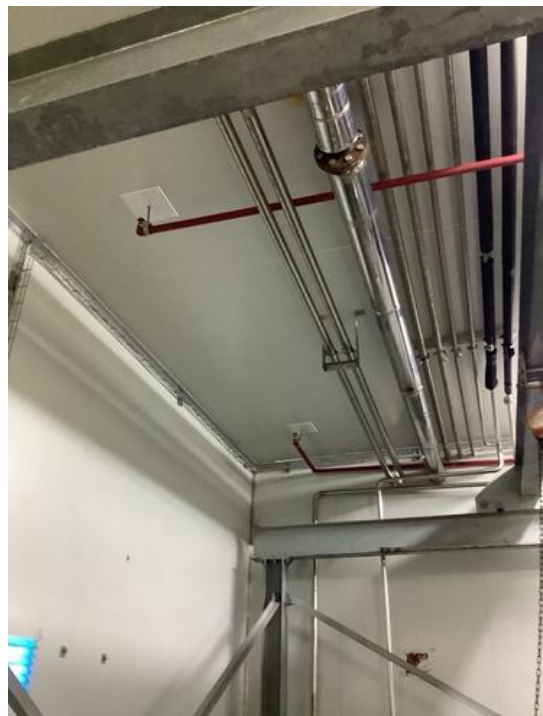
Soft cheese

Distribution pattern of sprinklers affected.

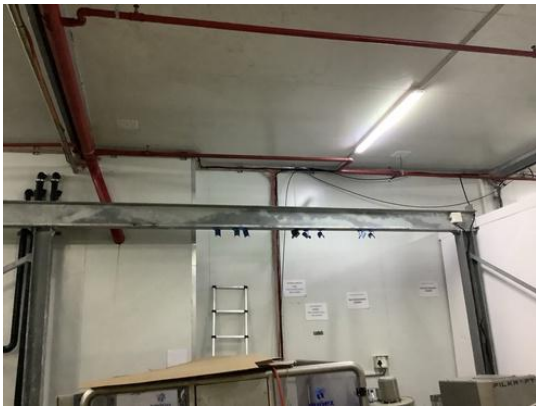
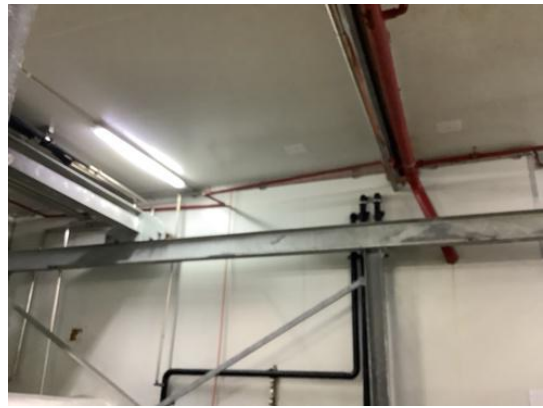
Soft cheese

1st range hangers are exceeding the maximum distance of 2,0 metres from the distribution pipe.

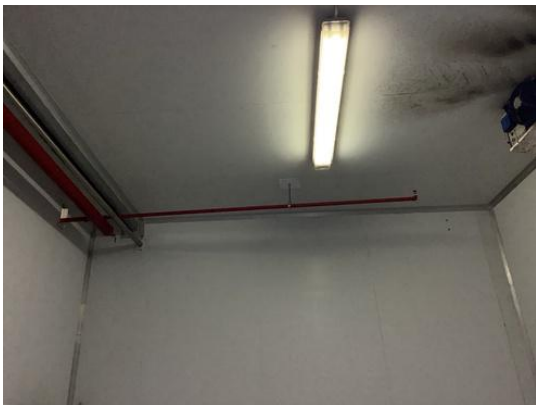
Soft cheese mincing area

Sprinklers are out of effective working distance.

Sprinklers exceed 1500 mm from walls of a cold room or freezer (10th Edition).

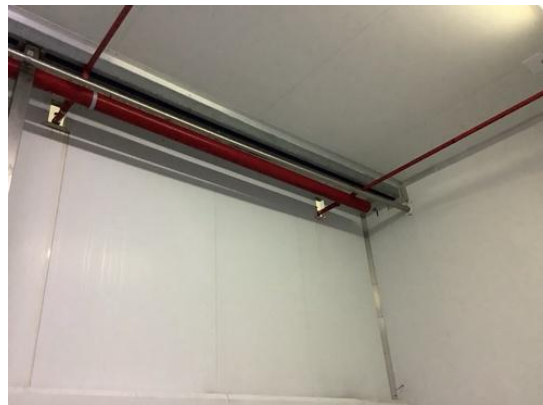
Soft cheese mincing area adjacent store

Terminal hangers on distribution pipes are exceeding the maximum distance of 450 mm from the end of the distribution pipe.

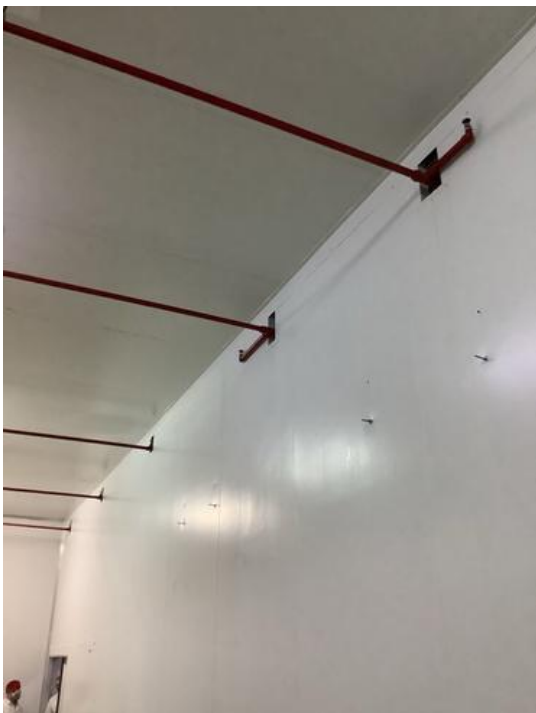
Soft cheese fridge

Sprinkler spaced to close to a wall or partitioning - the minimum distance a sprinkler may be from a wall or partition shall not be less than 150 mm.

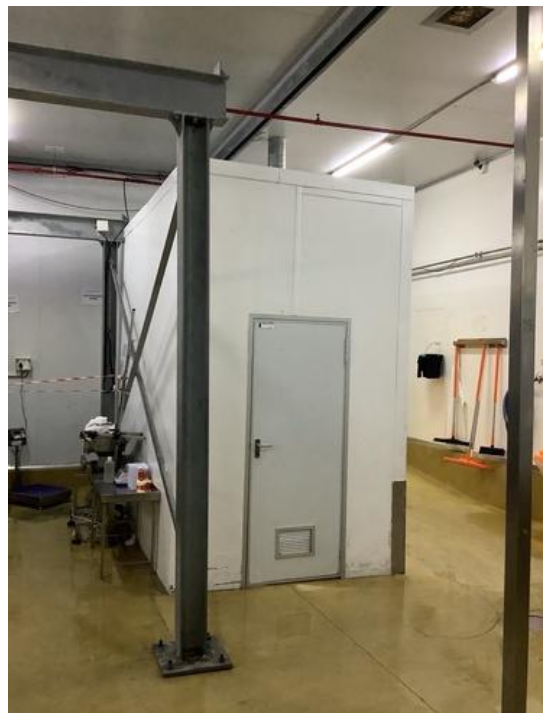
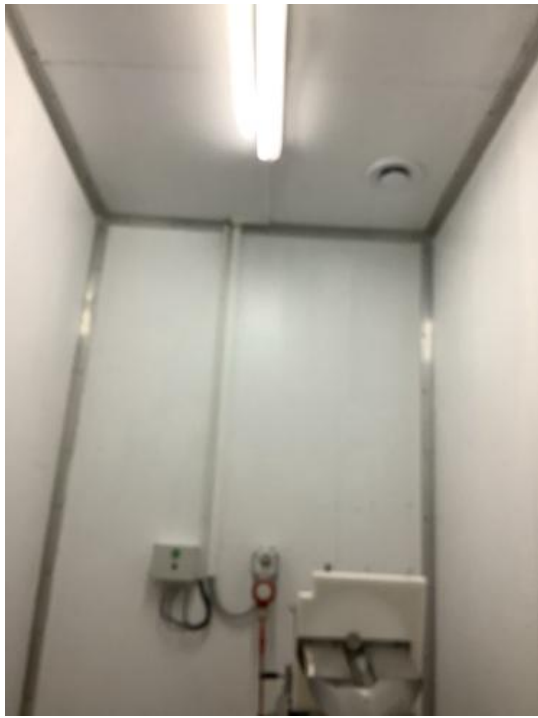
Soft cheese chocolate grinding

Enclosed structures not sprinkler protected.

A fire originating within an unprotected area will burn in an uncontrolled manner without alerting the sprinkler system unit until such time as it breaks out of the structure. The subsequent release of heat will operate multiple sprinklers at roof level above the fire area and remote from it causing massive damage.
