Inspection of Automatic Sprinkler System

East London Industrial Development
Zone Building GW 1 (Valeo)

UNC.9029

18.06.2024 09:50 SAST

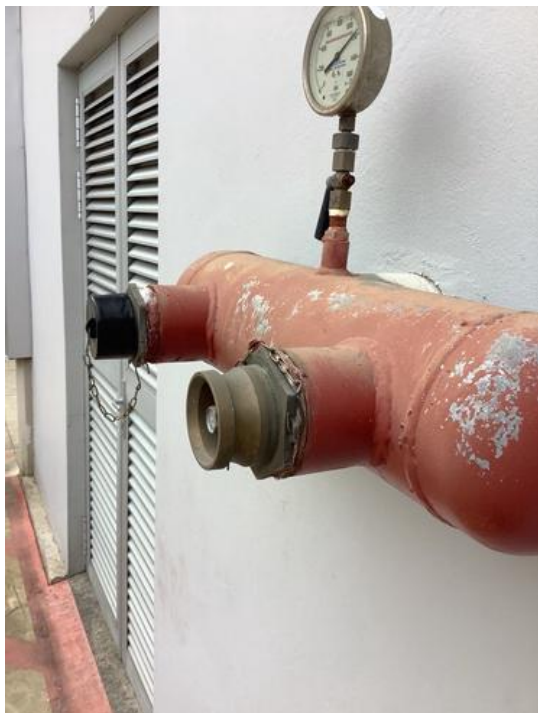
Photo 9

It appears that the booster connection piping to the main distribution riser is too long, which may restrict the opening of the booster plunger into the main distribution riser, this will prevent effective boosting of the sprinkler system and must be revised.

The missing booster connector cover must be replaced.

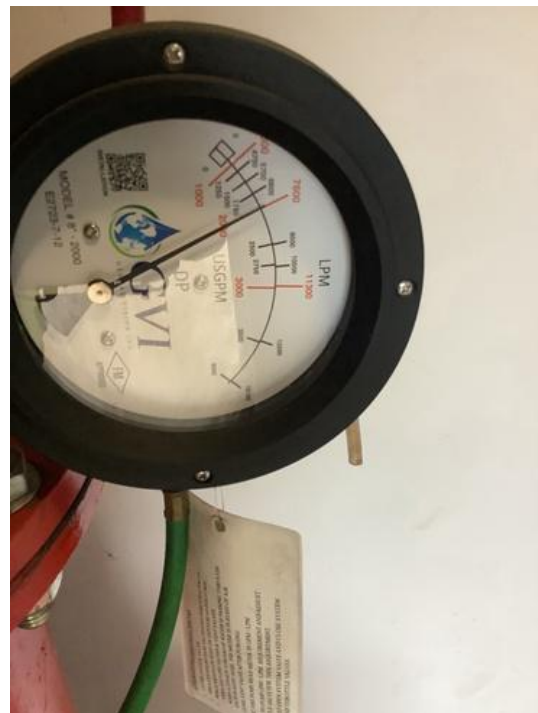
Photo 10

Pass

7600 l/min @ 1040 kPa

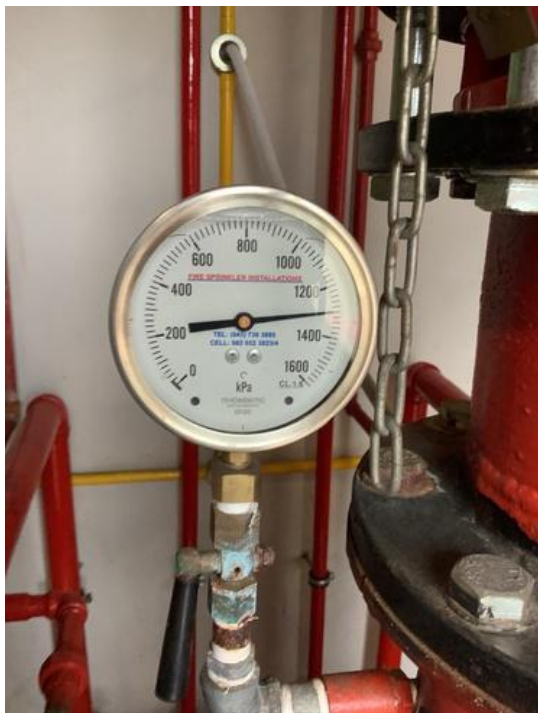
Photo 13

Maximum 1200 kPa

The system pressure has exceeded the maximum allowable pressure of 1200 kPa, this must be investigated and rectified by your installer.

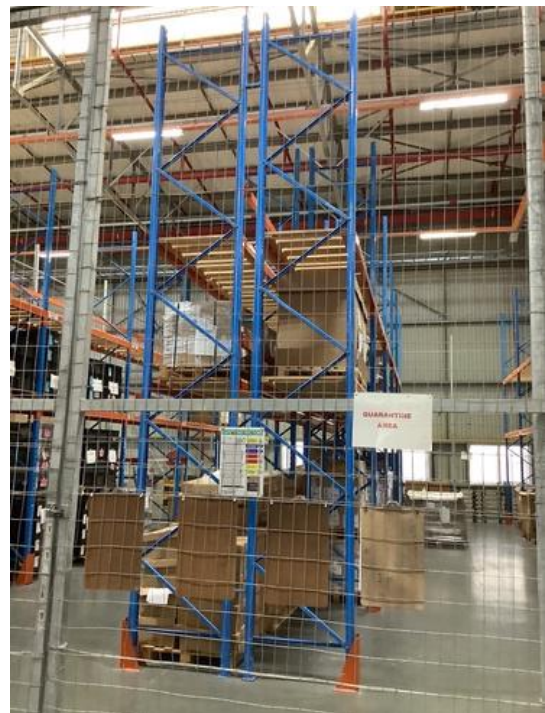
Photo 14

Shelves exceed 1,0 metre in width.

The shelves must be reduced to a maximum width of 1,0 metre or intermediate sprinkler protection will be mandatory at each shelf tier level.

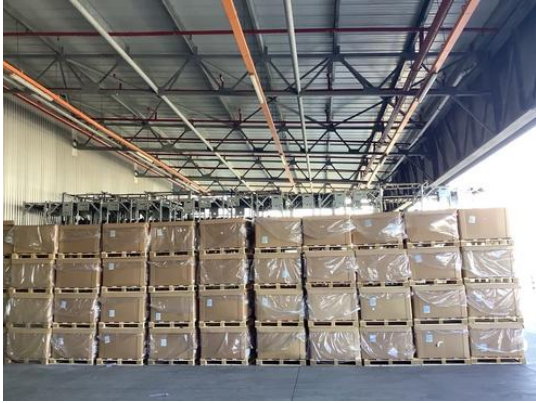
Photo 15

The installation of ESFR sprinklers in the canopies of this building are a non-compliance but will be accepted on this occasion on provision that these canopies are not allocated as storage areas. Only load and offload process to take place under these canopies.

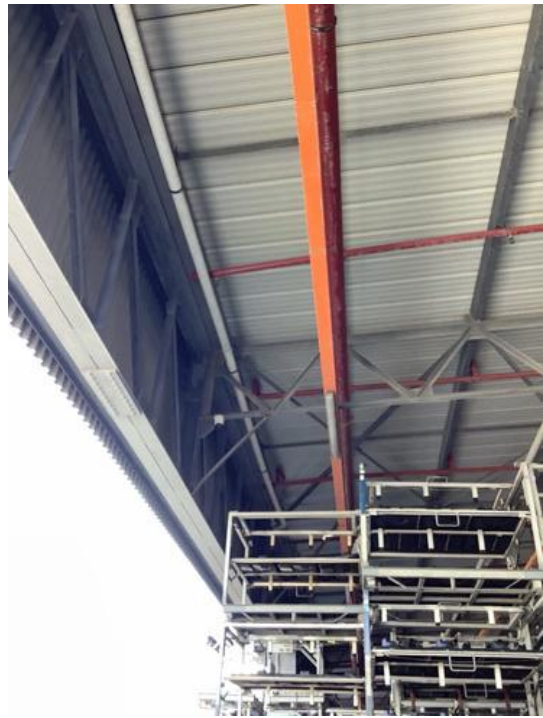
Photo 16

Terminal range pipe hangers are exceeding the maximum distance of 750 mm from the end of the range pipe.

Loading canopy

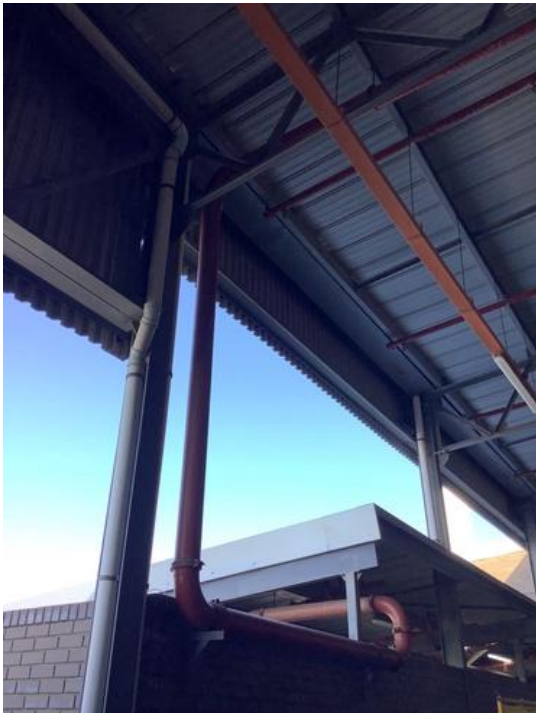
Photo 17

Distribution rise/drop pipes shall be secured directly to the building structure or by hangers securing horizontal distribution pipes within 300 mm of the riser.

Dropper to waste area

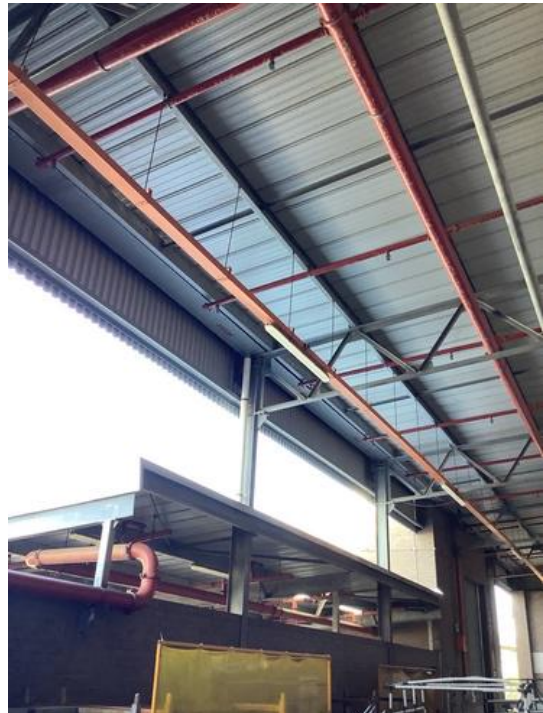
Photo 18

Terminal range pipe hangers are exceeding the maximum distance of 750 mm from the end of the range pipe.

Waste area

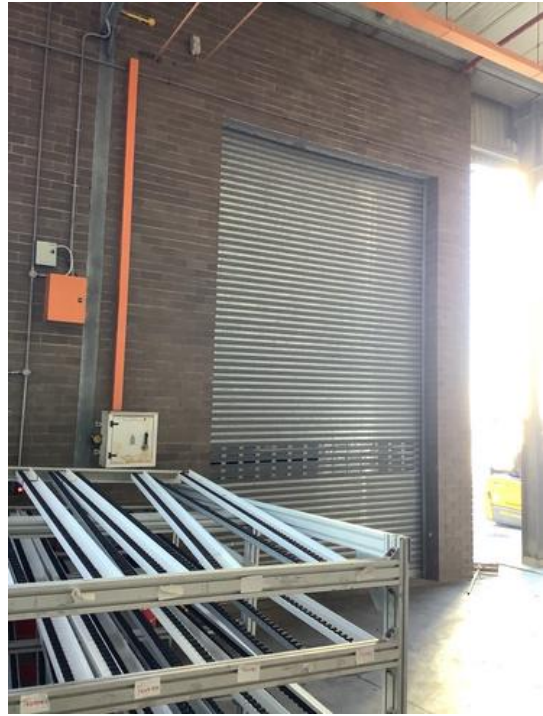
Photo 20

Adjacent building within 10,0 metres / 15,0 of the sprinkler protected building.

Electrical rooms
Generator

Any detached building in the Ordinary Hazard or Extra Light Hazard class, any part of which is within 10,0 m of a protected building, must itself be sprinkler protected.

Any detached building in the Extra High Hazard class, any part of which is within 15,0 m of a protected building, must itself be sprinkler protected.

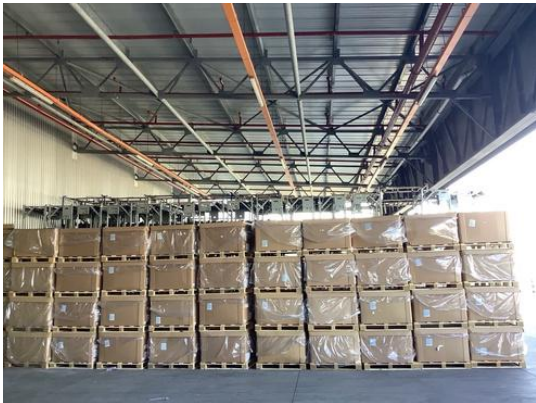
Photo 21

The installation of ESFR sprinklers in the canopies of this building are a non-compliance but will be accepted on this occasion on provision that these canopies are not allocated as storage areas. Only load and offload process to take place under these canopies.

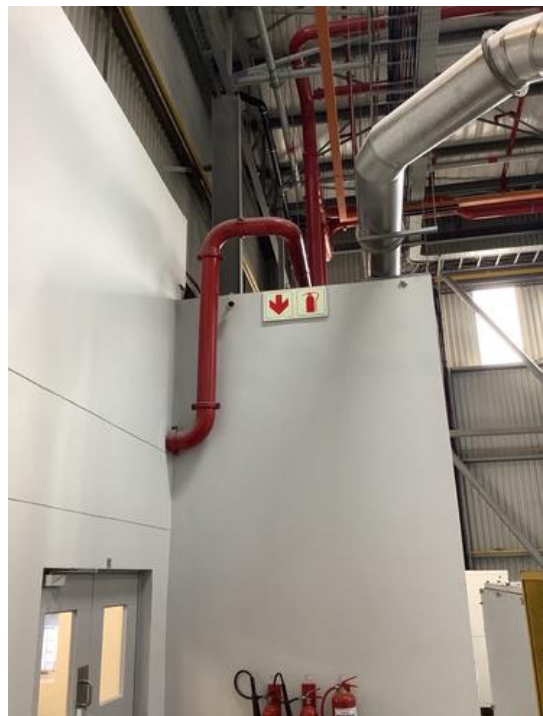
Photo 22

Distribution rise/drop pipes shall be secured directly to the building structure or by hangers securing horizontal distribution pipes within 300 mm of the riser.

To logistics office and boardroom at valve chamber

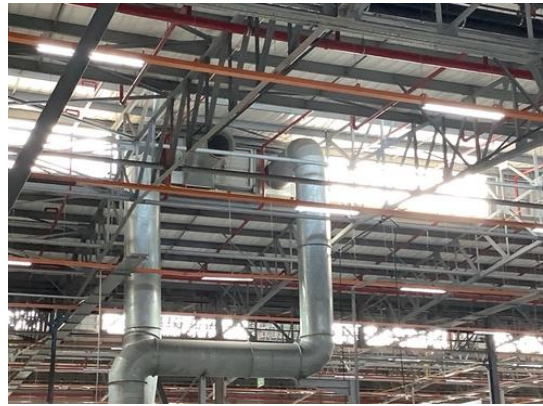
Photo 24

ESFR Mechanical Ventilation
ventilation has been installed in conjunction with ESFR sprinkler protection.

It is imperative that the mechanical vents do not open automatically in a fire situation as the ESFR sprinkler system will be adversely effected which could result in the ESFR system failure.

It is important that the mechanical vents be manually operated and that the Fire Chief in charge of operations during a fire be able to make the decision whether it should be opened or remain closed.

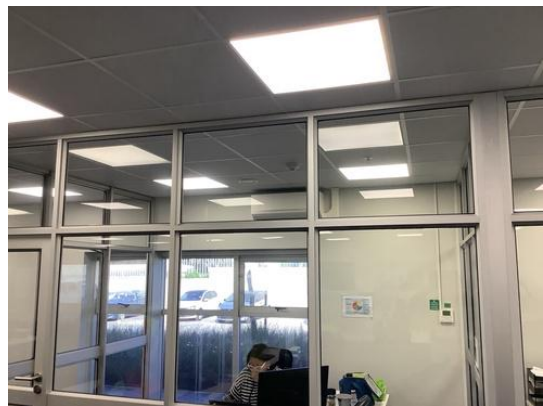
Photo 26

Sprinklers are out of effective working distance.

Offices facing car park
