Inspection of Automatic Sprinkler System

FE1 Hop Refab East London Industrial
Development Zone

UNC.8803

09.05.2024 08:00 SAST

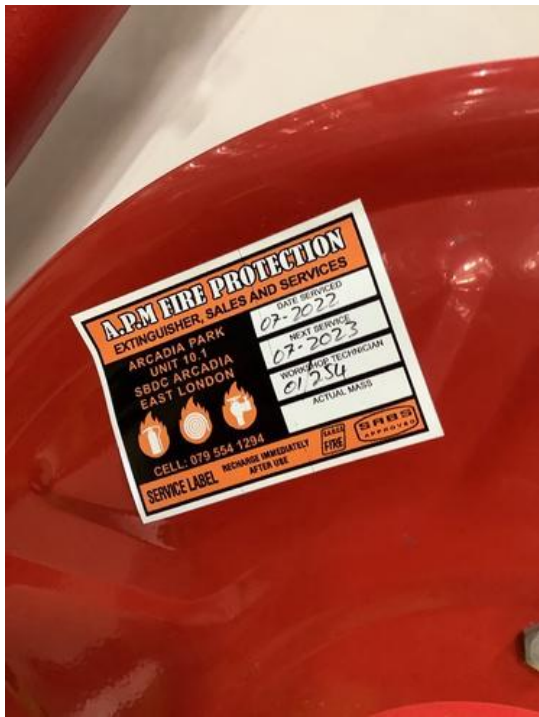
Photo 1

Clear access to the hand fire appliances must be maintained at all times.

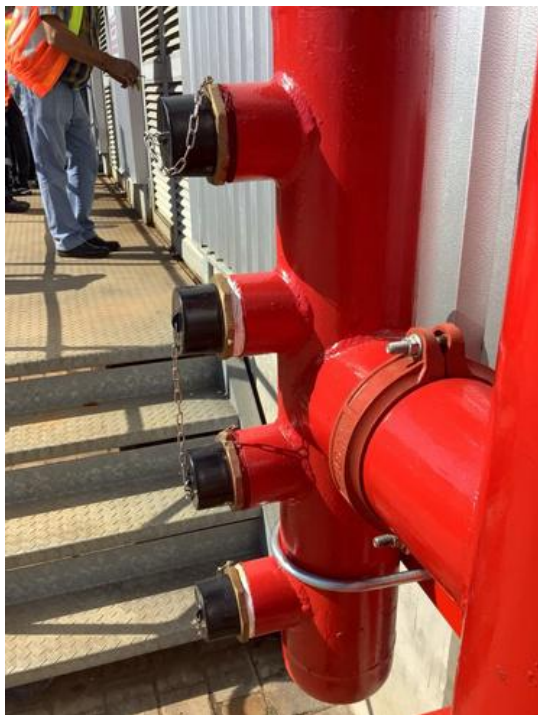
Photo 9

It appears that the booster connection piping to the main distribution riser is too long, which may restrict the opening of the booster plunger into the main distribution riser, this will prevent effective boosting of the sprinkler system and must be revised.

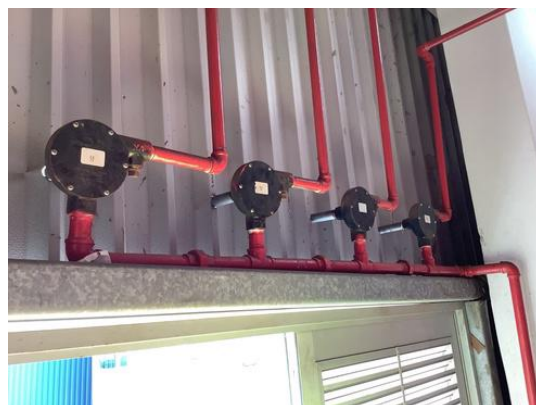
Photo 12

The water motor alarm drain pipes discharge into a common manifold. This must be revised so that the drain pipes are taken separately to waste.

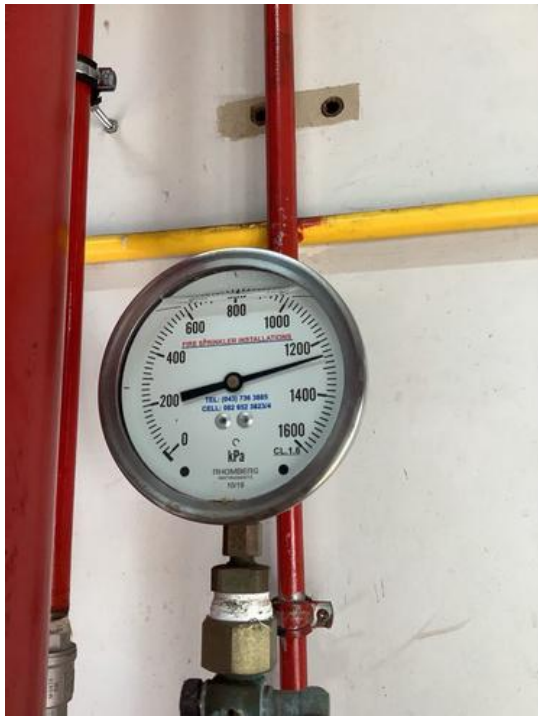
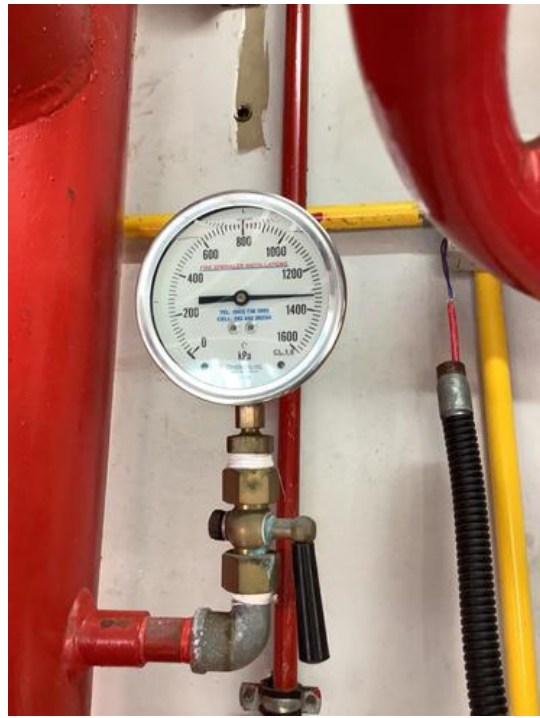
Maximum 1200 kPa

The system pressure has exceeded the maximum allowable pressure of 1200 kPa, this must be investigated and rectified by your installer.

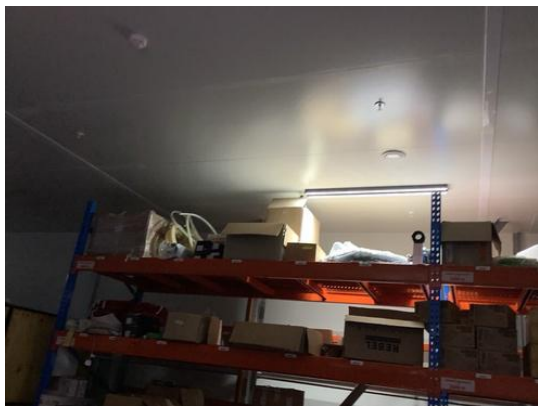
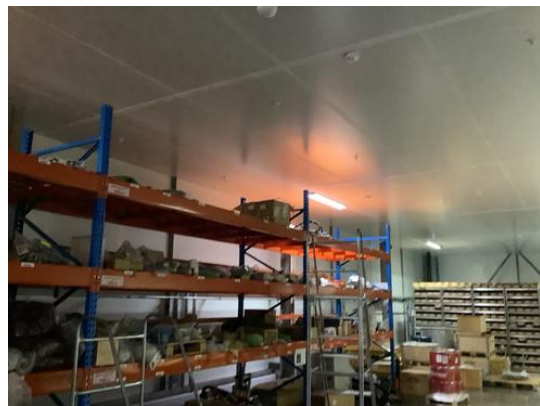
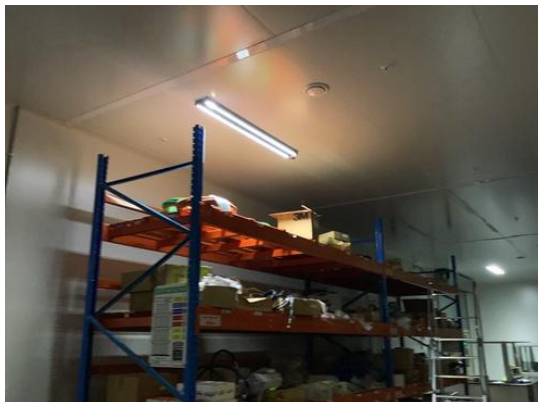
Are the required clearances being maintained.

No

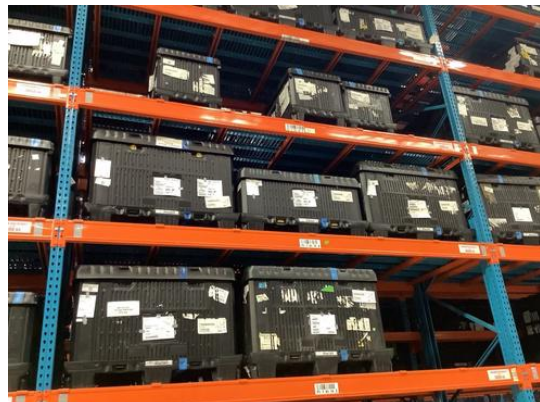
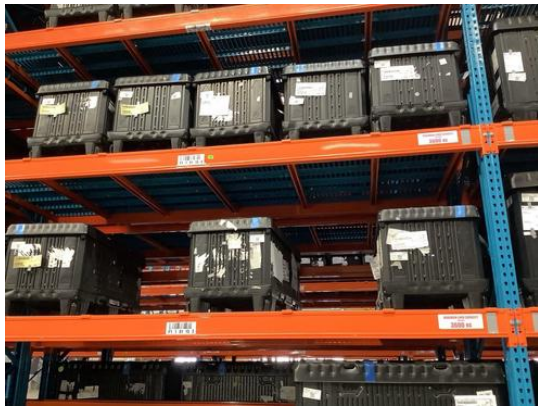
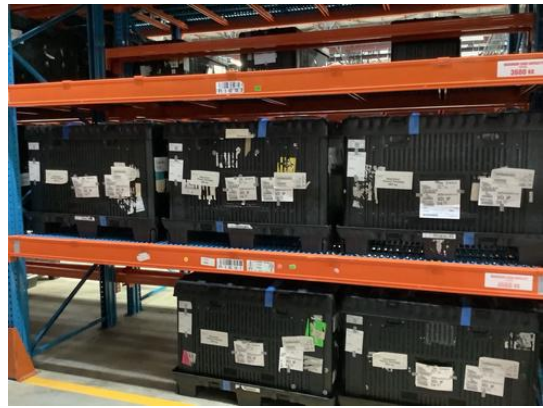
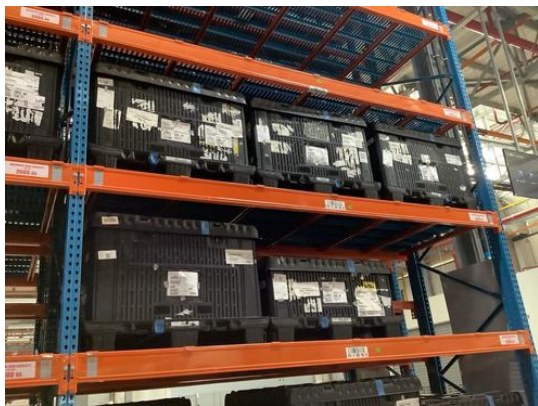
The longitudinal and/or transverse flue spaces are not being maintained

The minimum longitudinal and transverse flue spaces shall not be less than 150 mm.

Transverse only where the black plastic crates are stored

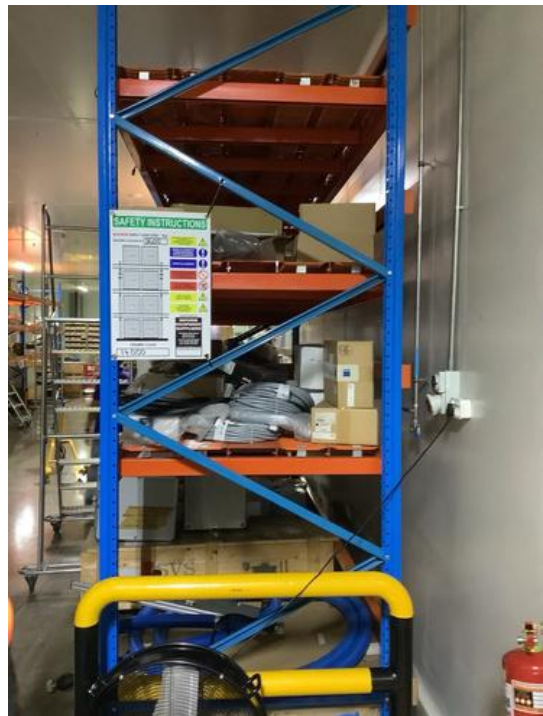
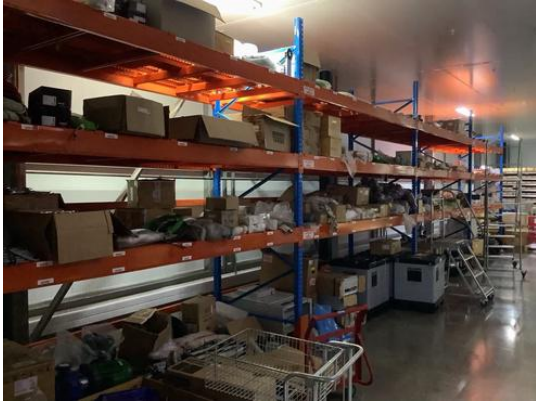
Shelves exceed 1,0 metre in width.

TSSstores
Paint store

The shelves must be reduced to a maximum width of 1,0 metre or intermediate sprinkler protection will be mandatory at each shelf tier level.

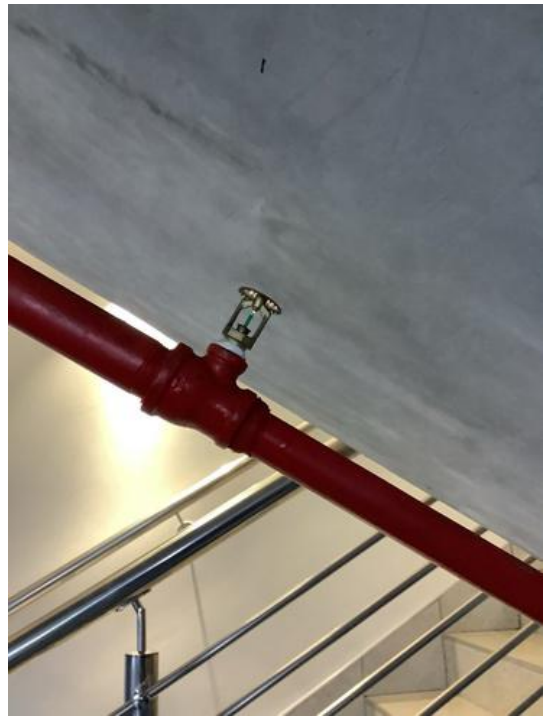
Photo 24

Mix operating temperature sprinklers.

The 93 degree Celsius sprinklers under the stairs must be replaced with 68;degree

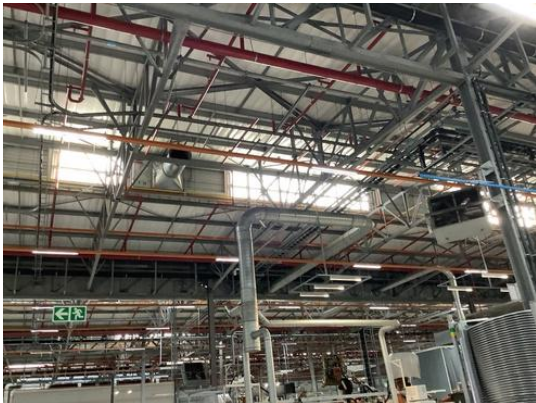
Photo 25

ESFR Mechanical Ventilation

ventilation has been installed in conjunction with ESFR sprinkler protection.

It is imperative that the mechanical vents do not open automatically in a fire situation as the ESFR sprinkler system will be adversely effected which could result in the ESFR system failure.

It is important that the mechanical vents be manually operated and that the Fire Chief in charge of operations during a fire be able to make the decision whether it should be opened or remain closed.

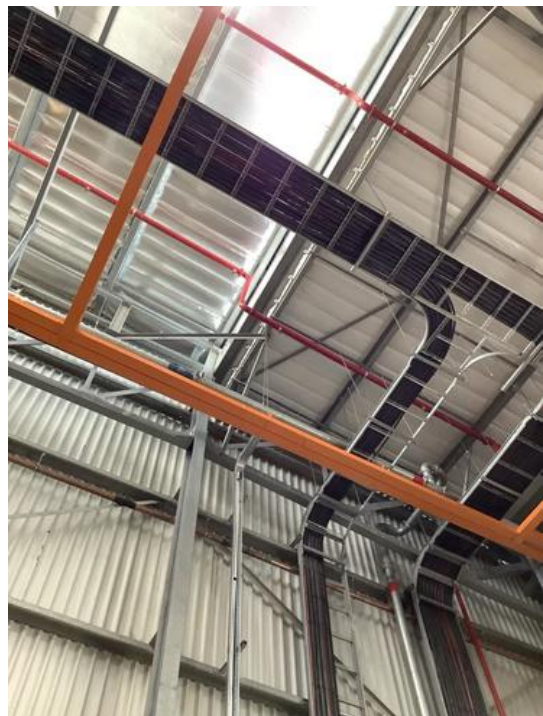
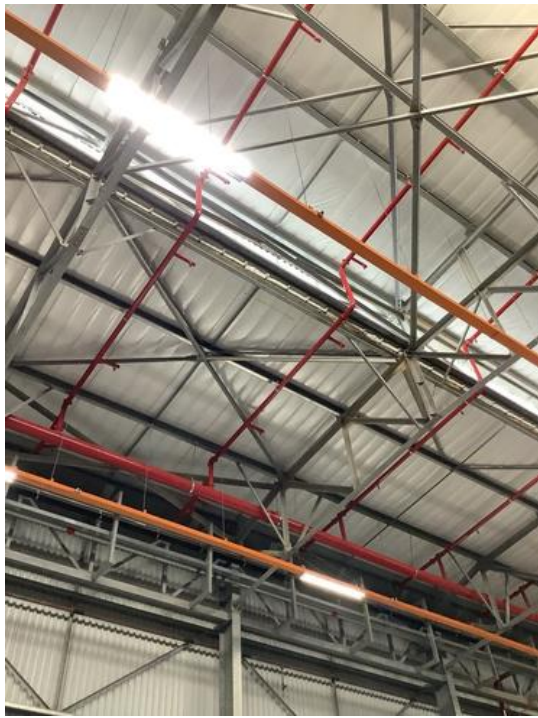
The sprinkler pipe work must be correctly supported.

An additional hangers required. Various on right of building

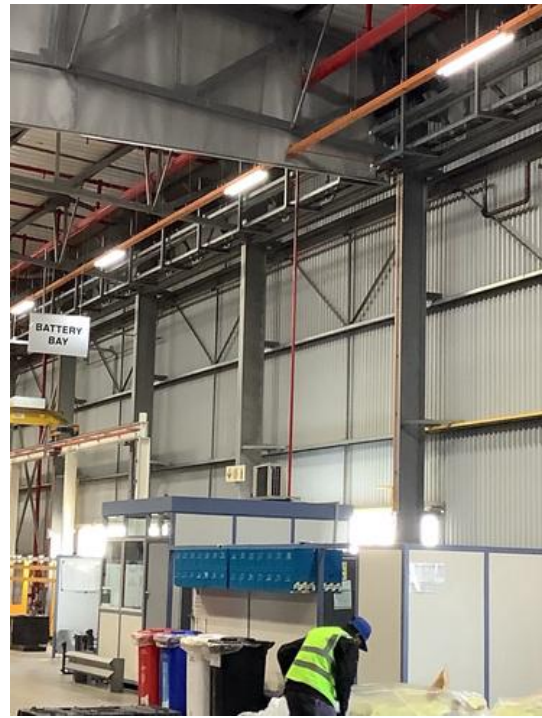
Photo 28

Distribution rise/drop pipes shall be secured directly to the building structure or by hangers securing horizontal distribution pipes within 300 mm of the riser.

Dropper to office next to charging bay

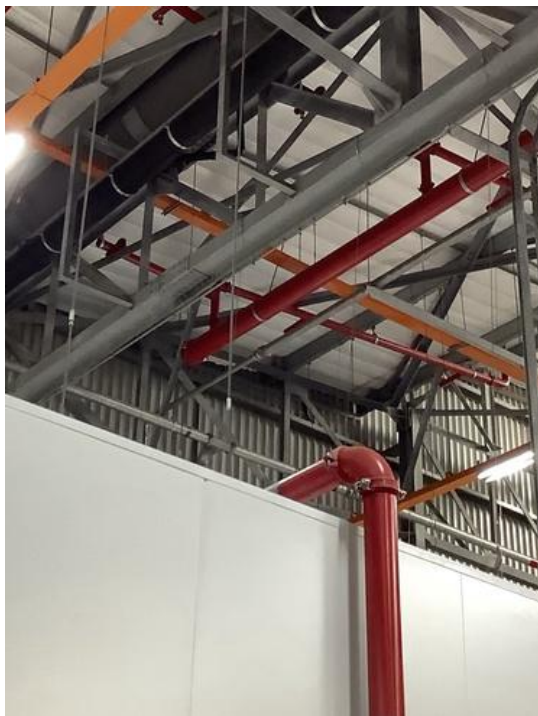
Photo 29

Terminal hangers on distribution pipes are exceeding the maximum distance of 450 mm from the end of the distribution pipe.

Various roof mains

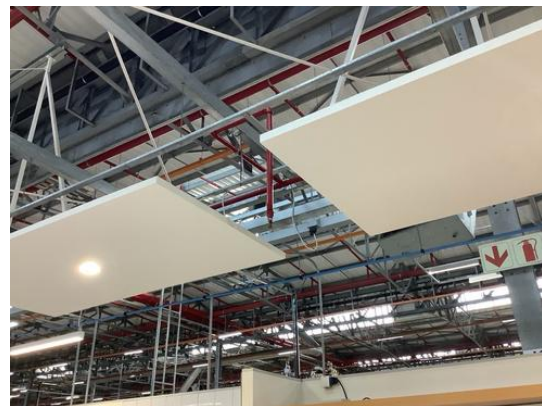
Photo 30

Factory rest area

Approved heat collection plates to be installed

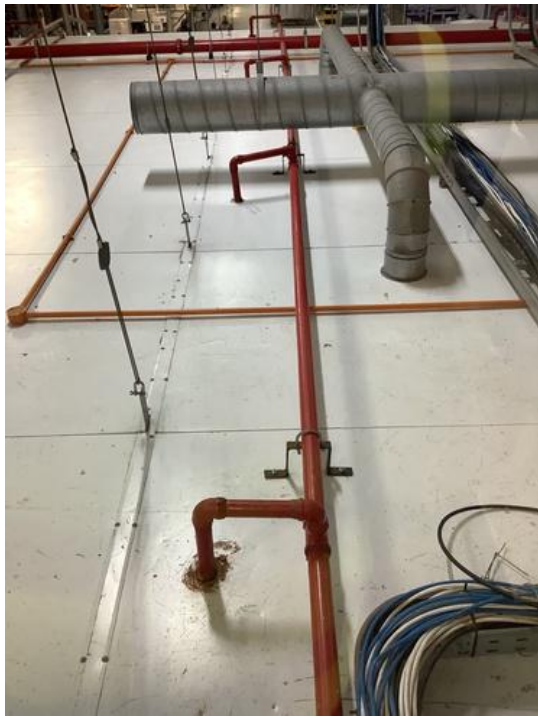
Photo 31

The sprinkler pipe work must be correctly supported.

Warehouse offices

Pipe work must be supported independently from the composite panel

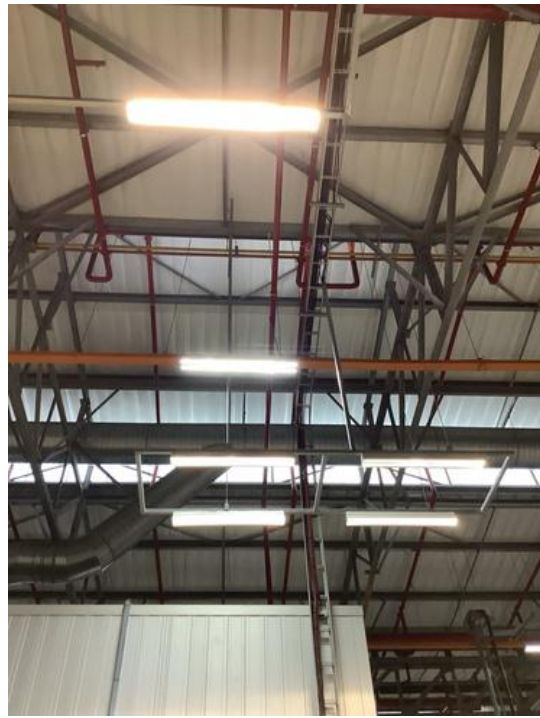
Photo 32

Electrical Cable or other services attached to sprinkler pipework.

On feed to laser room

All electrical cables or any other services attached to the sprinkler pipe work must be removed and independently supported.

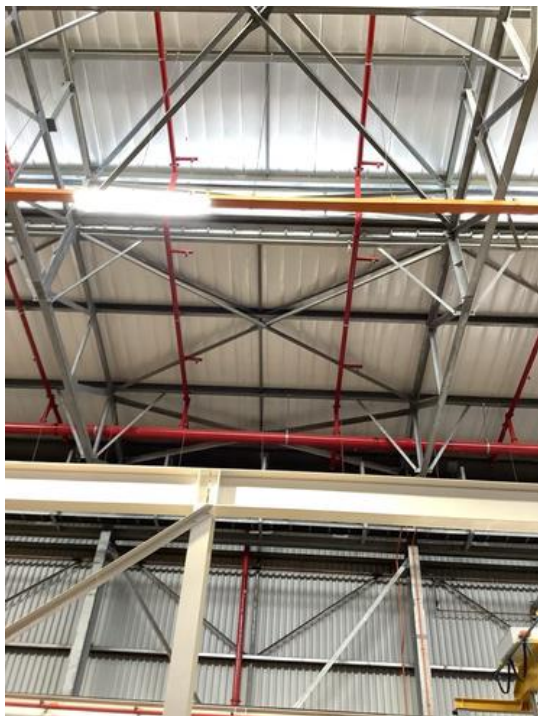
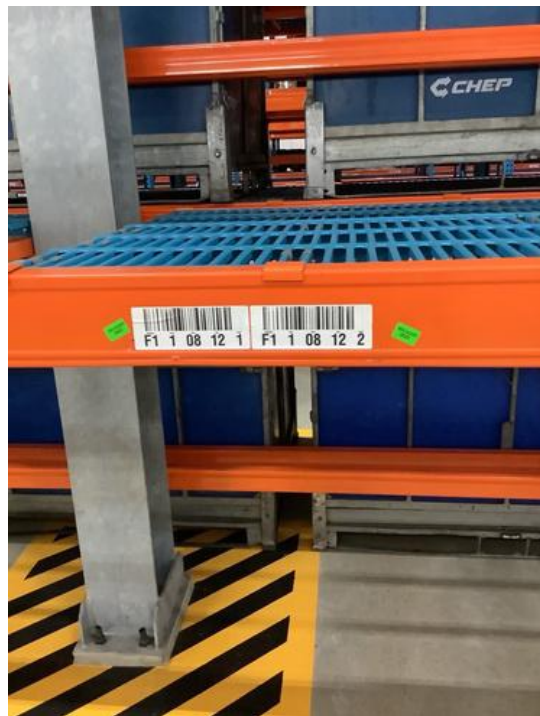
Hangers have come adrift and must be re-fixed to their original positions.

12th range from back range

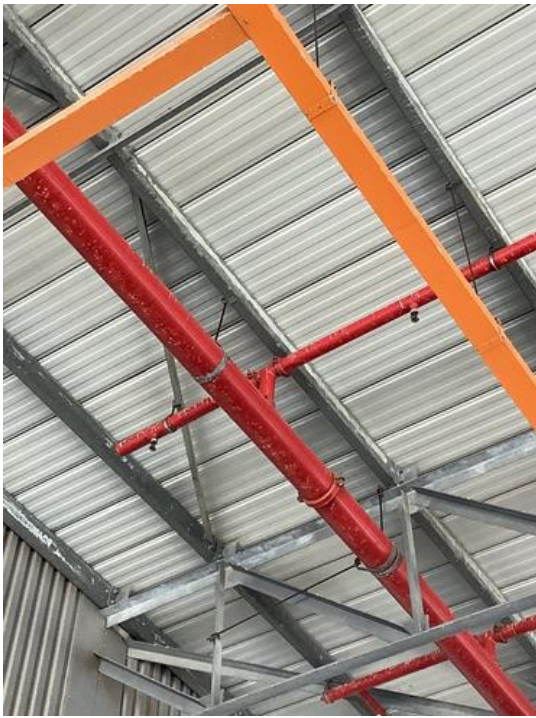
Photo 35

Corrosion is evident on the sprinkler pipe work and must be addressed by your installer.

Mainly on the hangers

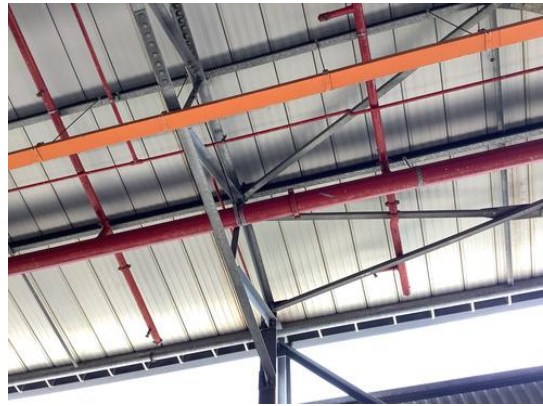
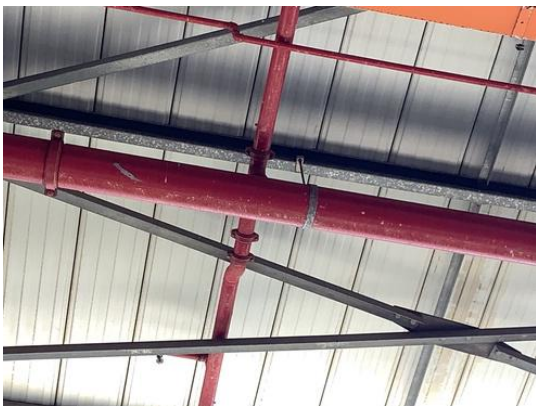
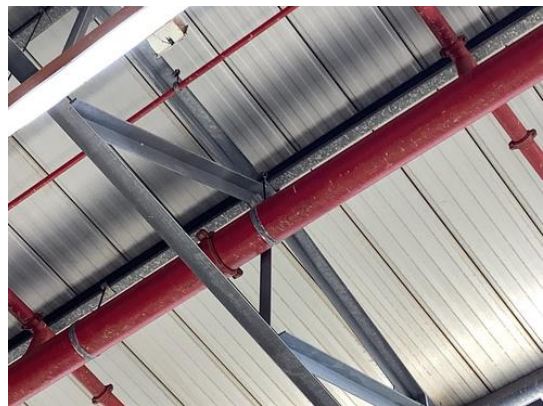
The sprinkler pipe work must be correctly supported.

Canopies

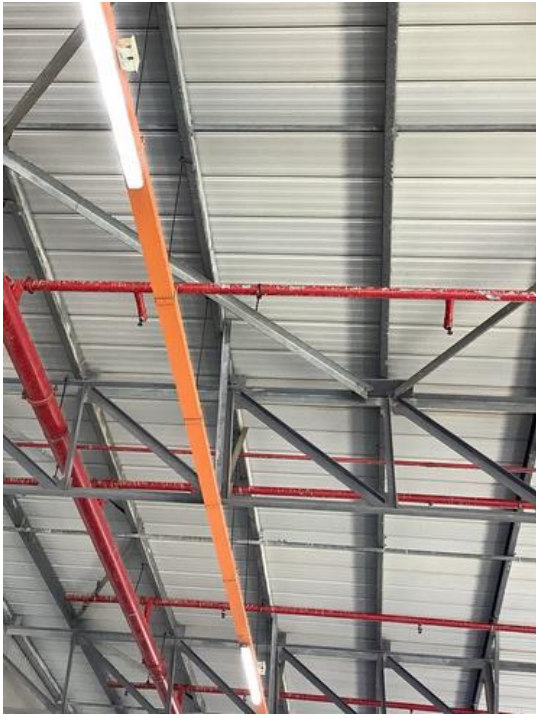
Photo 39

Hangers have come adrift and must be re-fixed to their original positions.

Middle of first canopy on the left

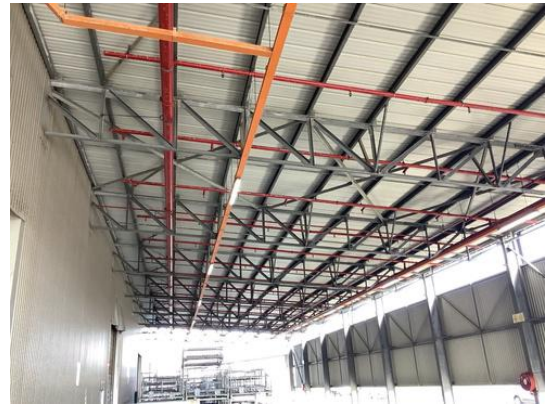
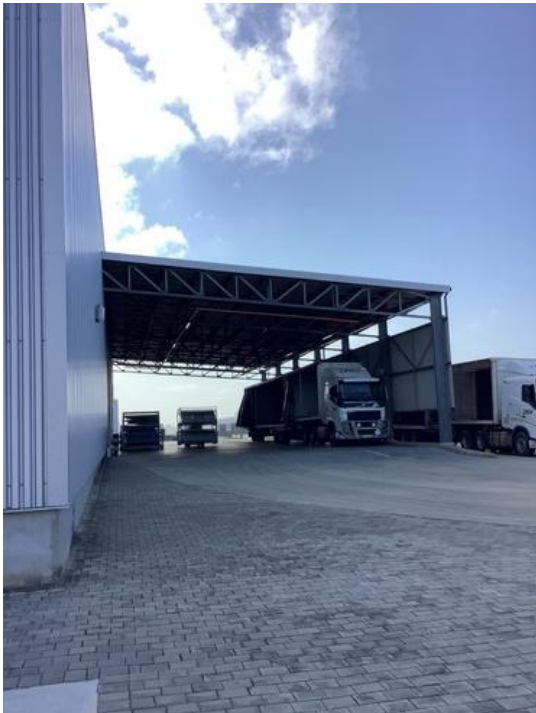
NOTE:
The installation of ESFR sprinklers in the canopies of this building are a non-compliance but will be accepted on this occasion on provision that these canopies are not allocated as storage areas. Only load and offload process to take place under these canopies.
