Inspection of Automatic Sprinkler System

East London Industrial Development
Zone Building HE1 (Polytech)

UNC.9263

18.06.2024 11:53 SAST

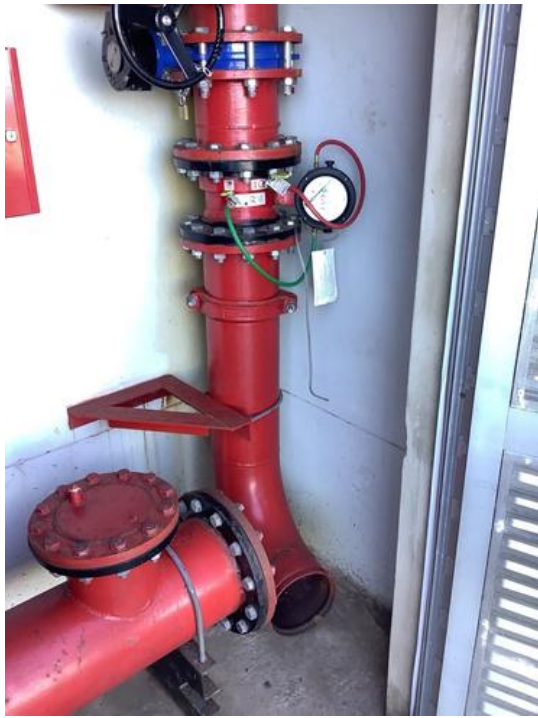
Photo 5

7.14 Flow Measuring Device Installed.

Fail

Not installed as per manufacturer's specifications.
This must be corrected

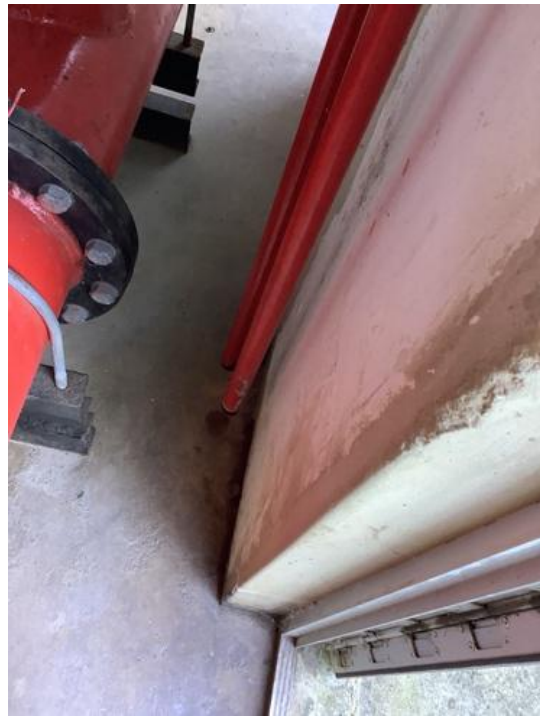
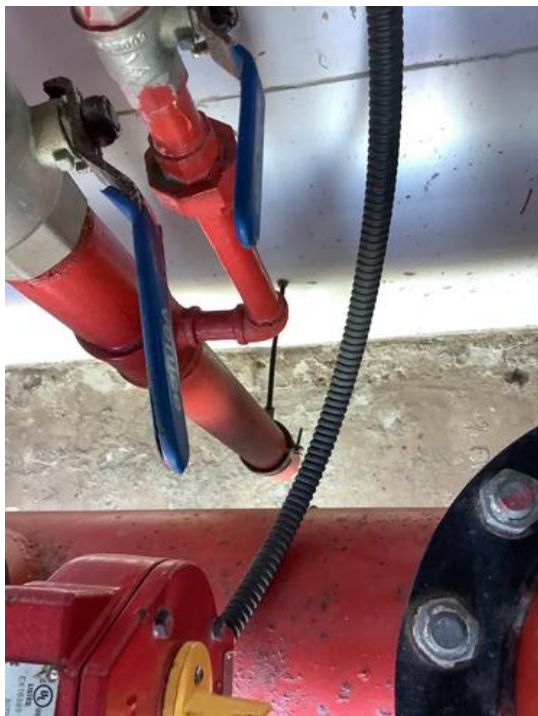
The drain and test pipes discharge within the valve cabinet. This must be revised so they discharge externally to the valve cabinet.

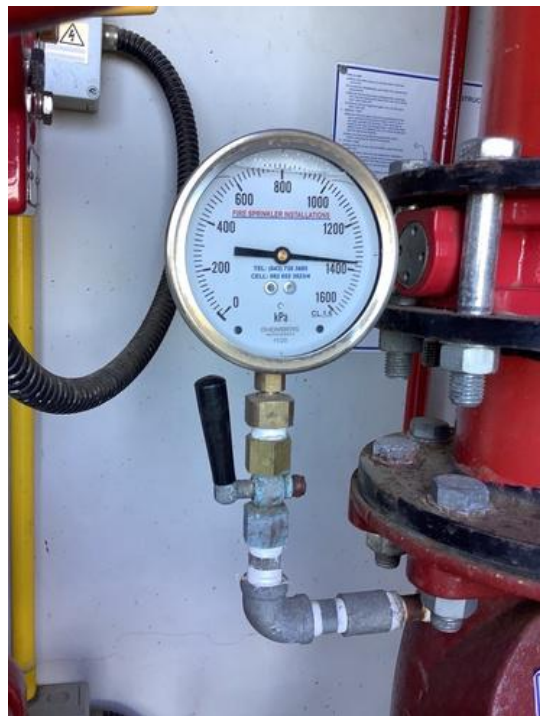
Photo 8

7.22 Trunk Main Pressure (kPa)

880

7.23 Installation Pressure (kPa)

1360

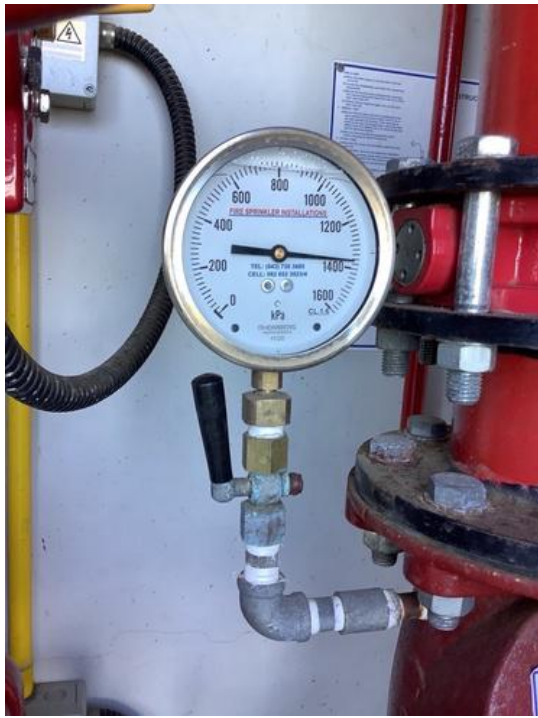
Photo 9

Maximum 1200 kPa

The system pressure has exceeded the maximum allowable pressure of 1200 kPa, this must be investigated and rectified by your installer.

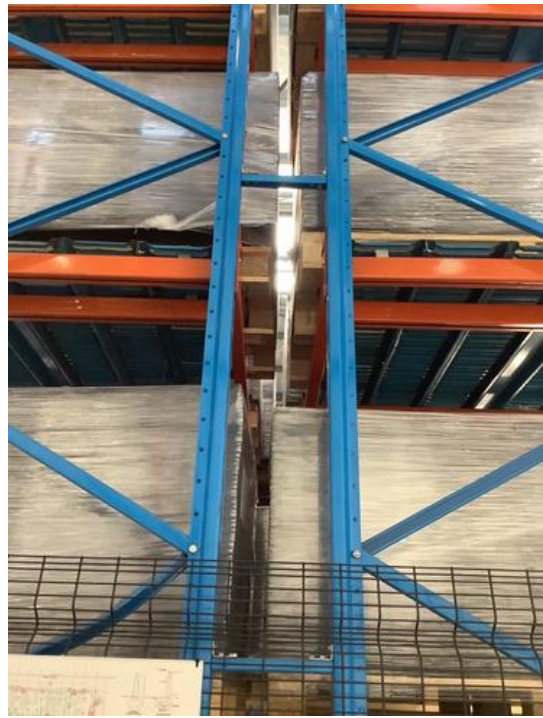
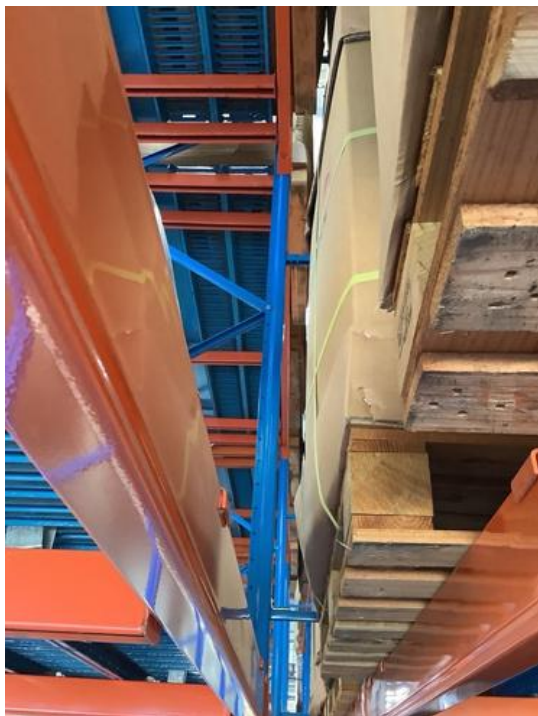
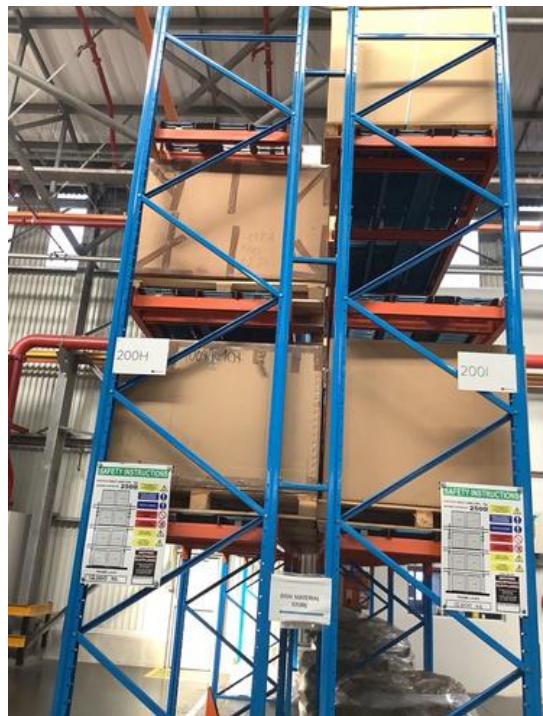
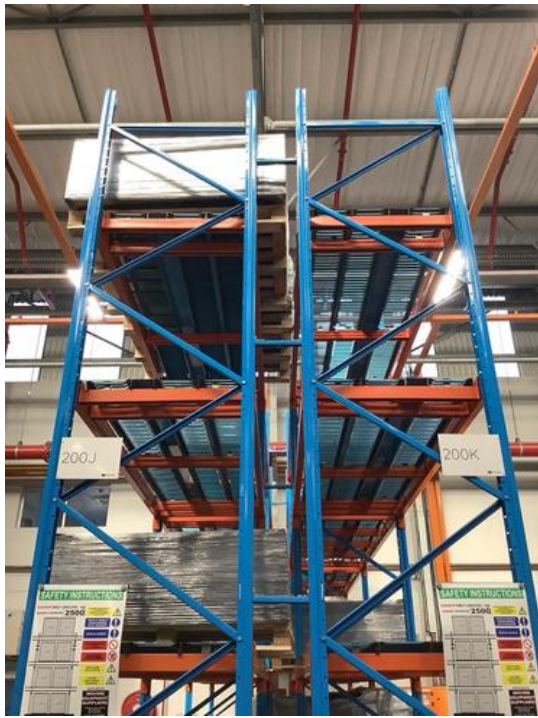
The longitudinal and/or transverse flue spaces are not being maintained

The minimum longitudinal and transverse flue spaces shall not be less than 150 mm.

Racks

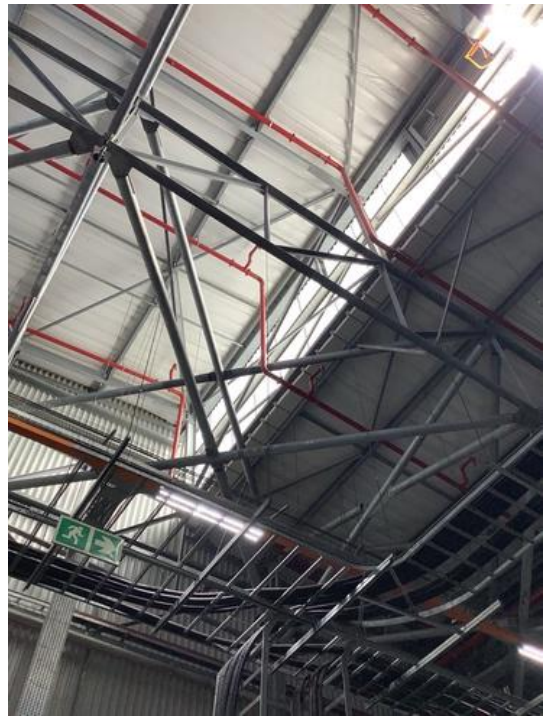
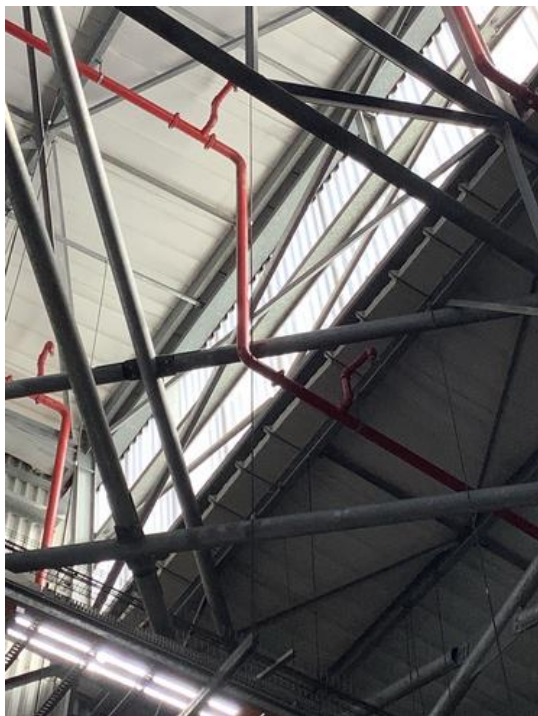
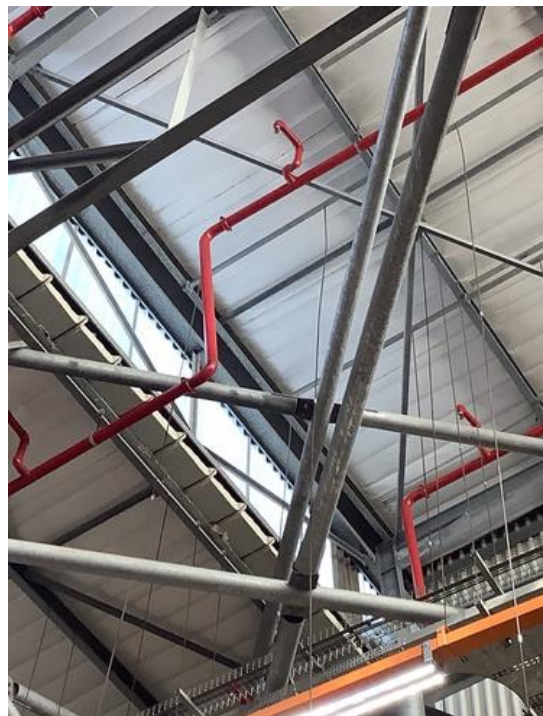
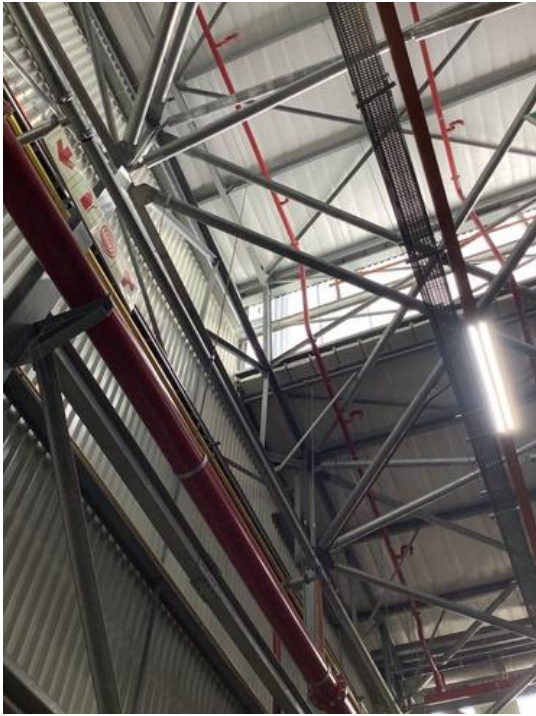
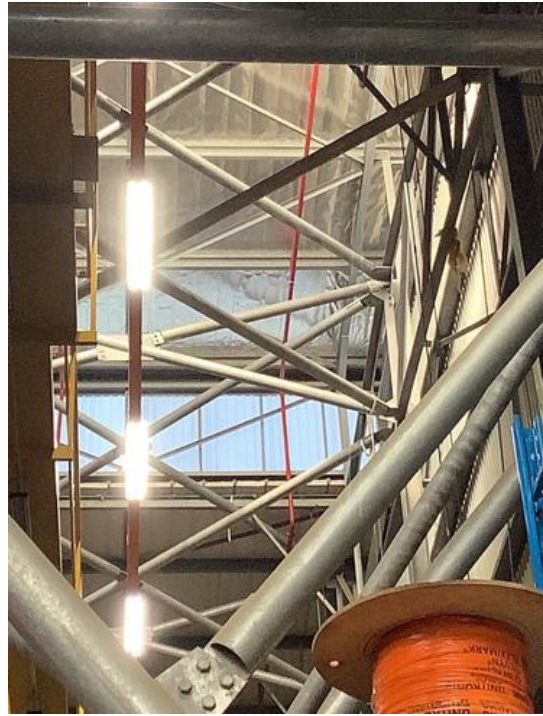
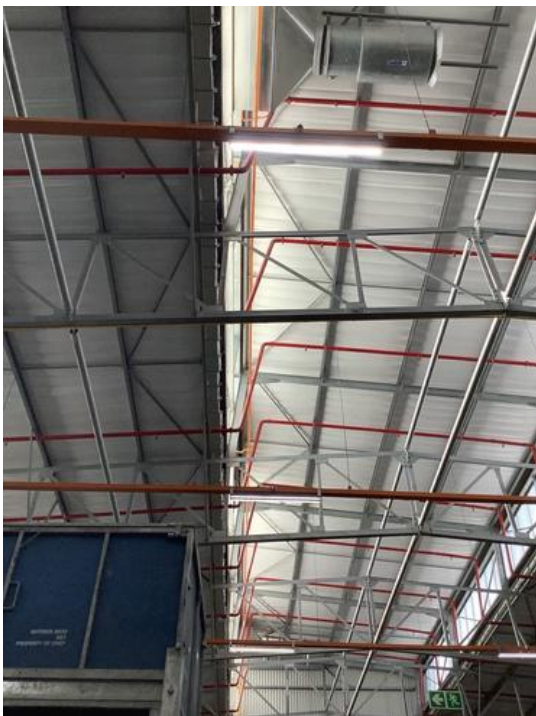
Pipe Support

The sprinkler pipe work must be correctly supported.

Risers to roof monitors

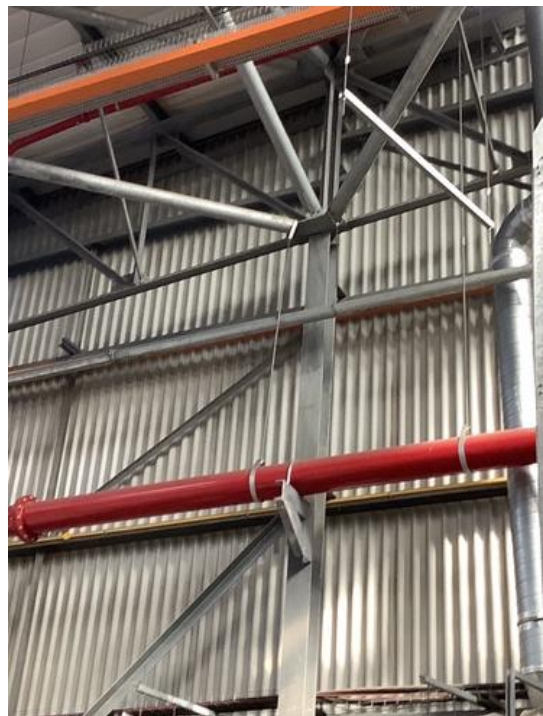
Photo 20

Belt-to-belt hangers utilized.

Main feed

Belt-to-belt hangers must be removed and the pipe work correctly supported.

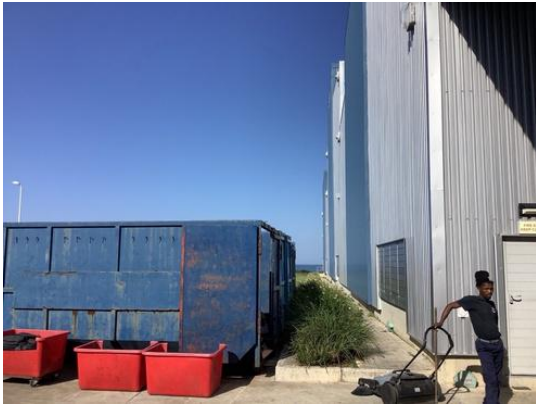
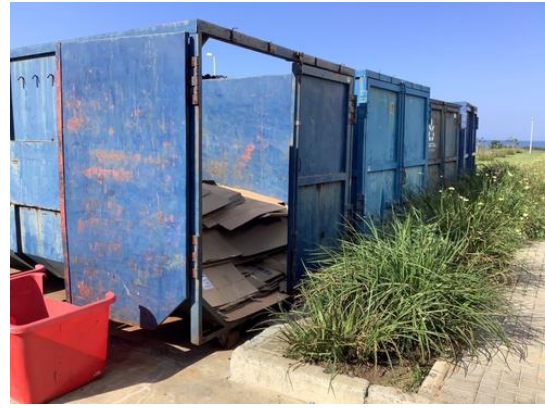
Storage too close to building.

Drencher heads required which are purpose made sprinklers designed to spray water over a surface to provide protection against fire exposure. It is not acceptable to use standard sprinkler heads with the fusible elements removed for the purpose of providing wall or face wetting. The drencher system must extend along the walls of the protected building to a distance of 15.0 metres beyond each end of the stored goods. The feed for the drenchers must be taken from the underside of the valves and not from the downstream side of the installation. The stop valve controlling the drencher installation shall be located near to the sprinkler control valves, but must be at least 10,0 metres from the goods stored or from the area where they are expected to operate.

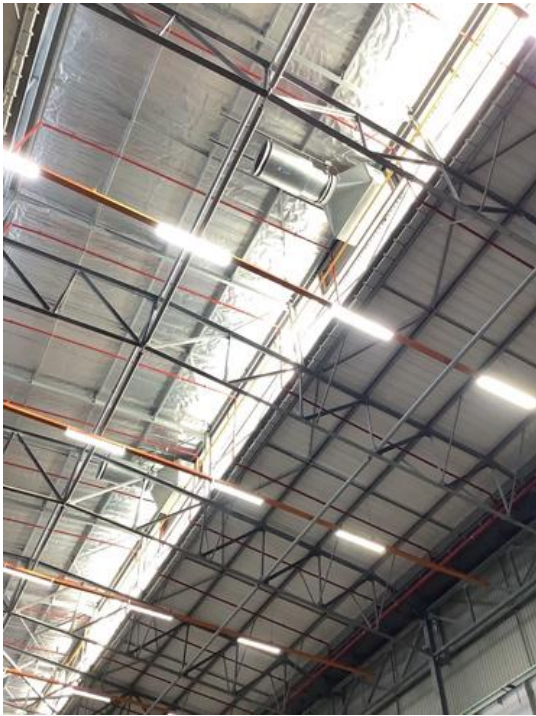
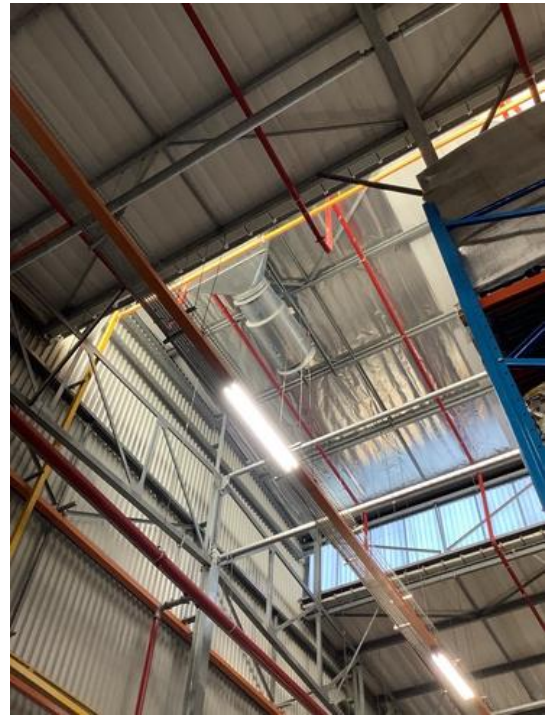
ESFR Mechanical Ventilation (to be verified)

Ventilation has been installed in conjunction with ESFR sprinkler protection.

It is imperative that the mechanical vents do not open automatically in a fire situation as the ESFR sprinkler system will be adversely effected which could result in the ESFR system failure.

Roof monitors

It is important that the mechanical vents be manually operated and that the Fire Chief in charge of operations during a fire be able to make the decision whether it should be opened or remain closed.

It might also be advisable to zone the mechanical vents so as to have the option of opening all the vents at the same time or only certain zones.

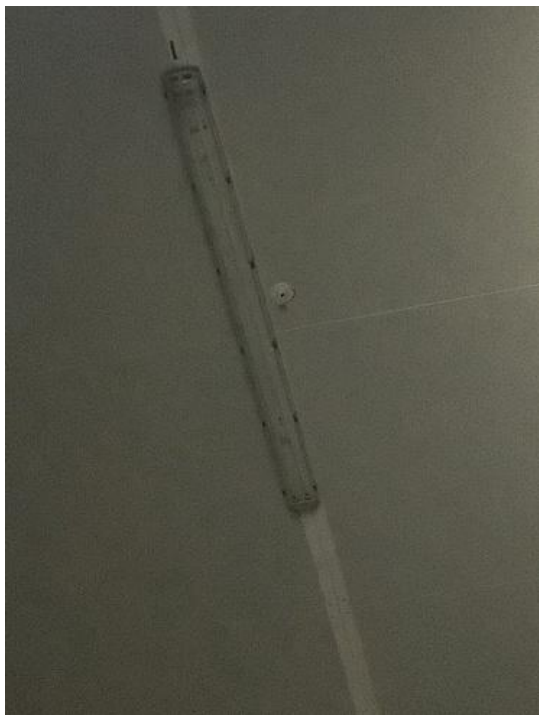
Photo 25

Distribution pattern of sprinklers affected.

Centre of cold room

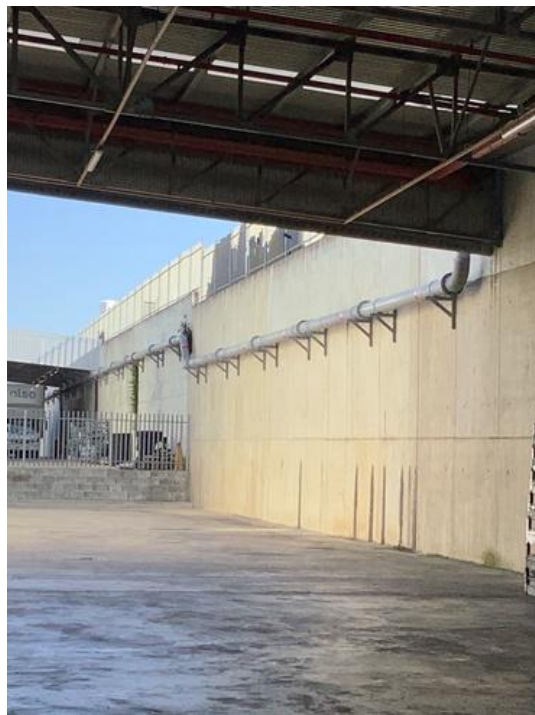
Photo 26

Exposed / unprotected pipe work

Main feed

Sprinkler pipe work must pass through a sprinkler protected area or be encased in a 2 hour fire rated enclosure.

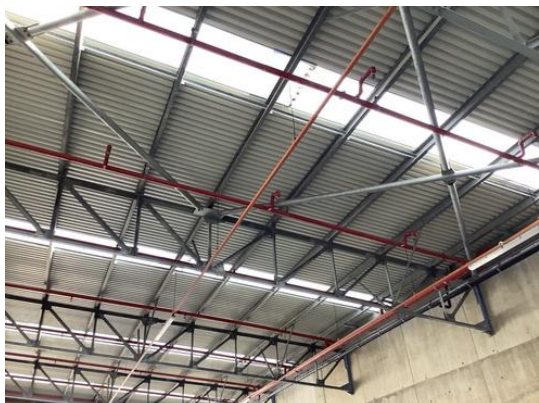
Photo 27

ESFR combustibile roof sheets

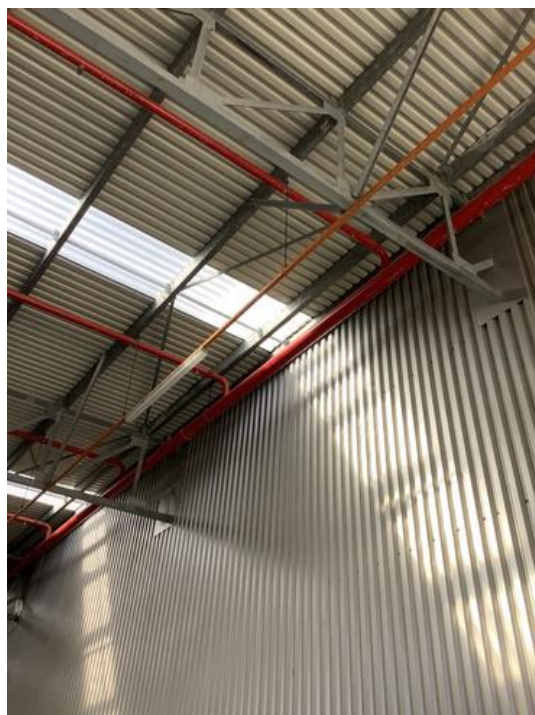
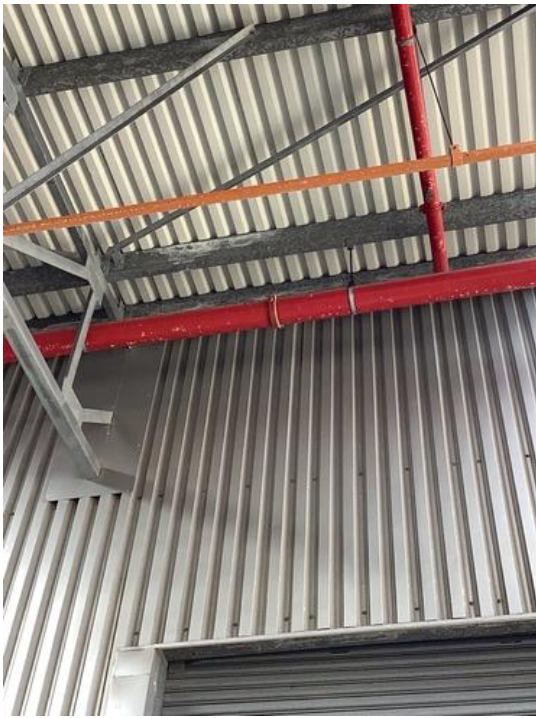
The sprinkler pipe work must be correctly supported.

Distribution main

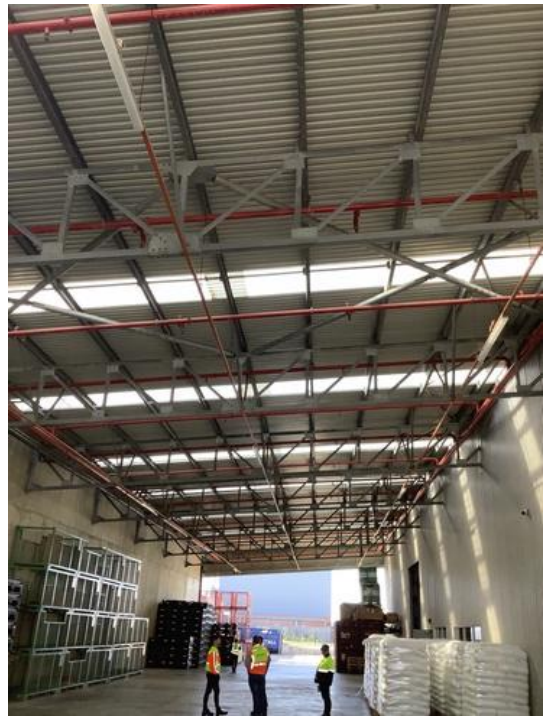
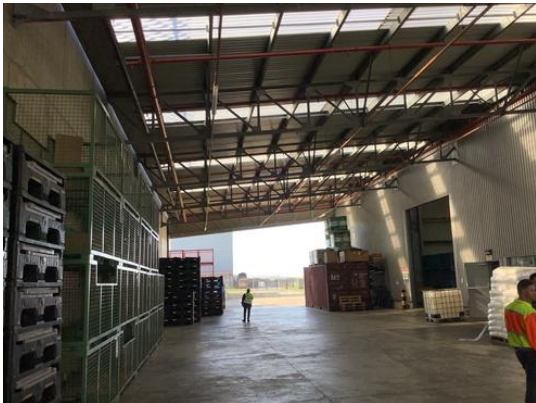
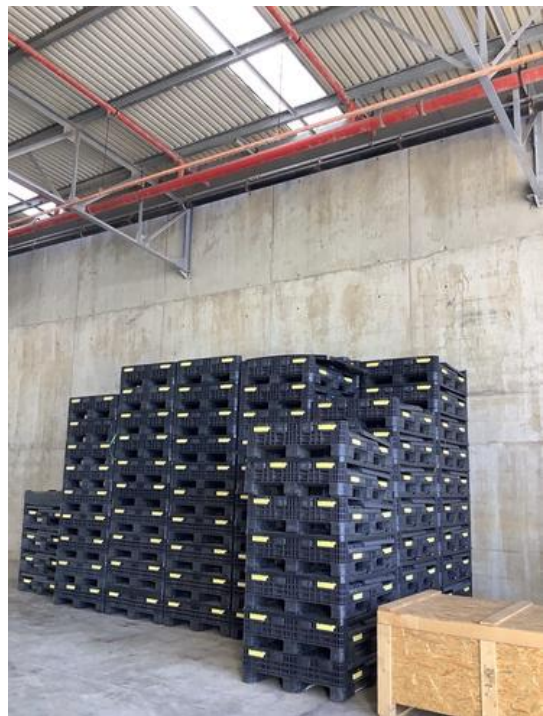
The installation of ESFR sprinklers in the canopies of this building are a non-compliance but will be accepted on this occasion on provision that these canopies are not allocated as storage areas. Only load and offload process to take place under these canopies.

Loading canopy
