Inspection of Automatic Sprinkler System

EW1 TI Automotive East London
Industrial Development Zone

UNC8802

09.05.2024 08:00 SAST

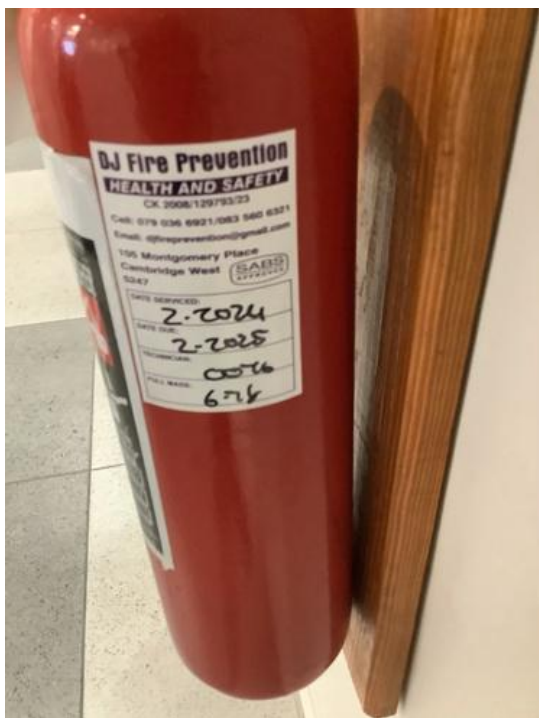
Photo 1

Clear access to the hand fire appliances must be maintained at all times.

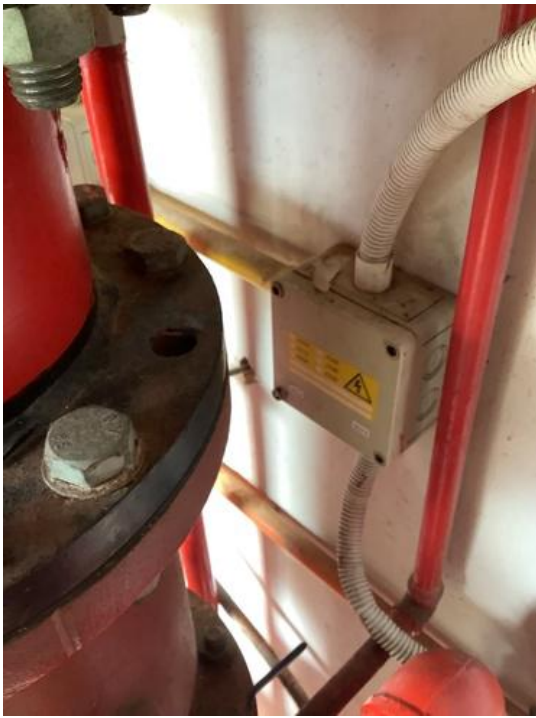
Photo 8

The bolts for these flanges must be removed and replaced with the correctly sized bolts so as to ensure that at least two full thread pitches past the chamfer protrude beyond the nut.

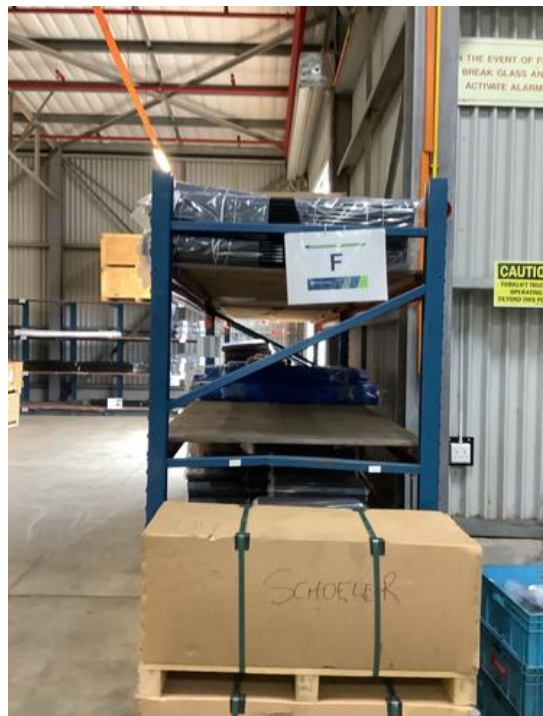
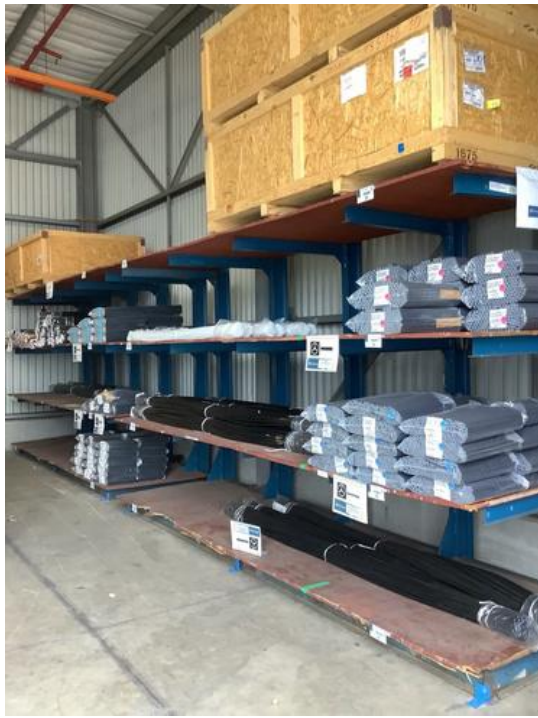
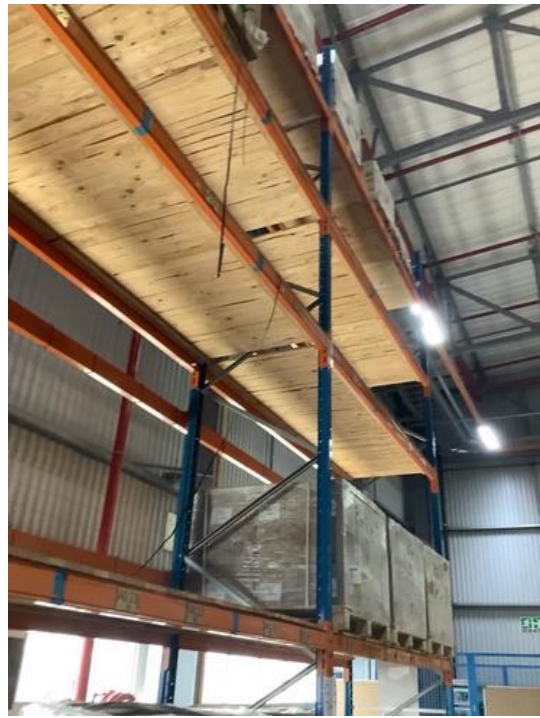
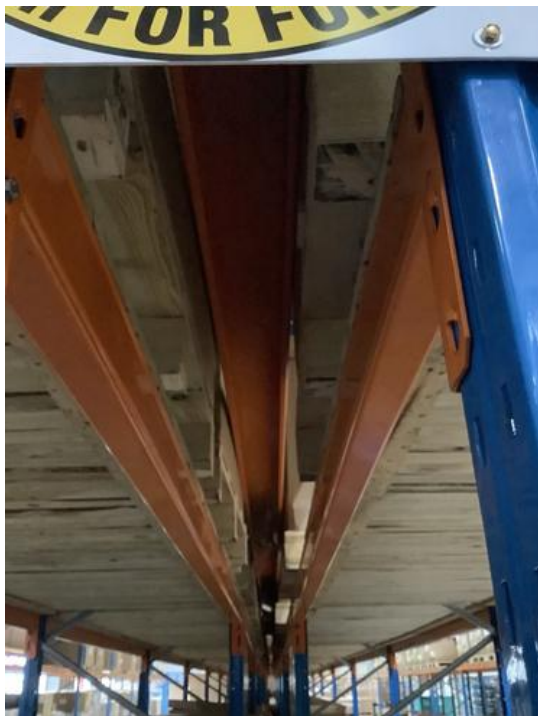
Solid shelving is not accepted for use in an ESFR sprinkler protected area and these shelves will require intermediate sprinkler protection at every tier level. Alternatively the solid shelves must be replaced with slatted shelving designed as per this standard.

The storage heights must be maintained in accordance with the maximum allowable stack heights as detailed in this report. Should this not be possible, intermediate level protection is deemed to be mandatory.

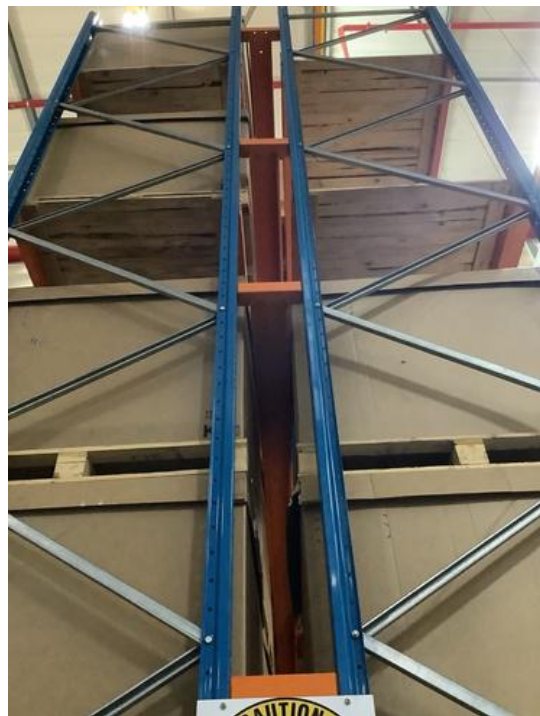
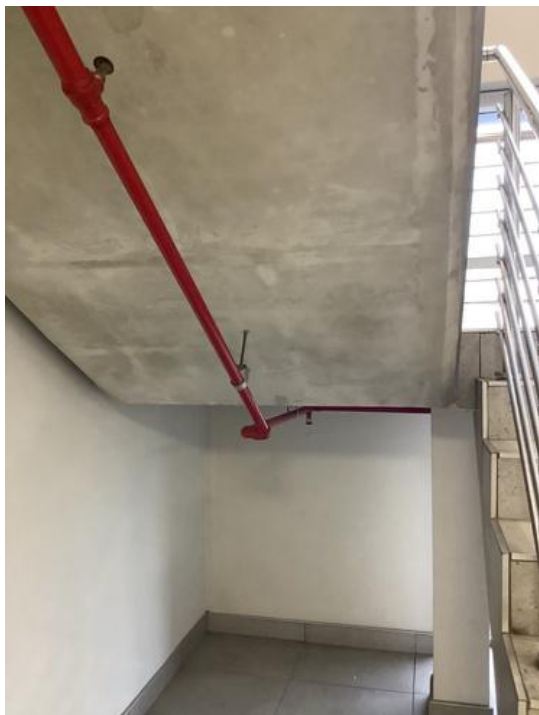
Longitudinal and transverse flu spaces are critical under ESFR protection. There are none on these shelves

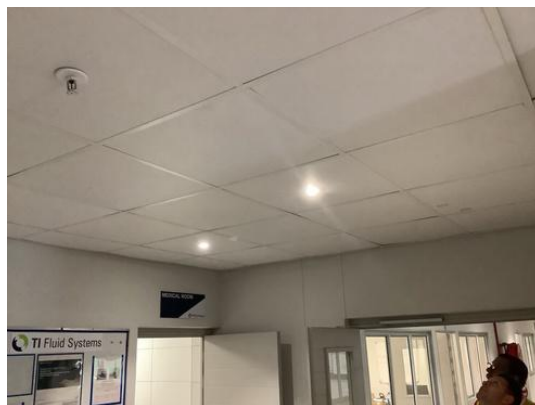
Photo 17

Mix operating temperature sprinklers.

Upright spray pattern sprinklers installed in the pendent position.

Reception area beneath stairs

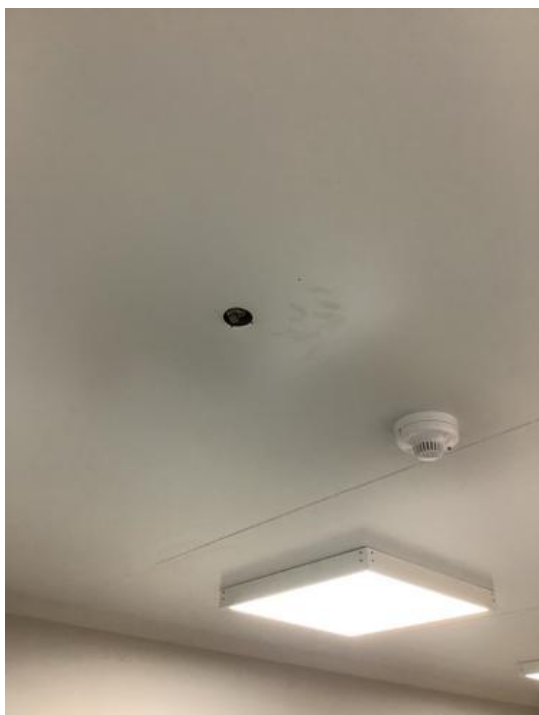
Photo 18

Sprinklers are out of effective working distance.

Ground floor outside the first aid room

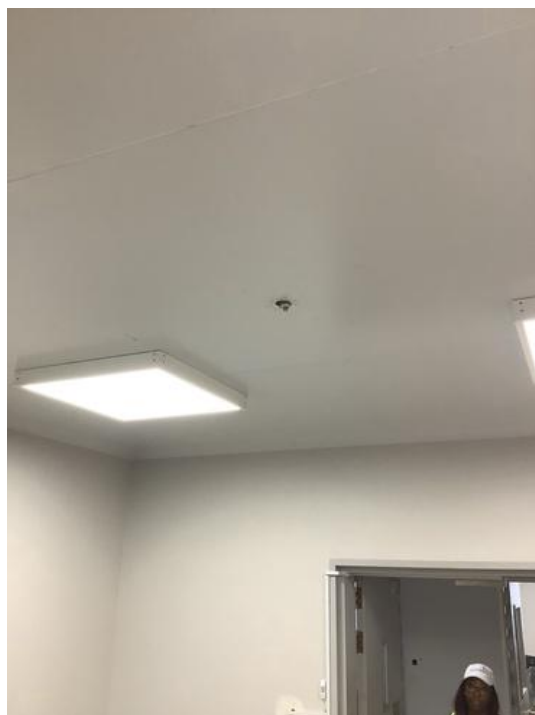
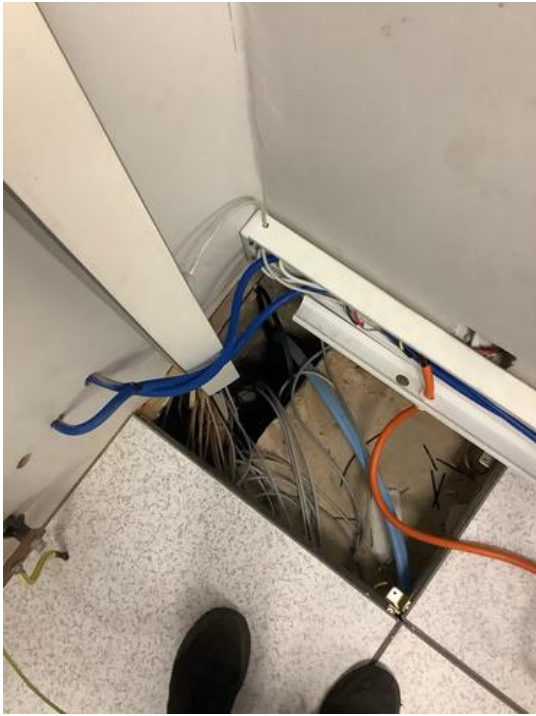
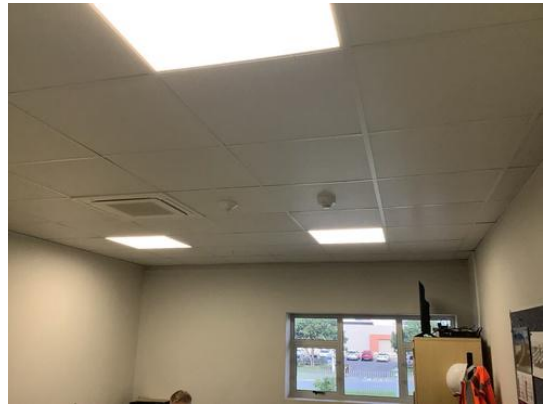
Portion of premises sprinkler protected with communicating sections that are not.

Partial protection can lead to a fire originating in the protected area radiating heat into the unprotected portion of the premises and starting secondary fires. The heat from these fires radiates or spreads back into the protected area causing excessive sprinkler operation.

1st floor server room
Plugged sprinklers must be reinstated

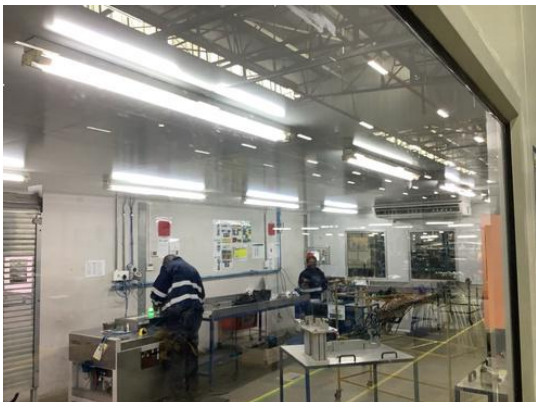
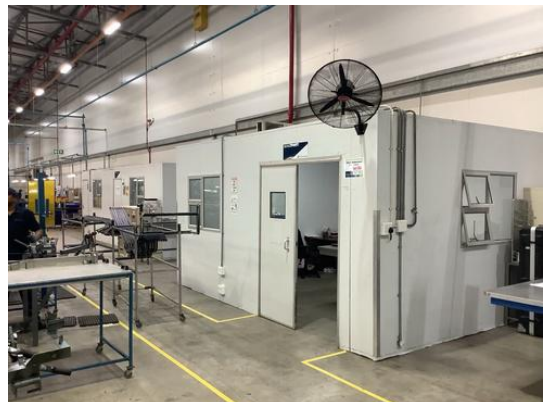
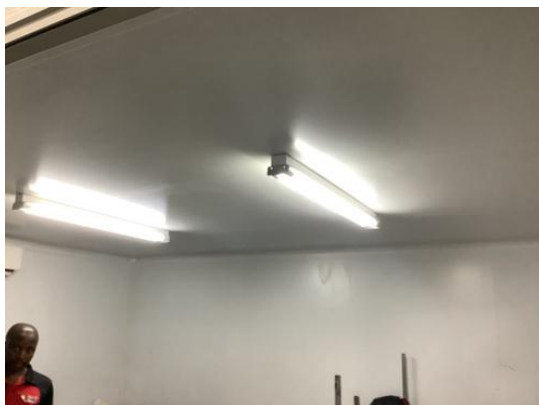
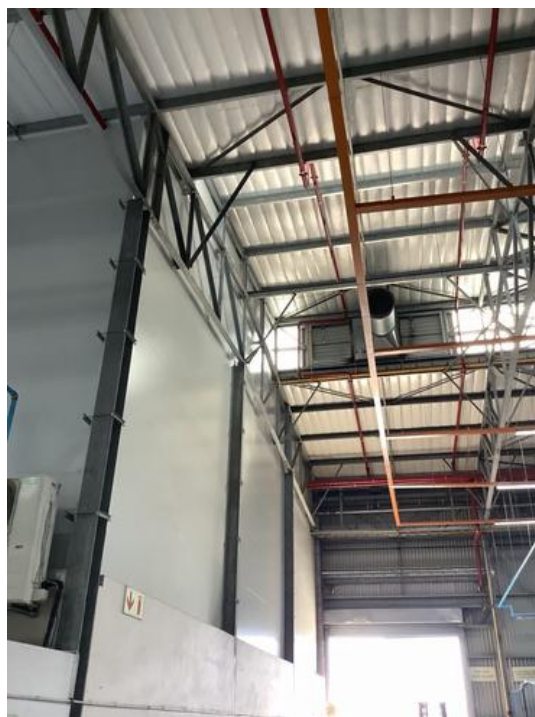
Portion of premises sprinkler protected with communicating sections that are not.

Partial protection can lead to a fire originating in the protected area radiating heat into the unprotected portion of the premises and starting secondary fires. The heat from these fires radiates or spreads back into the protected area causing excessive sprinkler operation.

New warehouse offices
All internal structures

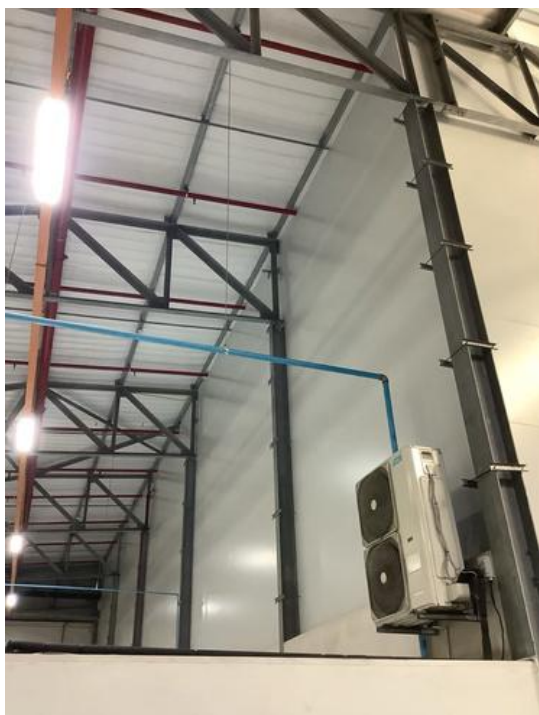
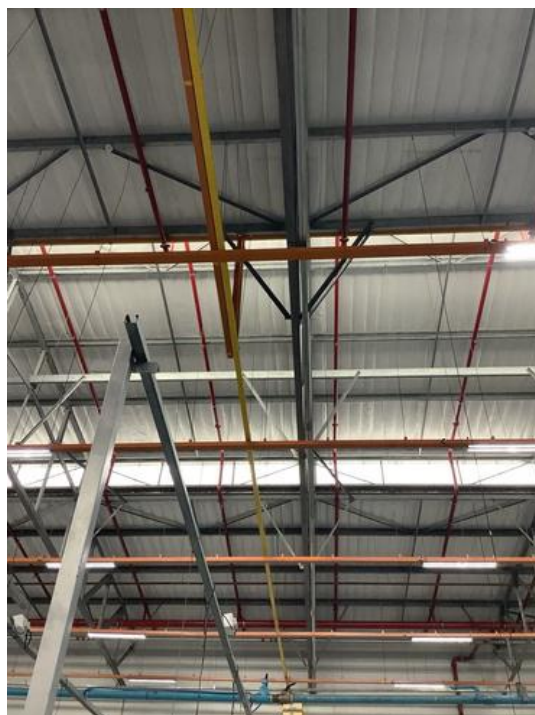
Sprinklers exceed 600 mm from isotherm panel wall

Iso panel walls

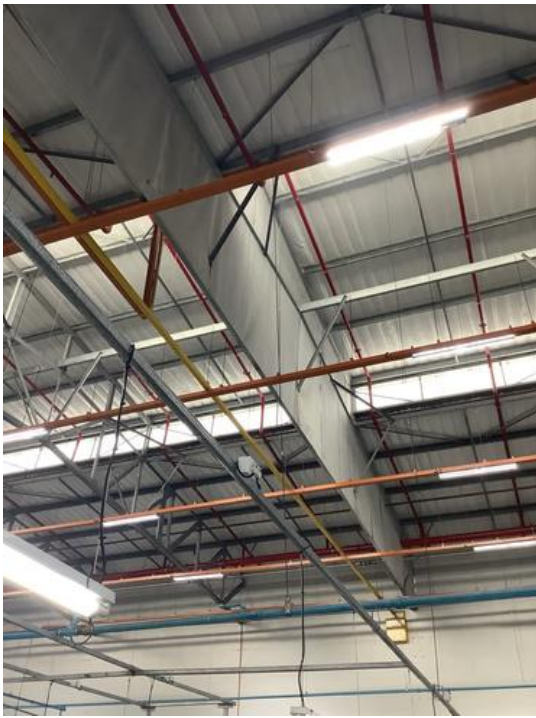
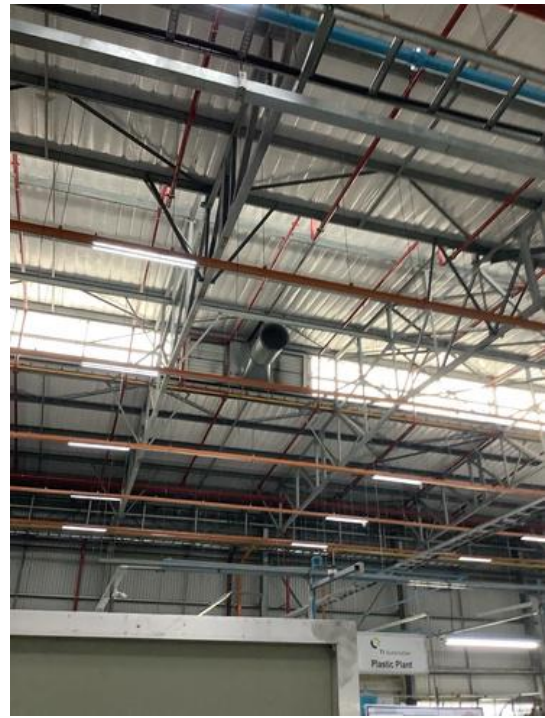
Sprinklers are incorrectly spaced from the draft curtain at roof level.

Where smoke or draft curtains are fitted at ceiling level to separate differing levels of protection, the sprinklers on either side of the smoke or draft curtain shall be equidistant from the smoke or draft curtain. This must be rectified.

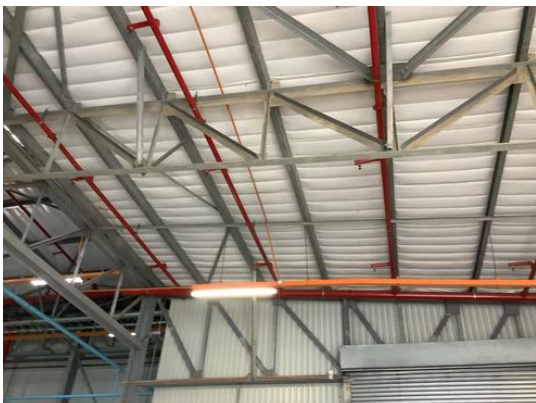
Photo 32

Mechanical ventilation has been installed in conjunction with ESFR sprinkler protection.

It is imperative that the mechanical vents do not open automatically in a fire situation as the ESFR sprinkler system will be adversely effected which could result in the ESFR system failure.

It is important that the mechanical vents be manually operated and that the Fire Chief in charge of operations during a fire be able to make the decision whether it should be opened or remain closed.

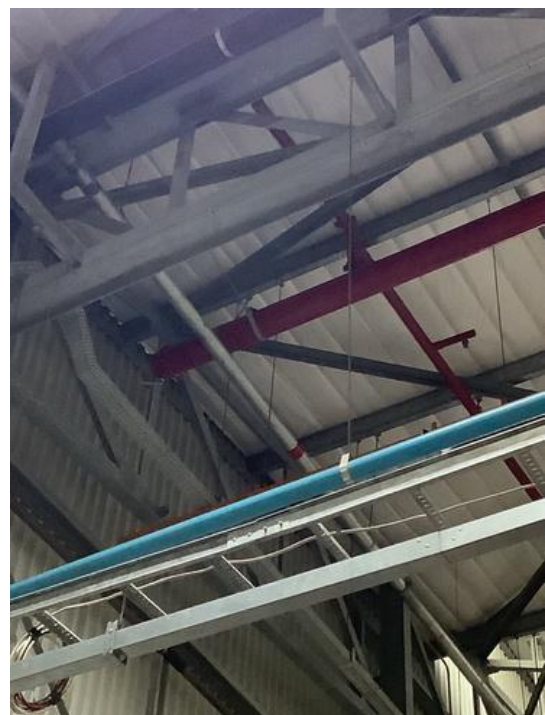
Photo 33

Sprinkler heads must be correctly aligned.

Receiving

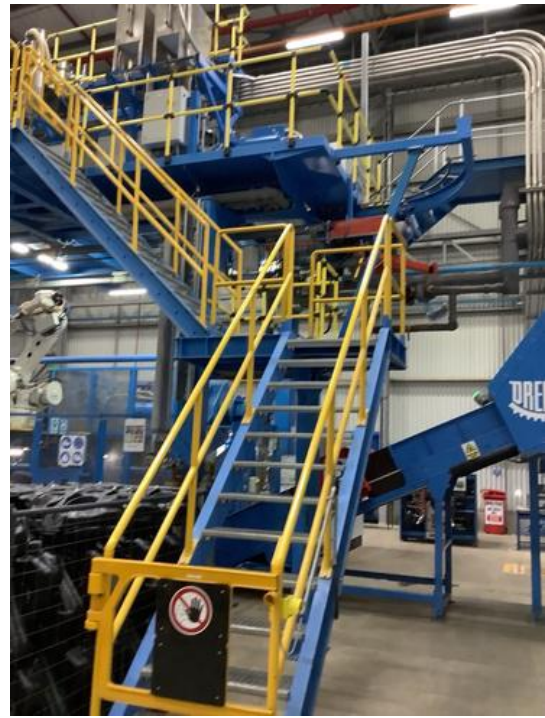
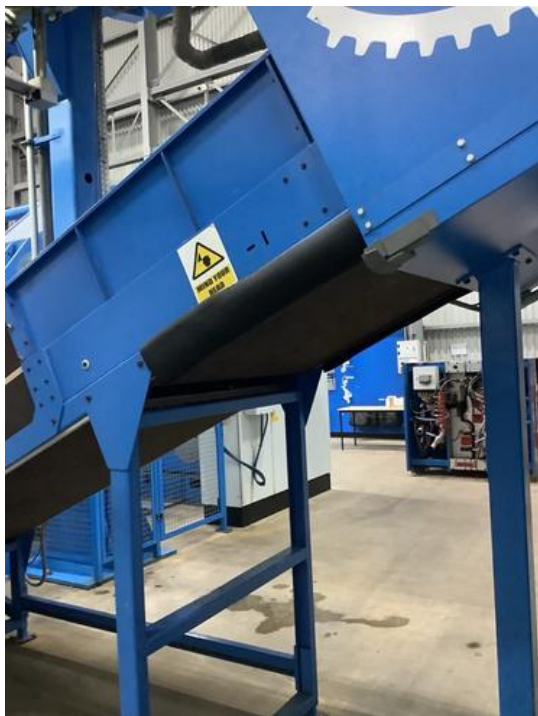
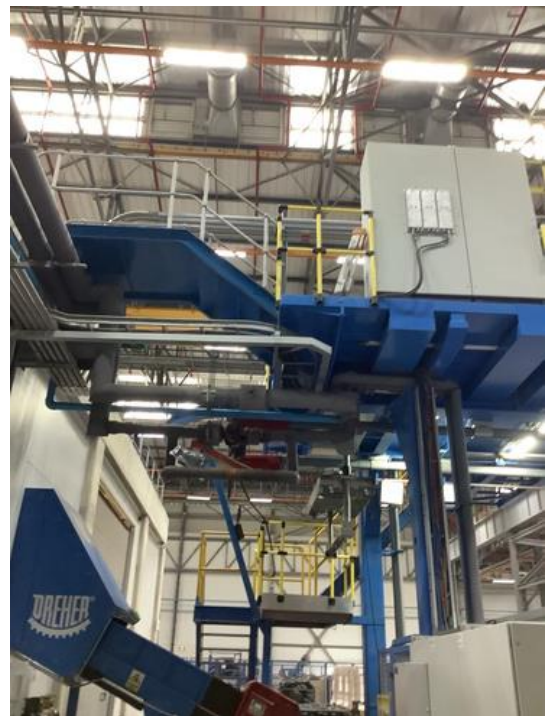
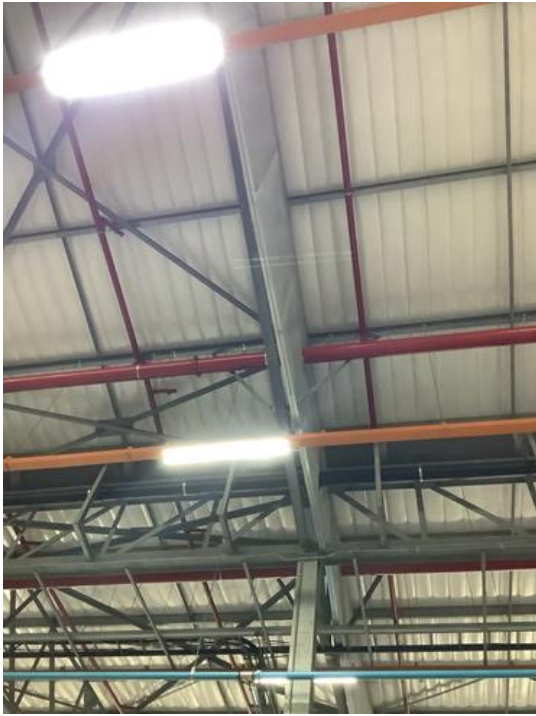
Surfaces exceeding 1,0 metre in width.

Surfaces which exceed 1,0 metre in width will obstruct the water discharged from the sprinklers above which could result in an ignition beneath these surfaces not being controlled or extinguished.

The general obstruction is classed as 1,000 mm therefore sprinkler protection is required beneath any such obstruction which includes, but is not limited to;

Walkways, solid or open grid, and Work tables.

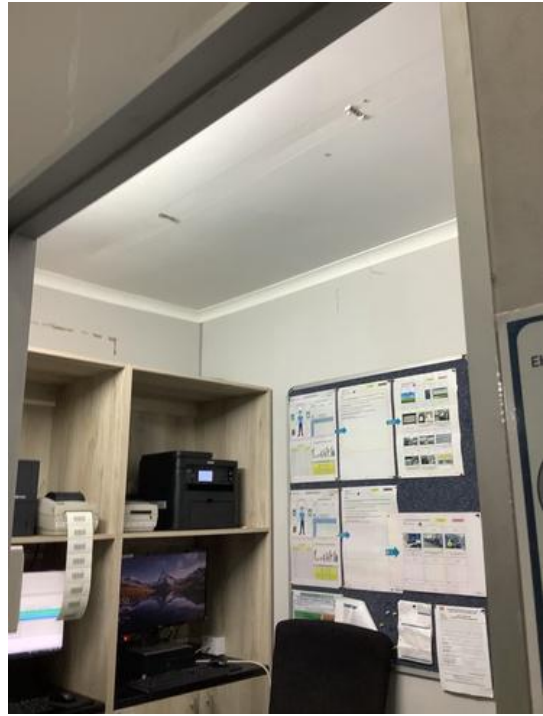
Photo 39

Sprinklers are incorrectly spaced from the draft curtain at roof level.

Where smoke or draft curtains are fitted at ceiling level to separate differing levels of protection, the sprinklers on either side of the smoke or draft curtain shall be equidistant from the smoke or draft curtain. This must be rectified.

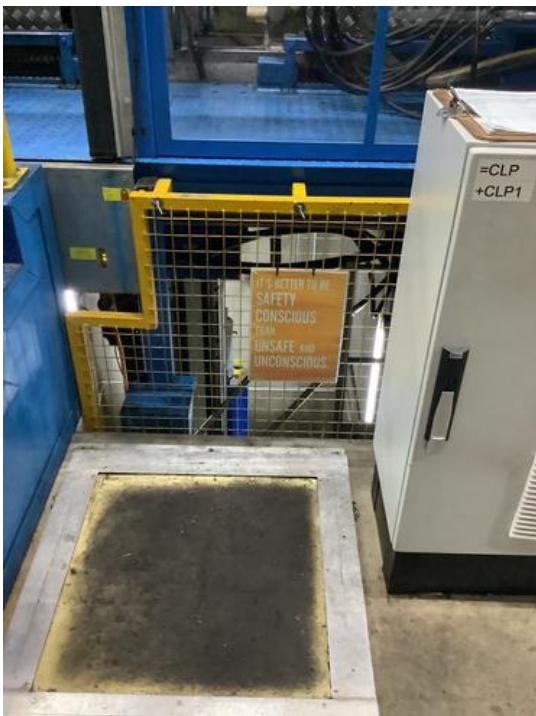
Photo 40

Portion of premises sprinkler protected with communicating sections that are not.

Partial protection can lead to a fire originating in the protected area radiating heat into the unprotected portion of the premises and starting secondary fires. The heat from these fires radiates or spreads back into the protected area causing excessive sprinkler operation.

Sequencing office

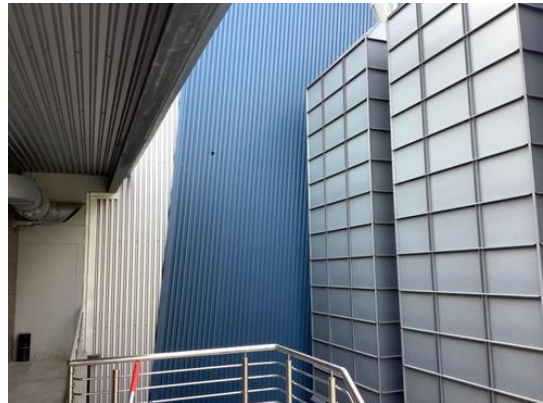
Photo 41

Enclosed structures not sprinkler protected.

A fire originating within an unprotected area will burn in an uncontrolled manner without alerting the sprinkler system unit until such time as it breaks out of the structure. The subsequent release of heat will operate multiple sprinklers at roof level above the fire area and remote from it causing massive damage.

Pit under moulding machine

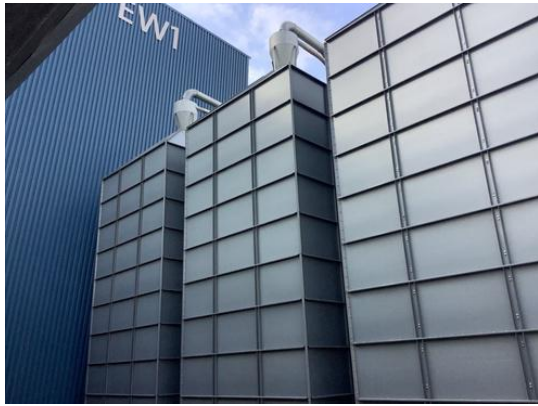
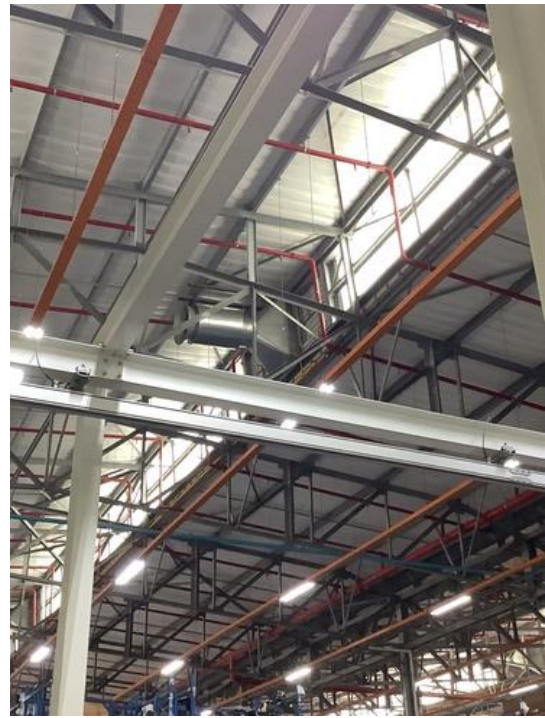
Storage too close to building.

Drencher heads required which are purpose made sprinklers designed to spray water over a surface to provide protection against fire exposure. It is not acceptable to use standard sprinkler heads with the fusible elements removed for the purpose of providing wall or face wetting. The drencher system must extend along the walls of the protected building to a distance of 15.0 metres beyond each end of the stored goods. The feed for the drenchers must be taken from the underside of the valves and not from the downstream side of the installation. The stop valve controlling the drencher installation shall be located near to the sprinkler control valves, but must be at least 10,0 metres from the goods stored or from the area where they are expected to operate.

Raw material silos

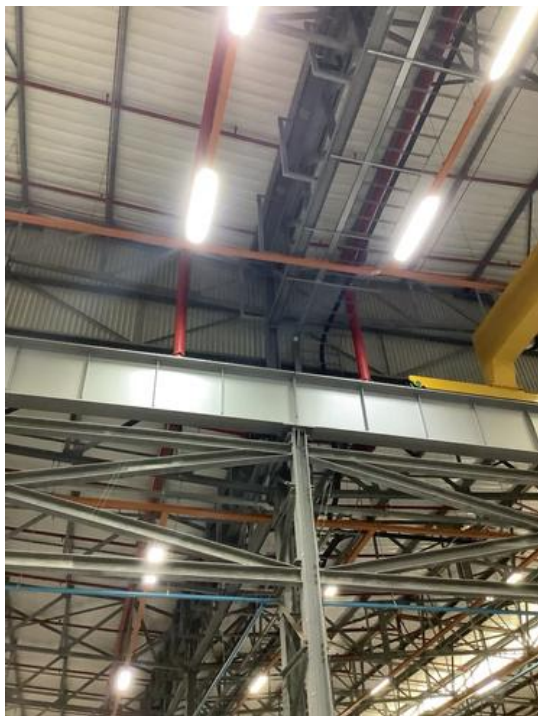
Photo 44

Mechanical ventilation has been installed in conjunction with ESFR sprinkler protection.

It is imperative that the mechanical vents do not open automatically in a fire situation as the ESFR sprinkler system will be adversely effected which could result in the ESFR system failure.

It is important that the mechanical vents be manually operated and that the Fire Chief in charge of operations during a fire be able to make the decision whether it should be opened or remain closed.
