Company	: BVI Border	Date	: 25 July 2018
Attention	: Mr. Werner De Lange	email	: WernerDL@bvi.co.za
From	: Mr. Frikkie De Jager	Total pages	: 46

Ref: 25072018/pgrecfdj1

GEOTECHNICAL PRELIMINARY REPORT – ELIDZ PLATFORM A

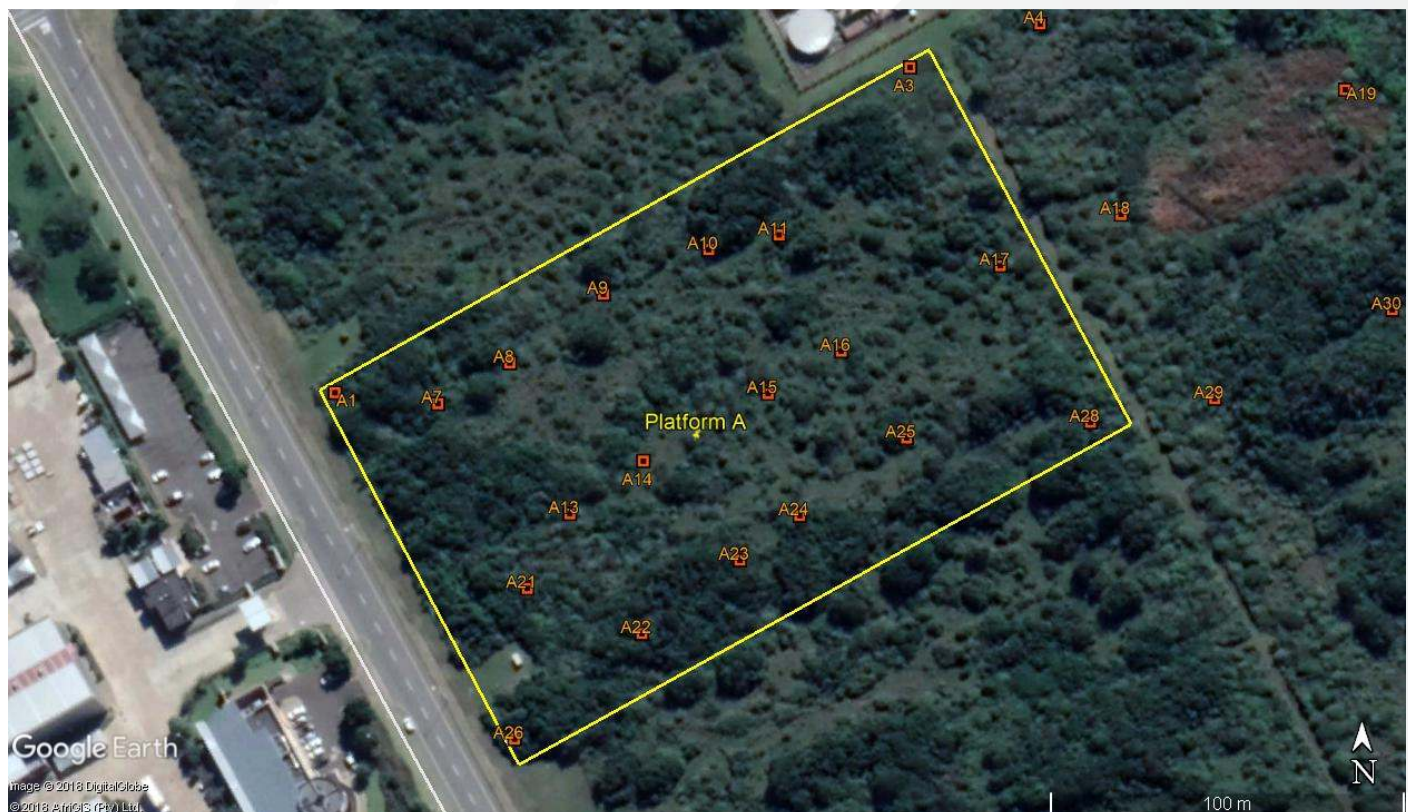
Figure 1: Test pit positions and numbering on Platform A

A total of 28 test pits, numbered Test Pit A1 to A31 were excavated in the most northern portion of the project area designated for Platform A and future expansions. A total of 19 of the 28 test pits were excavated within the proposed footprint of Platform A. The positions of the test pits are indicated in the Figure below, with detailed test pit logs attached in the end of this document for reference. Please note that several test pits could not be excavated in the required positions due to very dense vegetation. ELDZC officials did not give permission that the more prominent trees could be cut down to gain access to these positions.

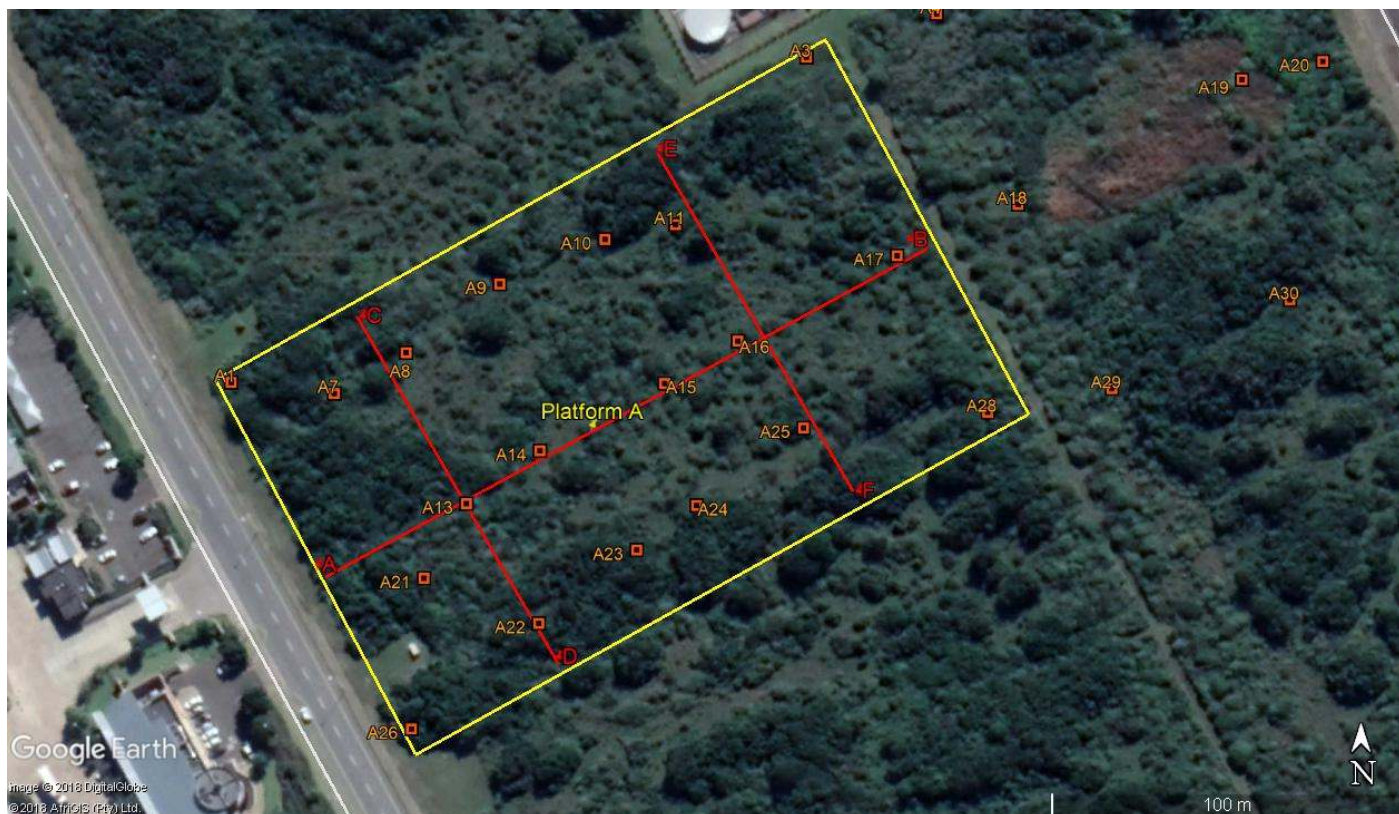
Figure 2: Cross section indication for Platform A

The generalised soil profile and sections are indicated in the figures below.

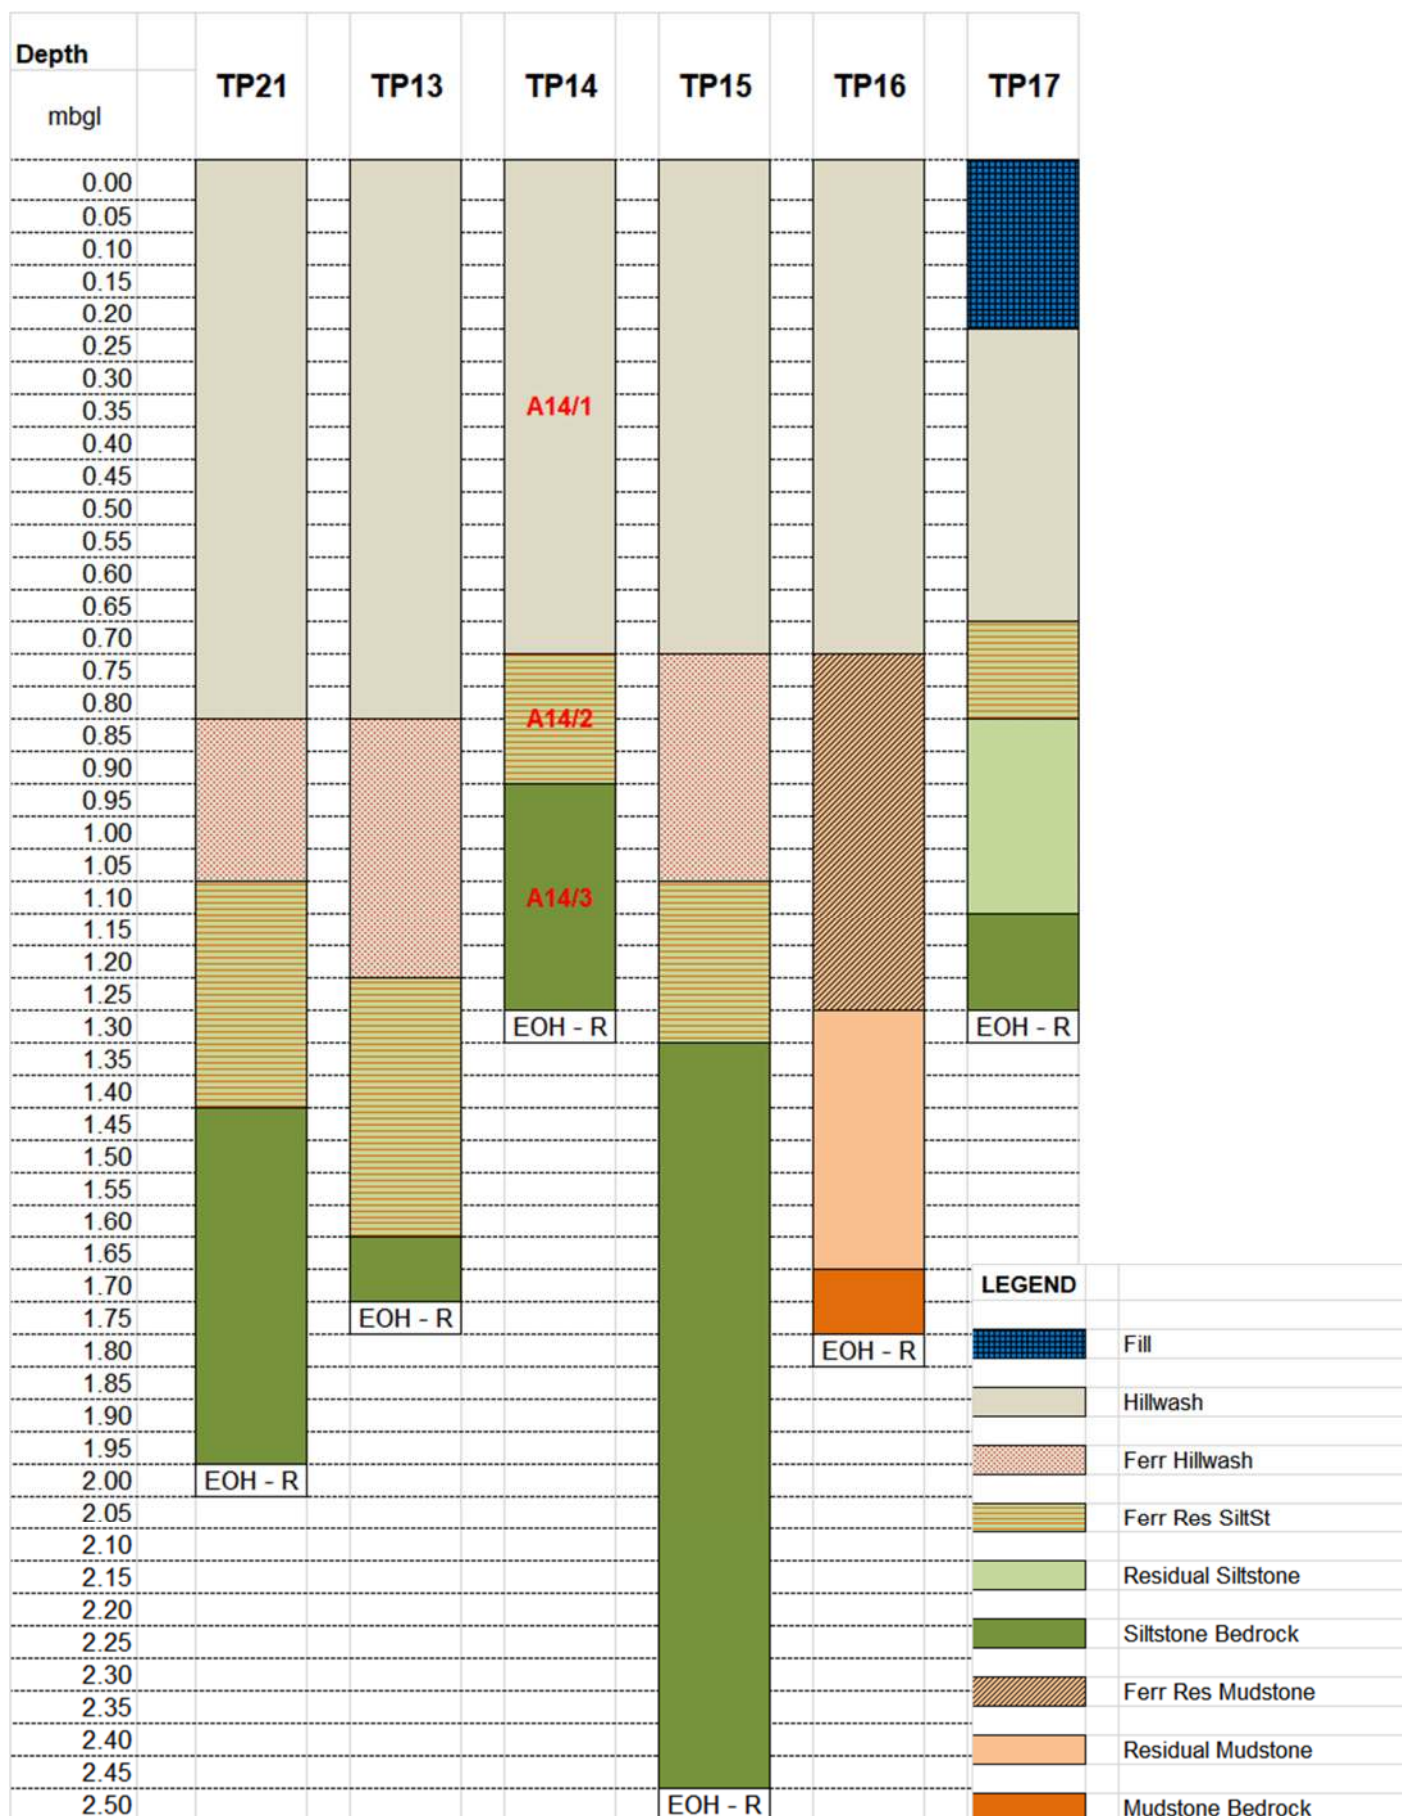
Figure 3: Generalised soil conditions – Section A-B

The area is generally covered by hillwash material that is composed of sandy clay that exhibits a firm consistency and intact soil structure. Plant roots were recorded in this material over the entire site. The hillwash material becomes ferruginised at depth in localised portions of the area, characterised in profile by the occurrence of ferricrete nodules. The hillwash material extends to a maximum depth of approximately 1.20 mbgl.

The transported material is underlain by residual siltstone / mudstone that is composed of sandy clay to clayey sand with scattered to occasional siltstone / mudstone gravel to cobbles. The material exhibits a firm to stiff consistency and fractured and inherent structure, with a maximum thickness of approximately 1.0 m. The upper portion of the residual materials are generally ferruginised, characterised in profile by scattered to abundant ferricrete nodules.

Siltstone or mudstone bedrock material was encountered in all test pits from a depth between 0.80 to 1.75 mbgl (mean 1.23 mbgl). The material is highly to moderately weathered, fine grained, medium jointed with a soft rock to moderately hard rock hardness.

The hillwash and residual siltstone / mudstone materials are not suitable as competent founding horizon(s) for the proposed structure due to adverse geotechnical conditions of these materials that will result in differential movement.

The moderately to slightly weathered siltstone bedrock material on which excavation with the TLB-type excavator refused is a competent foundation horizon for the proposed structure. The depth to this competent horizon ranges between 1.15 and 2.60 mbgl (mean 1.72 mbgl). It is therefore recommended that the structure be founded on this material. Other alternatives can be discussed and will depend on laboratory analysis results of the materials.

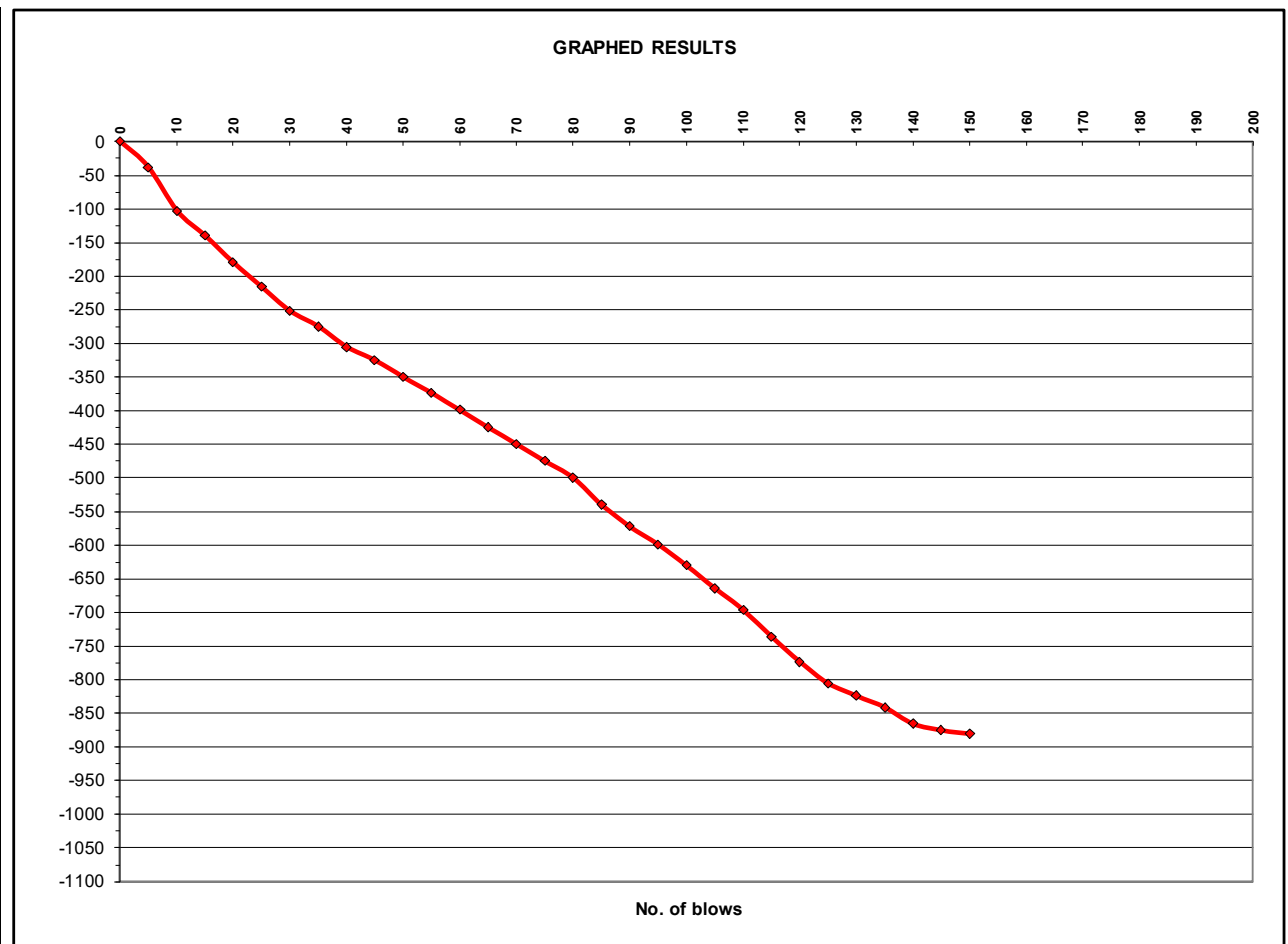
NO. OF BLOWS	TP 1				
	Values (mm)	Cumulative penetration (mm)	mm/blow	UCS (kPa)	CBR
0	10	0	0.0		
5	48	-38	7.6	318	31
10	113	-103	13.0	177	16
15	150	-140	7.4	327	32
20	190	-180	8.0	301	29
25	226	-216	7.2	337	33
30	262	-252	7.2	337	33
35	285	-275	4.6	550	59
40	315	-305	6.0	411	42
45	335	-325	4.0	640	70
50	360	-350	5.0	502	53
55	384	-374	4.8	525	56
60	409	-399	5.0	502	53
65	435	-425	5.2	481	51
70	460	-450	5.0	502	53
75	485	-475	5.0	502	53
80	510	-500	5.0	502	53
85	550	-540	8.0	301	29
90	582	-572	6.4	383	39
95	609	-599	5.4	461	48
100	640	-630	6.2	397	40
105	674	-664	6.8	359	36
110	706	-696	6.4	383	39
115	746	-736	8.0	301	29
120	783	-773	7.4	327	32
125	815	-805	6.4	383	39
130	834	-824	3.8	677	75
135	851	-841	3.4	764	87
140	875	-865	4.8	525	56
145	885	-875	2.0	1362	170
150	890	-880	1.0	2900	410
155					
160					
165					
170					
175					
180					
185					
190					
195					
200

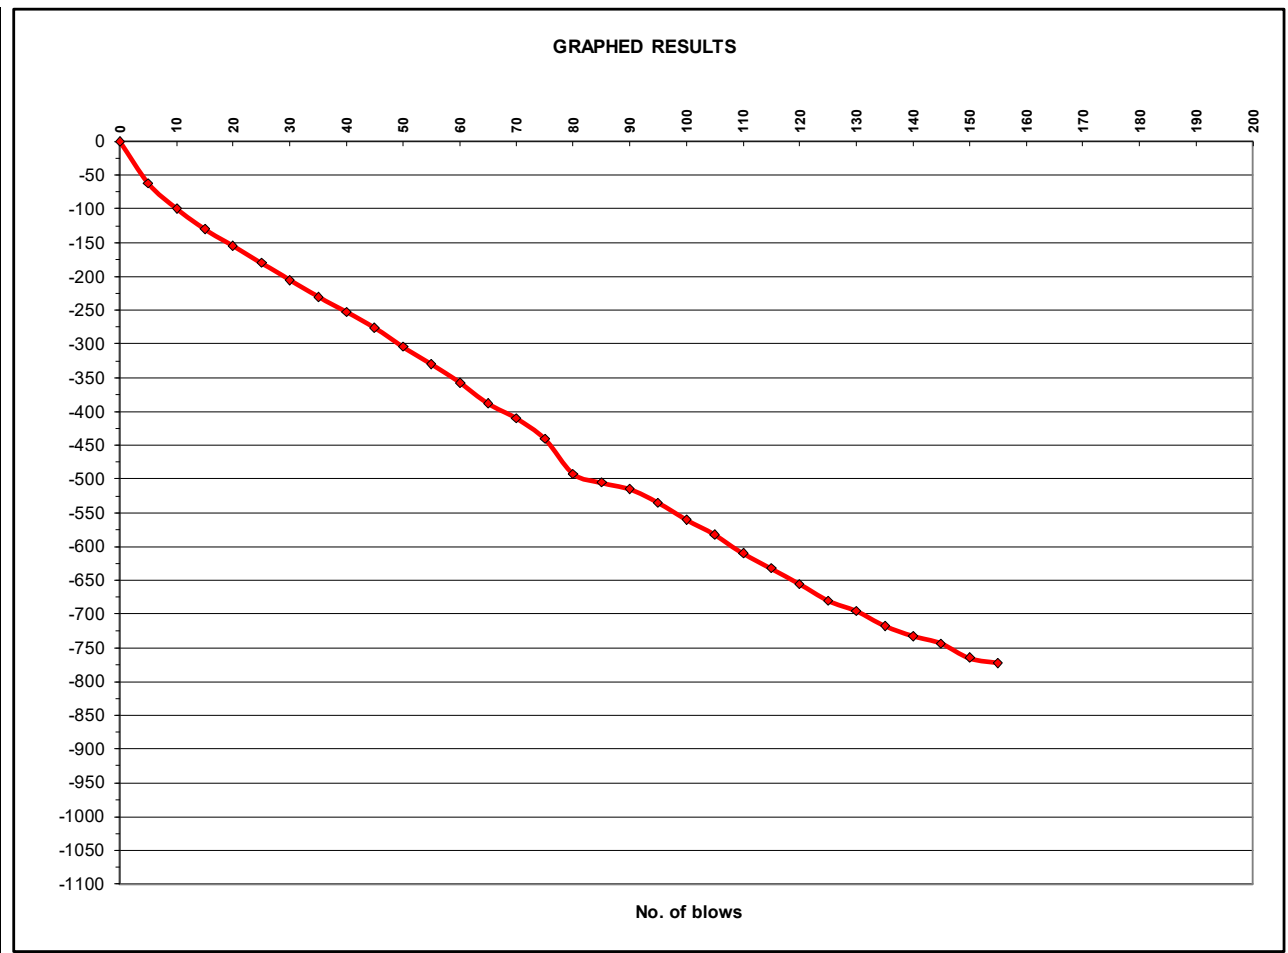
NO. OF BLOWS	TP 3				
	Values (mm)	Cumulative penetration (mm)	mm/blow	UCS (kPa)	CBR
0	10	0	0.0		
5	72	-62	12.4	186	17
10	110	-100	7.6	318	31
15	140	-130	6.0	411	42
20	165	-155	5.0	502	53
25	190	-180	5.0	502	53
30	215	-205	5.0	502	53
35	240	-230	5.0	502	53
40	262	-252	4.4	577	62
45	286	-276	4.8	525	56
50	314	-304	5.6	443	46
55	340	-330	5.2	481	51
60	367	-357	5.4	461	48
65	398	-388	6.2	397	40
70	420	-410	4.4	577	62
75	450	-440	6.0	411	42
80	502	-492	10.4	226	21
85	515	-505	2.6	1023	122
90	525	-515	2.0	1362	170
95	545	-535	4.0	640	70
100	570	-560	5.0	502	53
105	592	-582	4.4	577	62
110	620	-610	5.6	443	46
115	642	-632	4.4	577	62
120	665	-655	4.6	550	59
125	690	-680	5.0	502	53
130	705	-695	3.0	876	102
135	727	-717	4.4	577	62
140	742	-732	3.0	876	102
145	753	-743	2.2	1228	151
150	775	-765	4.4	577	62
155	782	-772	1.4	2010	267
160					
165					
170					
175					
180					
185					
190					
195					
200

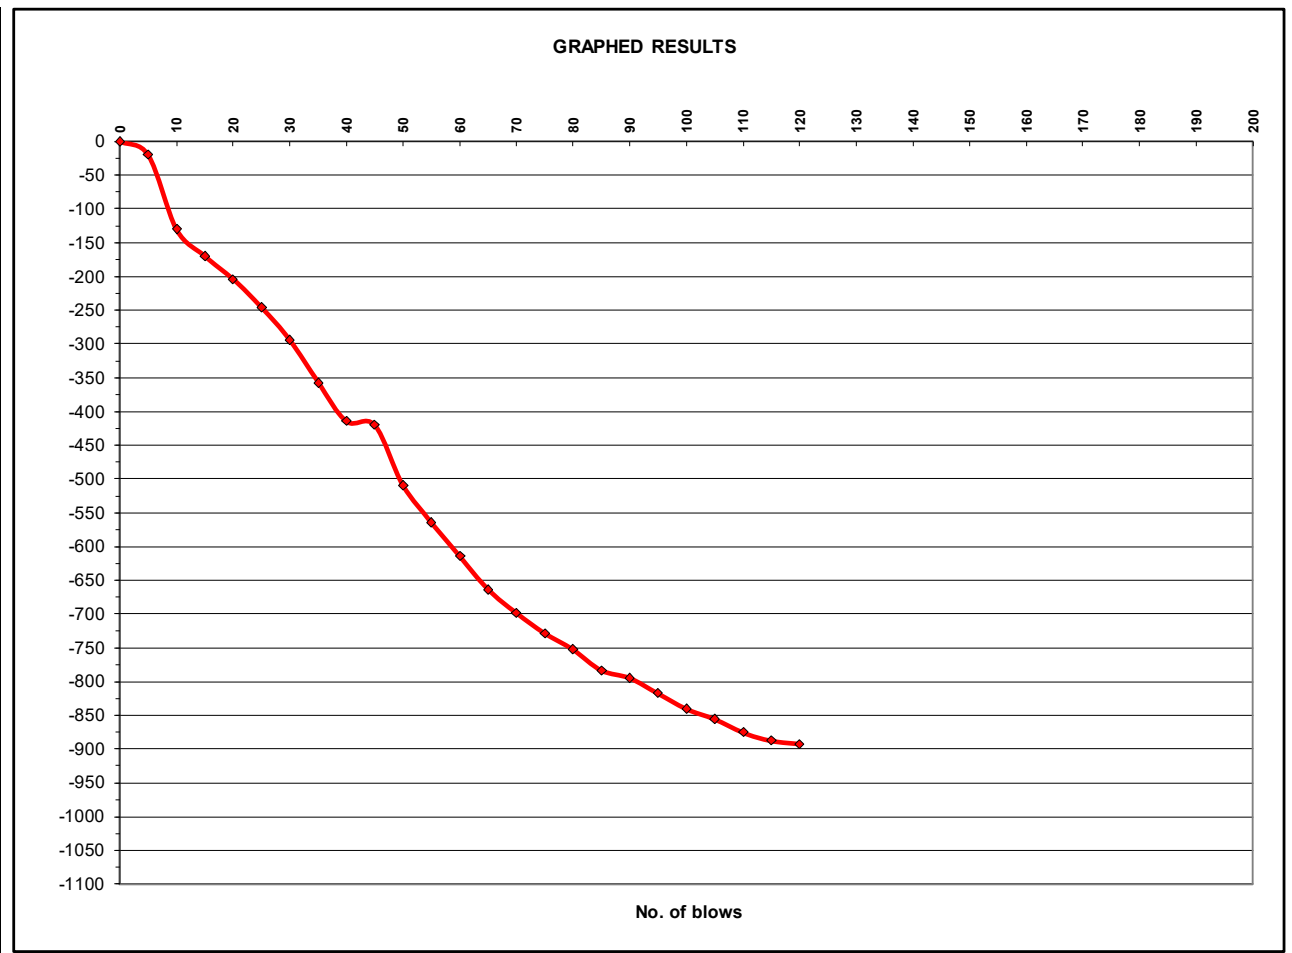
NO. OF BLOWS	TP 7				
	Values (mm)	Cumulative penetration (mm)	mm/blow	UCS (kPa)	CBR
0	20	0	0.0		
5	40	-20	4.0	640	70
10	150	-130	22.0	100	8
15	190	-170	8.0	301	29
20	224	-204	6.8	359	36
25	266	-246	8.4	285	27
30	314	-294	9.6	246	23
35	377	-357	12.6	183	16
40	434	-414	11.4	204	19
45	440	-420	1.2	2377	325
50	529	-509	17.8	126	11
55	584	-564	11.0	212	20
60	634	-614	10.0	236	22
65	683	-663	9.8	241	23
70	718	-698	7.0	348	35
75	748	-728	6.0	411	42
80	772	-752	4.8	525	56
85	803	-783	6.2	397	40
90	814	-794	2.2	1228	151
95	837	-817	4.6	550	59
100	860	-840	4.6	550	59
105	875	-855	3.0	876	102
110	895	-875	4.0	640	70
115	907	-887	2.4	1117	135
120	912	-892	1.0	2900	410
125					
130					
135					
140					
145					
150					
155					
160					
165					
170					
175					
180					
185					
190					
195					
200

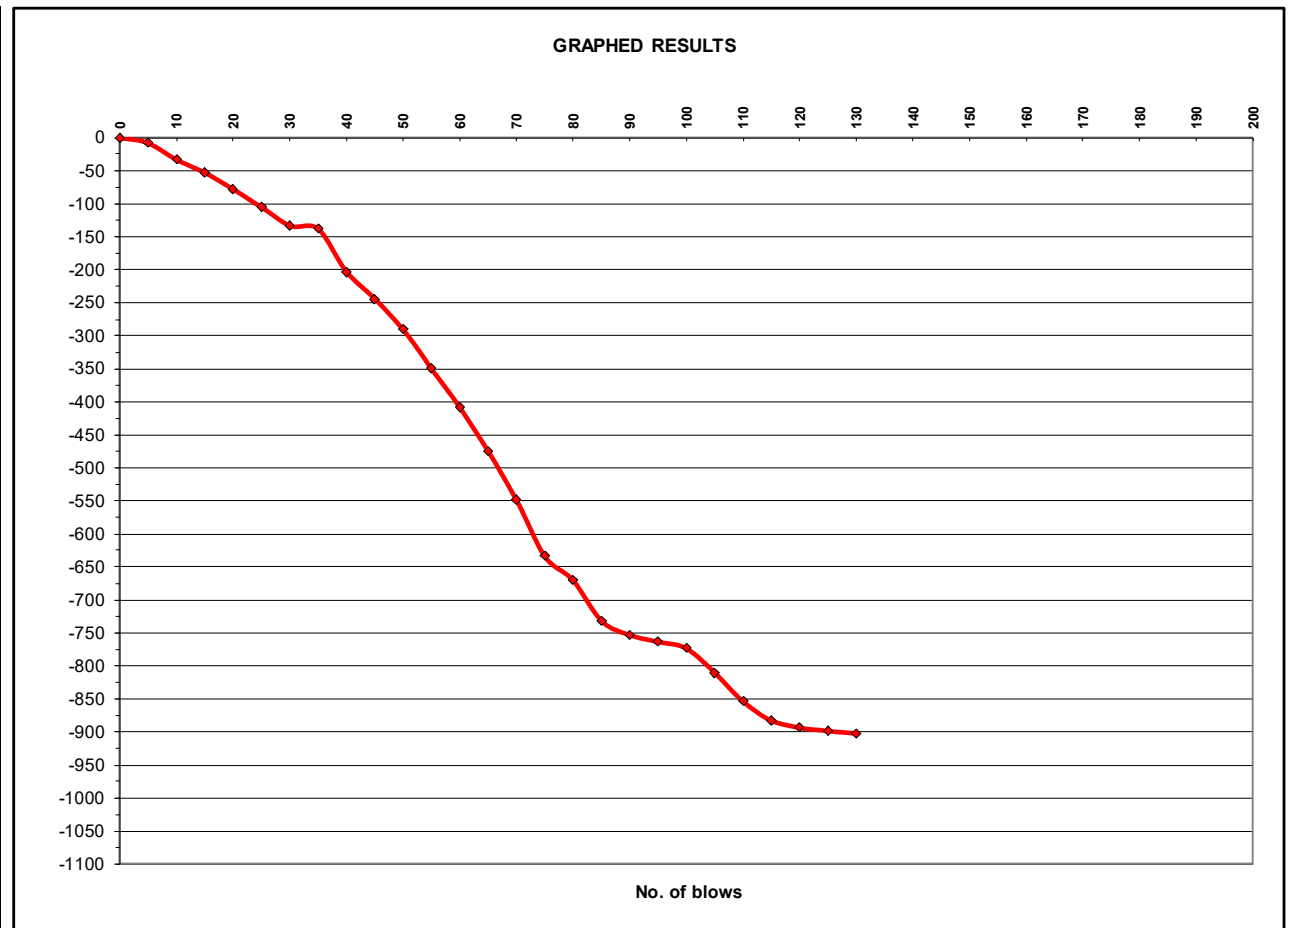
NO. OF BLOWS	TP 8				
	Values (mm)	Cumulative penetration (mm)	mm/blow	UCS (kPa)	CBR
0	12	0	0.0		
5	20	-8	1.6	1737	226
10	45	-33	5.0	502	53
15	65	-53	4.0	640	70
20	90	-78	5.0	502	53
25	117	-105	5.4	461	48
30	145	-133	5.6	443	46
35	150	-138	1.0	2900	410
40	215	-203	13.0	177	16
45	256	-244	8.2	293	28
50	302	-290	9.2	258	24
55	361	-349	11.8	197	18
60	420	-408	11.8	197	18
65	486	-474	13.2	174	15
70	560	-548	14.8	154	13
75	645	-633	17.0	132	11
80	682	-670	7.4	327	32
85	743	-731	12.2	190	17
90	765	-753	4.4	577	62
95	775	-763	2.0	1362	170
100	785	-773	2.0	1362	170
105	822	-810	7.4	327	32
110	865	-853	8.6	278	27
115	894	-882	5.8	427	44
120	905	-893	2.2	1228	151
125	910	-898	1.0	2900	410
130	914	-902	0.8	3699	544
135					
140					
145					
150					
155					
160					
165					
170					
175					
180					
185					
190					
195					
200

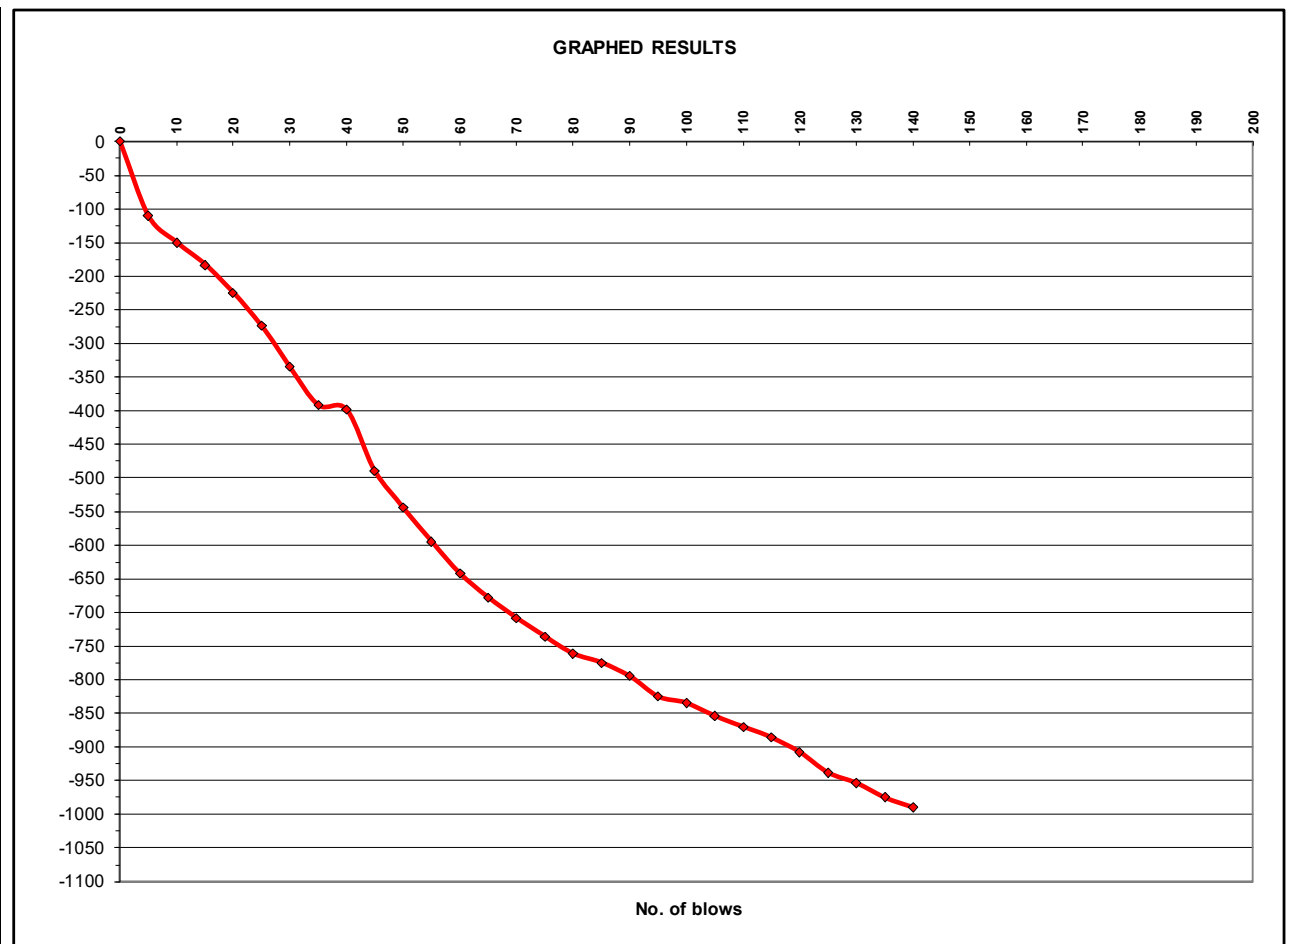
NO. OF BLOWS	TP 9				
	Values (mm)	Cumulative penetration (mm)	mm/blow	UCS (kPa)	CBR
0	40	0	0.0		
5	150	-110	22.0	100	8
10	190	-150	8.0	301	29
15	223	-183	6.6	371	37
20	265	-225	8.4	285	27
25	314	-274	9.8	241	23
30	375	-335	12.2	190	17
35	432	-392	11.4	204	19
40	439	-399	1.4	2010	267
45	530	-490	18.2	123	10
50	584	-544	10.8	217	20
55	635	-595	10.2	231	21
60	682	-642	9.4	252	24
65	718	-678	7.2	337	33
70	748	-708	6.0	411	42
75	776	-736	5.6	443	46
80	801	-761	5.0	502	53
85	815	-775	2.8	944	111
90	835	-795	4.0	640	70
95	865	-825	6.0	411	42
100	875	-835	2.0	1362	170
105	894	-854	3.8	677	75
110	910	-870	3.2	816	94
115	926	-886	3.2	816	94
120	948	-908	4.4	577	62
125	978	-938	6.0	411	42
130	994	-954	3.2	816	94
135	1015	-975	4.2	607	66
140	1030	-990	3.0	876	102
145					
150					
155					
160					
165					
170					
175					
180					
185					
190					
195					
200

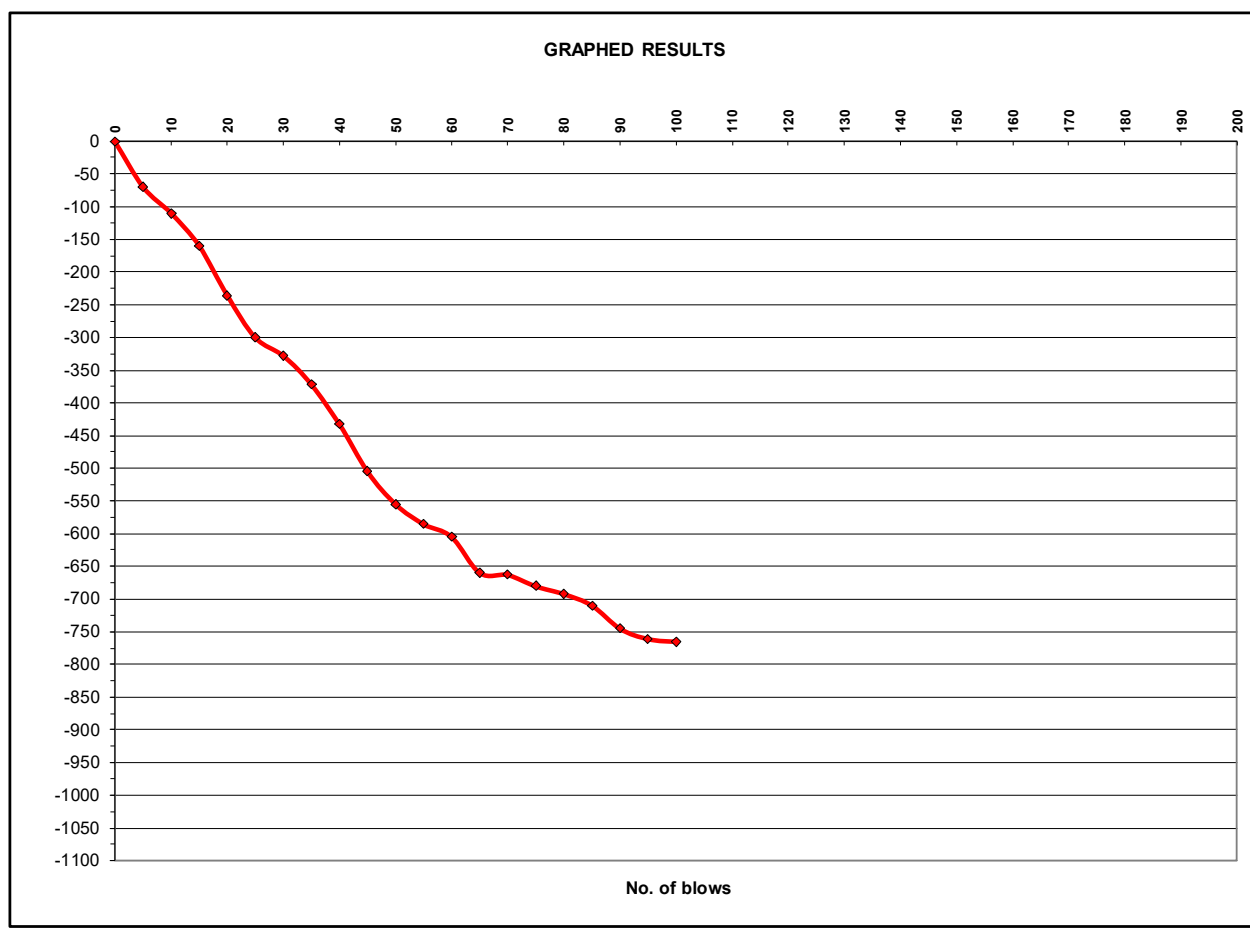
NO. OF BLOWS	TP 10				
	Values (mm)	Cumulative penetration (mm)	mm/blow	UCS (kPa)	CBR
0	20	0	0.0		
5	90	-70	14.0	163	14
10	130	-110	8.0	301	29
15	180	-160	10.0	236	22
20	256	-236	15.2	149	13
25	320	-300	12.8	180	16
30	348	-328	5.6	443	46
35	392	-372	8.8	271	26
40	453	-433	12.2	190	17
45	525	-505	14.4	158	14
50	575	-555	10.0	236	22
55	605	-585	6.0	411	42
60	625	-605	4.0	640	70
65	680	-660	11.0	212	20
70	683	-663	0.6	5061	784
75	700	-680	3.4	764	87
80	712	-692	2.4	1117	135
85	730	-710	3.6	718	81
90	765	-745	7.0	348	35
95	781	-761	3.2	816	94
100	785	-765	0.8	3699	544
105					
110					
115					
120					
125					
130					
135					
140					
145					
150					
155					
160					
165					
170					
175					
180					
185					
190					
195					
200

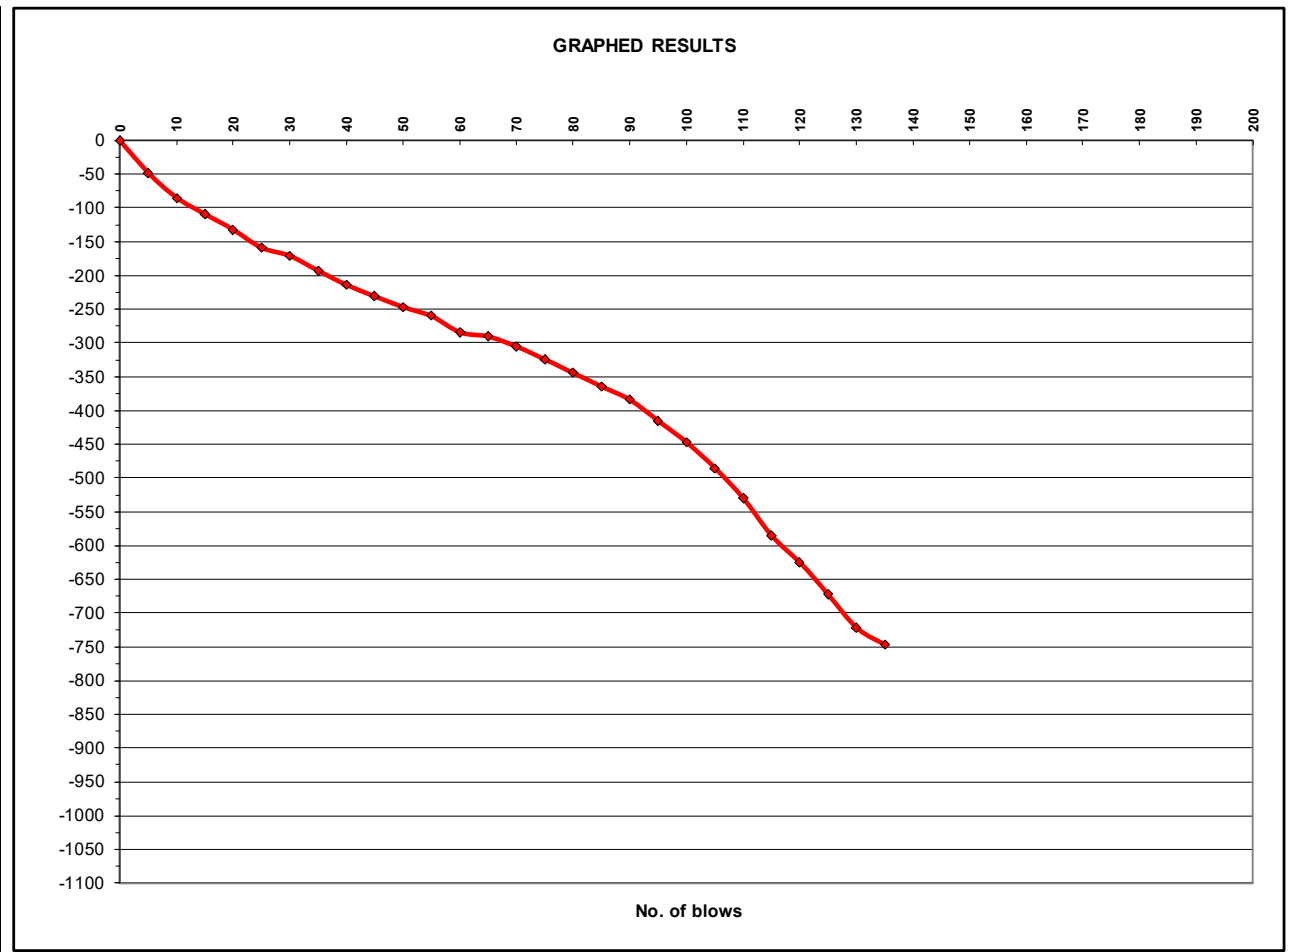
NO. OF BLOWS	TP 11				
	Values (mm)	Cumulative penetration (mm)	mm/blow	UCS (kPa)	CBR
0	30	0	0.0		
5	78	-48	9.6	246	23
10	115	-85	7.4	327	32
15	139	-109	4.8	525	56
20	162	-132	4.6	550	59
25	189	-159	5.4	461	48
30	201	-171	2.4	1117	135
35	223	-193	4.4	577	62
40	244	-214	4.2	607	66
45	261	-231	3.4	764	87
50	277	-247	3.2	816	94
55	290	-260	2.6	1023	122
60	314	-284	4.8	525	56
65	320	-290	1.2	2377	325
70	335	-305	3.0	876	102
75	354	-324	3.8	677	75
80	374	-344	4.0	640	70
85	394	-364	4.0	640	70
90	414	-384	4.0	640	70
95	445	-415	6.2	397	40
100	477	-447	6.4	383	39
105	515	-485	7.6	318	31
110	560	-530	9.0	264	25
115	615	-585	11.0	212	20
120	655	-625	8.0	301	29
125	702	-672	9.4	252	24
130	752	-722	10.0	236	22
135	776	-746	4.8	525	56
140					
145					
150					
155					
160					
165					
170					
175					
180					
185					
190					
195					
200

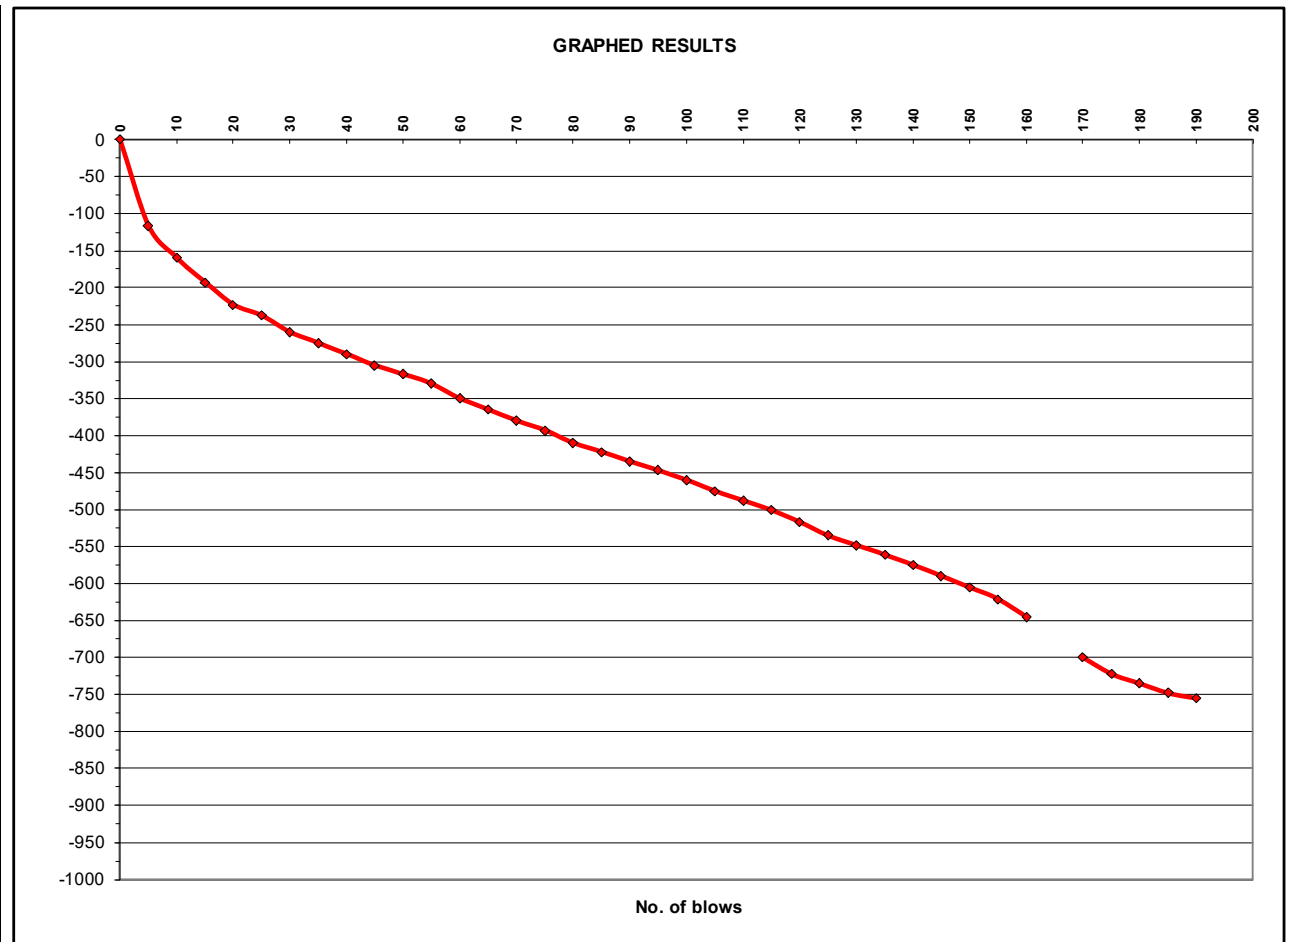
NO. OF BLOWS	TP 13				
	Values (mm)	Cumulative penetration (mm)	mm/blow	UCS (kPa)	CBR
0	25	0	0.0		
5	141	-116	23.2	94	8
10	185	-160	8.8	271	26
15	218	-193	6.6	371	37
20	248	-223	6.0	411	42
25	263	-238	3.0	876	102
30	285	-260	4.4	577	62
35	300	-275	3.0	876	102
40	315	-290	3.0	876	102
45	330	-305	3.0	876	102
50	342	-317	2.4	1117	135
55	355	-330	2.6	1023	122
60	375	-350	4.0	640	70
65	390	-365	3.0	876	102
70	405	-380	3.0	876	102
75	418	-393	2.6	1023	122
80	435	-410	3.4	764	87
85	447	-422	2.4	1117	135
90	460	-435	2.6	1023	122
95	472	-447	2.4	1117	135
100	485	-460	2.6	1023	122
105	500	-475	3.0	876	102
110	513	-488	2.6	1023	122
115	526	-501	2.6	1023	122
120	542	-517	3.2	816	94
125	560	-535	3.6	718	81
130	573	-548	2.6	1023	122
135	586	-561	2.6	1023	122
140	600	-575	2.8	944	111
145	615	-590	3.0	876	102
150	630	-605	3.0	876	102
155	646	-621	3.2	816	94
160	670	-645	4.8	525	56
165					
170	700	-700	140.0	13	1
175	722	-722	4.4	577	62
180	735	-735	2.6	1023	122

185	748	-748	2.6	1023	122
190	755	-755	1.4	2010	267
195					
200

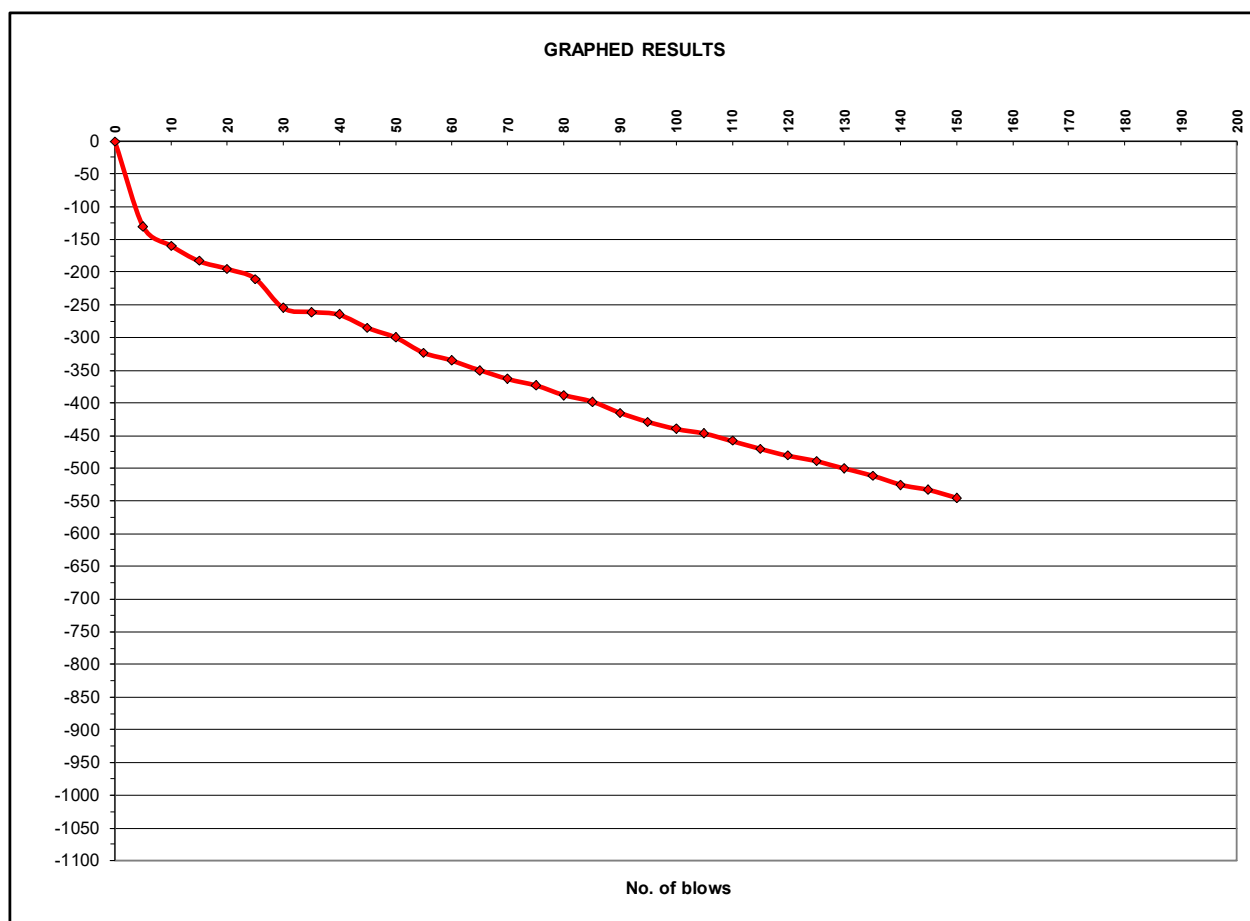
NO. OF BLOWS	TP 14				
	Values (mm)	Cumulative penetration (mm)	mm/blow	UCS (kPa)	CBR
0	25	0	0.0		
5	155	-130	26.0	83	7
10	185	-160	6.0	411	42
15	208	-183	4.6	550	59
20	220	-195	2.4	1117	135
25	235	-210	3.0	876	102
30	280	-255	9.0	264	25
35	286	-261	1.2	2377	325
40	290	-265	0.8	3699	544
45	310	-285	4.0	640	70
50	325	-300	3.0	876	102
55	348	-323	4.6	550	59
60	360	-335	2.4	1117	135
65	375	-350	3.0	876	102
70	388	-363	2.6	1023	122
75	398	-373	2.0	1362	170
80	413	-388	3.0	876	102
85	423	-398	2.0	1362	170
90	440	-415	3.4	764	87
95	454	-429	2.8	944	111
100	465	-440	2.2	1228	151
105	472	-447	1.4	2010	267
110	483	-458	2.2	1228	151
115	495	-470	2.4	1117	135
120	506	-481	2.2	1228	151
125	514	-489	1.6	1737	226
130	525	-500	2.2	1228	151
135	536	-511	2.2	1228	151
140	550	-525	2.8	944	111
145	558	-533	1.6	1737	226
150	570	-545	2.4	1117	135
155					
160					
165					
170					
175					
180					
185					
190					
195					
200

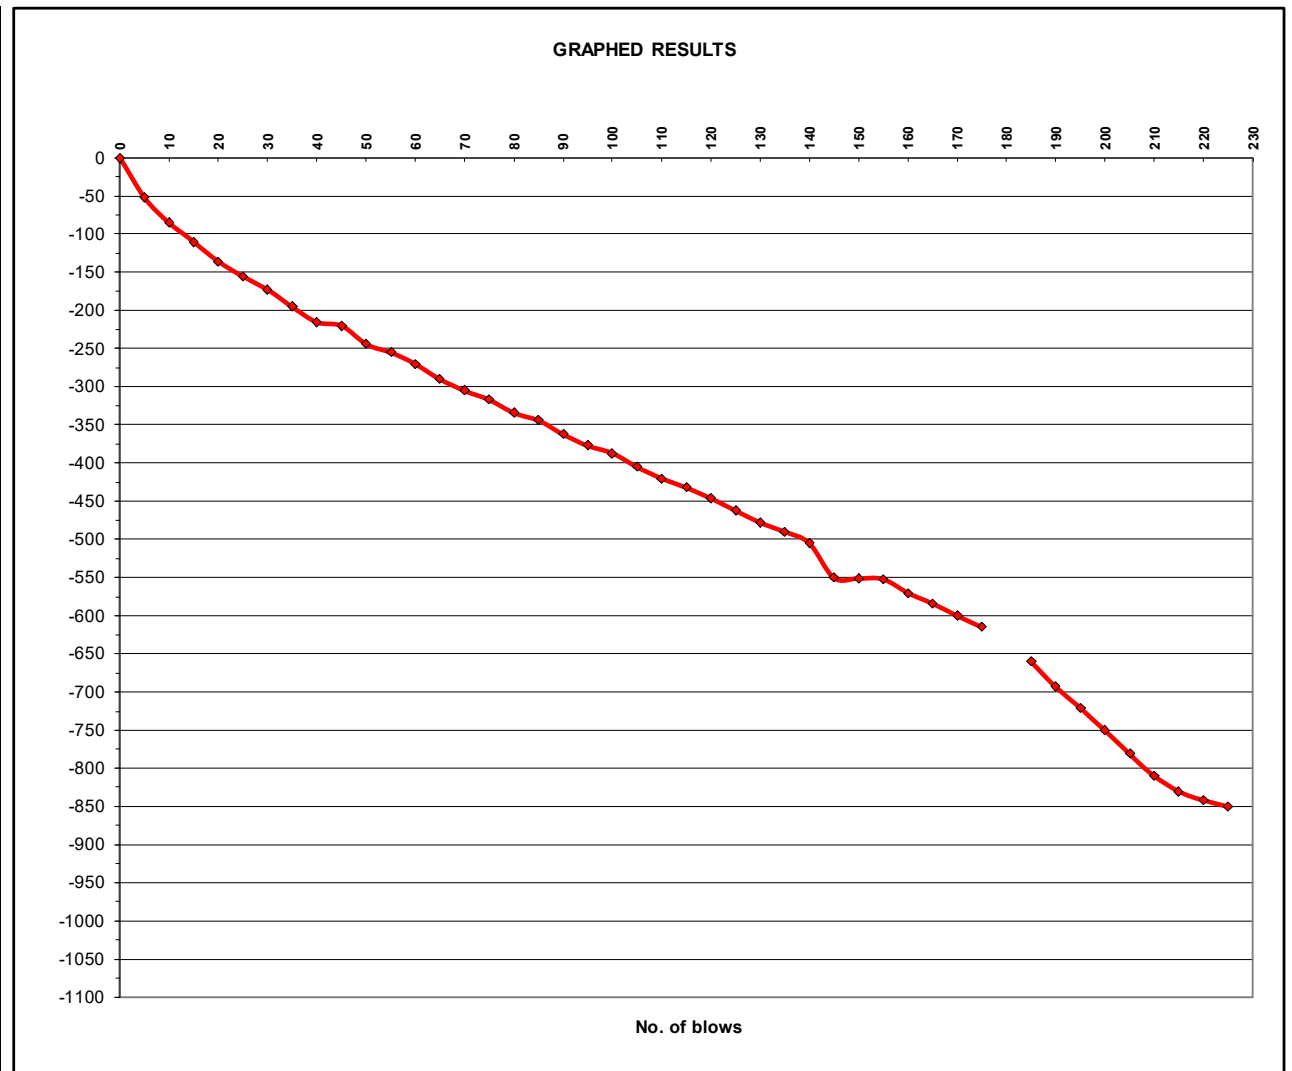
NO. OF BLOWS	TP 15				
	Values (mm)	Cumulative penetration (mm)	mm/blow	UCS (kPa)	CBR
0	30	0	0.0		
5	82	-52	10.4	226	21
10	115	-85	6.6	371	37
15	140	-110	5.0	502	53
20	166	-136	5.2	481	51
25	185	-155	3.8	677	75
30	203	-173	3.6	718	81
35	225	-195	4.4	577	62
40	245	-215	4.0	640	70
45	250	-220	1.0	2900	410
50	274	-244	4.8	525	56
55	285	-255	2.2	1228	151
60	300	-270	3.0	876	102
65	320	-290	4.0	640	70
70	335	-305	3.0	876	102
75	347	-317	2.4	1117	135
80	364	-334	3.4	764	87
85	374	-344	2.0	1362	170
90	392	-362	3.6	718	81
95	407	-377	3.0	876	102
100	417	-387	2.0	1362	170
105	435	-405	3.6	718	81
110	450	-420	3.0	876	102
115	462	-432	2.4	1117	135
120	476	-446	2.8	944	111
125	492	-462	3.2	816	94
130	508	-478	3.2	816	94
135	520	-490	2.4	1117	135
140	535	-505	3.0	876	102
145	580	-550	9.0	264	25
150	581	-551	0.2	16760	3166
155	582	-552	0.2	16760	3166
160	600	-570	3.6	718	81
165	614	-584	2.8	944	111
170	630	-600	3.2	816	94
175	645	-615	3.0	876	102

180					
185	660	-660	132.0	14	1
190	693	-693	6.6	371	37
195	721	-721	5.6	443	46
200	750	-750	5.8	427	44
205	781	-781	6.2	397	40
210	810	-810	5.8	427	44
215	830	-830	4.0	640	70
220	842	-842	2.4	1117	135
225	850	-850	1.6	1737	226
230

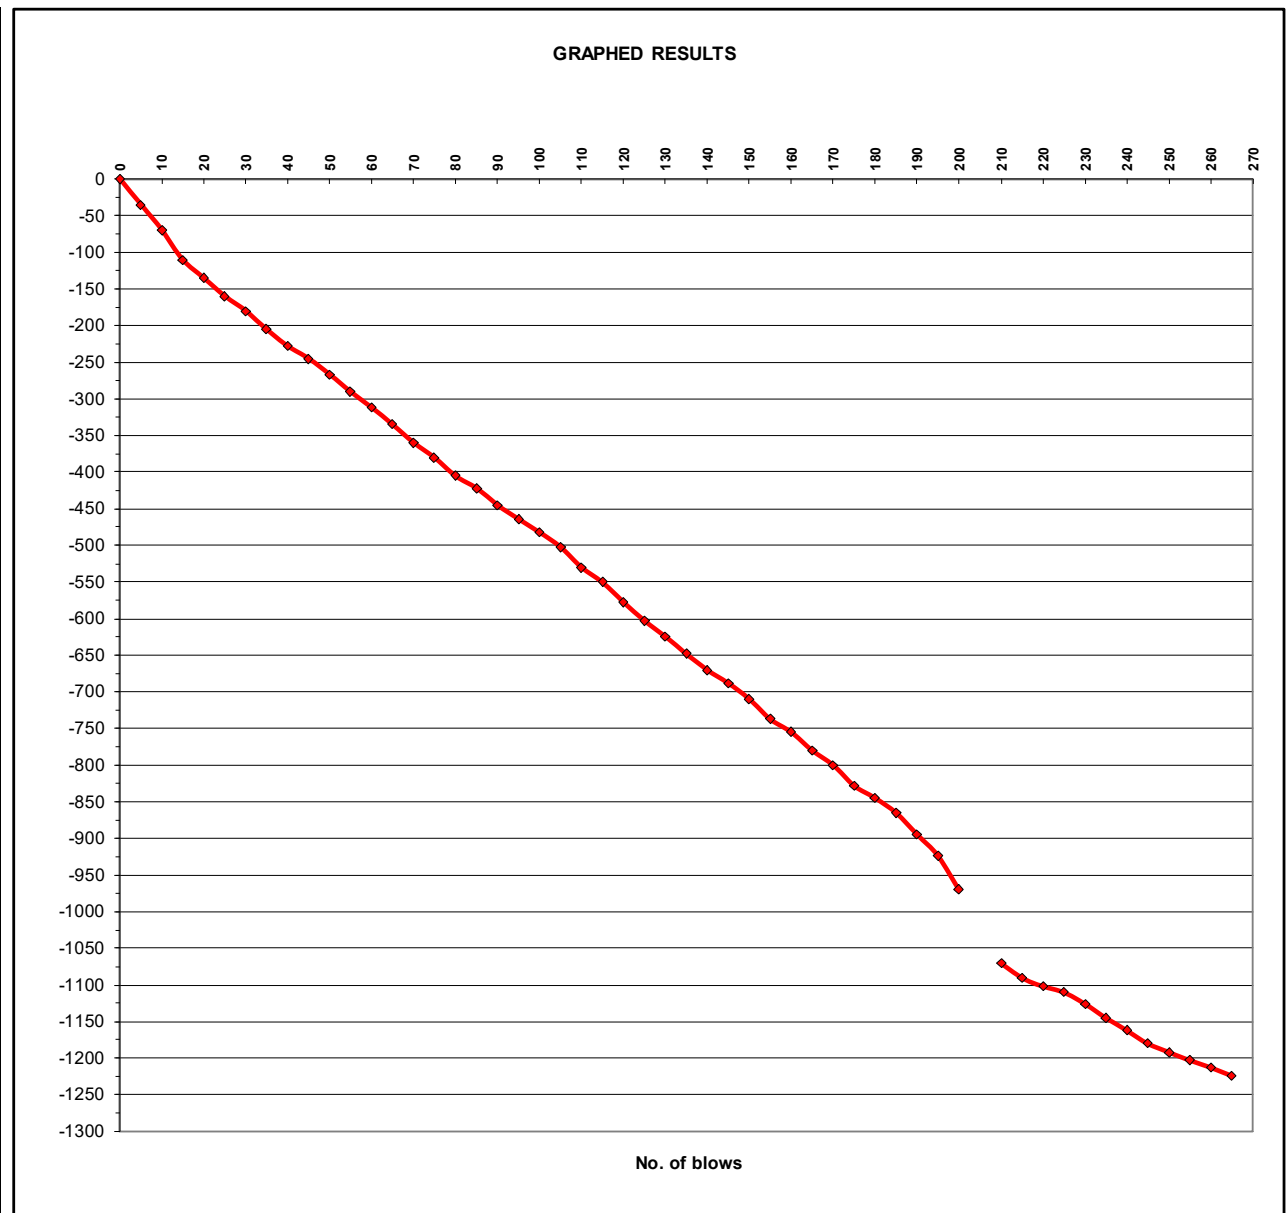
NO. OF BLOWS	TP 16				
	Values (mm)	Cumulative penetration (mm)	mm/blow	UCS (kPa)	CBR
0	70	0	0.0		
5	105	-35	7.0	348	35
10	140	-70	7.0	348	35
15	180	-110	8.0	301	29
20	205	-135	5.0	502	53
25	230	-160	5.0	502	53
30	250	-180	4.0	640	70
35	275	-205	5.0	502	53
40	298	-228	4.6	550	59
45	315	-245	3.4	764	87
50	337	-267	4.4	577	62
55	360	-290	4.6	550	59
60	382	-312	4.4	577	62
65	405	-335	4.6	550	59
70	430	-360	5.0	502	53
75	450	-380	4.0	640	70
80	475	-405	5.0	502	53
85	492	-422	3.4	764	87
90	515	-445	4.6	550	59
95	534	-464	3.8	677	75
100	552	-482	3.6	718	81
105	572	-502	4.0	640	70
110	600	-530	5.6	443	46
115	620	-550	4.0	640	70
120	647	-577	5.4	461	48
125	673	-603	5.2	481	51
130	695	-625	4.4	577	62
135	718	-648	4.6	550	59
140	740	-670	4.4	577	62
145	758	-688	3.6	718	81
150	780	-710	4.4	577	62
155	807	-737	5.4	461	48
160	825	-755	3.6	718	81
165	850	-780	5.0	502	53
170	870	-800	4.0	640	70
175	898	-828	5.6	443	46
180	915	-845	3.4	764	87

185	935	-865	4.0	640	70
190	965	-895	6.0	411	42
195	994	-924	5.8	427	44
200	1040	-970	9.2	258	24
205					
210	1070	-1070	214.0	8	0
215	1090	-1090	4.0	640	70
220	1102	-1102	2.4	1117	135
225	1110	-1110	1.6	1737	226
230	1126	-1126	3.2	816	94
235	1145	-1145	3.8	677	75
240	1162	-1162	3.4	764	87
245	1180	-1180	3.6	718	81
250	1192	-1192	2.4	1117	135
255	1203	-1203	2.2	1228	151
260	1213	-1213	2.0	1362	170
265	1224	-1224	2.2	1228	151
270
