Company	: BVI Border	Date	: 25 July 2018
Attention	: Mr. Werner De Lange	email	: WernerDL@bvi.co.za
From	: Mr. Frikkie De Jager	Total pages	: 46

Ref: 25072018/pgrecfdj1

GEOTECHNICAL PRELIMINARY REPORT – ELIDZ PLATFORM A

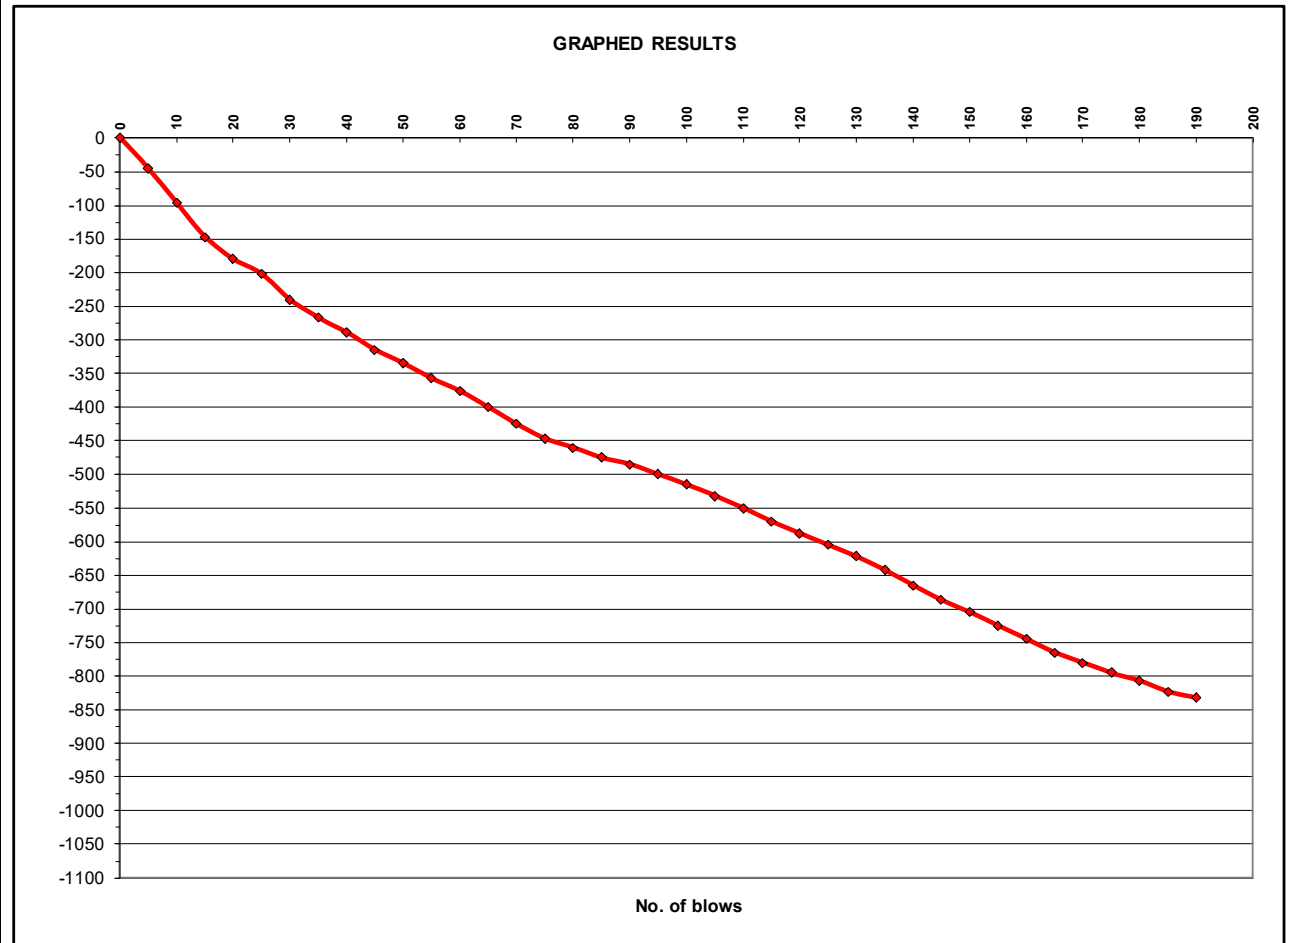
NO. OF BLOWS	TP 17				
	Values (mm)	Cumulative penetration (mm)	mm/blow	UCS (kPa)	CBR
0	25	0	0.0		
5	70	-45	9.0	264	25
10	122	-97	10.4	226	21
15	172	-147	10.0	236	22
20	205	-180	6.6	371	37
25	227	-202	4.4	577	62
30	265	-240	7.6	318	31
35	292	-267	5.4	461	48
40	314	-289	4.4	577	62
45	340	-315	5.2	481	51
50	360	-335	4.0	640	70
55	382	-357	4.4	577	62
60	401	-376	3.8	677	75
65	425	-400	4.8	525	56
70	450	-425	5.0	502	53
75	472	-447	4.4	577	62
80	485	-460	2.6	1023	122
85	500	-475	3.0	876	102
90	510	-485	2.0	1362	170
95	525	-500	3.0	876	102
100	540	-515	3.0	876	102
105	557	-532	3.4	764	87
110	575	-550	3.6	718	81
115	595	-570	4.0	640	70
120	613	-588	3.6	718	81
125	630	-605	3.4	764	87
130	647	-622	3.4	764	87
135	667	-642	4.0	640	70
140	690	-665	4.6	550	59
145	712	-687	4.4	577	62
150	730	-705	3.6	718	81
155	750	-725	4.0	640	70
160	770	-745	4.0	640	70
165	790	-765	4.0	640	70
170	805	-780	3.0	876	102
175	820	-795	3.0	876	102
180	832	-807	2.4	1117	135

185	848	-823	3.2	816	94
190	857	-832	1.8	1528	194
195					
200

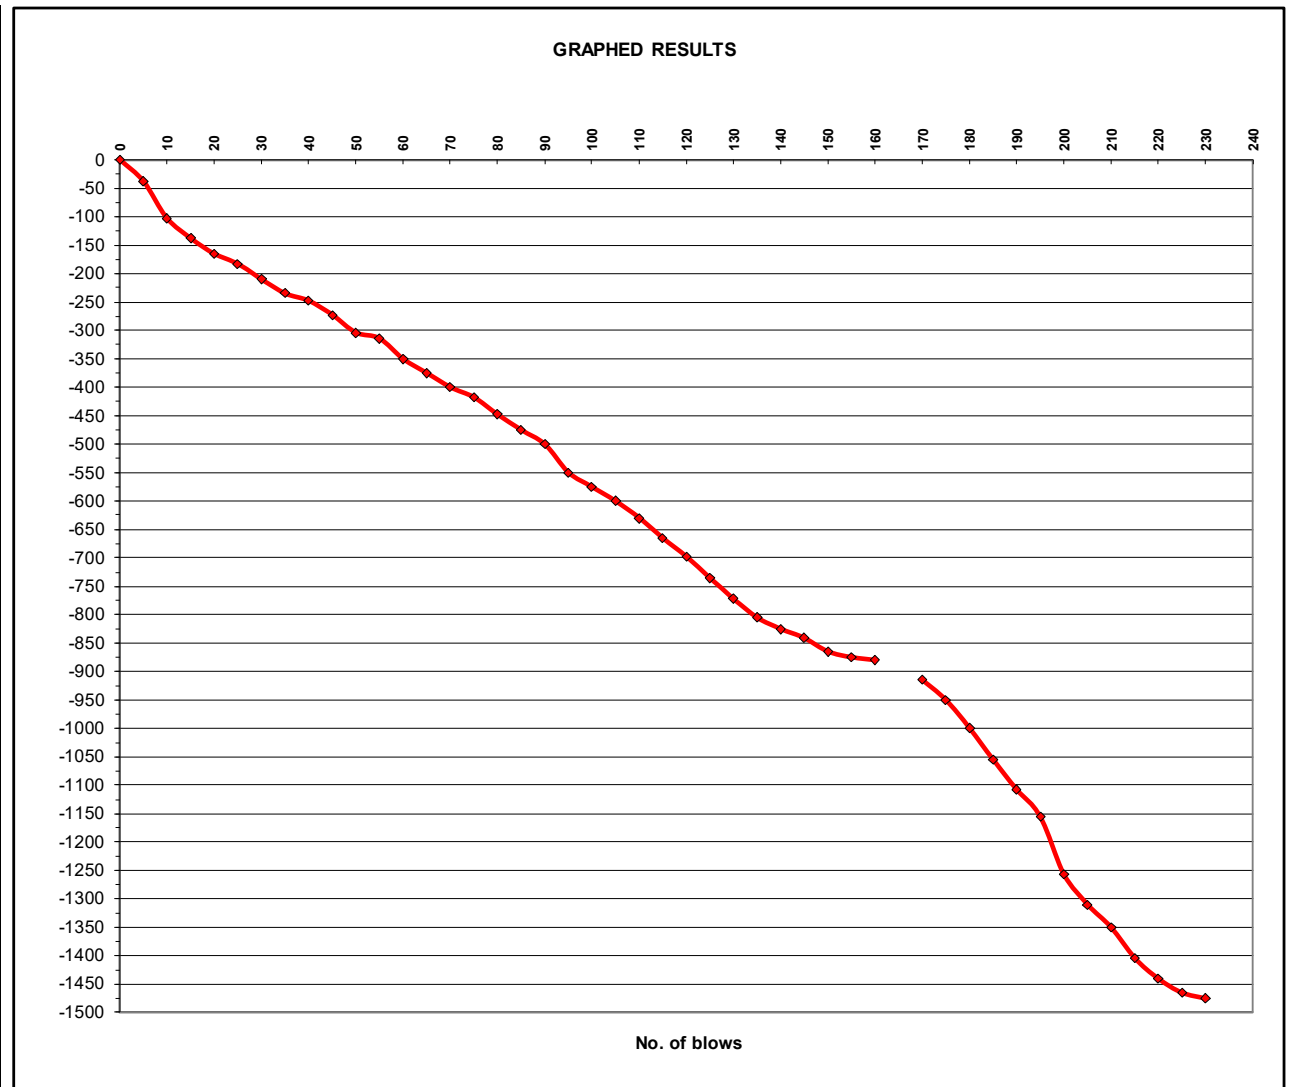
NO. OF BLOWS	TP 21				
	Values (mm)	Cumulative penetration (mm)	mm/blow	UCS (kPa)	CBR
0	10	0	0.0		
5	48	-38	7.6	318	31
10	113	-103	13.0	177	16
15	148	-138	7.0	348	35
20	175	-165	5.4	461	48
25	193	-183	3.6	718	81
30	220	-210	5.4	461	48
35	245	-235	5.0	502	53
40	258	-248	2.6	1023	122
45	283	-273	5.0	502	53
50	314	-304	6.2	397	40
55	324	-314	2.0	1362	170
60	360	-350	7.2	337	33
65	385	-375	5.0	502	53
70	410	-400	5.0	502	53
75	428	-418	3.6	718	81
80	458	-448	6.0	411	42
85	485	-475	5.4	461	48
90	510	-500	5.0	502	53
95	560	-550	10.0	236	22
100	585	-575	5.0	502	53
105	610	-600	5.0	502	53
110	640	-630	6.0	411	42
115	675	-665	7.0	348	35
120	708	-698	6.6	371	37
125	745	-735	7.4	327	32
130	782	-772	7.4	327	32
135	815	-805	6.6	371	37
140	835	-825	4.0	640	70
145	851	-841	3.2	816	94
150	875	-865	4.8	525	56
155	885	-875	2.0	1362	170
160	890	-880	1.0	2900	410
165					
170	915	-915	183.0	10	1
175	950	-950	7.0	348	35
180	1000	-1000	10.0	236	22
185	1055	-1055	11.0	212	20

190	1108	-1108	10.6	221	20
195	1155	-1155	9.4	252	24
200	1257	-1257	20.4	108	9
205	1310	-1310	10.6	221	20
210	1350	-1350	8.0	301	29
215	1404	-1404	10.8	217	20
220	1440	-1440	7.2	337	33
225	1465	-1465	5.0	502	53
230	1475	-1475	2.0	1362	170
235

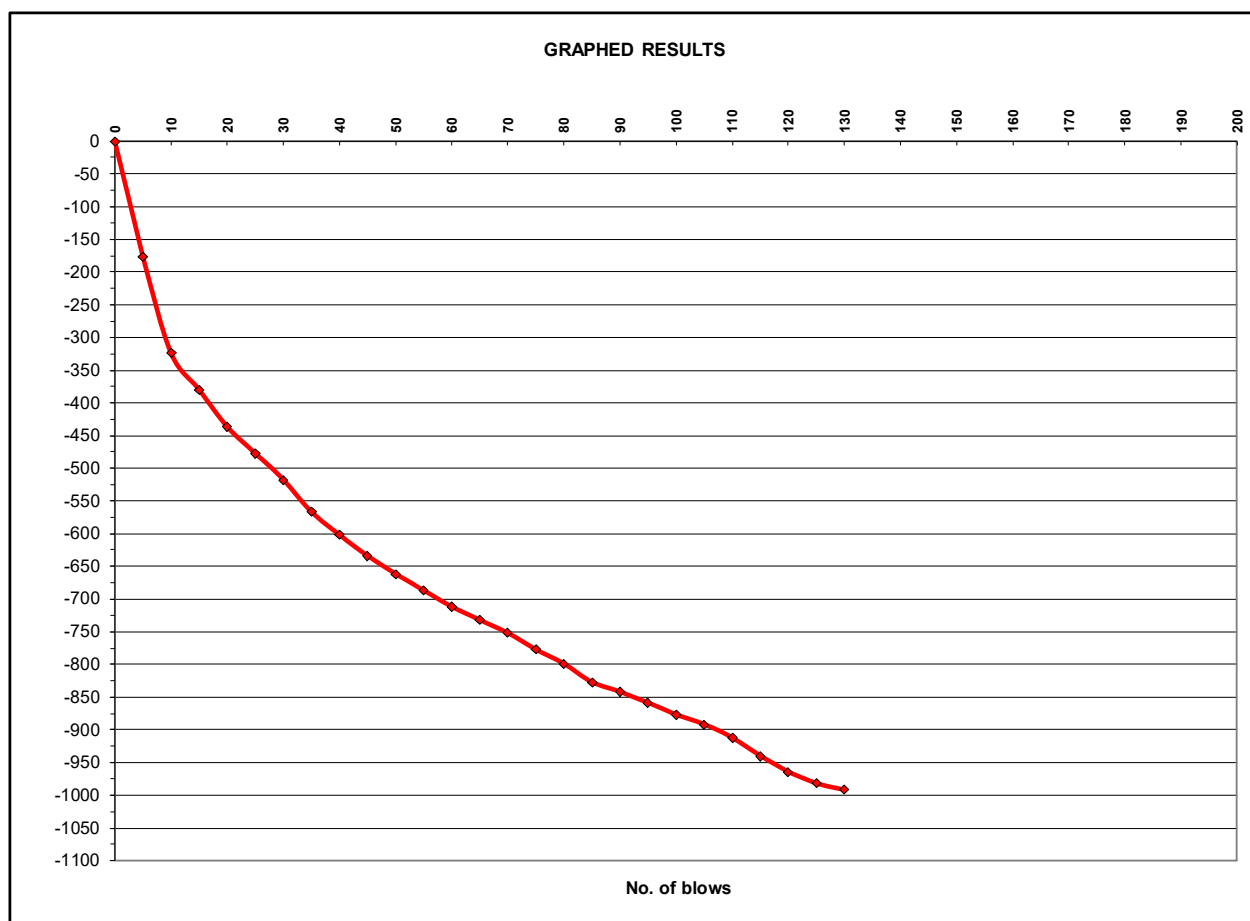
NO. OF BLOWS	TP 22				
	Values (mm)	Cumulative penetration (mm)	mm/blow	UCS (kPa)	CBR
0	28	0	0.0		
5	205	-177	35.4	59	4
10	352	-324	29.4	73	6
15	408	-380	11.2	208	19
20	465	-437	11.4	204	19
25	505	-477	8.0	301	29
30	546	-518	8.2	293	28
35	595	-567	9.8	241	23
40	630	-602	7.0	348	35
45	662	-634	6.4	383	39
50	690	-662	5.6	443	46
55	715	-687	5.0	502	53
60	740	-712	5.0	502	53
65	760	-732	4.0	640	70
70	780	-752	4.0	640	70
75	805	-777	5.0	502	53
80	827	-799	4.4	577	62
85	855	-827	5.6	443	46
90	870	-842	3.0	876	102
95	887	-859	3.4	764	87
100	905	-877	3.6	718	81
105	920	-892	3.0	876	102
110	940	-912	4.0	640	70
115	968	-940	5.6	443	46
120	992	-964	4.8	525	56
125	1010	-982	3.6	718	81
130	1020	-992	2.0	1362	170
135					
140					
145					
150					
155					
160					
165					
170					
175					
180					
185					
190					
195					
200

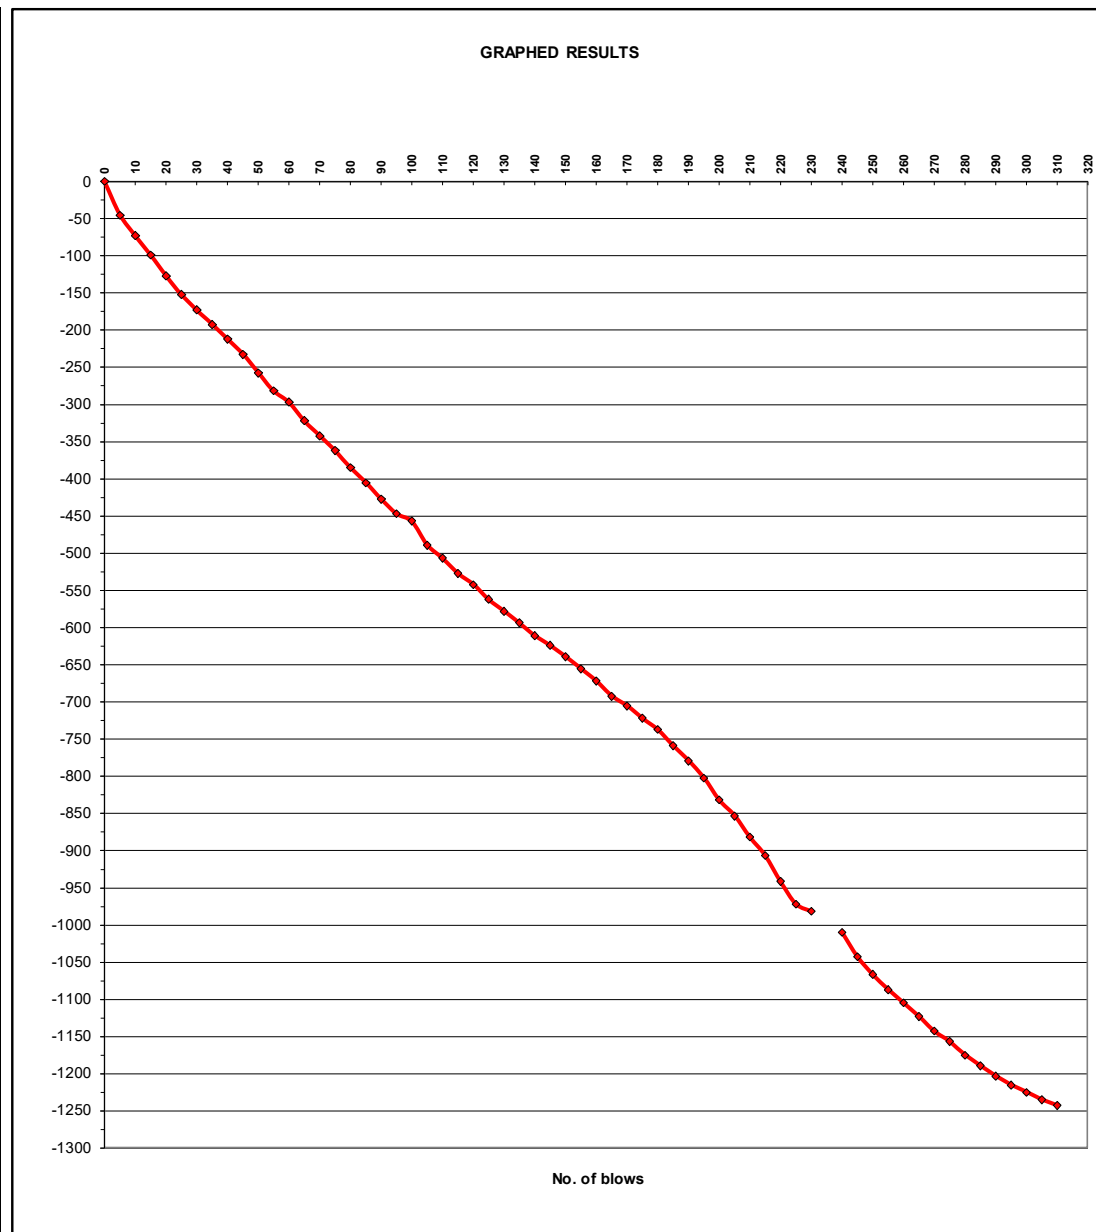
NO. OF BLOWS	TP 23				
	Values (mm)	Cumulative penetration (mm)	mm/blow	UCS (kPa)	CBR
0	23	0	0.0		
5	68	-45	9.0	264	25
10	96	-73	5.6	443	46
15	122	-99	5.2	481	51
20	150	-127	5.6	443	46
25	175	-152	5.0	502	53
30	196	-173	4.2	607	66
35	215	-192	3.8	677	75
40	235	-212	4.0	640	70
45	255	-232	4.0	640	70
50	280	-257	5.0	502	53
55	305	-282	5.0	502	53
60	320	-297	3.0	876	102
65	345	-322	5.0	502	53
70	365	-342	4.0	640	70
75	385	-362	4.0	640	70
80	408	-385	4.6	550	59
85	428	-405	4.0	640	70
90	450	-427	4.4	577	62
95	470	-447	4.0	640	70
100	480	-457	2.0	1362	170
105	512	-489	6.4	383	39
110	530	-507	3.6	718	81
115	550	-527	4.0	640	70
120	565	-542	3.0	876	102
125	585	-562	4.0	640	70
130	601	-578	3.2	816	94
135	617	-594	3.2	816	94
140	634	-611	3.4	764	87
145	647	-624	2.6	1023	122
150	662	-639	3.0	876	102
155	678	-655	3.2	816	94
160	695	-672	3.4	764	87
165	715	-692	4.0	640	70
170	728	-705	2.6	1023	122
175	745	-722	3.4	764	87
180	760	-737	3.0	876	102

185	782	-759	4.4	577	62
190	802	-779	4.0	640	70
195	825	-802	4.6	550	59
200	855	-832	6.0	411	42
205	876	-853	4.2	607	66
210	905	-882	5.8	427	44
215	930	-907	5.0	502	53
220	965	-942	7.0	348	35
225	995	-972	6.0	411	42
230	1005	-982	2.0	1362	170
235					
240	1010	-1010	202.0	9	0
245	1043	-1043	6.6	371	37
250	1067	-1067	4.8	525	56
255	1087	-1087	4.0	640	70
260	1105	-1105	3.6	718	81
265	1123	-1123	3.6	718	81
270	1143	-1143	4.0	640	70
275	1157	-1157	2.8	944	111
280	1175	-1175	3.6	718	81
285	1189	-1189	2.8	944	111
290	1203	-1203	2.8	944	111
295	1215	-1215	2.4	1117	135
300	1225	-1225	2.0	1362	170
305	1235	-1235	2.0	1362	170
310	1243	-1243	1.6	1737	226
315

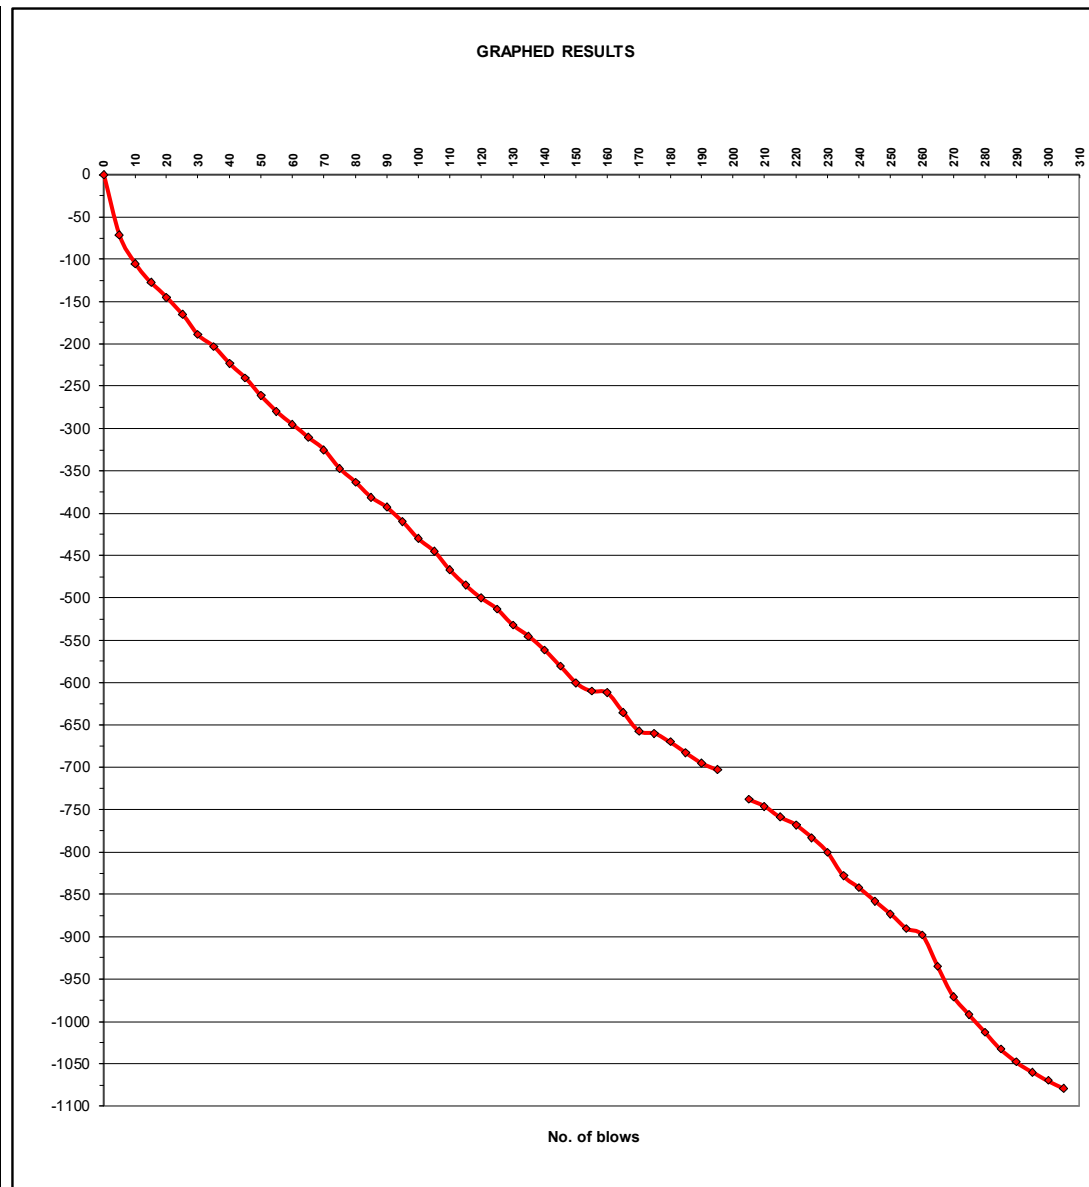
NO. OF BLOWS	TP 24				
	Values (mm)	Cumulative penetration (mm)	mm/blow	UCS (kPa)	CBR
0	15	0	0.0		
5	86	-71	14.2	161	14
10	120	-105	6.8	359	36
15	142	-127	4.4	577	62
20	160	-145	3.6	718	81
25	180	-165	4.0	640	70
30	204	-189	4.8	525	56
35	218	-203	2.8	944	111
40	238	-223	4.0	640	70
45	255	-240	3.4	764	87
50	276	-261	4.2	607	66
55	295	-280	3.8	677	75
60	310	-295	3.0	876	102
65	325	-310	3.0	876	102
70	340	-325	3.0	876	102
75	362	-347	4.4	577	62
80	378	-363	3.2	816	94
85	396	-381	3.6	718	81
90	408	-393	2.4	1117	135
95	425	-410	3.4	764	87
100	445	-430	4.0	640	70
105	460	-445	3.0	876	102
110	482	-467	4.4	577	62
115	500	-485	3.6	718	81
120	515	-500	3.0	876	102
125	528	-513	2.6	1023	122
130	547	-532	3.8	677	75
135	560	-545	2.6	1023	122
140	576	-561	3.2	816	94
145	595	-580	3.8	677	75
150	615	-600	4.0	640	70
155	625	-610	2.0	1362	170
160	627	-612	0.4	7873	1313
165	650	-635	4.6	550	59
170	672	-657	4.4	577	62
175	675	-660	0.6	5061	784
180	685	-670	2.0	1362	170

185	698	-683	2.6	1023	122
190	710	-695	2.4	1117	135
195	718	-703	1.6	1737	226
200					
205	738	-738	147.6	13	1
210	746	-746	1.6	1737	226
215	759	-759	2.6	1023	122
220	768	-768	1.8	1528	194
225	783	-783	3.0	876	102
230	800	-800	3.4	764	87
235	828	-828	5.6	443	46
240	842	-842	2.8	944	111
245	858	-858	3.2	816	94
250	873	-873	3.0	876	102
255	890	-890	3.4	764	87
260	898	-898	1.6	1737	226
265	935	-935	7.4	327	32
270	971	-971	7.2	337	33
275	992	-992	4.2	607	66
280	1013	-1013	4.2	607	66
285	1033	-1033	4.0	640	70
290	1048	-1048	3.0	876	102
295	1060	-1060	2.4	1117	135
300	1070	-1070	2.0	1362	170
305	1079	-1079	1.8	1528	194
310

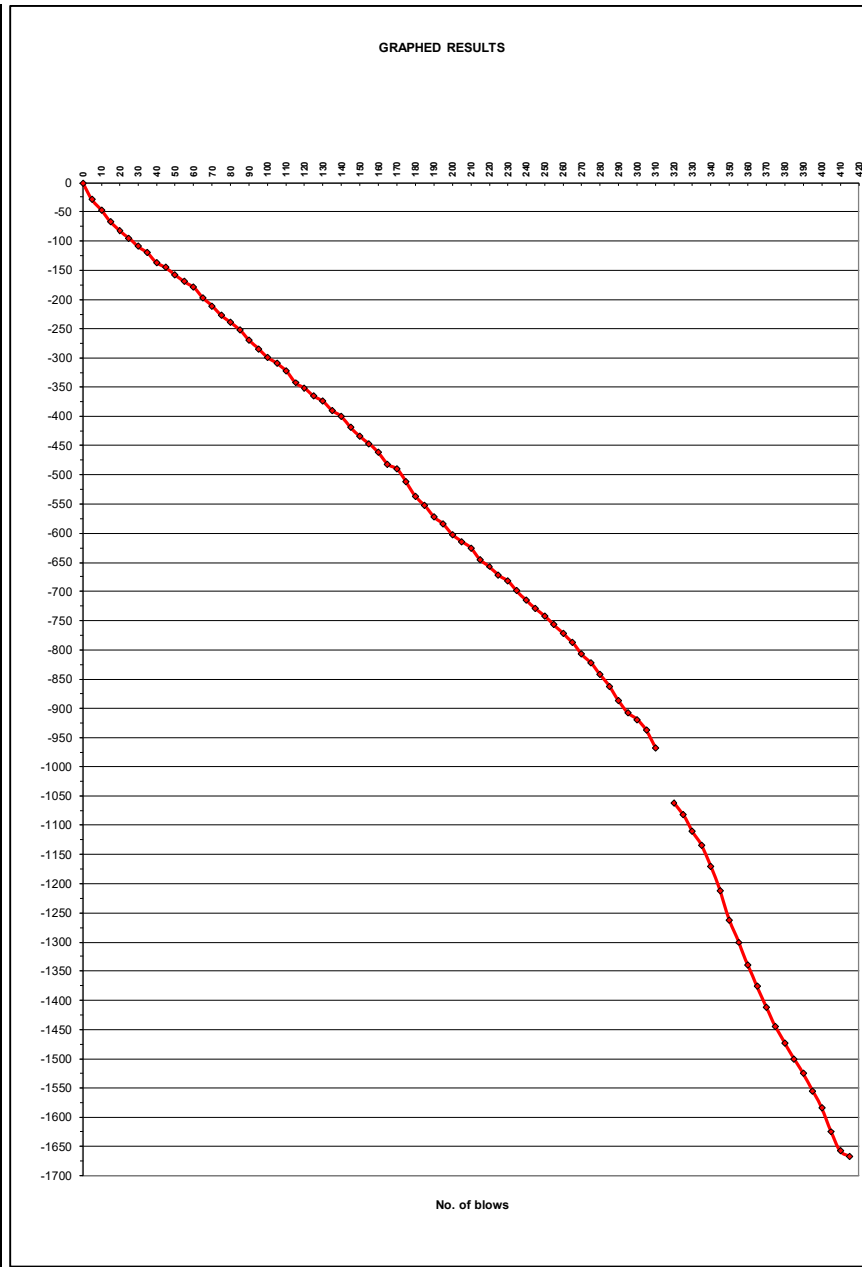
180	600	-537	5.0	502	53
185	615	-552	3.0	876	102
190	635	-572	4.0	640	70
195	647	-584	2.4	1117	135
200	665	-602	3.6	718	81
205	677	-614	2.4	1117	135
210	688	-625	2.2	1228	151
215	708	-645	4.0	640	70
220	720	-667	2.4	1117	135
225	735	-672	3.0	876	102
230	745	-682	2.0	1362	170
235	762	-699	3.4	764	87
240	778	-715	3.2	816	94
245	792	-729	2.8	944	111
250	805	-742	2.6	1023	122
255	820	-757	3.0	876	102
260	835	-772	3.0	876	102
265	850	-787	3.0	876	102
270	870	-807	4.0	640	70
275	885	-822	3.0	876	102
280	905	-842	4.0	640	70
285	925	-862	4.0	640	70
290	950	-887	5.0	502	53
295	970	-907	4.0	640	70
300	982	-919	2.4	1117	135
305	1000	-937	3.6	718	81
310	1030	-967	6.0	411	42
315					
320	1062	-1062	212.4	8	0
325	1082	-1082	4.0	640	70
330	1110	-1110	5.6	443	46
335	1135	-1135	5.0	502	53
340	1170	-1170	7.0	348	35
345	1212	-1212	8.4	285	27
350	1262	-1262	10.0	236	22
355	1300	-1300	7.6	318	31
360	1340	-1340	8.0	301	29
365	1376	-1376	7.2	337	33

370	1412	-1412	7.2	337	33
375	1445	-1445	6.6	371	37
380	1473	-1473	5.6	443	46
385	1500	-1500	5.4	461	48
390	1525	-1525	5.0	502	53
395	1555	-1555	6.0	411	42
400	1584	-1584	5.8	427	44
405	1625	-1625	8.2	293	28
410	1658	-1658	6.6	371	37
415	1668	-1668	2.0	1362	170
420

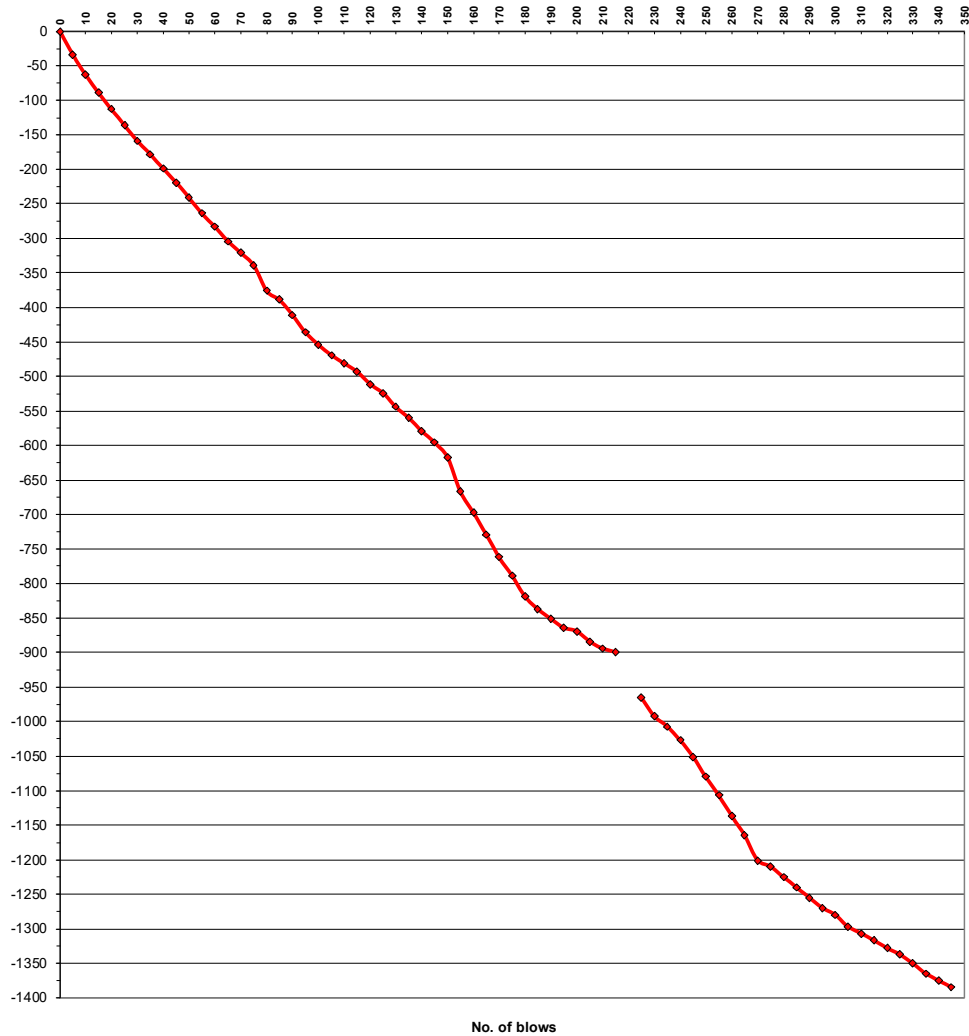
GRAPHED RESULTS

185	878	-837	3.6	718	81
190	892	-851	2.8	944	111
195	905	-864	2.6	1023	122
200	910	-869	1.0	2900	410
205	925	-884	3.0	876	102
210	935	-894	2.0	1362	170
215	940	-899	1.0	2900	410
220					
225	965	-965	193.0	9	1
230	992	-992	5.4	461	48
235	1007	-1007	3.0	876	102
240	1027	-1027	4.0	640	70
245	1051	-1051	4.8	525	56
250	1080	-1080	5.8	427	44
255	1107	-1107	5.4	461	48
260	1137	-1137	6.0	411	42
265	1165	-1165	5.6	443	46
270	1201	-1201	7.2	337	33
275	1210	-1210	1.8	1528	194
280	1225	-1225	3.0	876	102
285	1240	-1240	3.0	876	102
290	1255	-1255	3.0	876	102
295	1270	-1270	3.0	876	102
300	1280	-1280	2.0	1362	170
305	1297	-1297	3.4	764	87
310	1307	-1307	2.0	1362	170
315	1317	-1317	2.0	1362	170
320	1328	-1328	2.2	1228	151
325	1337	-1337	1.8	1528	194
330	1350	-1350	2.6	1023	122
335	1365	-1365	3.0	876	102
340	1375	-1375	2.0	1362	170
345	1385	-1385	2.0	1362	170
350

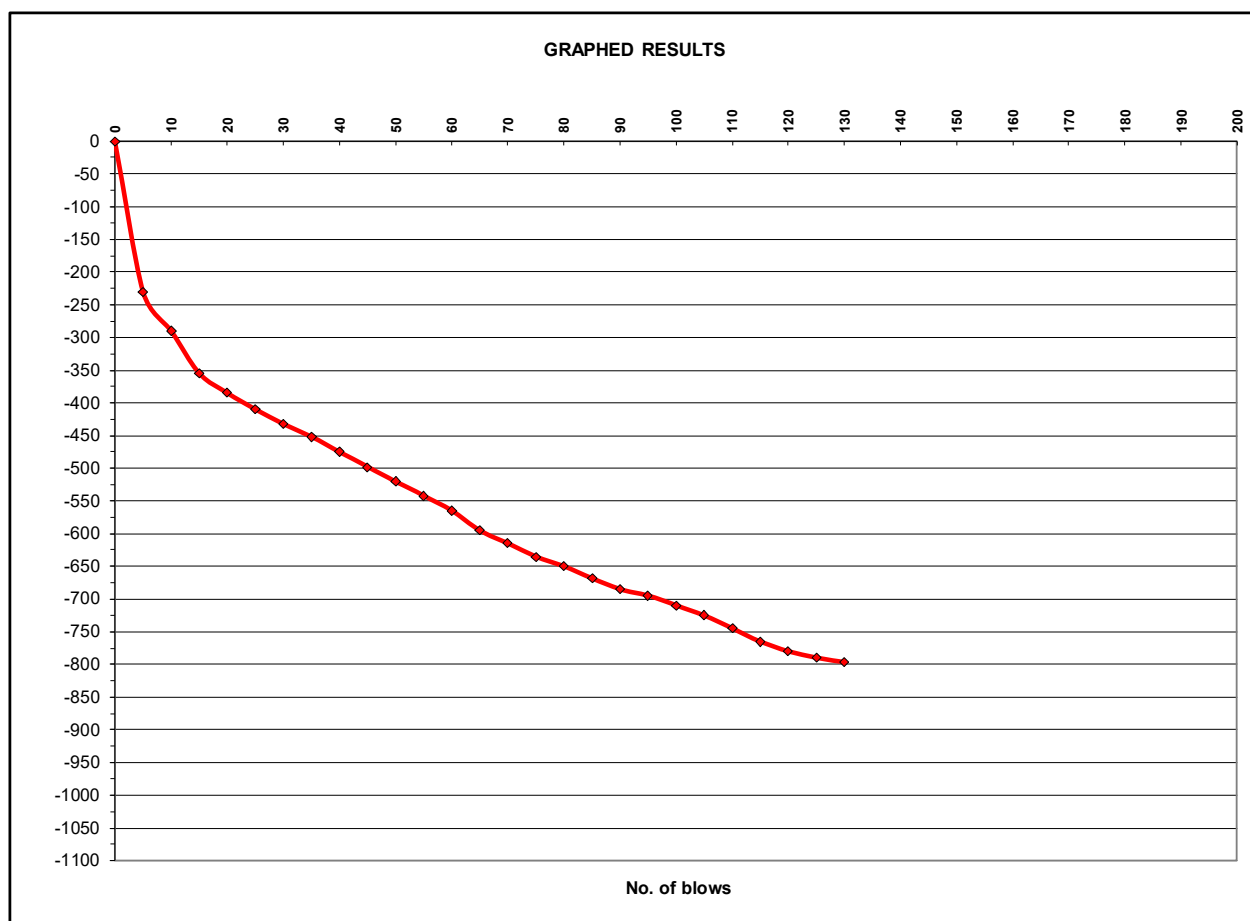
NO. OF BLOWS	TP 28				
	Values (mm)	Cumulative penetration (mm)	mm/blow	UCS (kPa)	CBR
0	10	0	0.0		
5	240	-230	46.0	45	3
10	300	-290	12.0	193	17
15	365	-355	13.0	177	16
20	395	-385	6.0	411	42
25	420	-410	5.0	502	53
30	442	-432	4.4	577	62
35	462	-452	4.0	640	70
40	485	-475	4.6	550	59
45	508	-498	4.6	550	59
50	530	-520	4.4	577	62
55	552	-542	4.4	577	62
60	575	-565	4.6	550	59
65	605	-595	6.0	411	42
70	625	-615	4.0	640	70
75	645	-635	4.0	640	70
80	660	-650	3.0	876	102
85	678	-668	3.6	718	81
90	695	-685	3.4	764	87
95	705	-695	2.0	1362	170
100	720	-710	3.0	876	102
105	735	-725	3.0	876	102
110	755	-745	4.0	640	70
115	775	-765	4.0	640	70
120	790	-780	3.0	876	102
125	800	-790	2.0	1362	170
130	807	-797	1.4	2010	267
135					
140					
145					
150					
155					
160					
165					
170					
175					
180					
185					
190					
195					
200
