AGES Omega (Pty) Ltd

Ref: 25072018/pgrecfdj2

GEOTECHNICAL PRELIMINARY REPORT – ELIDZ PLATFORM B

The following preliminary report is given for the above-mentioned project, for the area designated for Platform B.

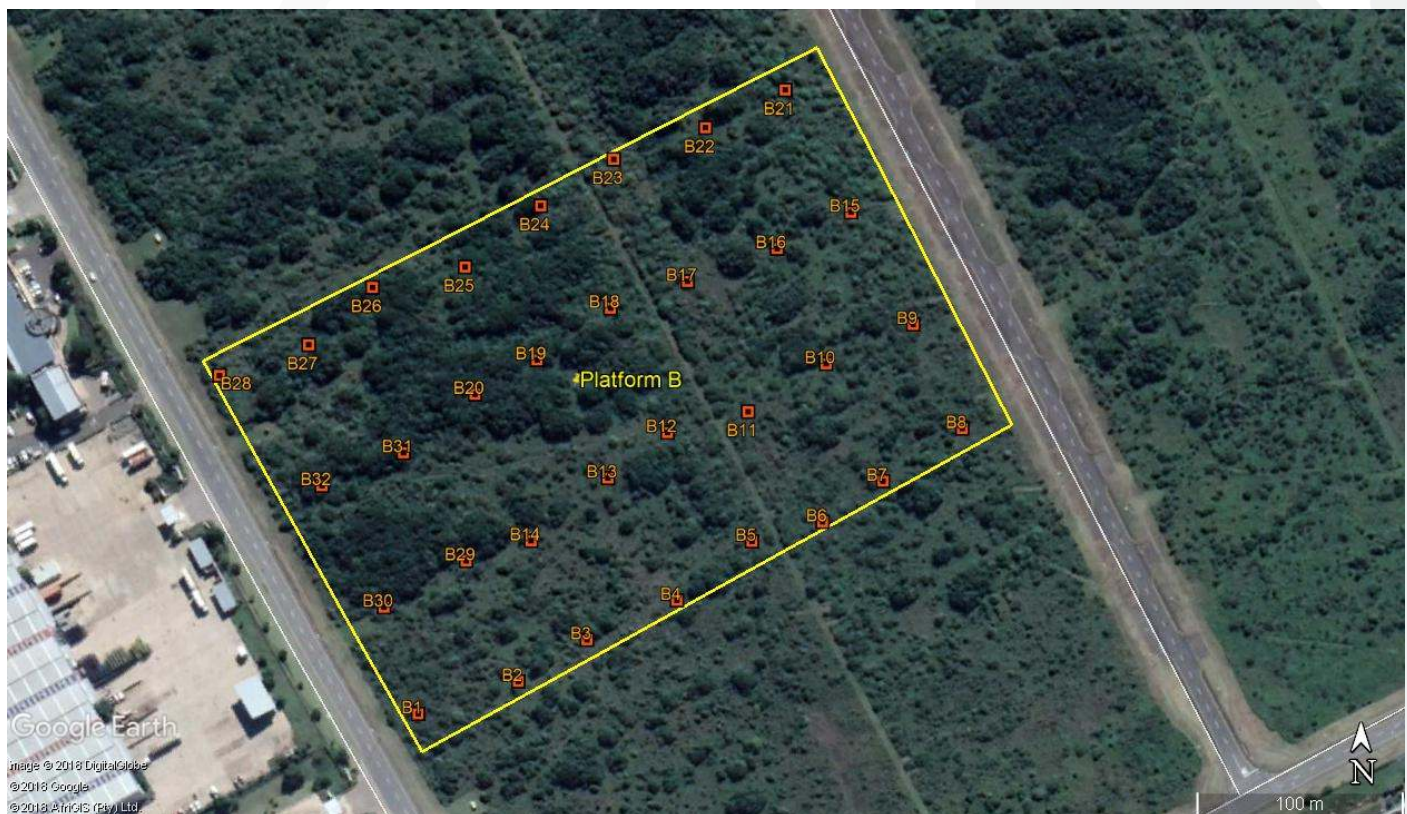
Figure 1: Test pit positions and numbering on Platform B

A total of 32 test pits, numbered Test Pit B1 to B32 were excavated in the central portion of the project area designated for Platform B and future expansions. The positions of the test pits are indicated in the Figure below, with detailed test pit logs attached in the end of this document for reference.

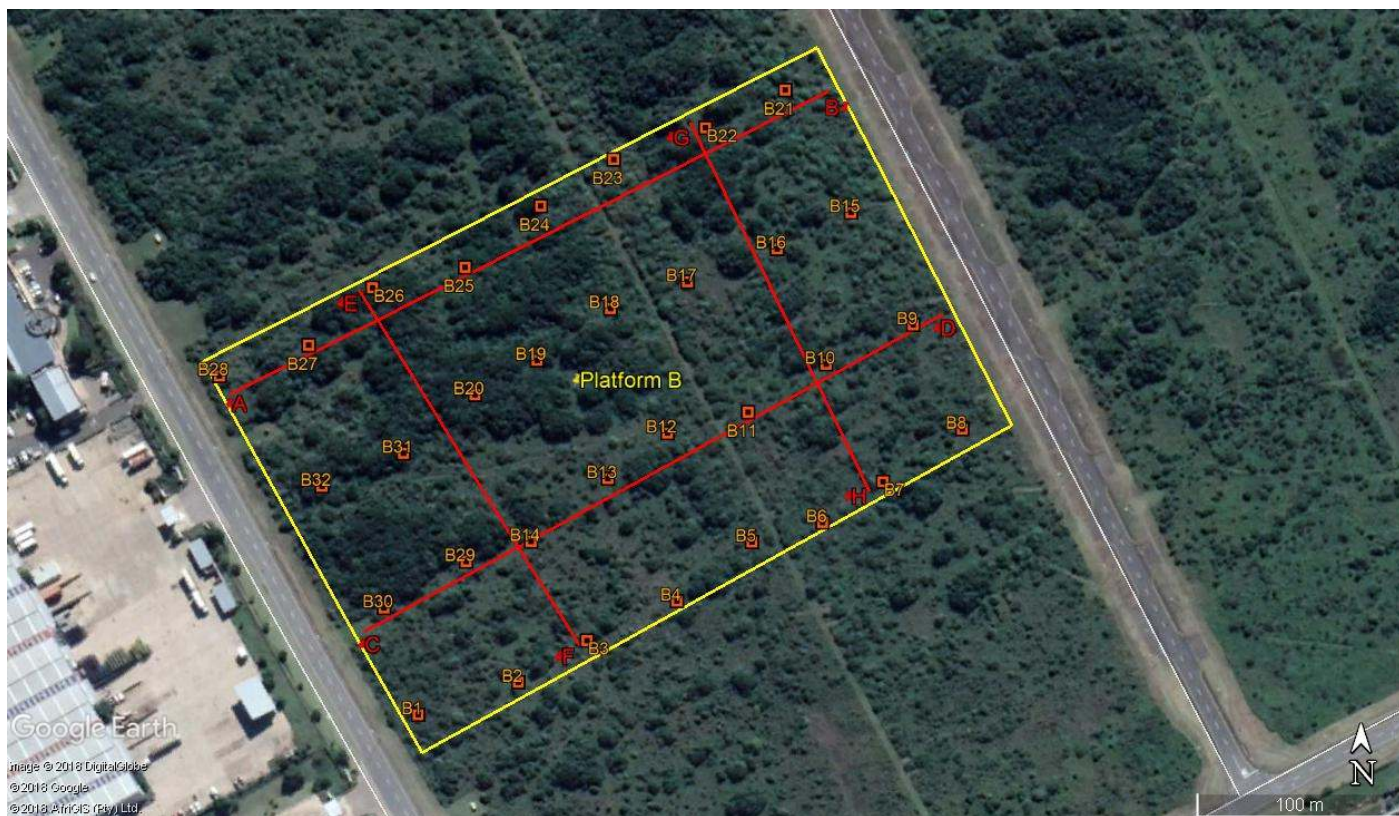
Figure 2: Cross section indication for Platform B

The generalised soil profile and sections are indicated in the figures below.

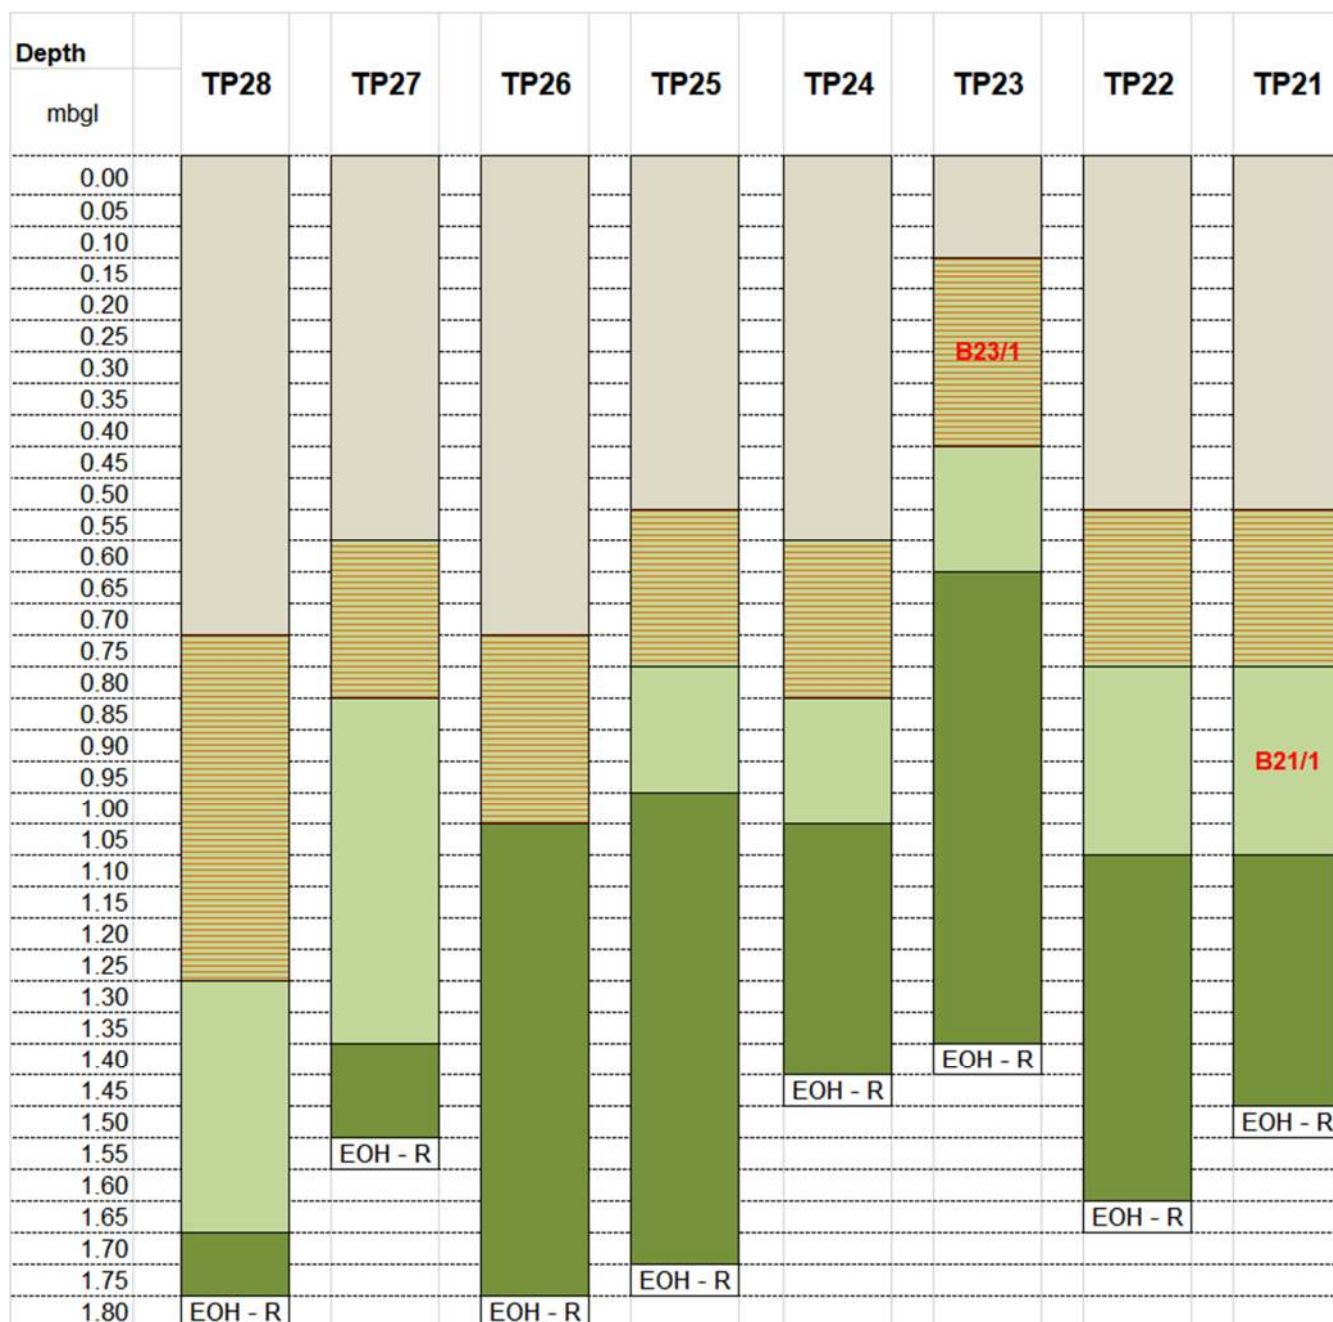
Figure 3: Generalised soil conditions – Section A-B

The area is generally covered by hillwash material that is composed of sandy clay that exhibits a firm consistency and intact soil structure. The hillwash material becomes ferruginised at depth in localised portions of the site, characterised in profile by the occurrence of ferricrete nodules. Plant roots were recorded in this material over the entire site. The hillwash material extends to a maximum depth of 1.10 mbgl.

The transported material is underlain by residual siltstone that is composed of sandy clay with scattered to occasional siltstone gravel to cobbles. The material exhibits a firm to stiff consistency and fractured and inherent structure, with a maximum thickness of approximately 1.0 m. The upper portion of the residual material is generally ferruginised, characterised in profile by scattered to abundant ferricrete nodules.

Siltstone bedrock material was encountered in all test pits from a depth between 0.60 to 1.65 mbgl (mean 1.09 mbgl). The material is highly to moderately weathered, fine grained, medium jointed with a soft rock to moderately hard rock hardness.

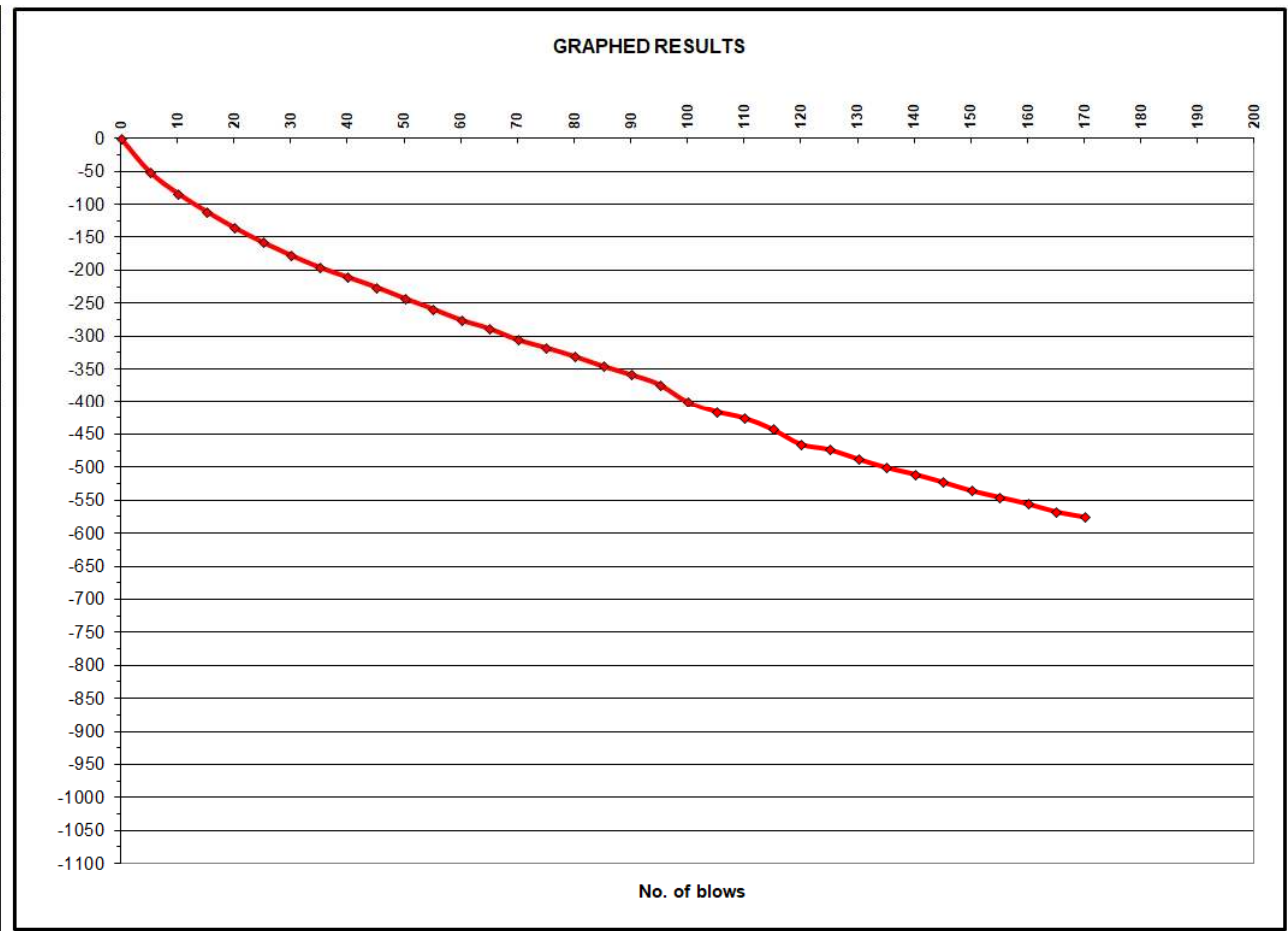
NO. OF BLOWS	TP 4				
	Values (mm)	Cumulative penetration (mm)	mm/blow	UCS (kPa)	CBR
0	5	0	0.0		
5	55	-50	10.0	236	22
10	88	-83	6.6	371	37
15	115	-110	5.4	461	48
20	140	-135	5.0	502	53
25	162	-157	4.4	577	62
30	182	-177	4.0	640	70
35	200	-195	3.6	718	81
40	215	-210	3.0	876	102
45	230	-225	3.0	876	102
50	247	-242	3.4	764	87
55	263	-258	3.2	816	94
60	280	-275	3.4	764	87
65	293	-288	2.6	1023	122
70	310	-305	3.4	764	87
75	322	-317	2.4	1117	135
80	335	-330	2.6	1023	122
85	350	-345	3.0	876	102
90	363	-358	2.6	1023	122
95	378	-373	3.0	876	102
100	405	-400	5.4	461	48
105	420	-415	3.0	876	102
110	430	-425	2.0	1362	170
115	447	-442	3.4	764	87
120	470	-465	4.6	550	59
125	478	-473	1.6	1737	226
130	492	-487	2.8	944	111
135	505	-500	2.6	1023	122
140	515	-510	2.0	1362	170
145	527	-522	2.4	1117	135
150	540	-535	2.6	1023	122
155	550	-545	2.0	1362	170
160	560	-555	2.0	1362	170
165	572	-567	2.4	1117	135
170	580	-575	1.6	1737	226
175					
180

185					
190					
195					
200

ANALYSES OF DYNAMIC CONE PENETRATION TEST RESULTS

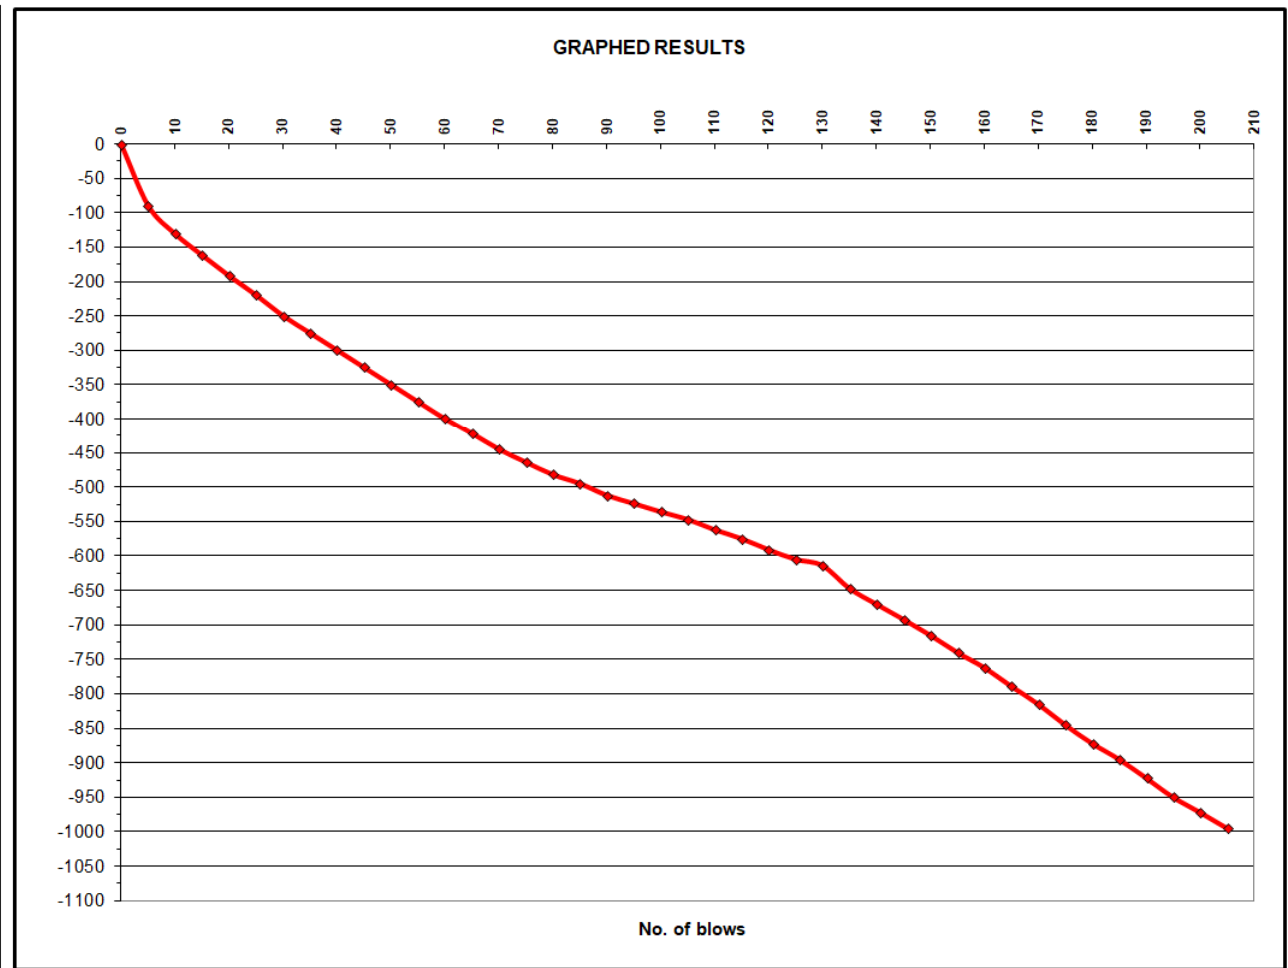
NO. OF BLOWS	TP 16				
	Values (mm)	Cumulative penetration (mm)	mm/blow	UCS (kPa)	CBR
0	11	0	0.0		
5	100	-89	17.8	126	11
10	141	-130	8.2	293	28
15	172	-161	6.2	397	40
20	202	-191	6.0	411	42
25	230	-219	5.6	443	46
30	260	-249	6.0	411	42
35	285	-274	5.0	502	53
40	310	-299	5.0	502	53
45	335	-324	5.0	502	53
50	360	-349	5.0	502	53
55	385	-374	5.0	502	53
60	410	-399	5.0	502	53
65	432	-421	4.4	577	62
70	455	-444	4.6	550	59
75	474	-463	3.8	677	75
80	492	-481	3.6	718	81
85	505	-494	2.6	1023	122
90	522	-511	3.4	764	87
95	534	-523	2.4	1117	135
100	546	-535	2.4	1117	135
105	557	-546	2.2	1228	151
110	572	-561	3.0	876	102
115	585	-574	2.6	1023	122
120	601	-590	3.2	816	94
125	615	-604	2.8	944	111
130	624	-613	1.8	1528	194
135	657	-646	6.6	371	37
140	680	-669	4.6	550	59
145	702	-691	4.4	577	62
150	725	-714	4.6	550	59
155	750	-739	5.0	502	53
160	772	-761	4.4	577	62
165	799	-788	5.4	461	48
170	825	-814	5.2	481	51
175	855	-844	6.0	411	42
180	882	-871	5.4	461	48

185	905	-894	4.6	550	59
190	932	-921	5.4	461	48
195	960	-949	5.6	443	46
200	982	-971	4.4	577	62
205	1005	-994	4.6	550	59
210

ANALYSES OF DYNAMIC CONE PENETRATION TEST RESULTS

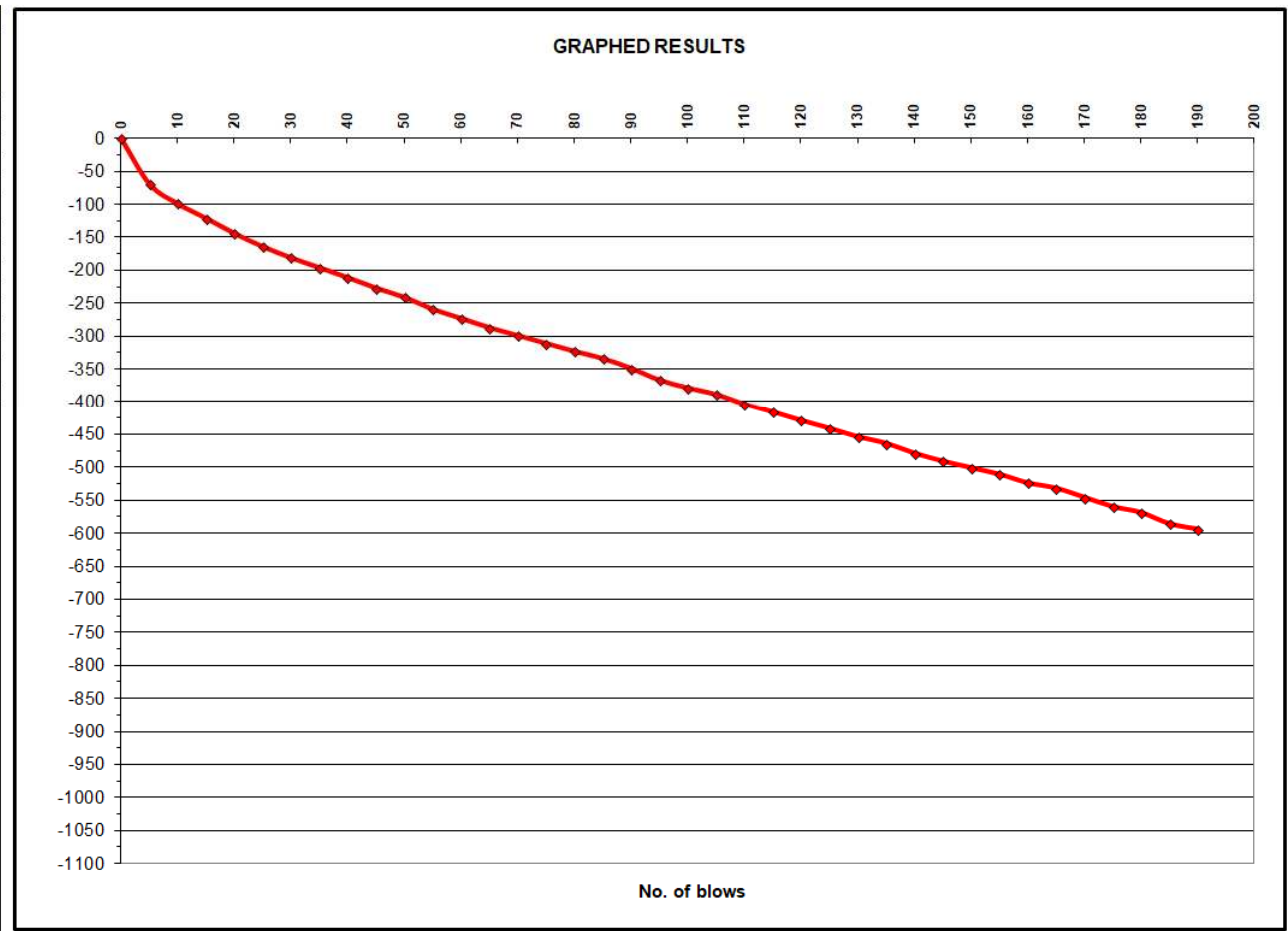
NO. OF BLOWS	TP 20				
	Values (mm)	Cumulative penetration (mm)	mm/blow	UCS (kPa)	CBR
0	11	0	0.0		
5	80	-69	13.8	166	15
10	110	-99	6.0	411	42
15	132	-121	4.4	577	62
20	155	-144	4.6	550	59
25	175	-164	4.0	640	70
30	192	-181	3.4	764	87
35	207	-196	3.0	876	102
40	222	-211	3.0	876	102
45	238	-227	3.2	816	94
50	252	-241	2.8	944	111
55	270	-259	3.6	718	81
60	284	-273	2.8	944	111
65	298	-287	2.8	944	111
70	310	-299	2.4	1117	135
75	322	-311	2.4	1117	135
80	334	-323	2.4	1117	135
85	345	-334	2.2	1228	151
90	360	-349	3.0	876	102
95	378	-367	3.6	718	81
100	390	-379	2.4	1117	135
105	400	-389	2.0	1362	170
110	415	-404	3.0	876	102
115	427	-416	2.4	1117	135
120	440	-429	2.6	1023	122
125	452	-441	2.4	1117	135
130	465	-454	2.6	1023	122
135	475	-464	2.0	1362	170
140	490	-479	3.0	876	102
145	502	-491	2.4	1117	135
150	512	-501	2.0	1362	170
155	522	-511	2.0	1362	170
160	535	-524	2.6	1023	122
165	543	-532	1.6	1737	226
170	557	-546	2.8	944	111
175	571	-560	2.8	944	111

180	580	-569	1.8	1528	194
185	597	-586	3.4	764	87
190	605	-594	1.6	1737	226
195					
200

ANALYSES OF DYNAMIC CONE PENETRATION TEST RESULTS

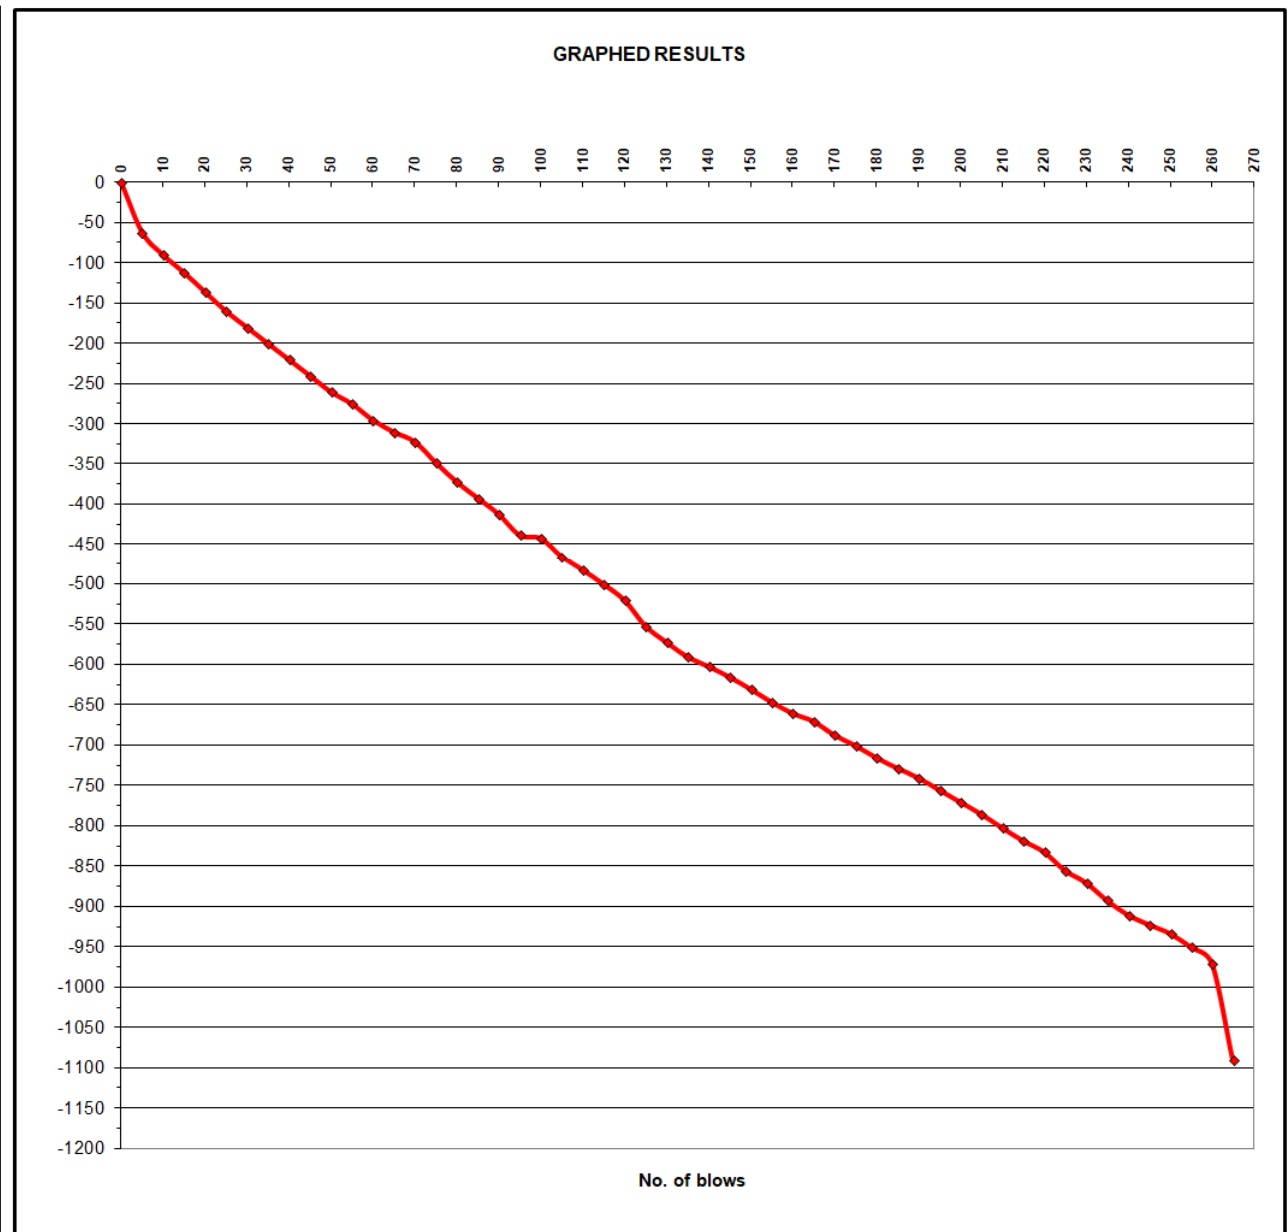
NO. OF BLOWS	TP 21				
	Values (mm)	Cumulative penetration (mm)	mm/blow	UCS (kPa)	CBR
0	10	0	0.0		
5	72	-62	12.4	186	17
10	100	-90	5.6	443	46
15	122	-112	4.4	577	62
20	146	-136	4.8	525	56
25	170	-160	4.8	525	56
30	190	-180	4.0	640	70
35	210	-200	4.0	640	70
40	230	-220	4.0	640	70
45	250	-240	4.0	640	70
50	270	-260	4.0	640	70
55	285	-275	3.0	876	102
60	305	-295	4.0	640	70
65	320	-310	3.0	876	102
70	332	-322	2.4	1117	135
75	358	-348	5.2	481	51
80	382	-372	4.8	525	56
85	402	-392	4.0	640	70
90	422	-412	4.0	640	70
95	448	-438	5.2	481	51
100	452	-442	0.8	3699	544
105	475	-465	4.6	550	59
110	492	-482	3.4	764	87
115	510	-500	3.6	718	81
120	530	-520	4.0	640	70
125	562	-552	6.4	383	39
130	582	-572	4.0	640	70
135	600	-590	3.6	718	81
140	612	-602	2.4	1117	135
145	625	-615	2.6	1023	122
150	640	-630	3.0	876	102
155	656	-646	3.2	816	94
160	670	-660	2.8	944	111
165	680	-670	2.0	1362	170
170	697	-687	3.4	764	87
175	710	-700	2.6	1023	122
180	725	-715	3.0	876	102

185	738	-728	2.6	1023	122
190	750	-740	2.4	1117	135
195	765	-755	3.0	876	102
200	780	-770	3.0	876	102
205	795	-785	3.0	876	102
210	812	-802	3.4	764	87
215	828	-818	3.2	816	94
220	842	-832	2.8	944	111
225	865	-855	4.6	550	59
230	880	-870	3.0	876	102
235	902	-892	4.4	577	62
240	920	-910	3.6	718	81
245	932	-922	2.4	1117	135
250	943	-933	2.2	1228	151
255	960	-950	3.4	764	87
260	980	-970	4.0	640	70
265	1100	-1090	24.0	91	7
270

ANALYSES OF DYNAMIC CONE PENETRATION TEST RESULTS

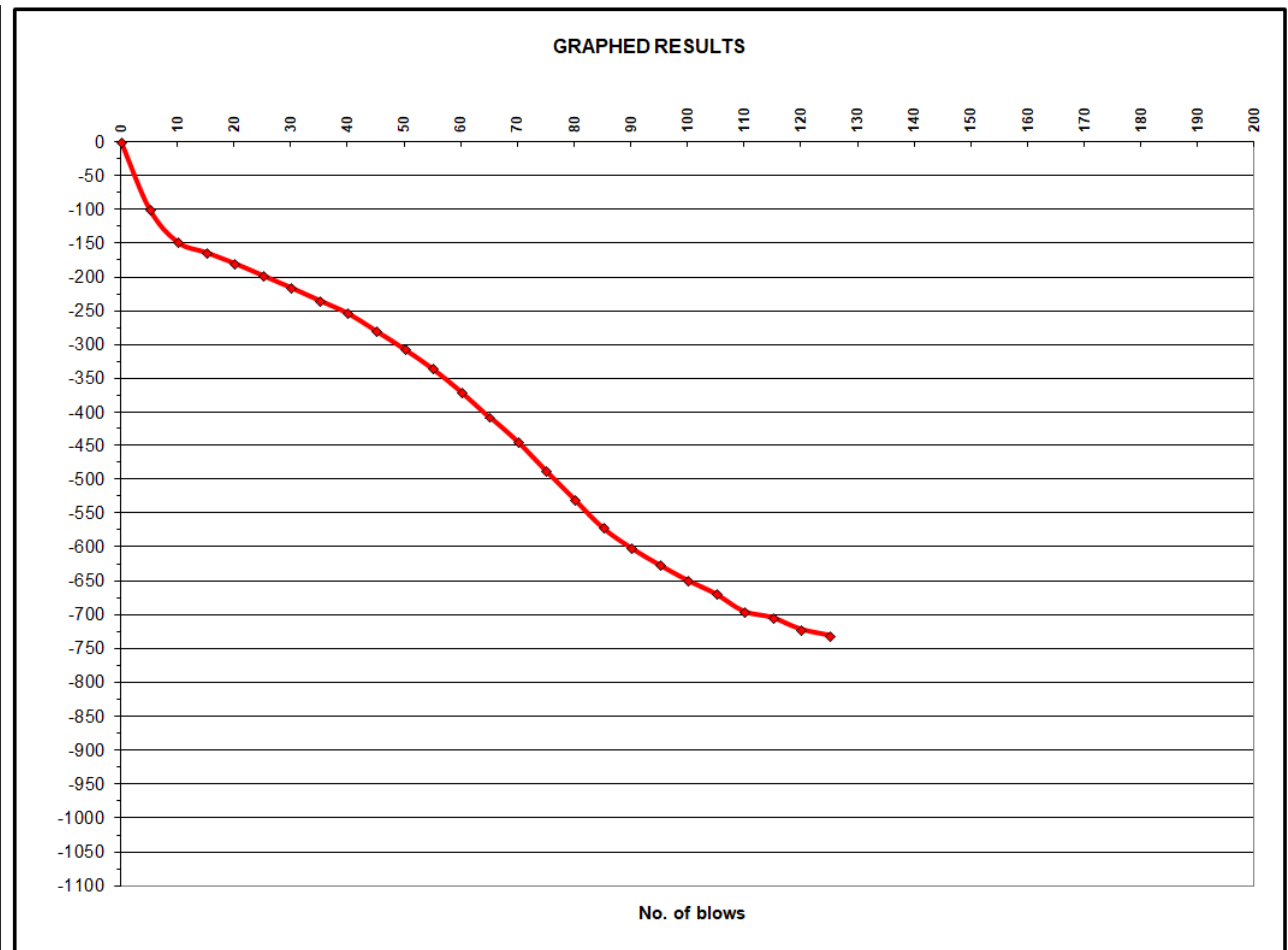
NO. OF BLOWS	TP 23				
	Values (mm)	Cumulative penetration (mm)	mm/blow	UCS (kPa)	CBR
0	1	0	0.0		
5	100	-99	19.8	112	9
10	149	-148	9.8	241	23
15	164	-163	3.0	876	102
20	180	-179	3.2	816	94
25	198	-197	3.6	718	81
30	216	-215	3.6	718	81
35	235	-234	3.8	677	75
40	254	-253	3.8	677	75
45	280	-279	5.2	481	51
50	307	-306	5.4	461	48
55	336	-335	5.8	427	44
60	370	-369	6.8	359	36
65	408	-407	7.6	318	31
70	445	-444	7.4	327	32
75	488	-487	8.6	278	27
80	530	-529	8.4	285	27
85	572	-571	8.4	285	27
90	602	-601	6.0	411	42
95	627	-626	5.0	502	53
100	650	-649	4.6	550	59
105	670	-669	4.0	640	70
110	696	-695	5.2	481	51
115	705	-704	1.8	1528	194
120	722	-721	3.4	764	87
125	731	-730	1.8	1528	194
130					
135					
140					
145					
150					
155					
160					
165					
170					
175					
180					
185					
190					
195					
200

ANALYSES OF DYNAMIC CONE PENETRATION TEST RESULTS

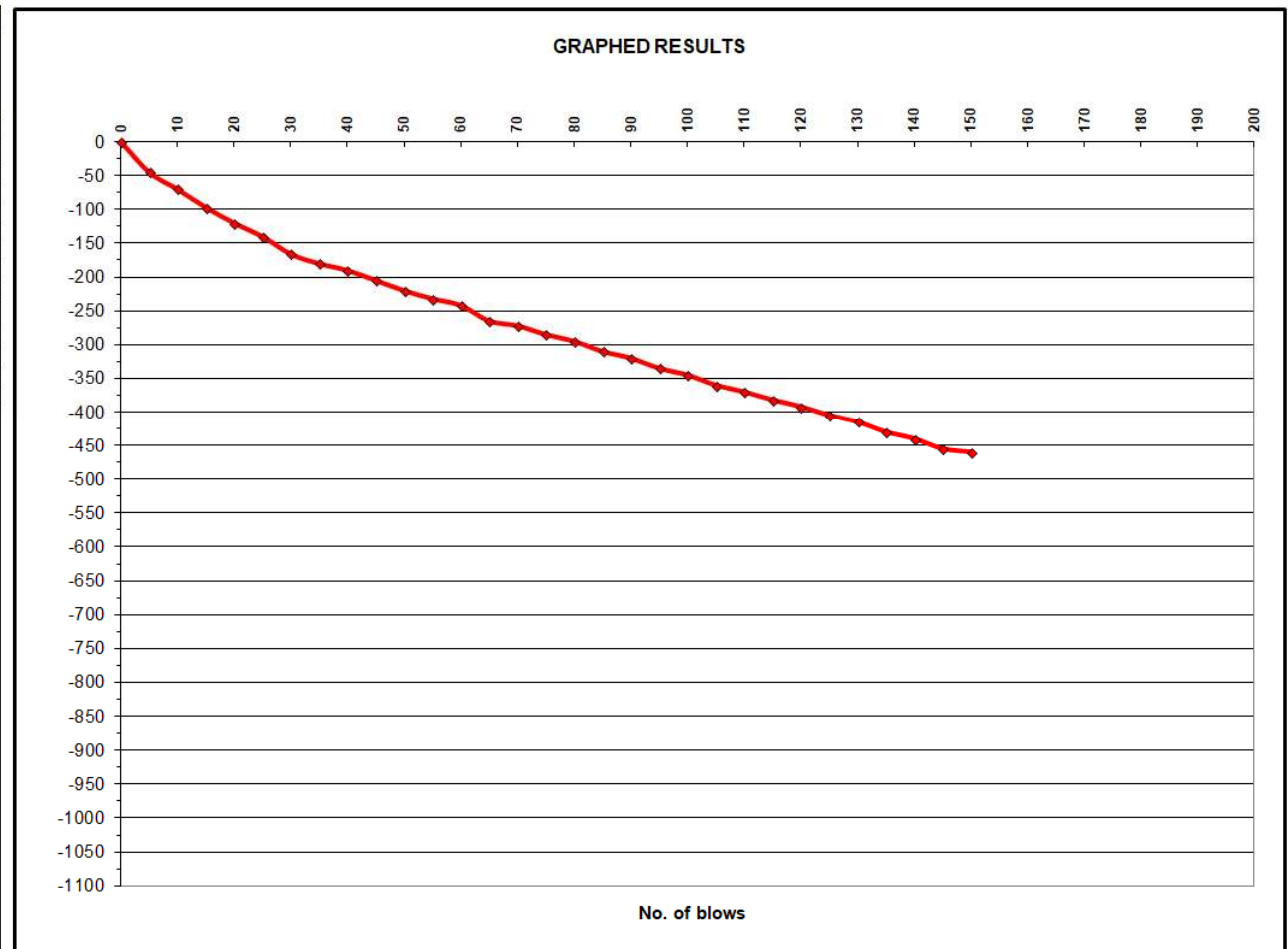
NO. OF BLOWS	TP 32				
	Values (mm)	Cumulative penetration (mm)	mm/blow	UCS (kPa)	CBR
0	10	0	0.0		
5	55	-45	9.0	264	25
10	80	-70	5.0	502	53
15	107	-97	5.4	461	48
20	130	-120	4.6	550	59
25	150	-140	4.0	640	70
30	176	-166	5.2	481	51
35	190	-180	2.8	944	111
40	200	-190	2.0	1362	170
45	215	-205	3.0	876	102
50	230	-220	3.0	876	102
55	242	-232	2.4	1117	135
60	252	-242	2.0	1362	170
65	275	-265	4.6	550	59
70	282	-272	1.4	2010	267
75	295	-285	2.6	1023	122
80	305	-295	2.0	1362	170
85	320	-310	3.0	876	102
90	330	-320	2.0	1362	170
95	345	-335	3.0	876	102
100	355	-345	2.0	1362	170
105	370	-360	3.0	876	102
110	380	-370	2.0	1362	170
115	392	-382	2.4	1117	135
120	402	-392	2.0	1362	170
125	415	-405	2.6	1023	122
130	425	-415	2.0	1362	170
135	440	-430	3.0	876	102
140	450	-440	2.0	1362	170
145	465	-455	3.0	876	102
150	470	-460	1.0	2900	410
155					
160					
165					
170					
175					
180					
185					
190					
195					
200
