Technical Report
2020 / 02 / 08 GTEC

SUNNINGDALE DAIRY EXTENSION - ELIDZ

Soils investigation for the proposed extension of Sunningdale Dairy at the East London IDZ, Buffalo City Metropolitan Municipality

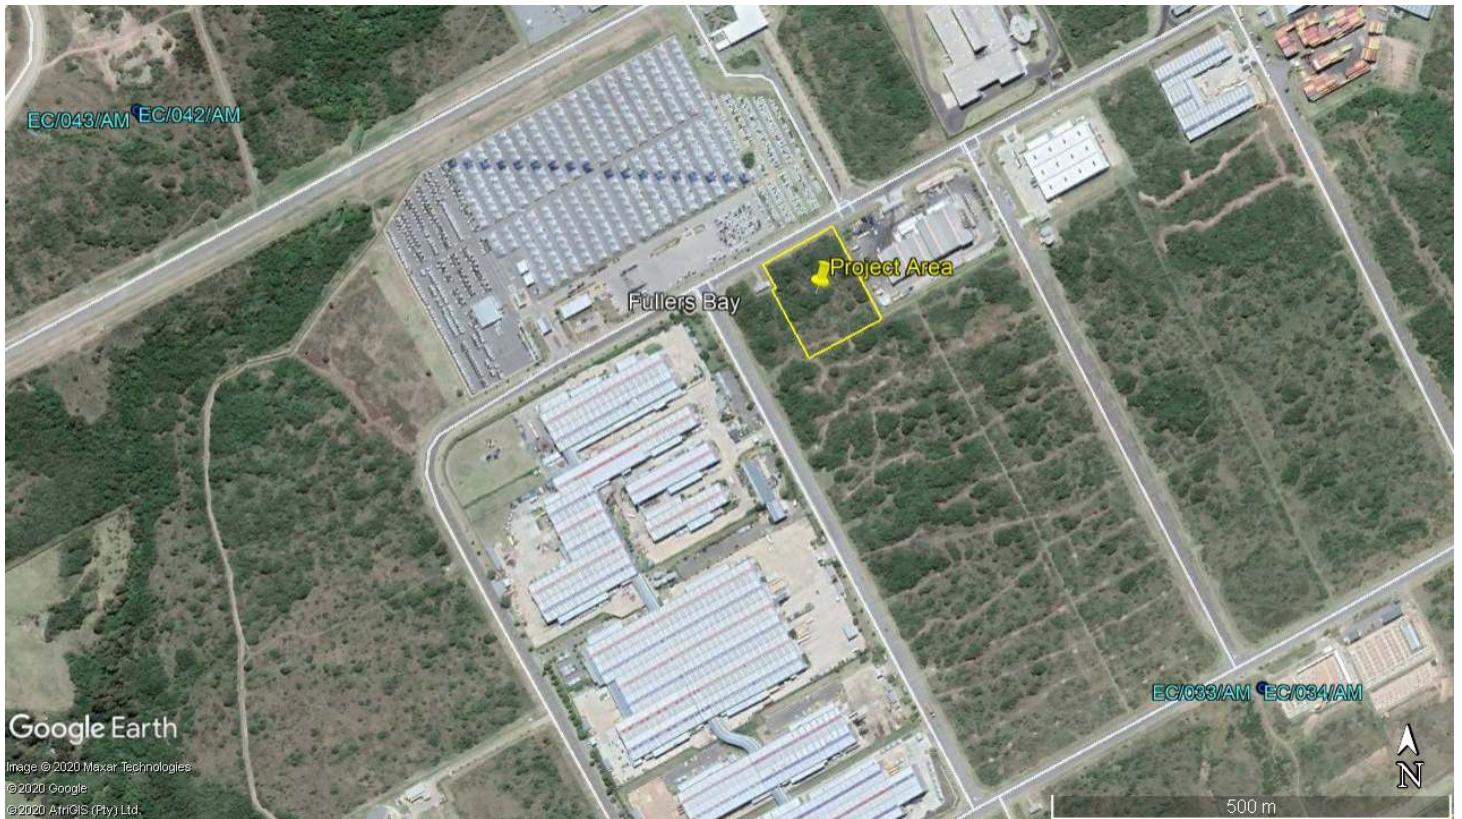
Figure 3: Groundwater survey – Position of monitoring boreholes within 1 km radius of project site

Two sets of groundwater monitoring boreholes occur within 1 km of the site. The positions of the boreholes are indicated in the figure below. The borehole is utilised for groundwater quality monitoring by the ELIDZ. The static groundwater levels recorded in 2012 was measured at 3.2 - 3.5 m at boreholes 33 and 34 respectively south of the site, and between 1.5 and 9.7 m at boreholes 42 and 43 respectively that occurs to the northwest of the site.

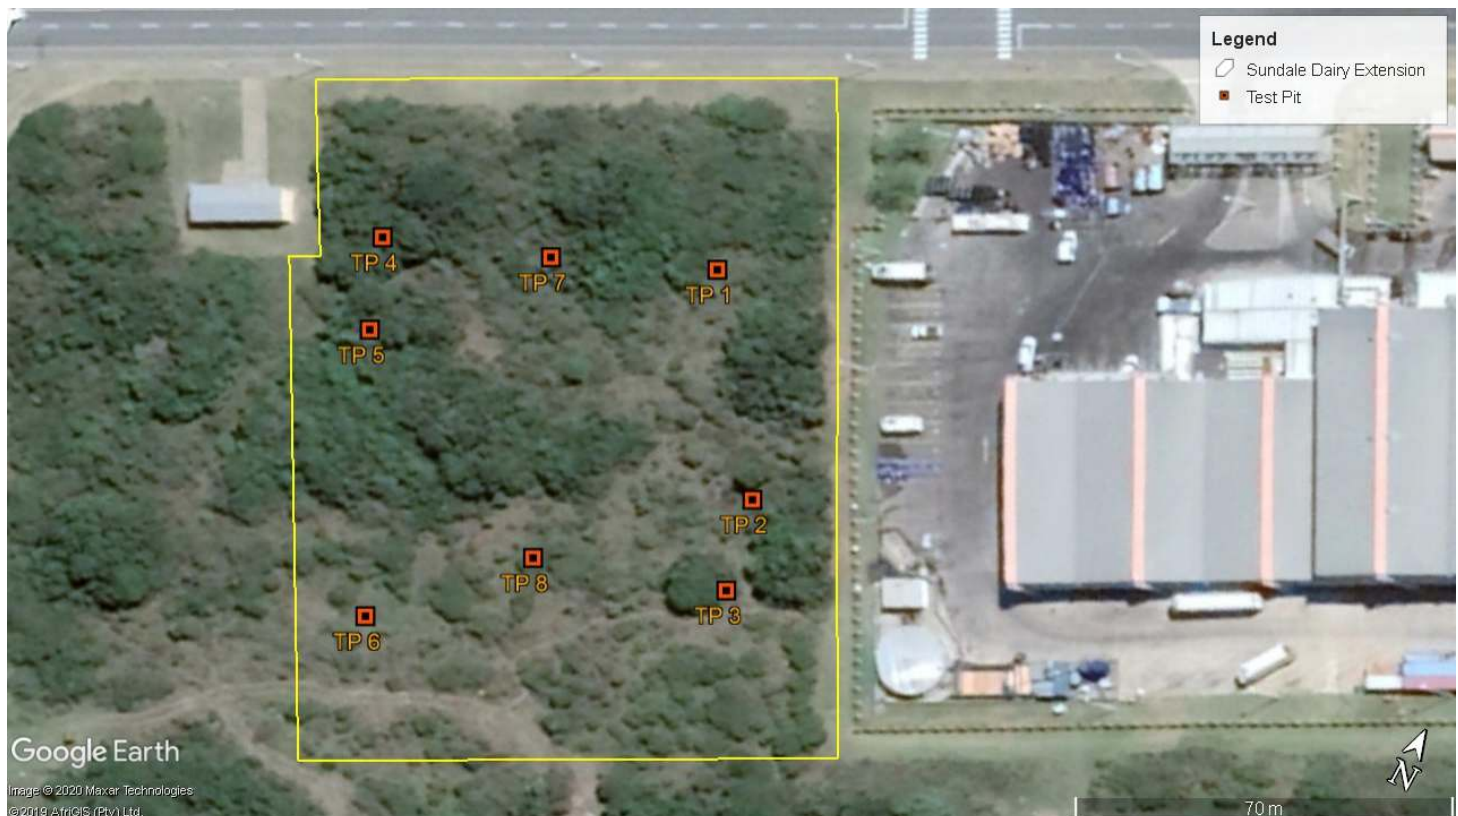
Figure 4: Detailed layout of test pits

A total of 8 test pits, numbered SND TP1 to SND TP8 were excavated in the project area on the 14th of January 2020 utilising a CAT 428F 4x4 TLB-type excavator obtained from Messrs. Plus Plan Hire in East London. The test pits were profiled on the same day according to the Guidelines for soil and rock profiling (2002).

The positions of the test pits are indicated in the Figure below, with detailed test pit logs attached in Appendix A. Please note that several test pits could not be excavated in the required positions due to very dense vegetation.

A total of 8 test pits, numbered SND TP 1 to SND TP8 were excavated on the project area utilising a CAT 428F 4X4 TLB-type excavator on the 14th of January 2020. The position of the test pits was highly influenced by the thick vegetation on site. The test pits were profiled on the same day according to the Guidelines for soil and rock profiling (2002). The positions of the test pits are indicated in the Figure below.

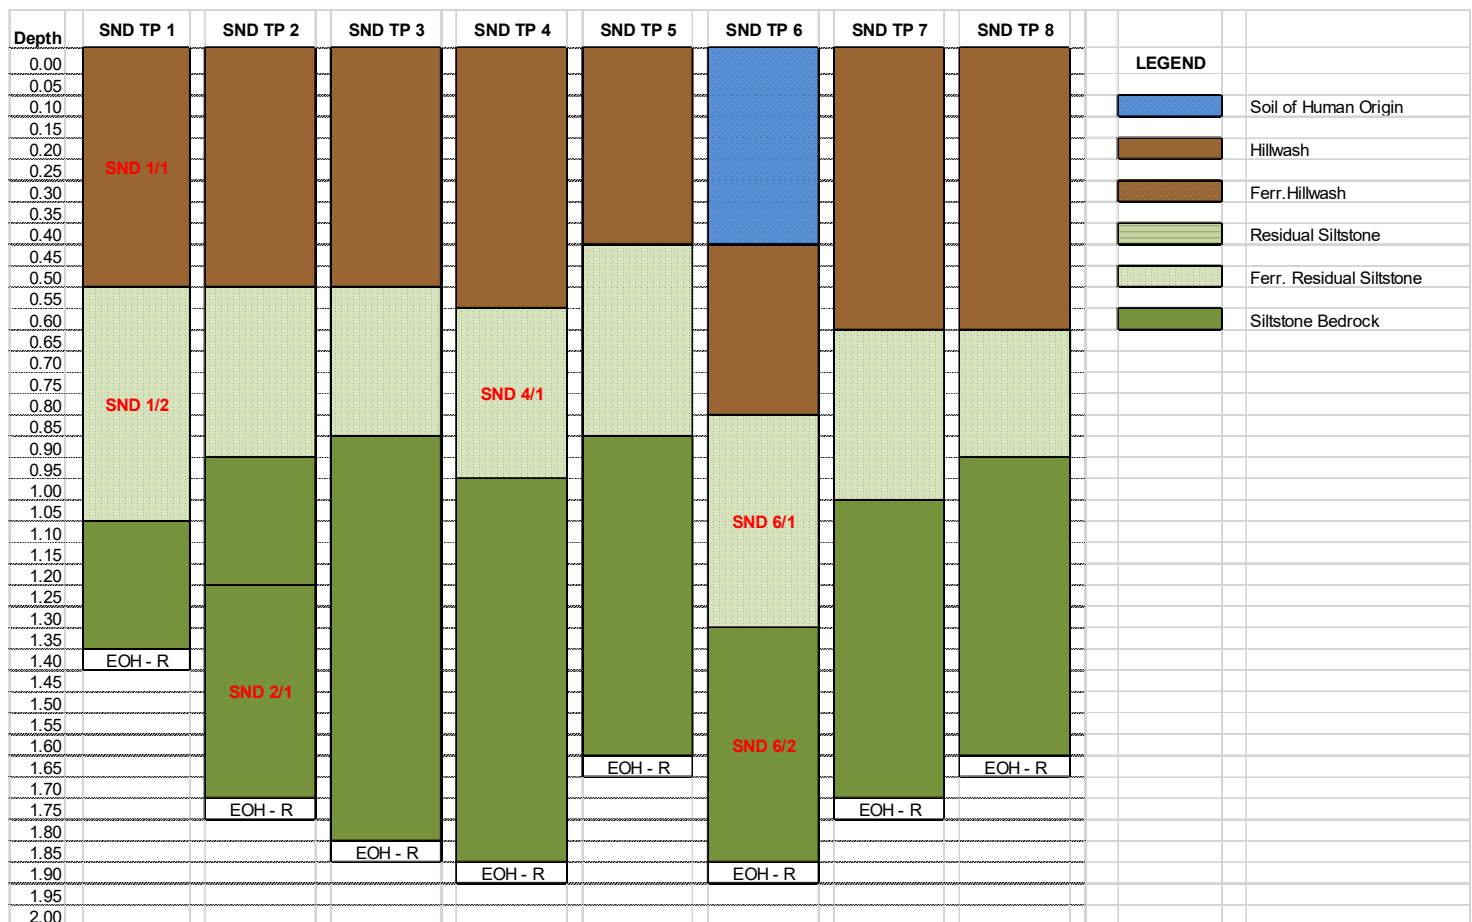
Figure 5: Generalised soil conditions

Siltstone bedrock material was encountered in all test pits. The material is highly weathered to moderately weathered, medium grained, thinly bedded and highly to medium fractured with a soft rock to moderately hard rock hardness. The material was encountered from a depth between 0.85 and 1.30 mbgl (mean 1.02 mbgl) with refusal occurring from a depth between 1.35 and 1.85 mbgl (mean 1.68 mbgl).

The generalised soil profile and sections are indicated in the figures below.

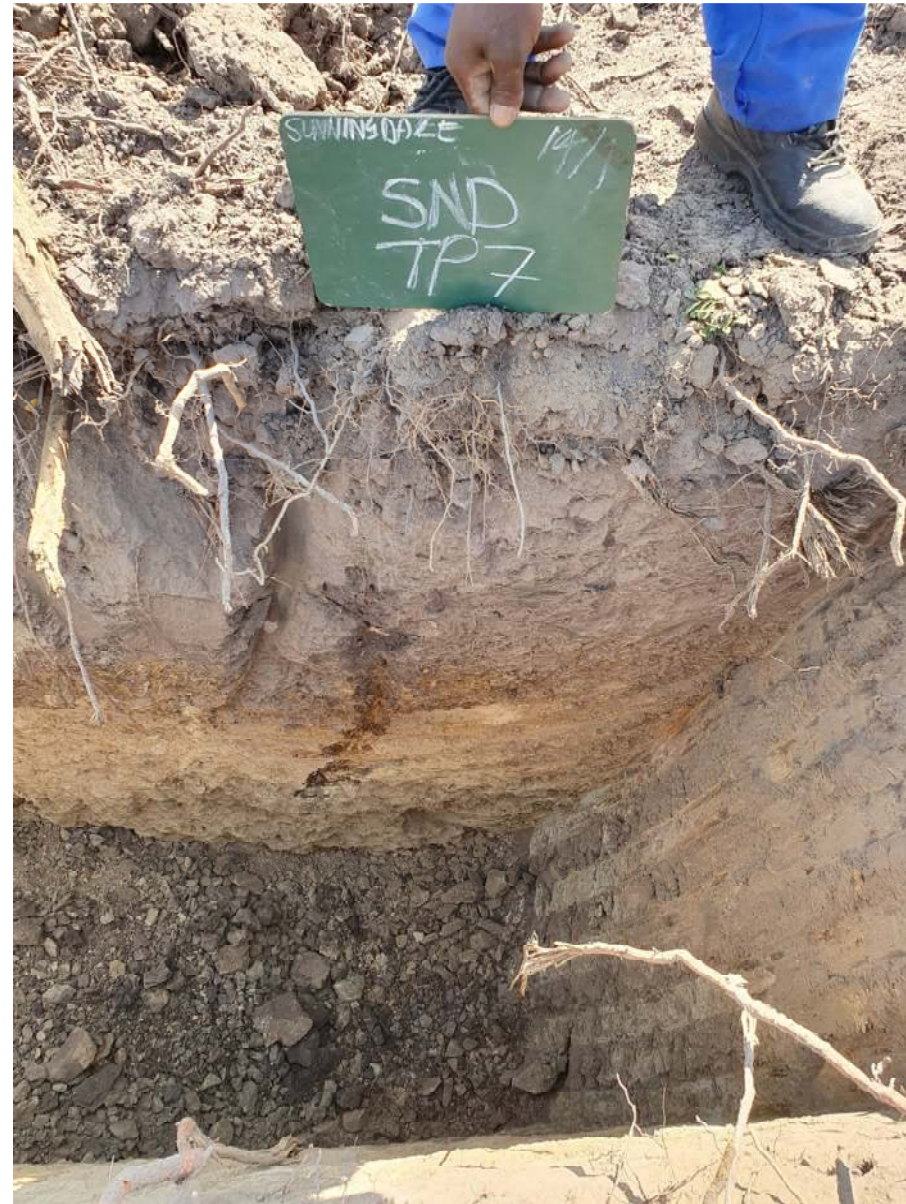
PROJECT: GTEC ELIDZ Sundale Dairy Extension		TEST PIT NO.: SND TP8	
CLIENT: BVI Border	LATITUDE: 32.05479° S	LOGGED BY: Mahwande Busakwe	
CONTRACTOR: Plus Plant Hire	LONGITUDE: 27.84971° E	DATE EXCAVATED: 14 January 2020	
MACHINE TYPE: CAT 420F 4x4 TLB-type excavator	ELEVATION: 51 mamsl	DATE PROFILED: 14 January 2020

Depth	Lithology	Description	Sampling
0		Moist, dark greyish brown, in profile dark greyish brown, firm, micro-shattered, clayey sand. Roots. HILLWASH.	
100			
200			
300			
400			
500			
600			
700		Abundant to frequent ferricrete nodules densely to moderately densely packed in a matrix of Moist, brown, sandy clay. Firm overall consistency. FERRUGINISED RESIDUAL SILTSTONE.	
800			
900			
1000		Khaki brown, highly weathered to moderately weathered, medium grained, medium jointed, soft rock to moderately hard rock. SILTSTONE BEDROCK.	
1100			
1200			
1300			
1400			
1500			
1600			
1700		Excavation refused on hard rock SILTSTONE BEDROCK.	
1800			
1900			
2000			
2100			
2200			
2300			
2400			
2500			
2600			
2700			
2800			
2900			
3000

10 Sanson Road Vincent Postnet 203, PBag X9063 EAST LONDON, 5200 Tel. No.: +27 (0)86 188 8609 e-mail: omega@ages-group.com www.ages-omega.co.za	Notes: No groundwater seepage Good sidewall stability No sample taken

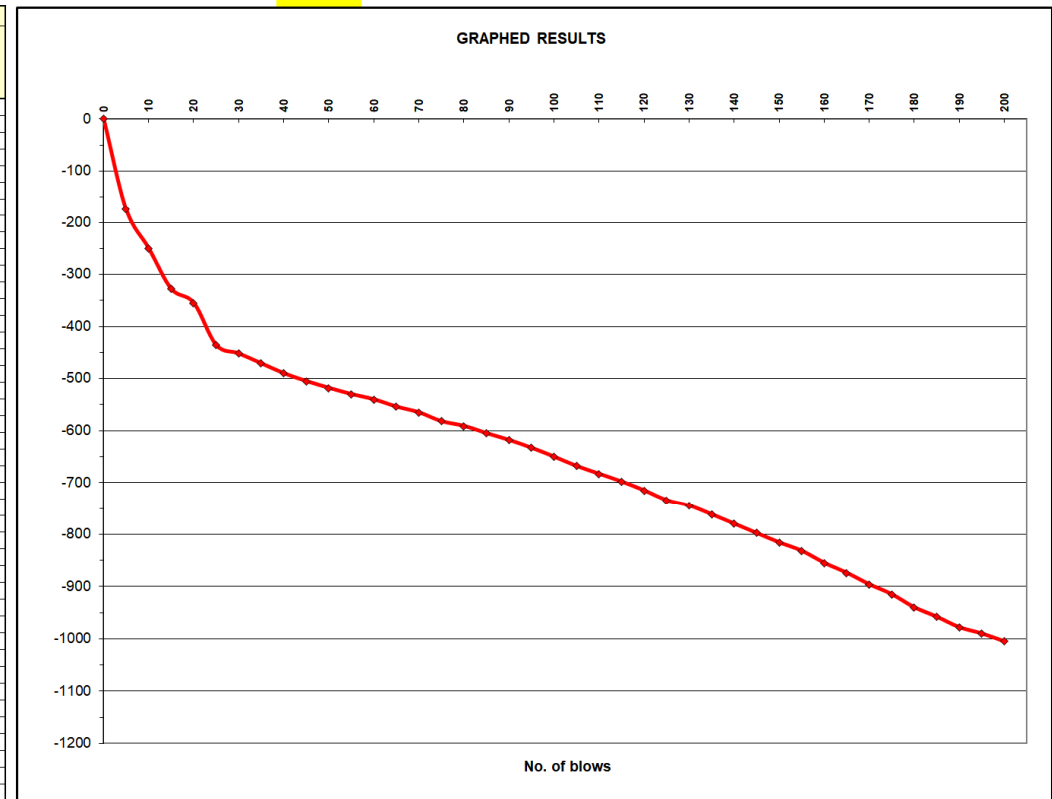
85	725	-605	2.8	944	111	120	374	226	0.0002	1257
90	738	-618	2.6	1023	122	127	405	233	0.0002	1294
95	753	-633	3.0	876	102	114	348	220	0.0002	1223
100	770	-650	3.4	764	87	104	304	210	0.0002	1165
105	788	-668	3.6	718	81	99	286	205	0.0002	1139
110	803	-683	3.0	876	102	114	348	220	0.0002	1223
115	818	-698	3.0	876	102	114	348	220	0.0002	1223
120	835	-715	3.4	764	87	104	304	210	0.0002	1165
125	854	-734	3.8	677	75	95	270	201	0.0002	1116
130	865	-745	2.2	1228	151	145	483	249	0.0002	1381
135	882	-762	3.4	764	87	104	304	210	0.0002	1165
140	900	-780	3.6	718	81	99	286	205	0.0002	1139
145	918	-798	3.6	718	81	99	286	205	0.0002	1139
150	936	-816	3.6	718	81	99	286	205	0.0002	1139
155	952	-832	3.2	816	94	109	325	215	0.0002	1193
160	975	-855	4.6	550	59	82	221	186	0.0002	1036
165	994	-874	3.8	677	75	95	270	201	0.0002	1116
170	1016	-896	4.4	577	62	85	231	190	0.0002	1054
175	1035	-915	3.8	677	75	95	270	201	0.0002	1116
180	1060	-940	5.0	502	53	77	202	180	0.0002	1002

185	1078	-958	3.6	718	81	99	286	205	0.0002	1139
190	1098	-978	4.0	640	70	91	256	197	0.0002	1094
195	1110	-990	2.4	1117	135	136	440	240	0.0002	1335
200	1125	-1005	3.0	876	102	114	348	220	0.0002	1223
205

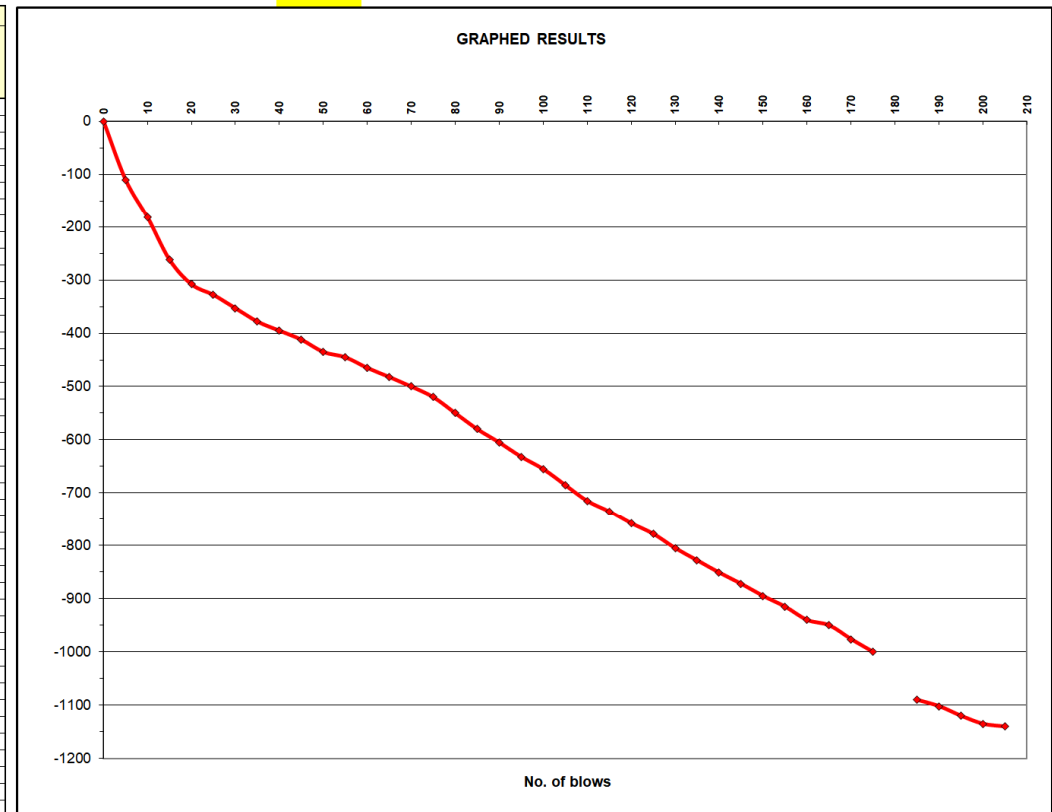
95	742	-632	5.4	461	48	72	186	175	0.0003
100	765	-655	4.6	550	59	82	221	186	0.0002
105	795	-685	6.0	411	42	67	167	168	0.0003
110	825	-715	6.0	411	42	67	167	168	0.0003
115	845	-735	4.0	640	70	91	256	197	0.0002
120	868	-758	4.6	550	59	82	221	186	0.0002
125	888	-778	4.0	640	70	91	256	197	0.0002
130	915	-805	5.4	461	48	72	186	175	0.0003
135	938	-828	4.6	550	59	82	221	186	0.0002
140	961	-851	4.6	550	59	82	221	186	0.0002
145	982	-872	4.2	607	66	88	243	193	0.0002
150	1005	-895	4.6	550	59	82	221	186	0.0002
155	1025	-915	4.0	640	70	91	256	197	0.0002
160	1050	-940	5.0	502	53	77	202	180	0.0002
165	1060	-950	2.0	1362	170	156	535	258	0.0002
170	1086	-976	5.2	481	51	75	194	178	0.0003
175	1110	-1000	4.8	525	56	79	211	183	0.0002
180									
185	1090	-1090	218.0	8	0	4	4	41	0.0011
190	1102	-1102	2.4	1117	135	136	440	240	0.0002
195	1120	-1120	3.6	718	81	99	286	205	0.0002
200	1135	-1135	3.0	876	102	114	348	220	0.0002
205	1140	-1140	1.0	2900	300	221	1116	338	0.0001
