Technical Report

ELIDZ - PROPOSED DATA CENTRE AT ERF 60917

Geotechnical investigation for the proposed data centre at Erf 60917 at the East London Industrial Development Zone, Buffalo City Metropolitan Municipality

February 2020

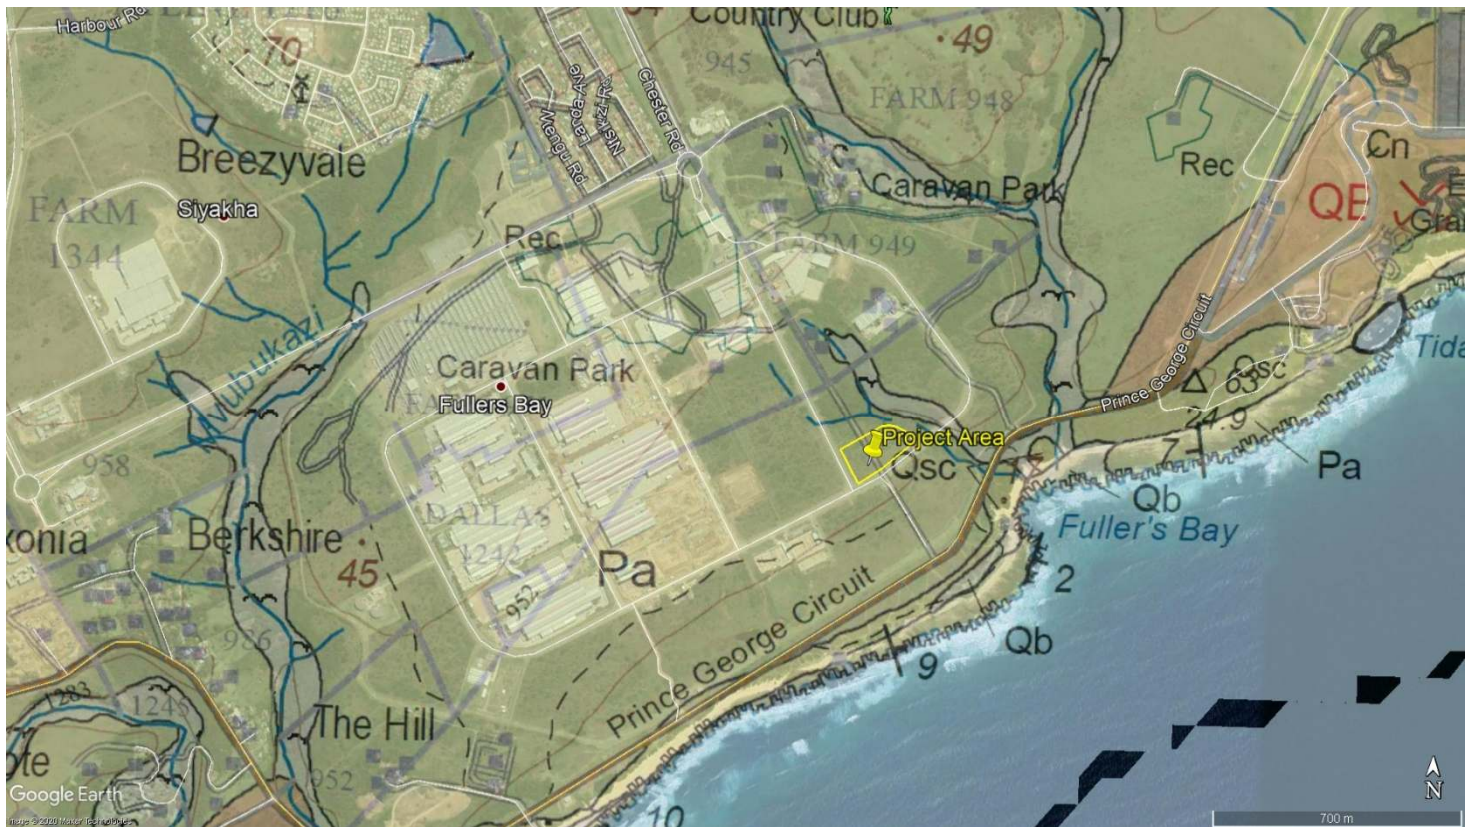
The project area is underlain by sedimentary rocks of the Middleton and Balfour Formations of the Adelaide Subgroup of the Beaufort Group that is part of the Karoo Supergroup sequence. The lithology comprises of mudstone and sandstone that is locally overlain by soil > 1 m thick.

Figure 2: Geological setting of project area (Pa – Adelaide Subgroup)

Dolerite dykes and sills have intruded the sedimentary strata of the Karoo Supergroup during the late Karoo volcanism. The geology map does not indicate the presence of any dolerite dyke or sill intrusions in the project area. A thin dolerite dyke with a basic east-west trend direction was encountered in the project area during the site investigation.

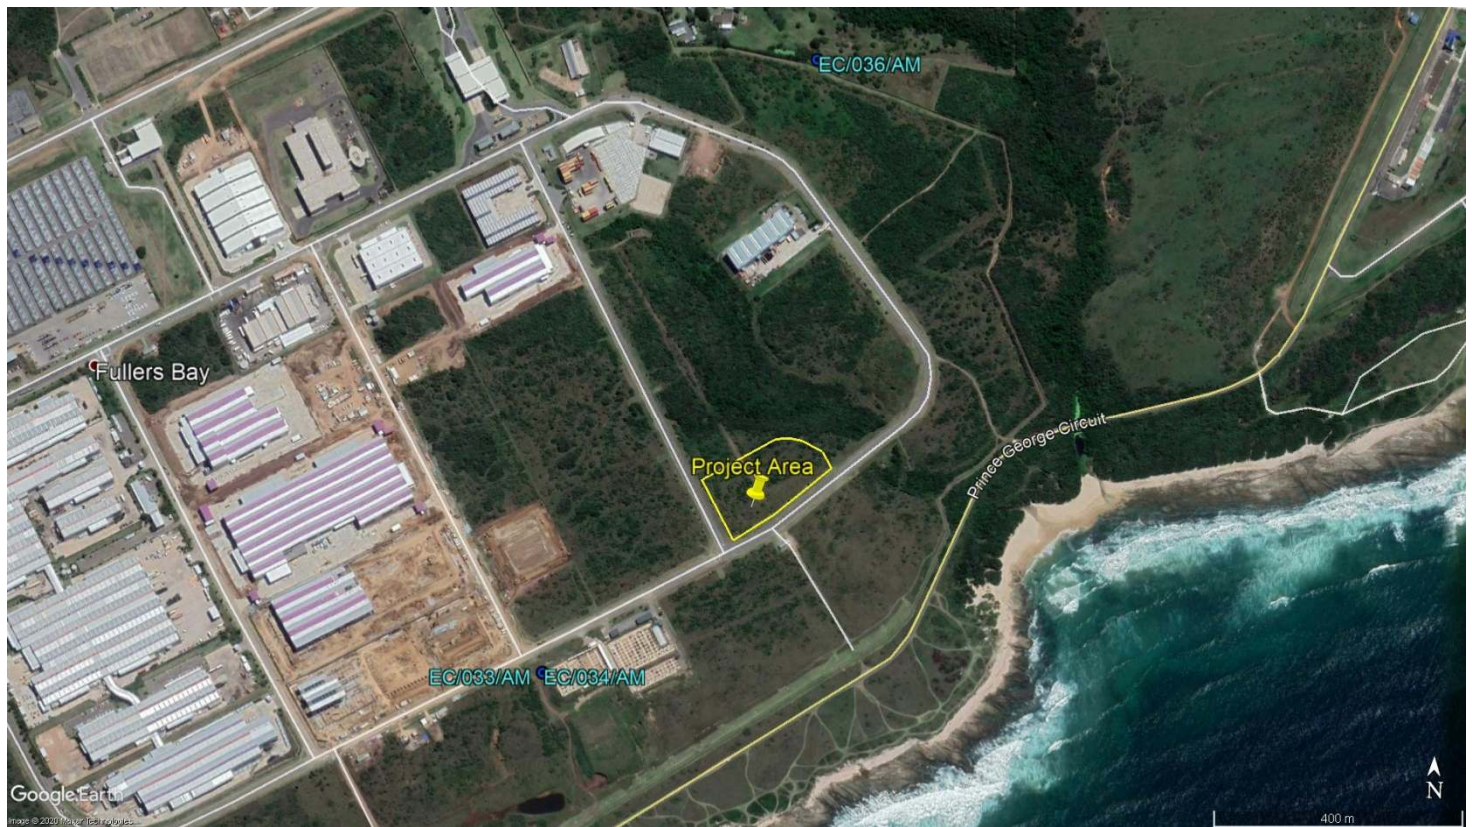
Two sets of groundwater monitoring boreholes occur within 1 km of the site. The positions of the boreholes are indicated in the figure below. The boreholes are utilised for groundwater quality monitoring by the ELIDZ. The static groundwater levels recorded in 2012 was measured at 3.2 - 3.5 mbgl at boreholes EC/033&034/AM respectively approximately 400 m southwest of the site, and 10.02 mbgl at borehole EC/036/AM that occurs approximately 650 m to the north northeast of the site.

Figure 3: Groundwater survey – Position of monitoring boreholes within 1 km radius of project site

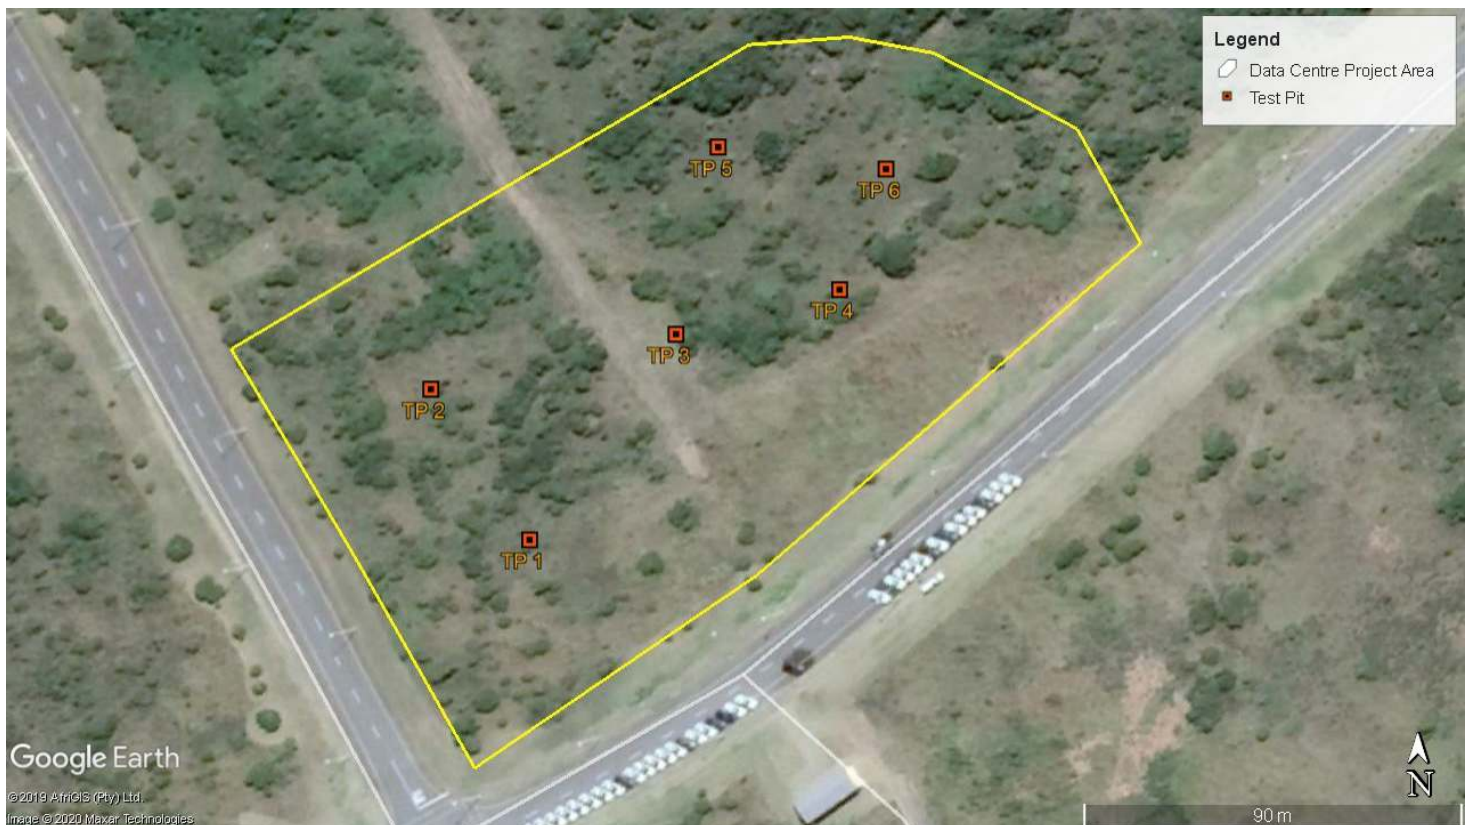
The positions of the test pits are indicated in the Figure below, with detailed test pit logs attached in Appendix A.

Figure 4: Detailed layout of test pits

A total of 6 test pits, numbered DC TP 1 to DC TP6 were excavated on the project area utilising a CAT 428E 4X4 TLB-type excavator on the 28th of January 2020. The position of the test pits was influenced by the thick vegetation on site especially towards the drainage on the east, and pits were placed based on geological site observations and access. The test pits were profiled on the same day according to the Guidelines for soil and rock profiling (2002).

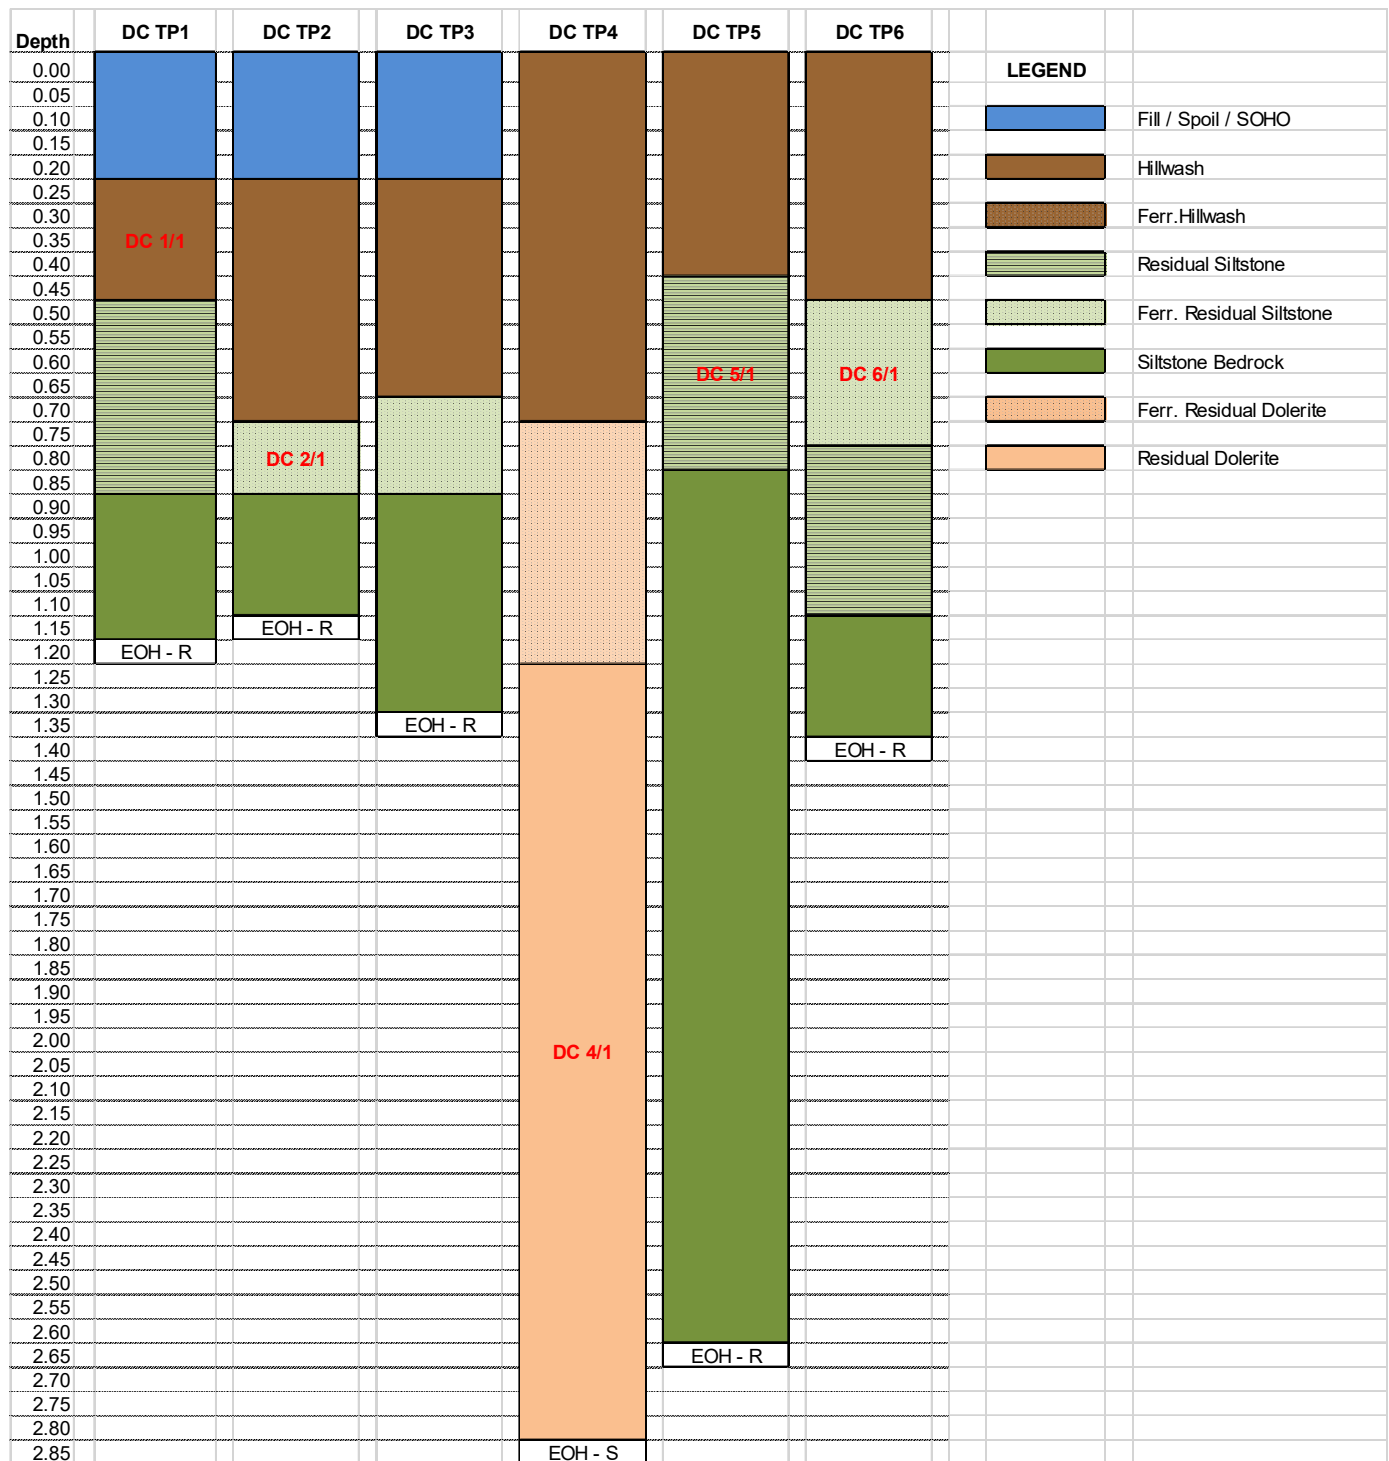
The generalised soil profile and sections are indicated in the figures below.

Figure 5: Generalised soil conditions

Siltstone bedrock material was encountered in all test pits. The material is highly weathered to moderately weathered, fine grained, thinly bedded and highly to medium fractured with a soft rock to moderately hard rock hardness. The material was encountered from a depth between 0.80 and 1.10 mbgl (mean 0.89 mbgl) with refusal occurring from a depth between 1.10 and 2.60 mbgl (mean 1.50 mbgl).

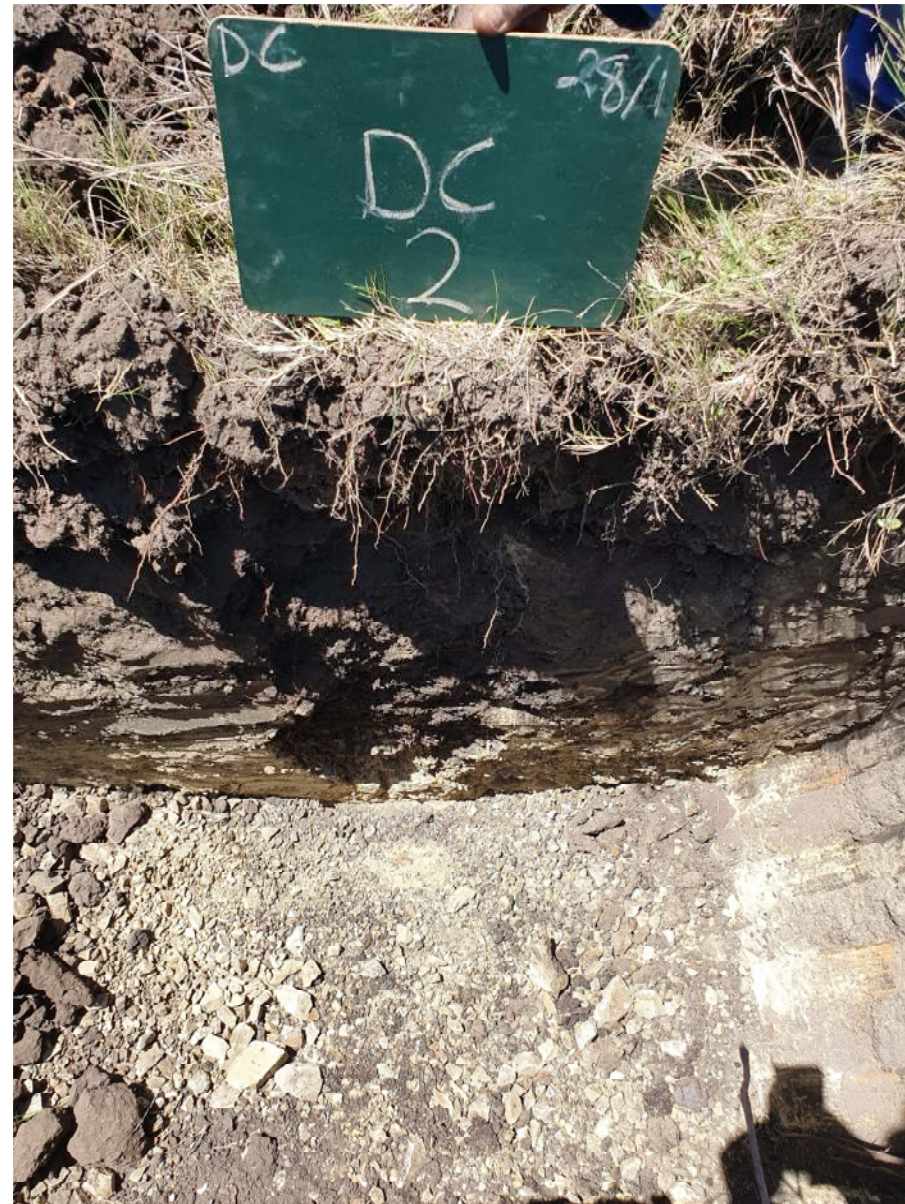
PROJECT: GTEC ELIDZ Data Center		TEST PIT NO.: DC 3	
CLIENT: BVI Border	LATITUDE: 33.05601° S	LOGGED BY: Mahwande Busakwe	
CONTRACTOR: Plus Plant Hire	LONGITUDE: 27.85900° E	DATE EXCAVATED: 28 January 2019	
MACHINE TYPE: CAT 428E 4x4 TLB-type excavator	ELEVATION: 22 mamsl	DATE PROFILED: 28 January 2019

Depth	Lithology	Description	Sampling
0		Moist, brown, in profile dusky brown, firm, clayey sand with frequent gravel. FILL.	
100			
200		Moist, dark brown, in profile dark greyish brown, firm, intact to micro-shattered, sandy clay, HILLWASH.	
300			
400			
500			
600			
700		Moist, dark brown, in profile dark brown blotched yellowish brown, firm, micro-shattered to inherent, sandy clay with frequently gravel and ferricrete nodule. FERRUGINISED RESIDUAL SILTSTONE.	
800			
900		Khaki, highly wto moderately weathered, fine grained, thickly jointed, soft rock to moderately hard rock. SILTSTONE BEDROCK.	
1000			
1100			
1200			
1300		Excavation refused on moderately hard rock SILTSTONE BEDROCK.	
1400			
1500			
1600			
1700			
1800			
1900			
2000			
2100			
2200			
2300			
2400			
2500			
2600			
2700			
2800			
2900			
3000

10 Sanson Road Vincent Postnet 203, PBag X9063 EAST LONDON, 5200 Tel. No.: +27 (0)86 188 8609 e-mail: omega@ages-group.com www.ages-omega.co.za	Notes: No groundwater seepage Good sidewall stability No sample taken

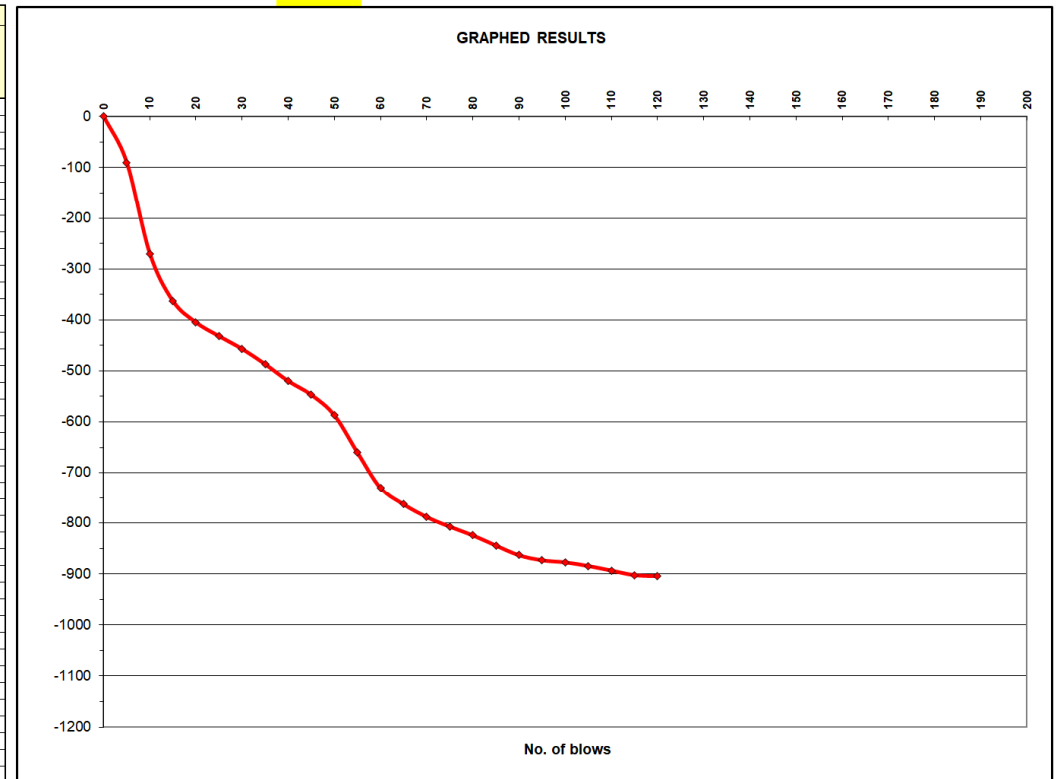
NO. OF BLOWS	DCP 1									
	Values (mm)	Cumulative penetration (mm)	mm/blow	UCS (kPa)	CBR% (Kleyn, 1984)	E (MPa) (Packard, 1973)	E (De Beer, 1991) MPa	E (Jianzhou et al., 1999)	ρ (mm)	k (kN/m ³)
0	88	0	0.0							
5	178	-90	18.0	124	10	29	52	109	0.0003	730
10	358	-270	36.0	58	4	17	25	84	0.0004	557
15	451	-363	18.6	120	10	28	50	108	0.0003	721
20	493	-405	8.4	285	27	51	116	147	0.0003	983
25	520	-432	5.4	461	48	72	186	175	0.0002	1167
30	545	-457	5.0	502	53	77	202	180	0.0002	1203
35	575	-487	6.0	411	42	67	167	168	0.0002	1120
40	608	-520	6.6	371	37	62	150	162	0.0002	1079
45	635	-547	5.4	461	48	72	186	175	0.0002	1167
50	675	-587	8.0	301	29	53	123	150	0.0002	1001
55	748	-660	14.6	156	14	34	65	119	0.0003	792
60	818	-730	14.0	163	14	35	68	121	0.0003	805
65	851	-763	6.6	371	37	62	150	162	0.0002	1079
70	876	-788	5.0	502	53	77	202	180	0.0002	1203
75	895	-807	3.8	677	75	95	270	201	0.0002	1339
80	912	-824	3.4	764	87	104	304	210	0.0002	1398

85	932	-844	4.0	640	70	91	256	197	0.0002	1312
90	951	-863	3.8	677	75	95	270	201	0.0002	1339
95	961	-873	2.0	1362	170	156	535	258	0.0001	1720
100	965	-877	0.8	3699	342	239	1414	369	0.0001	2458
105	972	-884	1.4	2010	232	189	781	296	0.0001	1976
110	981	-893	1.8	1528	185	165	598	269	0.0001	1792
115	990	-902	1.8	1528	185	165	598	269	0.0001	1792
120	992	-904	0.4	7873	442	279	2952	483	0.0001	3221
125										
130										
135										
140										
145										
150										
155										
160										
165										
170										
175										
180										
185										
190										
195										
200

The DCP testing gives an estimation on the expected excavation conditions and in-situ bearing capacity of the soil materials that was intersected with the test. The calculated Unconfined Compressive Strength of the materials as obtained from the penetration of the cone in mm per blow is averaged and can be summarised as follow:

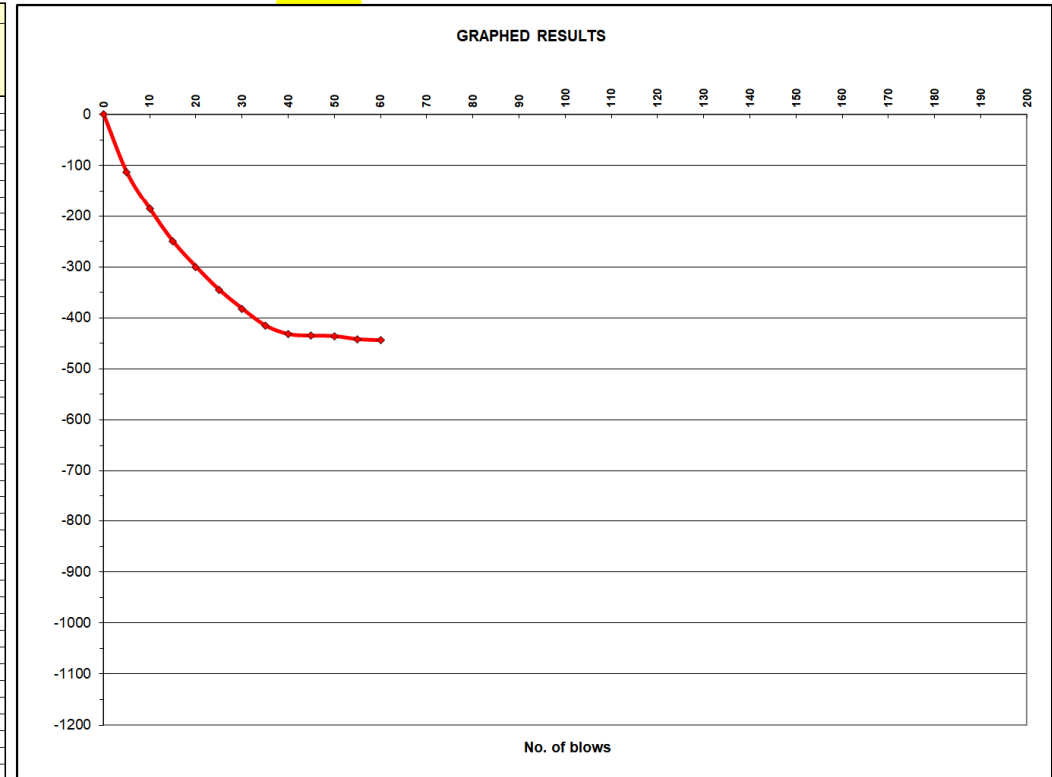
NO. OF BLOWS	DCP 2								
	Values (mm)	Cumulative penetration (mm)	mm/blow	UCS (kPa)	CBR% (Kieyn, 1984)	E (MPa) (Packard, 1973)	E (De Beer, 1991) MPa	E (Jianzhou et al., 1999)	k (kN/m ³)
0	110	0	0.0						
5	223	-113	22.6	97	8	24	41	100	0.0004
10	296	-186	14.6	156	14	34	65	119	0.0003
15	360	-250	12.8	180	16	37	74	125	0.0003
20	410	-300	10.0	236	22	45	97	138	0.0003
25	455	-345	9.0	264	25	49	108	143	0.0003
30	492	-382	7.4	327	32	57	133	155	0.0002
35	525	-415	6.6	371	37	62	150	162	0.0002
40	542	-432	3.4	764	87	104	304	210	0.0002
45	545	-435	0.6	5061	389	259	1919	413	0.0001
50	546	-436	0.2	16760	500	301	6161	633	0.0001
55	552	-442	1.2	2377	263	204	919	315	0.0001
60	554	-444	0.4	7873	442	279	2952	483	0.0001
65									
70									
75									
80									
85									
90									
95									
100									
105									
110									
115									
120									
125									
130									
135									
140									
145									
150

155									
160									
165									
170									
175									
180									
185									
190									
195									
200

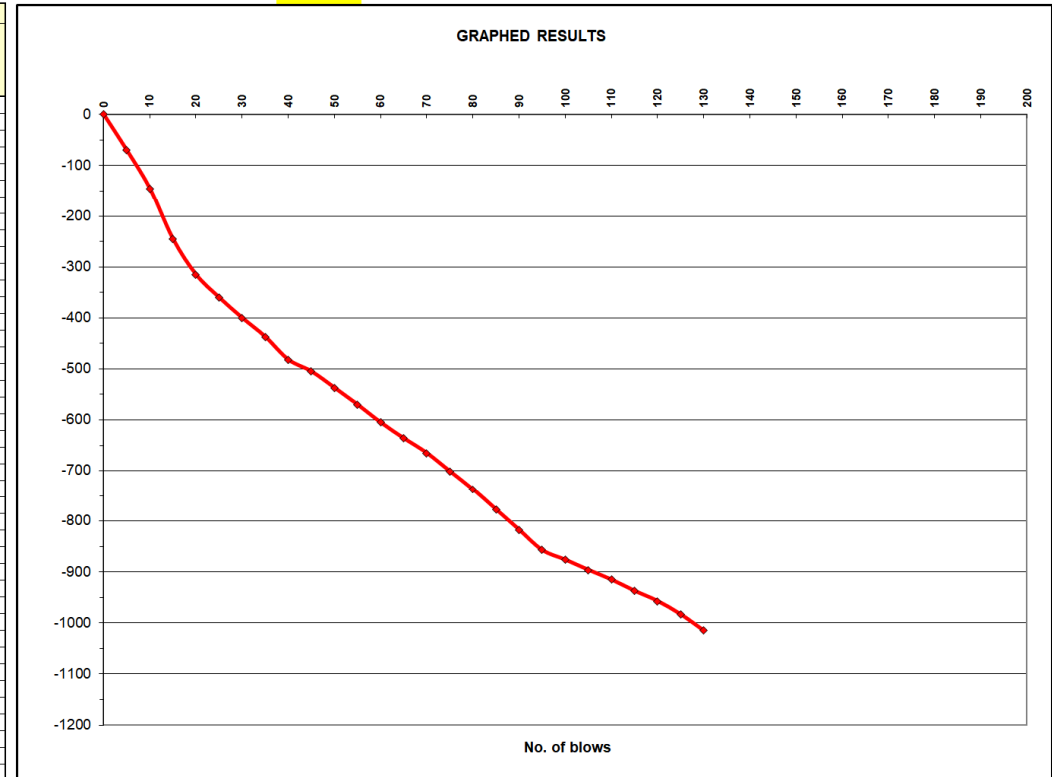
NO. OF BLOWS	DCP 3									
	Values (mm)	Cumulative penetration (mm)	mm/blow	UCS (kPa)	CBR% (Kieyn, 1984)	E (MPa) (Packard, 1973)	E (De Beer, 1991) MPa	E (Jianzhou et al., 1999)	ρ (mm)	k (kN/m ³)
0	105	0	0.0							
5	175	-70	14.0	163	14	35	68	121	0.0003	805
10	250	-145	15.0	152	13	33	63	118	0.0003	784
15	350	-245	20.0	111	9	26	46	105	0.0004	701
20	420	-315	14.0	163	14	35	68	121	0.0003	805
25	465	-360	9.0	264	25	49	108	143	0.0003	956
30	505	-400	8.0	301	29	53	123	150	0.0002	1001
35	542	-437	7.4	327	32	57	133	155	0.0002	1032
40	587	-482	9.0	264	25	49	108	143	0.0003	956
45	610	-505	4.6	550	59	82	221	186	0.0002	1243
50	642	-537	6.4	383	39	64	155	164	0.0002	1092
55	675	-570	6.6	371	37	62	150	162	0.0002	1079
60	710	-605	7.0	348	35	59	141	158	0.0002	1055
65	741	-636	6.2	397	40	65	161	166	0.0002	1106
70	770	-665	5.8	427	44	69	173	170	0.0002	1135
75	806	-701	7.2	337	33	58	137	157	0.0002	1043
80	842	-737	7.2	337	33	58	137	157	0.0002	1043

85	882	-777	8.0	301	29	53	123	150	0.0002	1001
90	922	-817	8.0	301	29	53	123	150	0.0002	1001
95	962	-857	8.0	301	29	53	123	150	0.0002	1001
100	981	-876	3.8	677	75	95	270	201	0.0002	1339
105	1001	-896	4.0	640	70	91	256	197	0.0002	1312
110	1020	-915	3.8	677	75	95	270	201	0.0002	1339
115	1042	-937	4.4	577	62	85	231	190	0.0002	1264
120	1062	-957	4.0	640	70	91	256	197	0.0002	1312
125	1088	-983	5.2	481	51	75	194	178	0.0002	1185
130	1120	-1015	6.4	383	39	64	155	164	0.0002	1092
135										
140										
145										
150										
155										
160										
165										
170										
175										
180										
185										
190										
195										
200

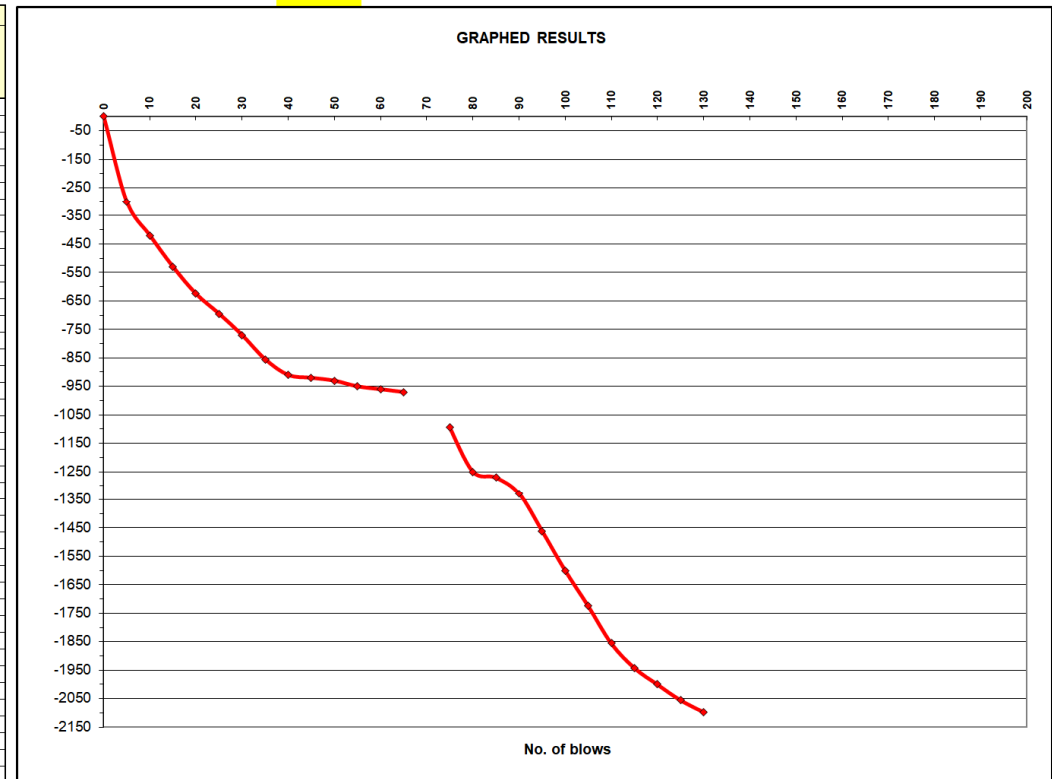
NO. OF BLOWS	DCP 4									
	Values (mm)	Cumulative penetration (mm)	mm/blow	UCS (kPa)	CBR% (Kieyn, 1984)	E (MPa) (Packard, 1973)	E (De Beer, 1991) MPa	E (Jianzhou et al., 1999)	ρ (mm)	k (kN/m ³)
0	115	0	0.0							
5	415	-300	60.0	33	2	11	14	68	0.0005	456
10	535	-420	24.0	91	7	23	38	98	0.0004	652
15	645	-530	22.0	100	8	24	42	101	0.0004	675
20	740	-625	19.0	117	10	27	49	107	0.0003	715
25	810	-695	14.0	163	14	35	68	121	0.0003	805
30	885	-770	15.0	152	13	33	63	118	0.0003	784
35	970	-855	17.0	132	11	30	55	112	0.0003	746
40	1025	-910	11.0	212	20	42	87	133	0.0003	884
45	1035	-920	2.0	1362	170	156	535	258	0.0001	1720
50	1045	-930	2.0	1362	170	156	535	258	0.0001	1720
55	1065	-950	4.0	640	70	91	256	197	0.0002	1312
60	1075	-960	2.0	1362	170	156	535	258	0.0001	1720
65	1085	-970	2.0	1362	170	156	535	258	0.0001	1720
70										
75	1095	-1095	219.0	8	0	4	4	41	0.0009	275
80	1250	-1250	31.0	69	5	19	29	89	0.0004	590
85	1271	-1271	4.2	607	66	88	243	193	0.0002	1288

90	1328	-1328	11.4	204	19	41	84	131	0.0003	872
95	1461	-1461	26.6	81	6	21	34	94	0.0004	627
100	1600	-1600	27.8	77	6	20	33	92	0.0004	616
105	1725	-1725	25.0	87	7	22	37	96	0.0004	642
110	1856	-1856	26.2	82	6	21	35	95	0.0004	631
115	1942	-1942	17.2	131	11	30	54	111	0.0003	743
120	2000	-2000	11.6	201	18	40	83	130	0.0003	866
125	2055	-2055	11.0	212	20	42	87	133	0.0003	884
130	2097	-2097	8.4	285	27	51	116	147	0.0003	983
135										
140										
145										
150										
155										
160										
165										
170										
175										
180										
185										
190										
195										
200

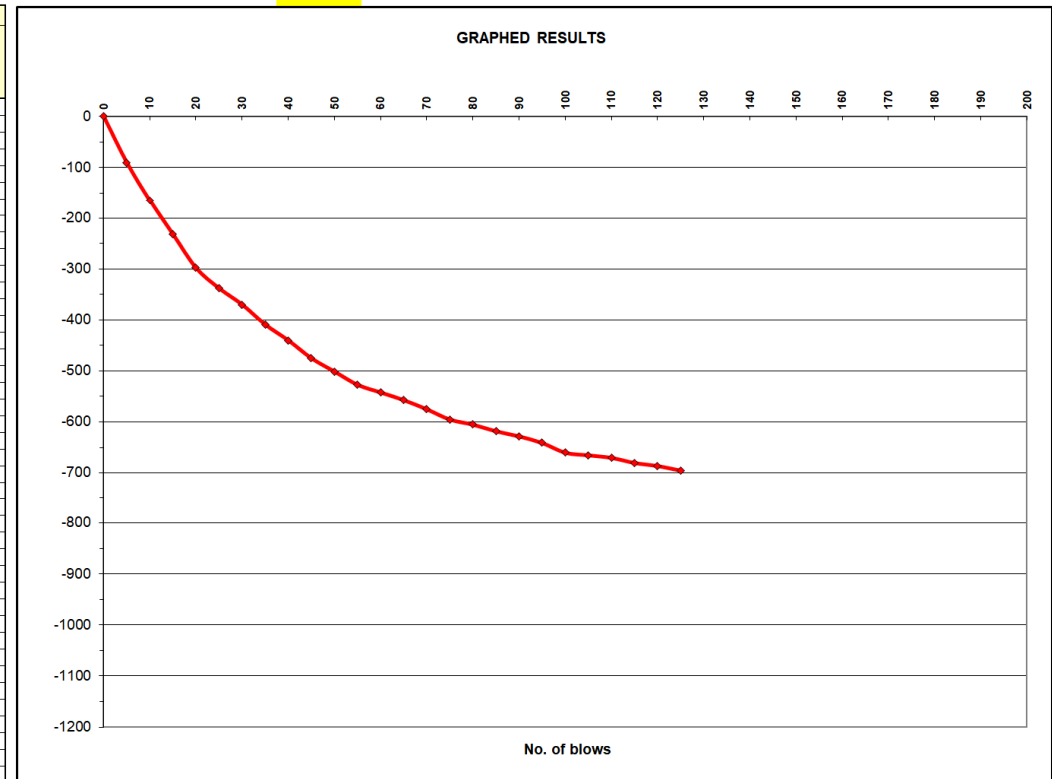
NO. OF BLOWS	DCP 5									
	Values (mm)	Cumulative penetration (mm)	mm/blow	UCS (kPa)	CBR% (Kieyn, 1984)	E (MPa) (Packard, 1973)	E (De Beer, 1991) MPa	E (Jianzhou et al., 1999)	ρ (mm)	k (kN/m ³)
0	100	0	0.0							
5	190	-90	18.0	124	10	29	52	109	0.0003	730
10	265	-165	15.0	152	13	33	63	118	0.0003	784
15	332	-232	13.4	171	15	36	71	123	0.0003	819
20	398	-298	13.2	174	15	36	72	124	0.0003	824
25	438	-338	8.0	301	29	53	123	150	0.0002	1001
30	470	-370	6.4	383	39	64	155	164	0.0002	1092
35	509	-409	7.8	309	30	55	126	152	0.0002	1011
40	540	-440	6.2	397	40	65	161	166	0.0002	1106
45	575	-475	7.0	348	35	59	141	158	0.0002	1055
50	601	-501	5.2	481	51	75	194	178	0.0002	1185
55	627	-527	5.2	481	51	75	194	178	0.0002	1185
60	642	-542	3.0	876	102	114	348	220	0.0002	1468
65	657	-557	3.0	876	102	114	348	220	0.0002	1468
70	675	-575	3.6	718	81	99	286	205	0.0002	1367
75	695	-595	4.0	640	70	91	256	197	0.0002	1312
80	705	-605	2.0	1362	170	156	535	258	0.0001	1720

85	718	-618	2.6	1023	122	127	405	233	0.0002	1552
90	728	-628	2.0	1362	170	156	535	258	0.0001	1720
95	741	-641	2.6	1023	122	127	405	233	0.0002	1552
100	760	-660	3.8	677	75	95	270	201	0.0002	1339
105	765	-665	1.0	2900	300	221	1116	338	0.0001	2253
110	770	-670	1.0	2900	300	221	1116	338	0.0001	2253
115	780	-680	2.0	1362	170	156	535	258	0.0001	1720
120	786	-686	1.2	2377	263	204	919	315	0.0001	2099
125	795	-695	1.8	1528	185	165	598	269	0.0001	1792
130										
135										
140										
145										
150										
155										
160										
165										
170										
175										
180										
185										
190										
195										
200

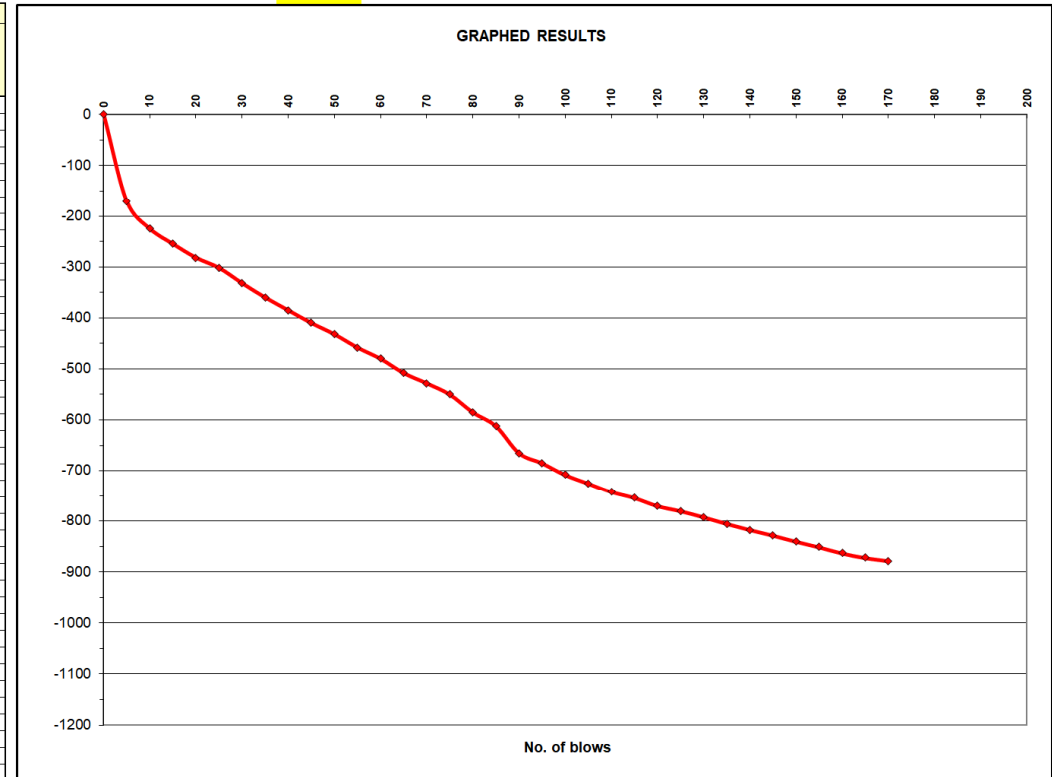
85	722	-612	5.4	461	48	72	186	175	0.0002	1167
90	775	-665	10.6	221	20	43	91	135	0.0003	897
95	795	-685	4.0	640	70	91	256	197	0.0002	1312
100	818	-708	4.6	550	59	82	221	186	0.0002	1243
105	835	-725	3.4	764	87	104	304	210	0.0002	1398
110	852	-742	3.4	764	87	104	304	210	0.0002	1398
115	864	-754	2.4	1117	135	136	440	240	0.0002	1602
120	880	-770	3.2	816	94	109	325	215	0.0002	1432
125	890	-780	2.0	1362	170	156	535	258	0.0001	1720
130	902	-792	2.4	1117	135	136	440	240	0.0002	1602
135	915	-805	2.6	1023	122	127	405	233	0.0002	1552
140	927	-817	2.4	1117	135	136	440	240	0.0002	1602
145	938	-828	2.2	1228	151	145	483	249	0.0002	1657
150	950	-840	2.4	1117	135	136	440	240	0.0002	1602
155	961	-851	2.2	1228	151	145	483	249	0.0002	1657
160	973	-863	2.4	1117	135	136	440	240	0.0002	1602
165	982	-872	1.8	1528	185	165	598	269	0.0001	1792
170	988	-878	1.2	2377	263	204	919	315	0.0001	2099
175										
180										
185										
190

195										
200
