Inspection of Automatic Sprinkler System

Feltex Automotive - East London
Industrial Development Zone - AE1

0191

19.06.2024 08:00 SAST

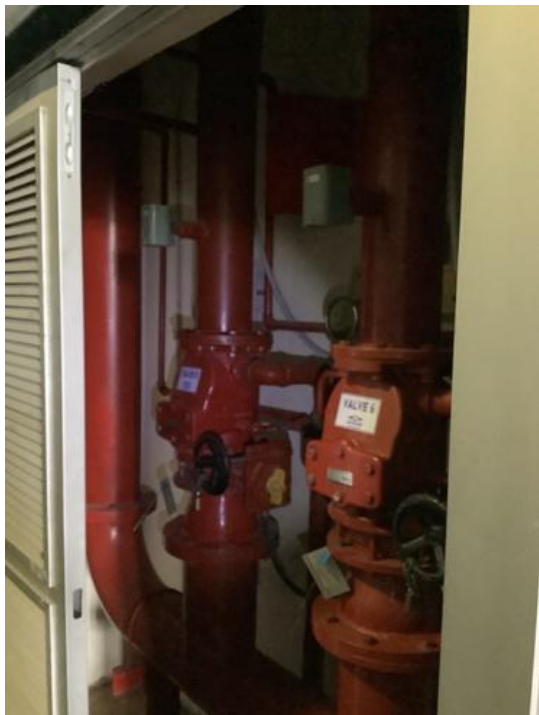
Photo 1

Location:

AE1

1 x 100mm, 2 x 150mm

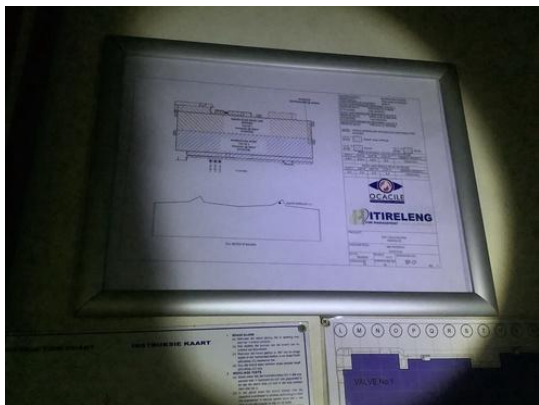
Photo 3

7.4 Block Plan Installed

Yes

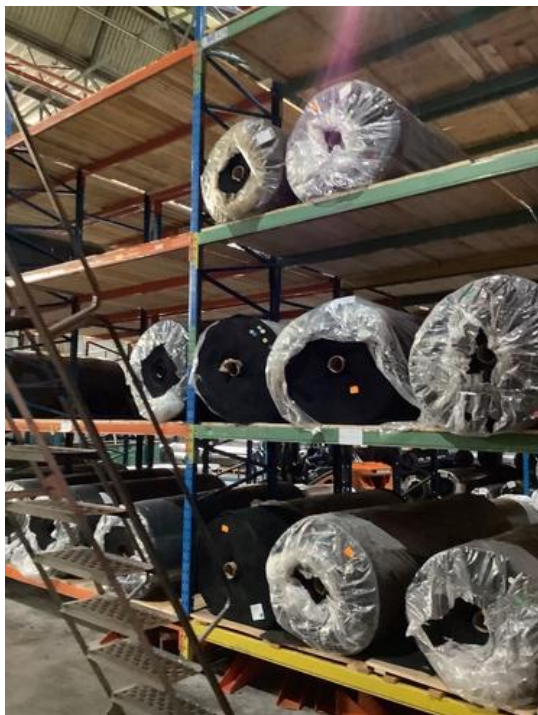
Photo 9

Are the storage heights exceeded.

Yes

The storage heights must be maintained in accordance with the maximum allowable stack heights as detailed in this report. Should this not be possible, intermediate level protection is deemed to be mandatory.

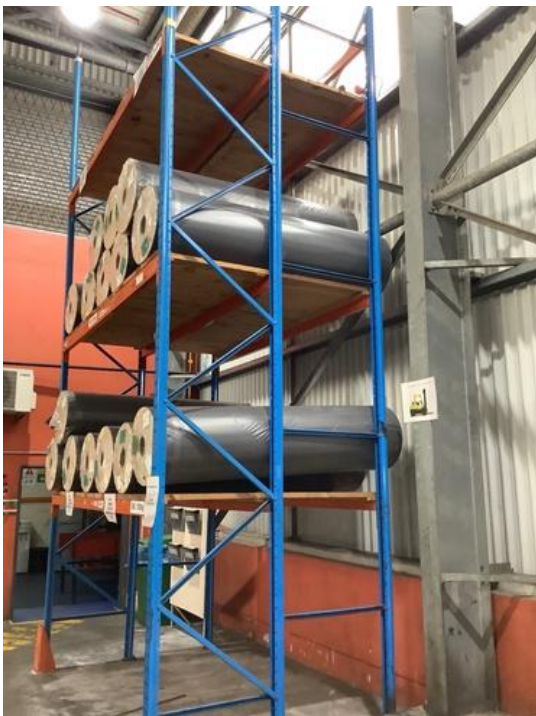
Photo 15

Shelves exceed 1,0 metre in width.

Quarantine store
Trim workshop

The shelves must be reduced to a maximum width of 1,0 metre or intermediate sprinkler protection will be mandatory at each shelf tier level.

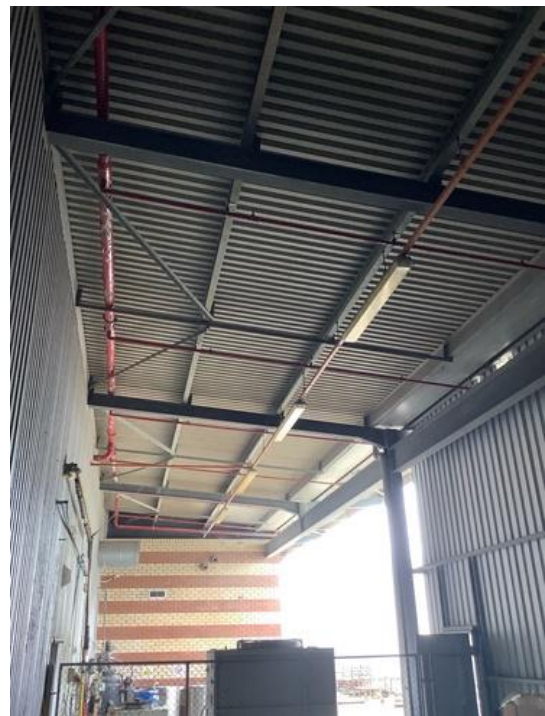
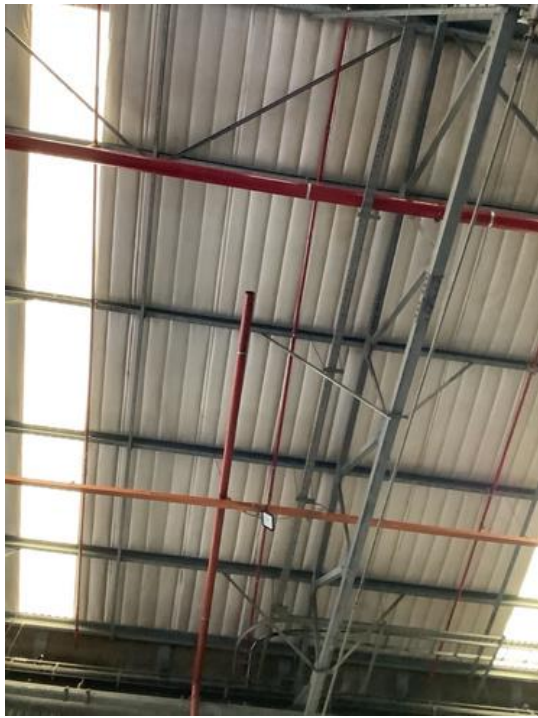
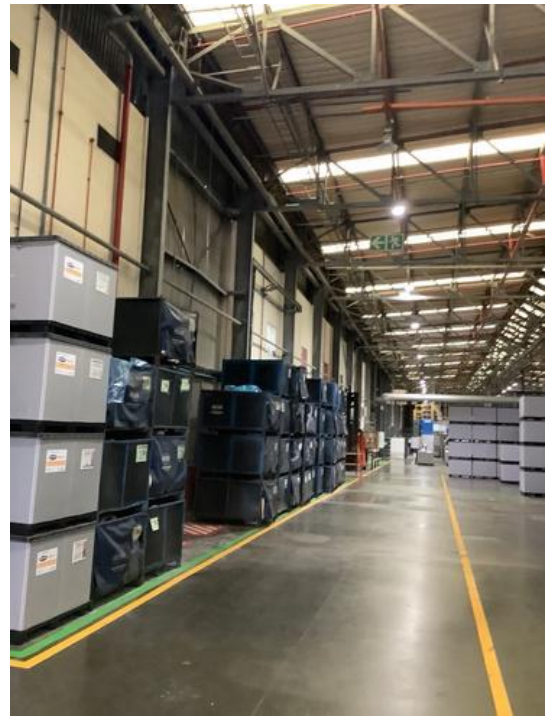
Partial Protection /
Communicating Areas

Portion of premises sprinkler protected with communicating sections that are not.

Partial protection can lead to a fire originating in the protected area radiating heat into the unprotected portion of the premises and starting secondary fires. The heat from these fires radiates or spreads back into the protected area causing excessive sprinkler operation.

All areas which have not been re-connected to the sprinkler system viz. offices, external canopies

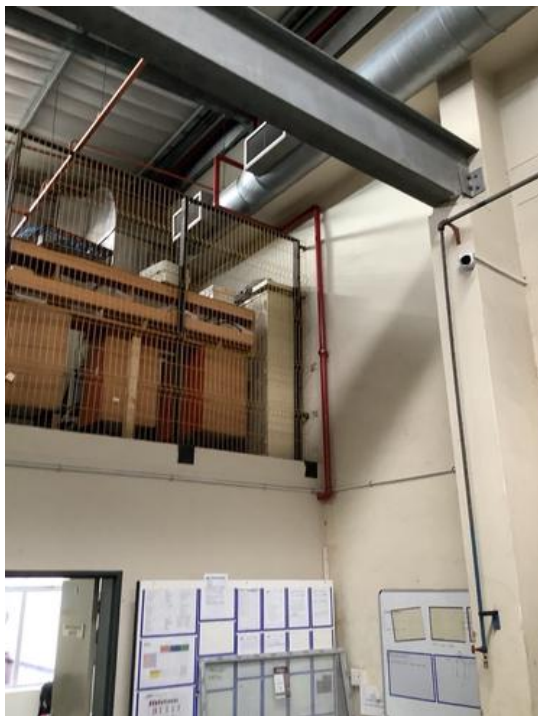
Photo 23

Pipe Support

Distribution rise/drop pipes shall be secured directly to the

building structure or by hangers securing horizontal distribution pipes within 300 mm of the riser.

Dropper to offices in workshop

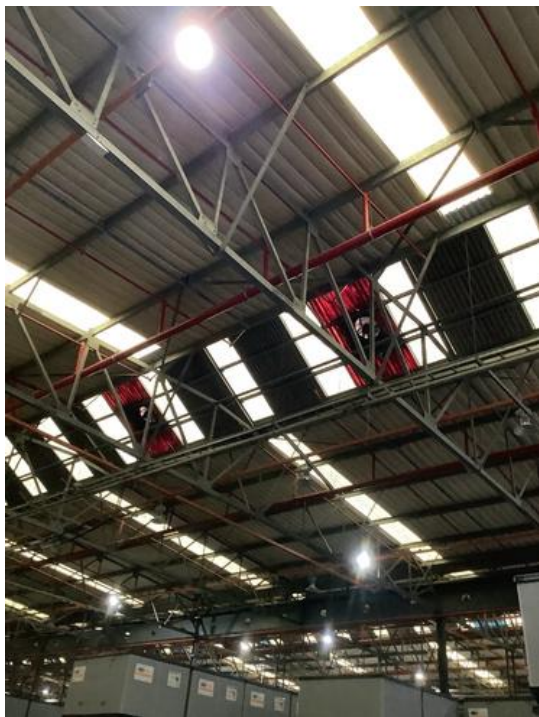
Photo 25

Sprinklers installed beneath open cell surfaces / translucent sheeting.

Various at roof

All sprinklers located beneath open celled floors or stairwells and translucent sheeting must have approved water shields fitted above the sprinklers.

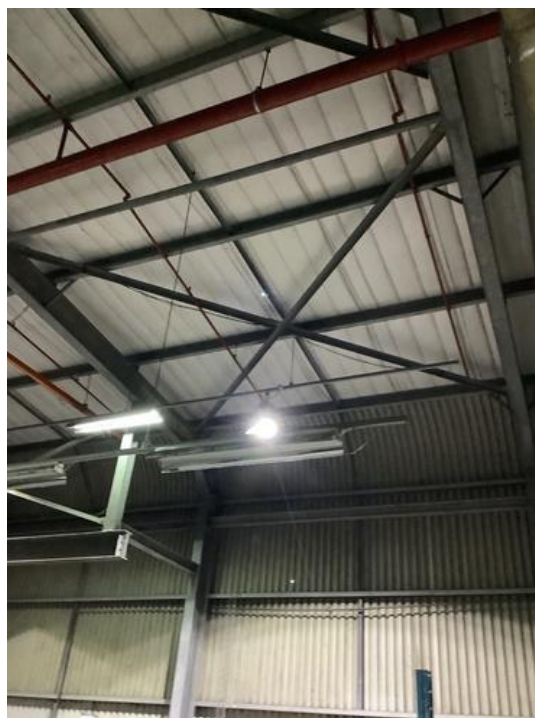
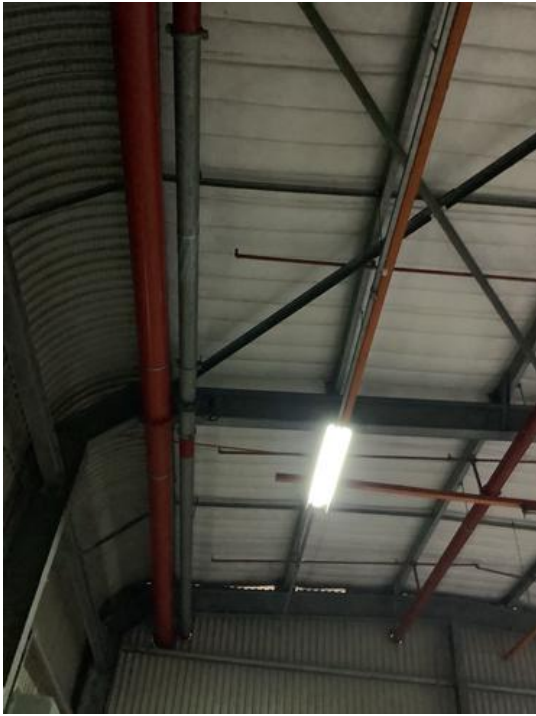
Terminal range pipe hangers are exceeding the maximum distance of 750 mm from the end of the range pipe.

Durban stock roof

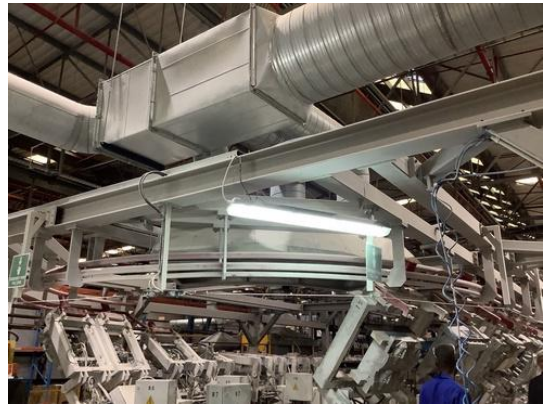
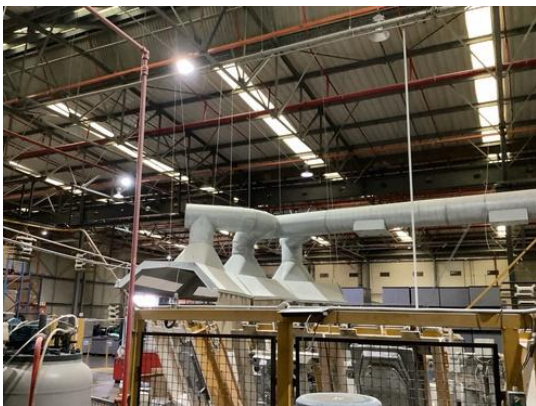
Extraction Canopies.

Cel 1

Extraction canopies where these are designed to extract grease laden vapours or heat through a ventilation system must be fully sprinkler protected, inclusive of exhaust ducts and exhaust plenum chambers, using 141° Celsius operating temperature spray pattern type nozzles unless alternative protection is installed.

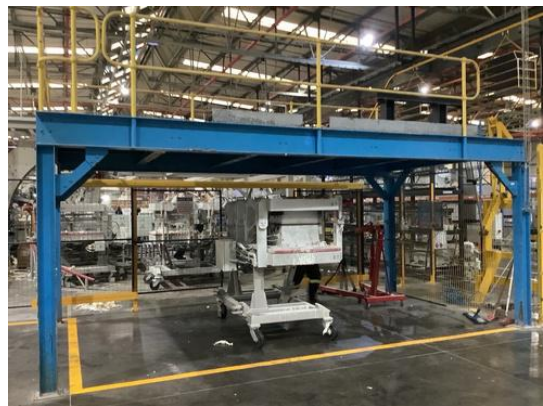
Photo 32

Surfaces exceeding 1,0 metre in width.

Surfaces which exceed 1,0 metre in width will obstruct the water discharged from the sprinklers above which could result in an ignition beneath these surfaces not being controlled or extinguished.

Carry open device

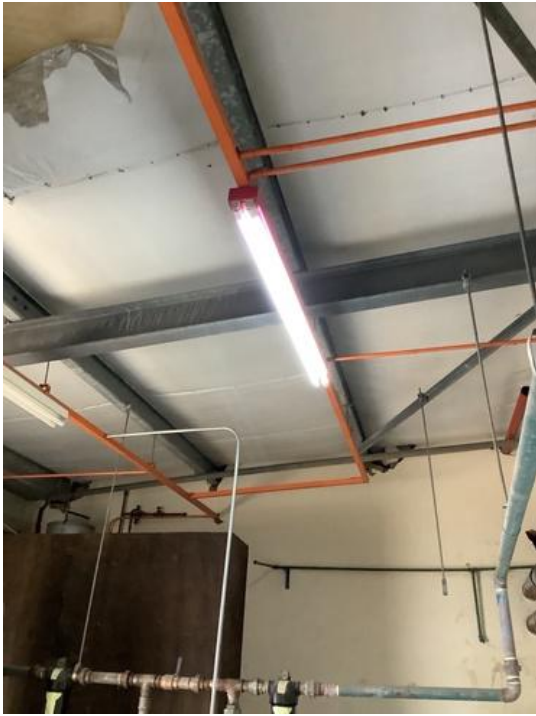
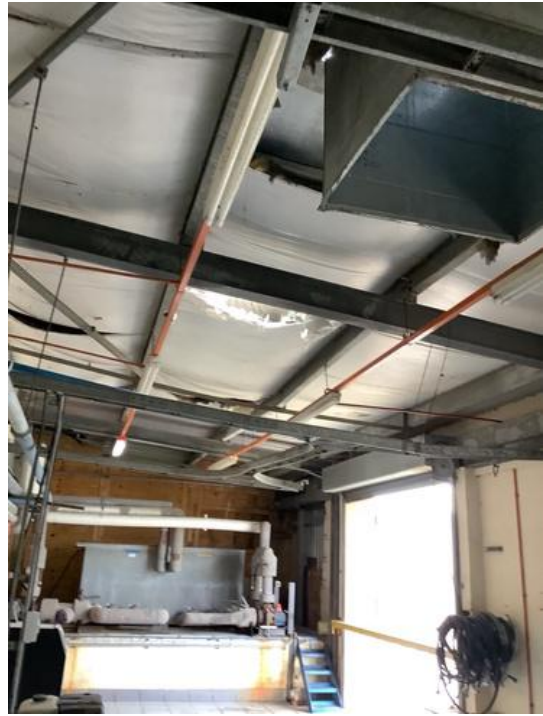
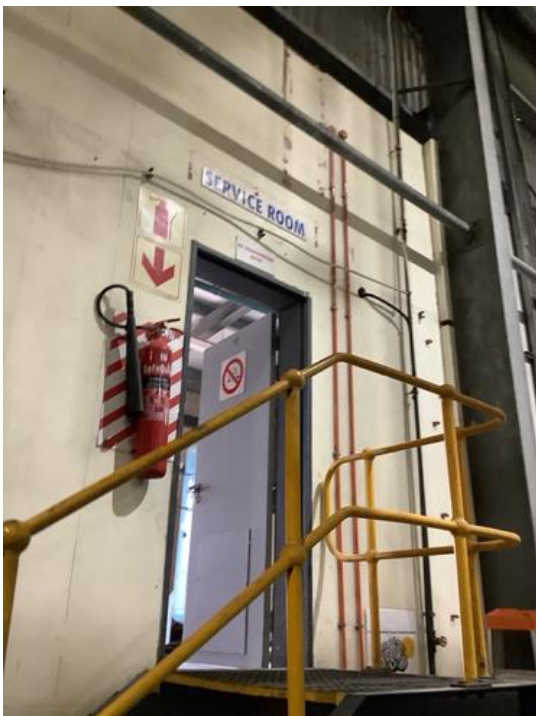
Portion of premises sprinkler protected with communicating sections that are not.

Partial protection can lead to a fire originating in the protected area radiating heat into the unprotected portion of the premises and starting secondary fires. The heat from these fires radiates or spreads back into the protected area causing excessive sprinkler operation.

Service room

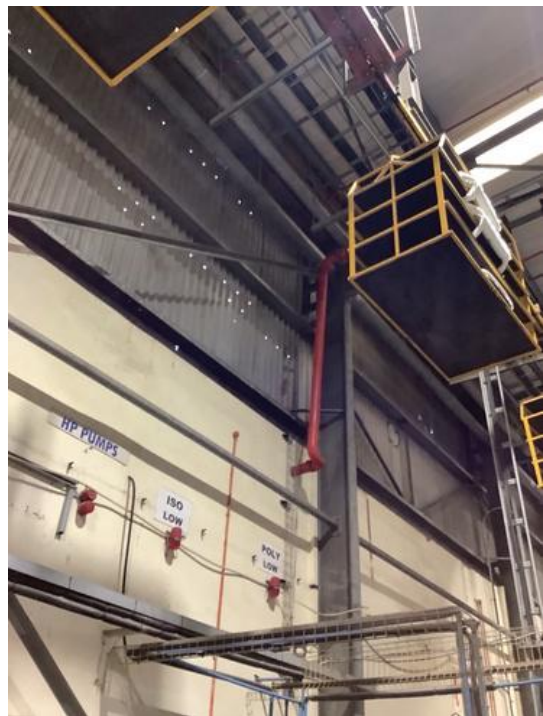
Photo 36

Distribution rise/drop pipes shall be secured directly to the building structure or by hangers securing horizontal distribution pipes within 300 mm of the riser.

Dropper to service room

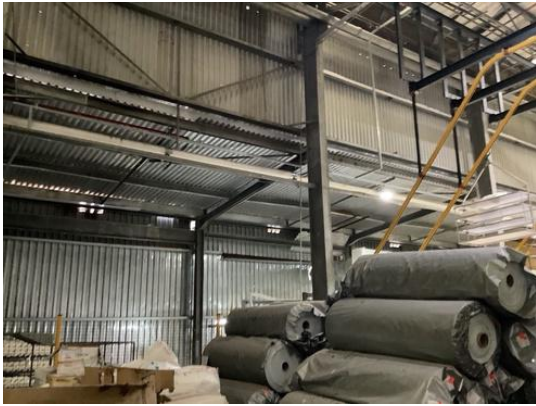
Photo 37

Portion of premises sprinkler protected with communicating sections that are not.

Partial protection can lead to a fire originating in the protected area radiating heat into the unprotected portion of the premises and starting secondary fires. The heat from these fires radiates or spreads back into the protected area causing excessive sprinkler operation.

Trimming

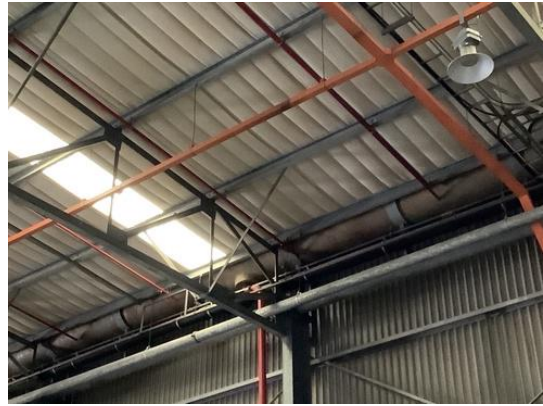
Photo 38

Terminal range pipe hangers are exceeding the maximum distance of 750 mm from the end of the range pipe.

South side roof ranges

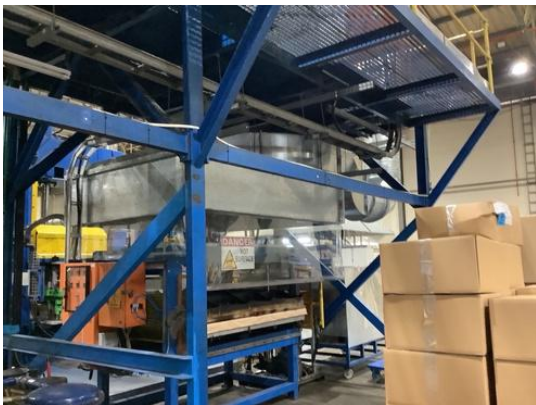
Photo 39

Extraction Canopies.

Heater platten

Extraction canopies where these are designed to extract grease laden vapours or heat through a ventilation system must be fully sprinkler protected, inclusive of exhaust ducts and exhaust plenum chambers, using 141° Celsius operating temperature spray pattern type nozzles unless alternative protection is installed.
