Technical Report

DAIMLER TRUCKS SOUTH AFRICA AT ZONE 1A ELIDZ

Geotechnical investigation for the proposed new Daimler Trucks South Africa facility in Zone 1A of the Est London IDZ, Buffalo City Metropolitan Municipality; Eastern Cape

January 2025

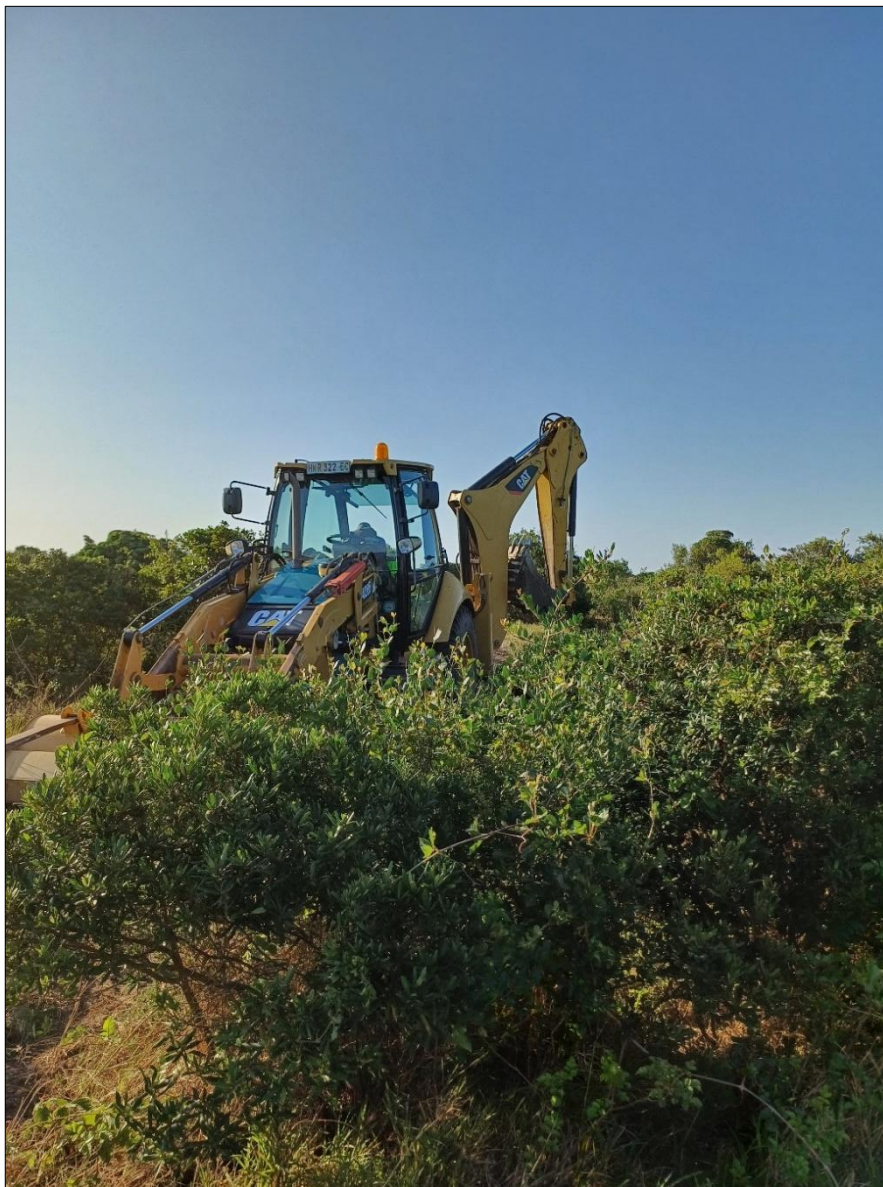
Figure 3: Excavation of test pit in process.

A total of 14, numbered DT 1 to DT 14 test pits were excavated on the 16th of October 2024 utilising a CAT 428F TLB-type excavator obtained from Messrs. Plus Plant Hire. The position of the test pits is indicated in Figure 2 below. The positions of test pits were sited by the client BVI. Profiling and sampling were conducted the same day by a competent person, with the pits backfilled with excavated material and tampered with the bucket of the TLB.

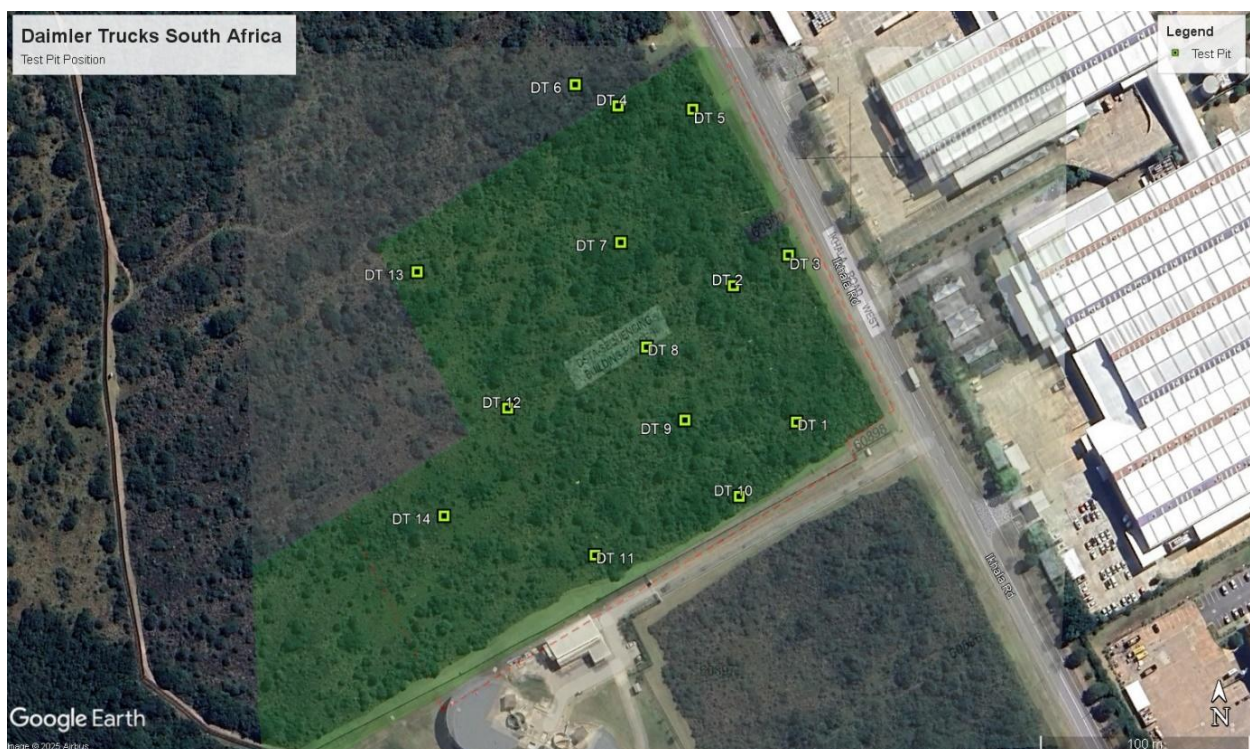
Figure 4: Detailed layout of test pits

The positions of the test pits are indicated in the Figure below, with detailed test pit logs and photographs attached in Appendix A.

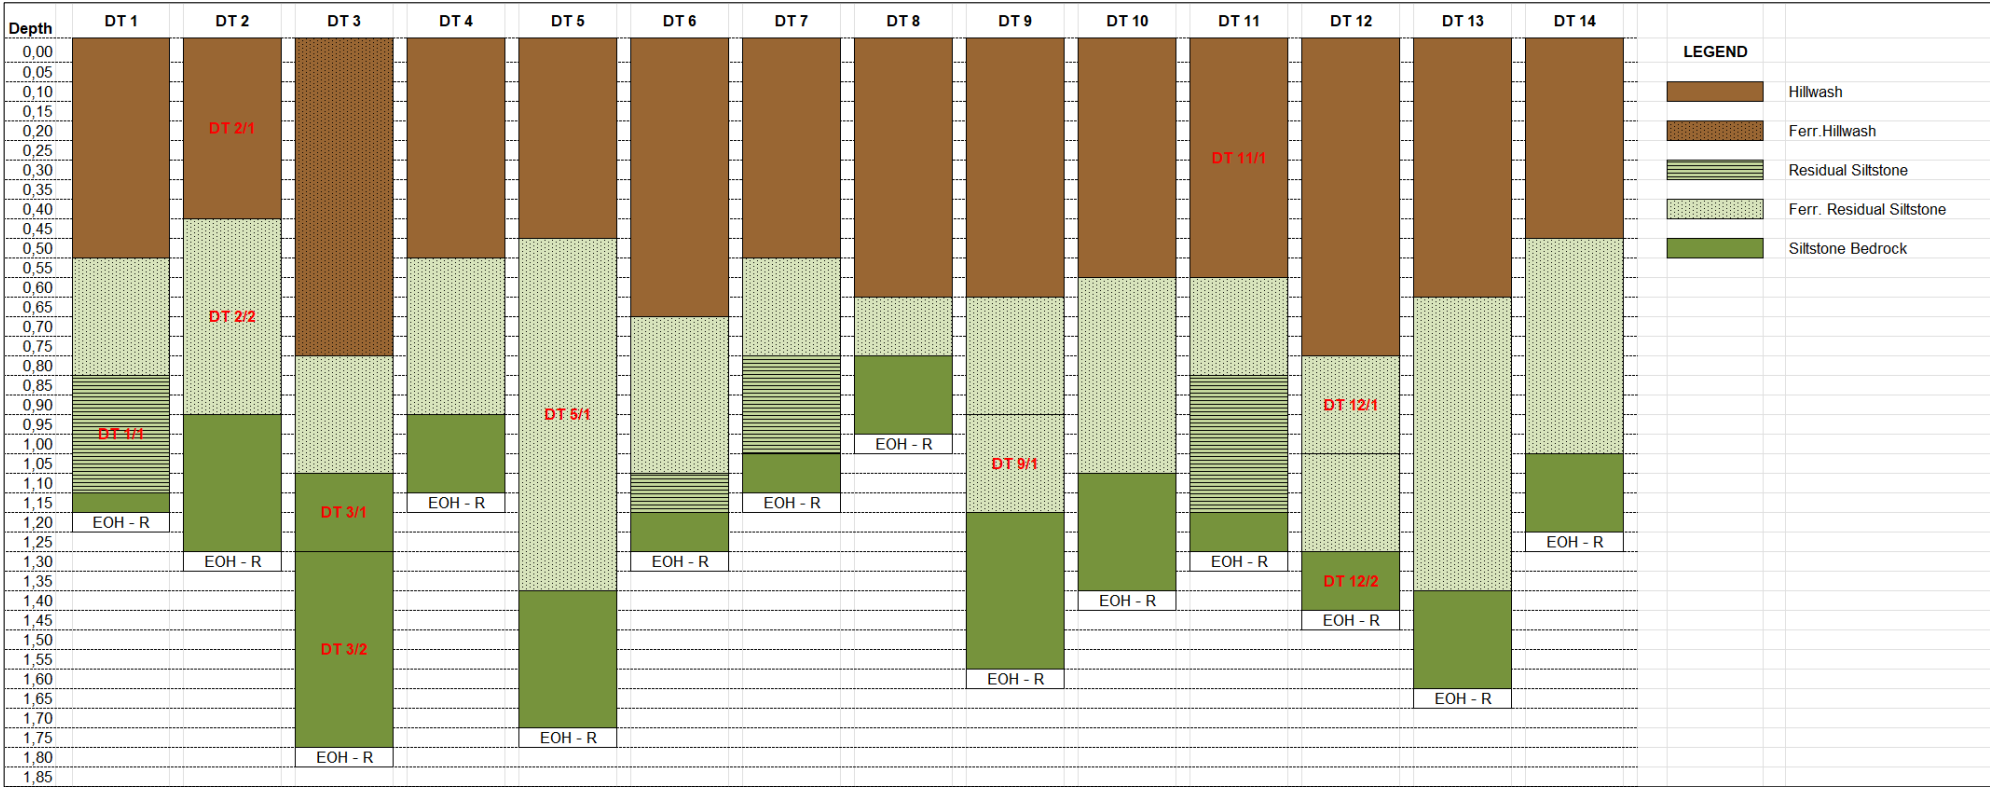
Figure 6: Graphical illustration of soil profiles

The residual soil material is underlain by a highly to moderately weathered, soft to hard rock, medium grained, siltstone bedrock material. The bedrock material was encountered in all the test pits from a depth of 0.75 to 1.35 mbgl (mean 1.12 mbgl).

Detailed test pit logs and photographs are attached at the end of the report. The generalised soil profile the site is indicated in the Figure below.

The site is characterised by moderately deep soils with competent sedimentary bedrock material in the form of siltstone generally from a depth of 0.95 to 1.75 mbgl (mean 1.32 mbgl). The composition of the transported and residual materials, in combination with the potential perched groundwater conditions result in problematic soil conditions that will be prone to ground movement due to consolidation / collapse settlement.

The following are basic foundation options for the proposed structures to be developed on site to be used as a guideline. The competent horizon is the sedimentary bedrock material occurring from an average depth of 1.32 mbgl. Foundation options will have to be discussed based on founding requirements.

- **Option 2: Deep strip foundations on competent bedrock**
 - Normal construction with drainage requirements.
 - Founding on competent horizon below the problem horizons, i.e., approximately 0.95 – 1.75 mbgl.

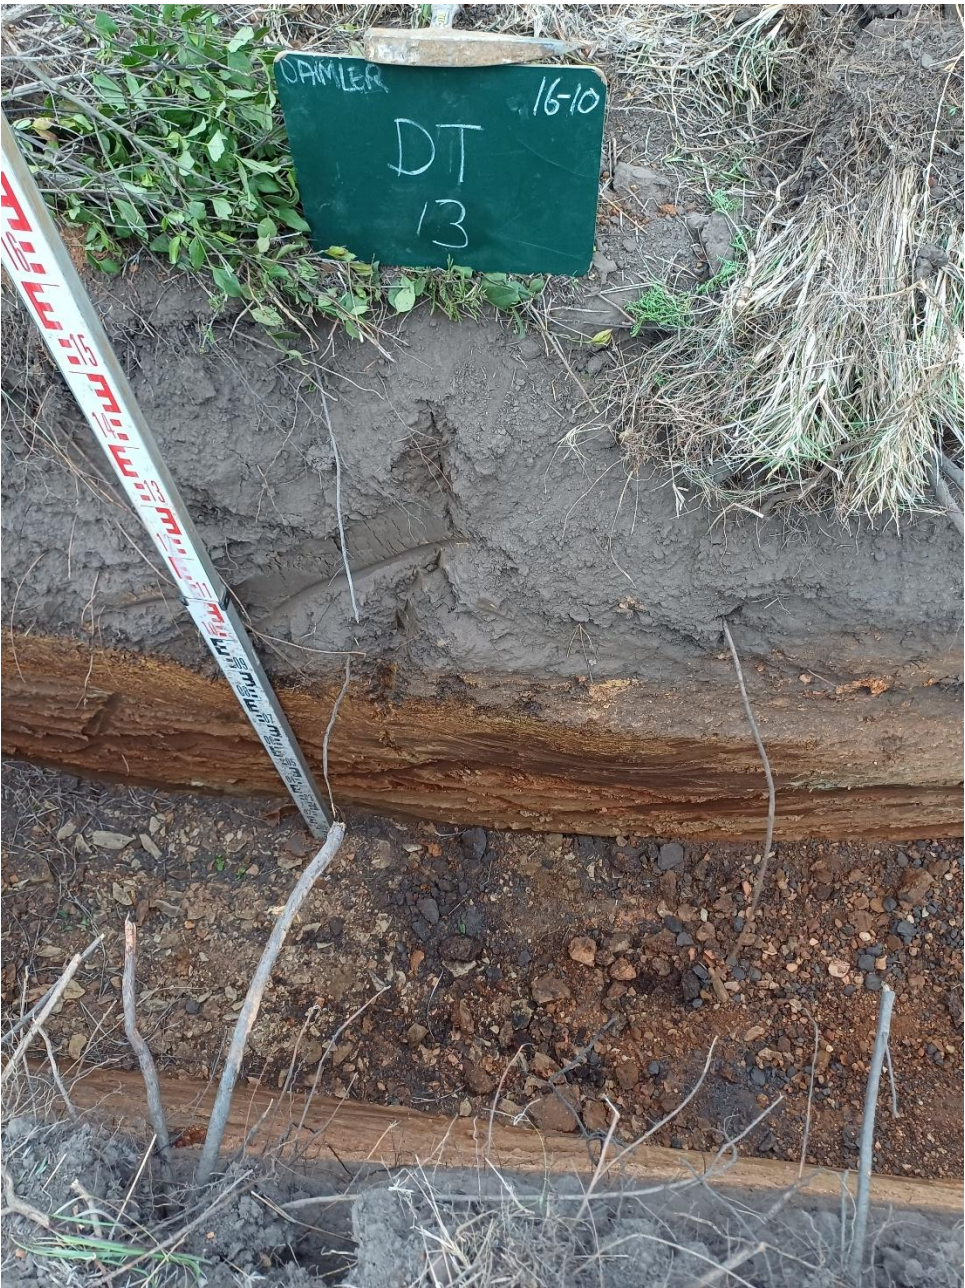
| PROJECT: GTEC - Daimler Trucks SA Zone 1A | | TEST PIT NO.: DT 13 | |

- No g/w seepage
- Good sidewall stability
- No samples taken
