# Inspection of Automatic Sprinkler System

Draeger/FSI	Complete
Client/Site Name	
Draeger/FSI	
Billing Address	
Fire Sprinkler Installations	
Attention:	
Hein Fietze Jullian Niehaus	
Document No	UNC.9918
Prepared by	Keith van Onselen
Conducted on	14.12.2022 13:27 SAST
Site Location	Draeger ERF 60952 East London Industrial Development Zone (ELIDZ) East London

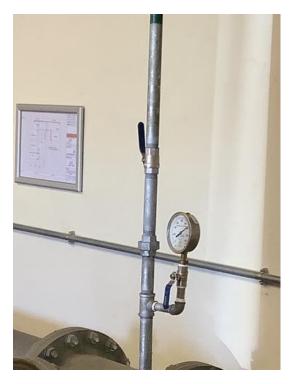
Photo 17

It was noted that an isolating valve is fitted on the supply pipe to the auto start test arrangement. This is not desirable as shutting this valve, will prevent the pump(s) from starting. This valve must be removed.
