# Inspection of Automatic Sprinkler System

Fire Suppression Solutions - Automould - ELIDZ -  
East London

UNC.8484

Automould (New warehouse  
extension)

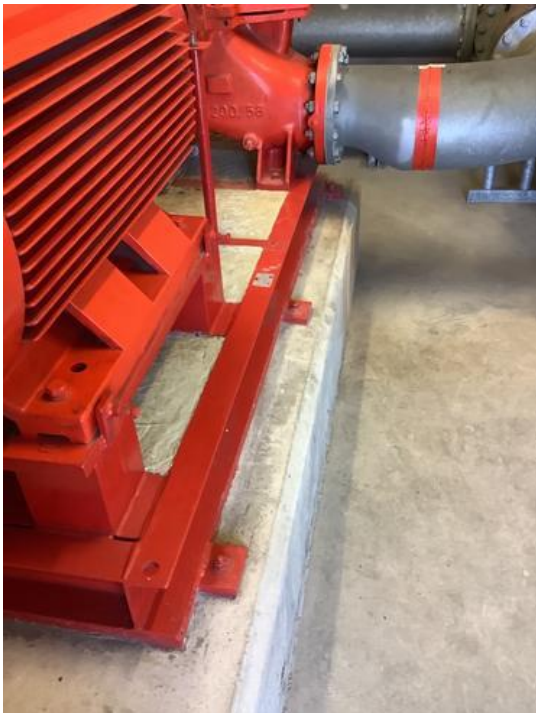
Photo 34

Foundation bolts have been passed through lugs that have been welded to the base plate for the pump set base frame. The bolts should pass through the purpose made holes in the pump set base frame. The stability of the pump set checked by your installer

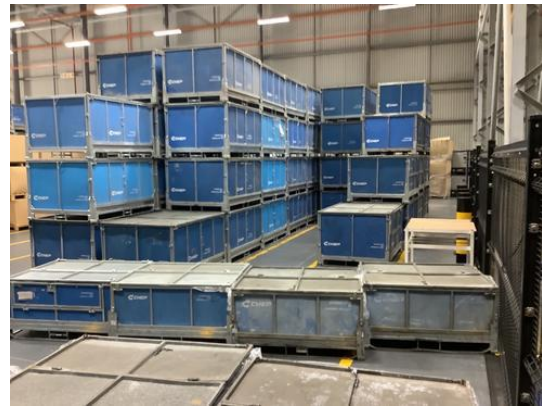
Photo 53

In all High Hazard areas a clear space of not less than 1,0 metre must be maintained between top of stored goods and sprinkler deflector.

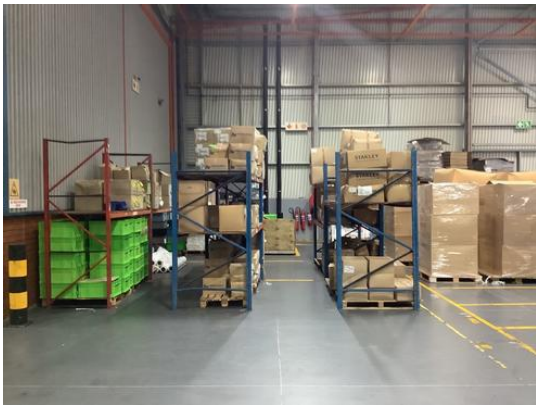
Photo 54

At the time of inspection the storage heights were being adhered to and found to be in order.
