Inspection of Automatic Sprinkler System

East London Industrial Development
Zone - AE6 vacant

UNC.10602

19.06.2024 08:49 SAST

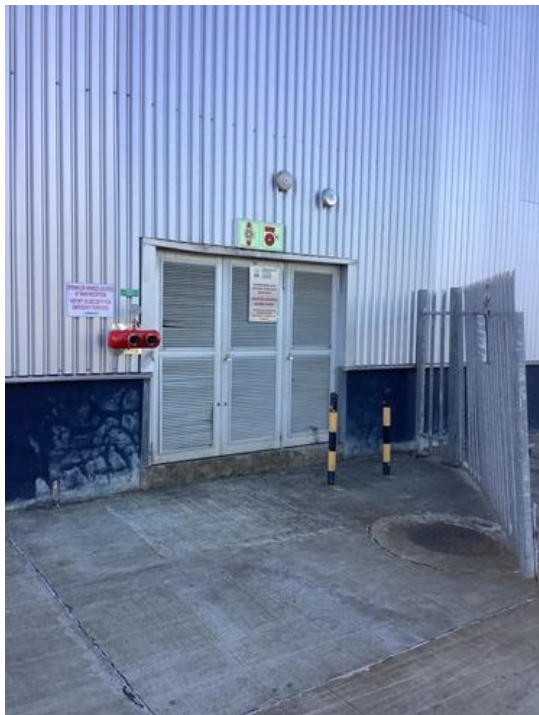
Photo 1

</div> <div> <div>Photo 1</div> <div>Photo 2</div> </div>	
Number of Alarm Valves Installed	2
7.2 Sprinkler Valve Location Plate Installed	Yes
7.3 Fire Brigade Booster Pressure Limitation Plate	Yes
7.4 Block Plan Installed	Yes
7.4.1 Is the block plan labelled in accordance with the areas fed by the sprinkler control valve assemblies	Yes
7.4.2 Are the correct installation details recorded on the block plan	Yes
<div>
