# Inspection of Automatic Sprinkler System

Yekani - East London Industrial  
Development Zone

UNC.8029

08.05.2024 12:26 SAST

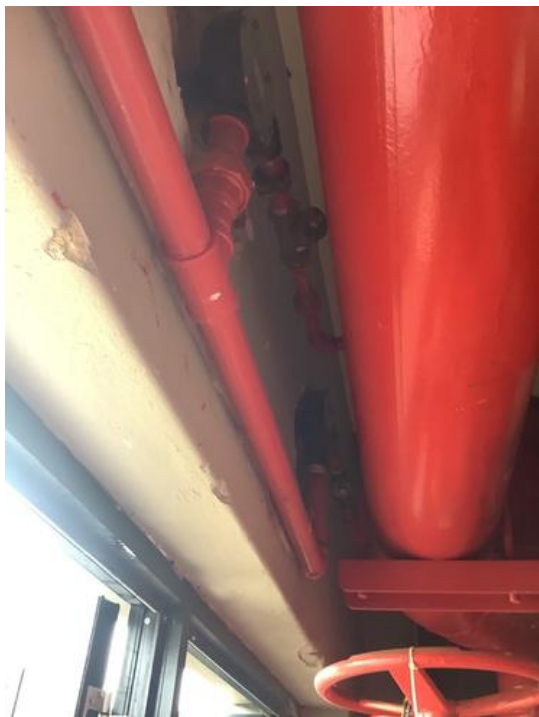
Photo 12

## 7.18 Loose / Missing Bolts, Nuts & Washers

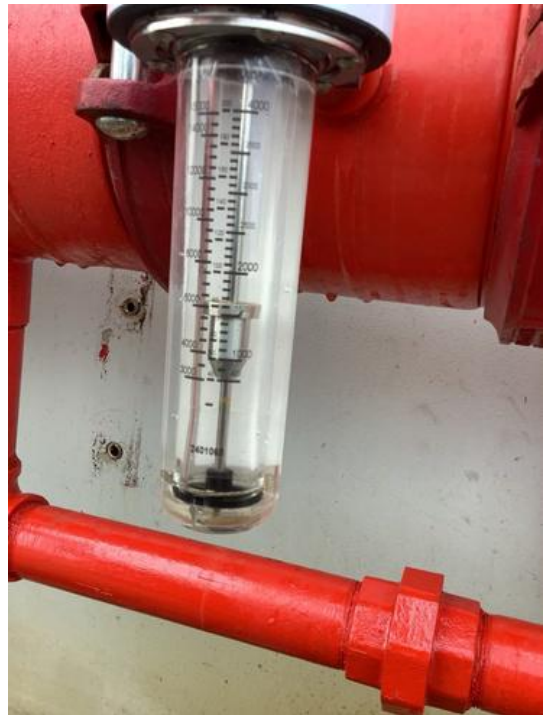
Photo 17

<b>Flow Test Results</b>	Pass
<b>Recorded Flow and Pressure</b>	6020 l/min 1140 kPa
<b>7.15 Correct Pressure Gauges Installed</b>	Yes
<b>7.16 Correct Gauge Cocks Installed</b>	Yes
<b>7.17 Flanges Short Bolted</b>	No
<b>7.18 Loose / Missing Bolts, Nuts &amp; Washers</b>	No
<b>7.19 False Alarm Prevention Pump Installed</b>	N/A
<b>7.20 Drain &amp; Test Pipes Installed Correctly</b>	No
