Inspection of Automatic Sprinkler System

East London Industrial Development
Zone - Estate Pump House

UNC.9004

08.05.2024 09:22 SAST

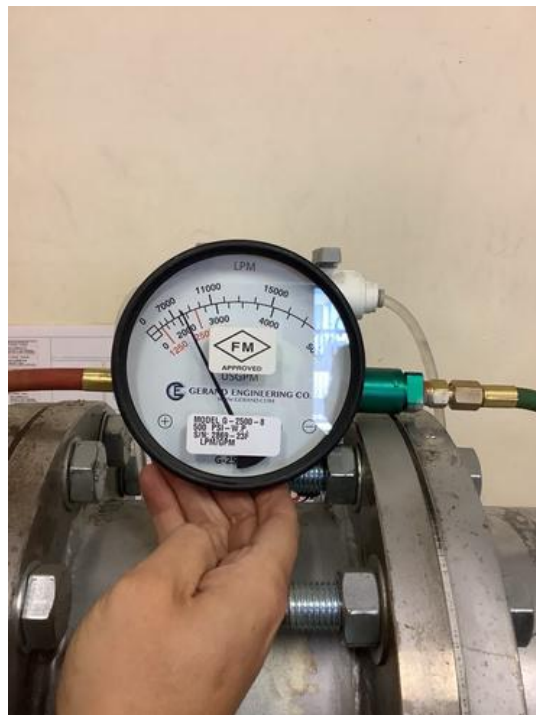
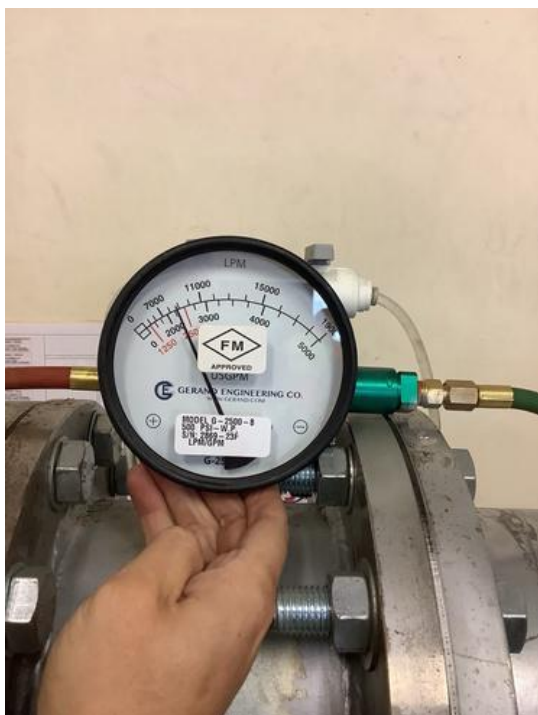
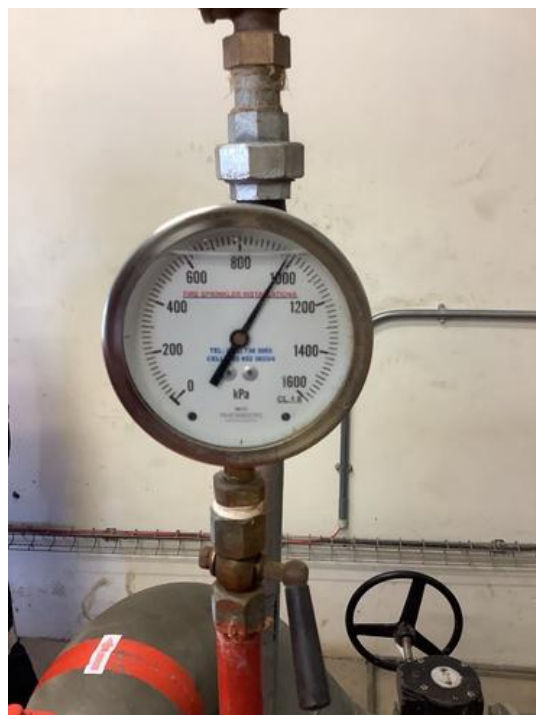
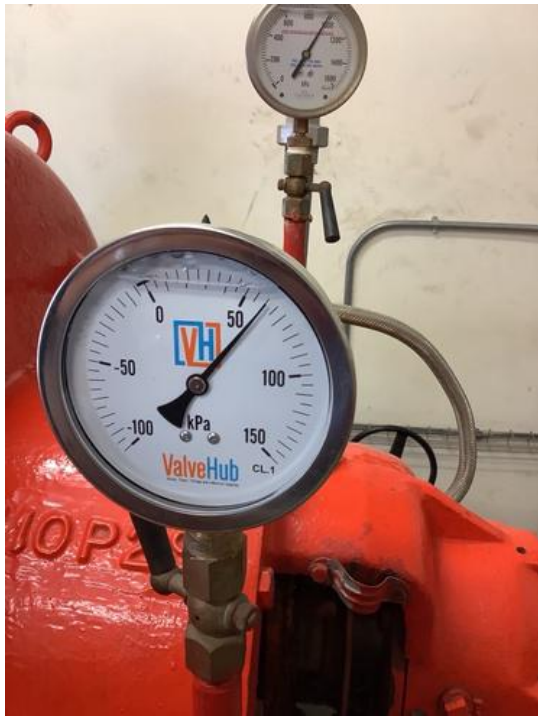
6.8.13 Sight Glass Clean	Yes
6.8.14 Flexible Coupling Correctly Installed	Yes
6.8.15 Glands Condition	O.K.
6.9 Electric Motor Driven Pump - Test	
6.9.1 Panel Lamp Test	O.K.
6.9.2 Hour Meter Before Test.	
71:50	
6.9.3 Emergency Start - Button Depressed	Motor Started
6.9.4 Test - Button Depressed	Motor Started
6.9.5 Churn Pressure (kPa)	
1140	
6.9.6 Flow Test Recorded	
9000 l/min @ 980 kPa

<div>Photo 14</div> <div>Photo 15</div> <div>Photo 16</div> <div>Photo 17</div>	
6.9.7 Pump Flow Test	Passed
6.9.8 Hour Meter After Test	
71:59	
The Electric motor driven pump must be tested for at least 10 minutes every week in accordance with the minimum requirements.	
6.10 Electric Motor Driven Pump Alarms	
6.10.1 Siren Alarm	Sounded
6.10. 2 Flashing Light	Operated
Pump 2	
► Pump Type	Diesel

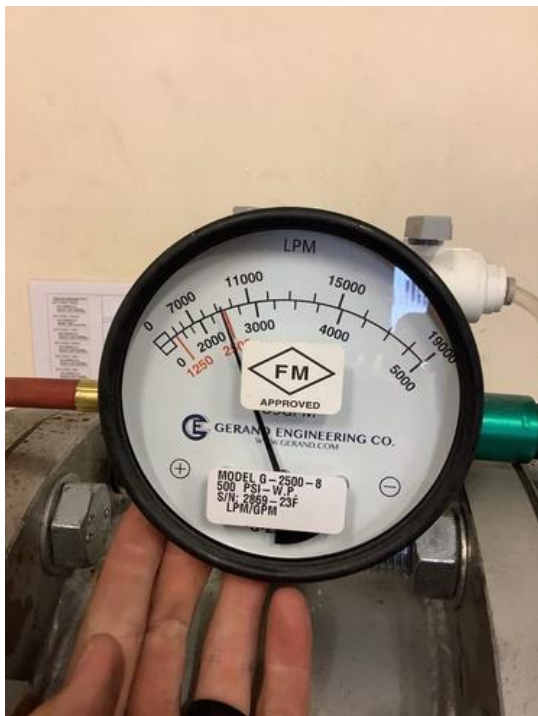
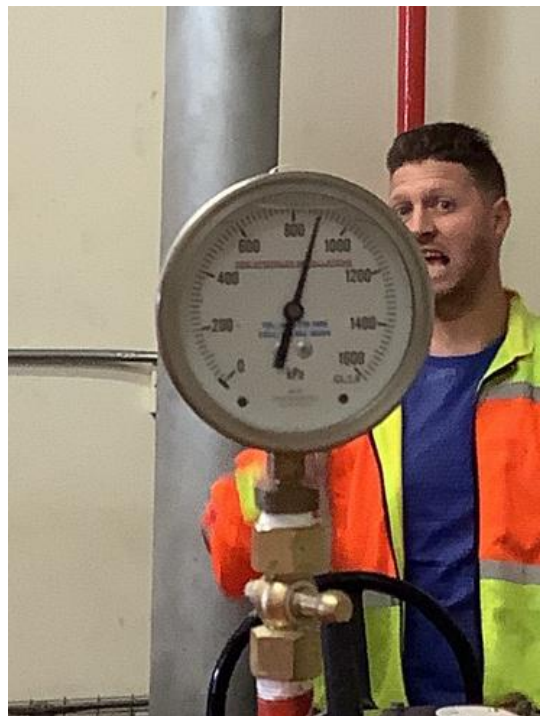
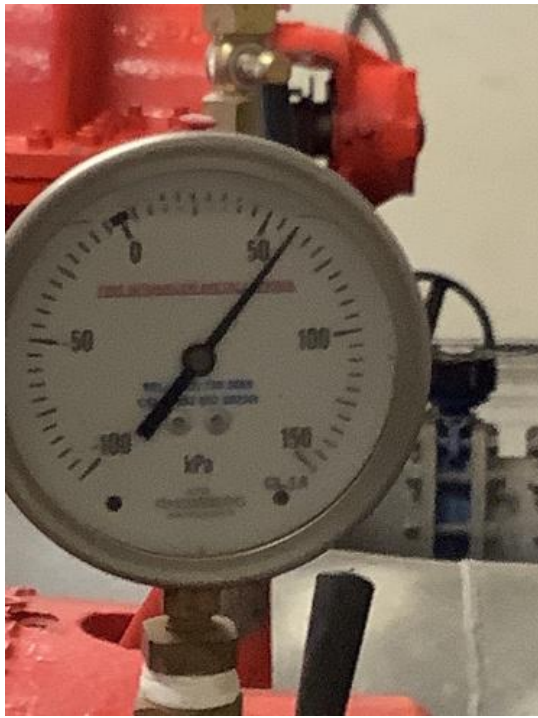
Photo 18	
6.6 Diesel Engine Driven Pump - Test	
6.6.1 Panel Lamp Test	O.K.
6.6.2 Hour Meter Before Test	
25:7	
6.6.3 Test - Button Depressed	Engine Started
6.6.4 Battery 1 - Button Depressed	Engine Started
6.6.5 Battery 2 - Button Depressed	Engine Started
6.6.6 Battery 1 & 2 - Button Depressed	Engine Started
6.6.7 RPM Recorded	
2000	
6.6.8 Churn Pressure (kPa)	
1160	
6.6.9 Flow Test Recorded	
9000 l/min @ 1000 kPa

Photo 19 Photo 20 Photo 21	
6.6.10 Pump Flow Test	Passed
6.6.11 Hour Meter After Test
