Inspection of Automatic Sprinkler System

East London Industrial Development
Zone Building HE1 (Polytech)

UNC.9263

18.06.2024 11:53 SAST

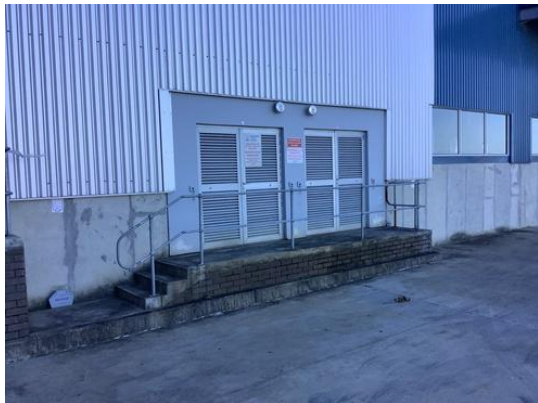
Photo 1

</div> <div> <div>Photo 1</div> <div>Photo 2</div> </div>	
Number of Alarm Valves Installed	1 x 100 mm, 1 x 200 mm
7.2 Sprinkler Valve Location Plate Installed	Yes
7.3 Fire Brigade Booster Pressure Limitation Plate	Yes
7.4 Block Plan Installed	Yes
7.4.1 Is the block plan labelled in accordance with the areas fed by the sprinkler control valve assemblies	Yes
7.4.2 Are the correct installation details recorded on the block plan	Yes
<div>

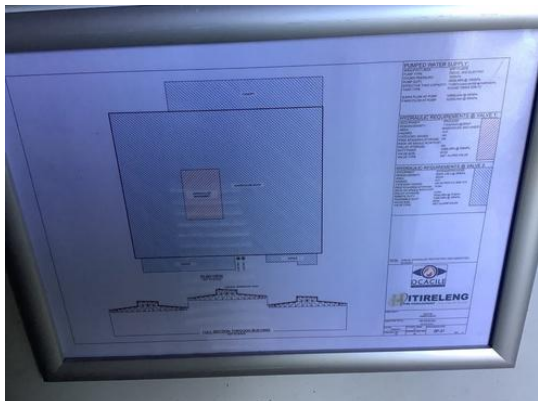
Photo 3

</div> <div> <div>Photo 3</div> <div>Photo 4</div> </div>	
7.5 Sprinkler Valve Instruction Chart	Yes
7.6 Is a sprinkler spares box present	Yes
7.6.1 Was the spares box contents accessible	Yes
7.6.2 Are the spares quantities correct	Yes
7.7 By Pass Arrangement Installed	Yes
